**PROJECT:** Closed and Load Restricted Bridge Replacements- Package 20

The South Carolina Department of Transportation (SCDOT) proposes to replace various closed or load-restricted bridges including the S-531 (Henry Funderburk Road) bridge over Mangum Creek in Chesterfield County, South Carolina. The project area is defined as that area within 75 feet of either side of the proposed roadway centerline and extending 1,500 feet from the bridge. The archaeological survey covered the entire project area, while the architectural survey examined all above-ground resources with sightlines to the bridge. This cultural resource survey was performed under contract with HNTB.

S-531 (Henry Funderburk Road) Bridge Replacement over Mangum Branch

# Bridge Replacement Package 20

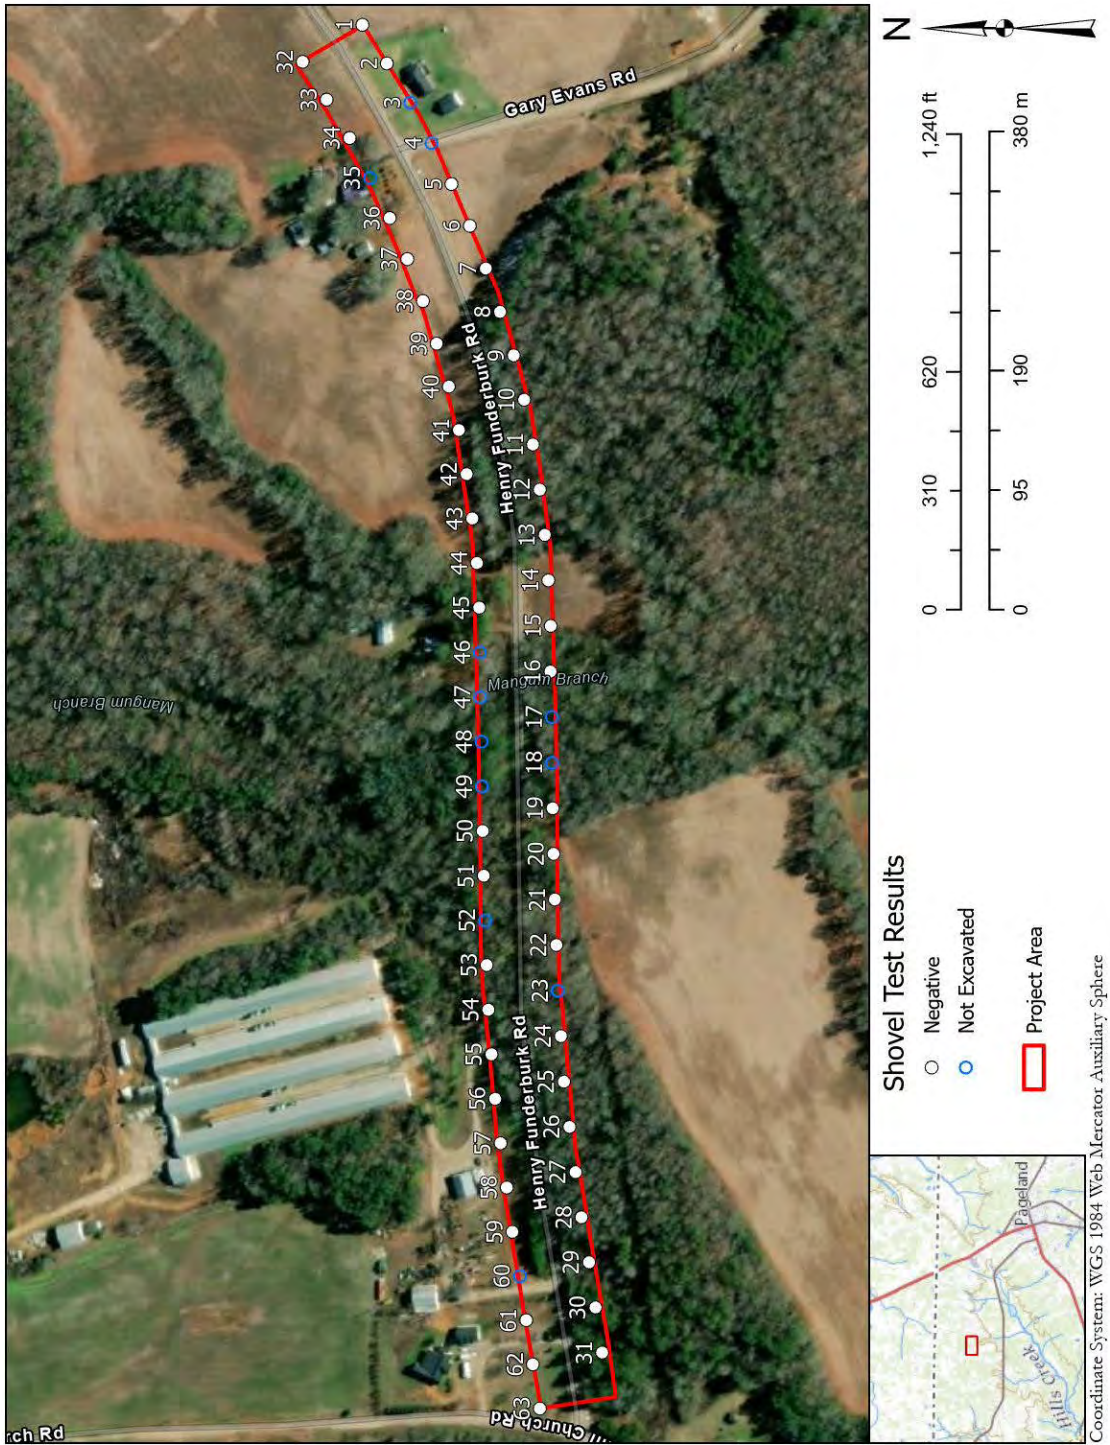
Figure 6.  
Shovel Test Map

Sixty-three shovel test locations were investigated across the project area, of which 51 were negative for cultural material. The remaining 12 shovel tests were not excavated due to very dense vegetation, gravel or paved driveways, landscaping, or waterlogged soils (Figure 6). One general soil profile was noted across the project area, consisting of approximately 15 centimeters of strong brown (7.5YR 5/6) silty loam Ap horizon overlying a yellowish red (5YR 4/6) silty clay subsoil (Figure 7). The Ap horizon contained small, angular rocks and soils throughout the project area were compacted.

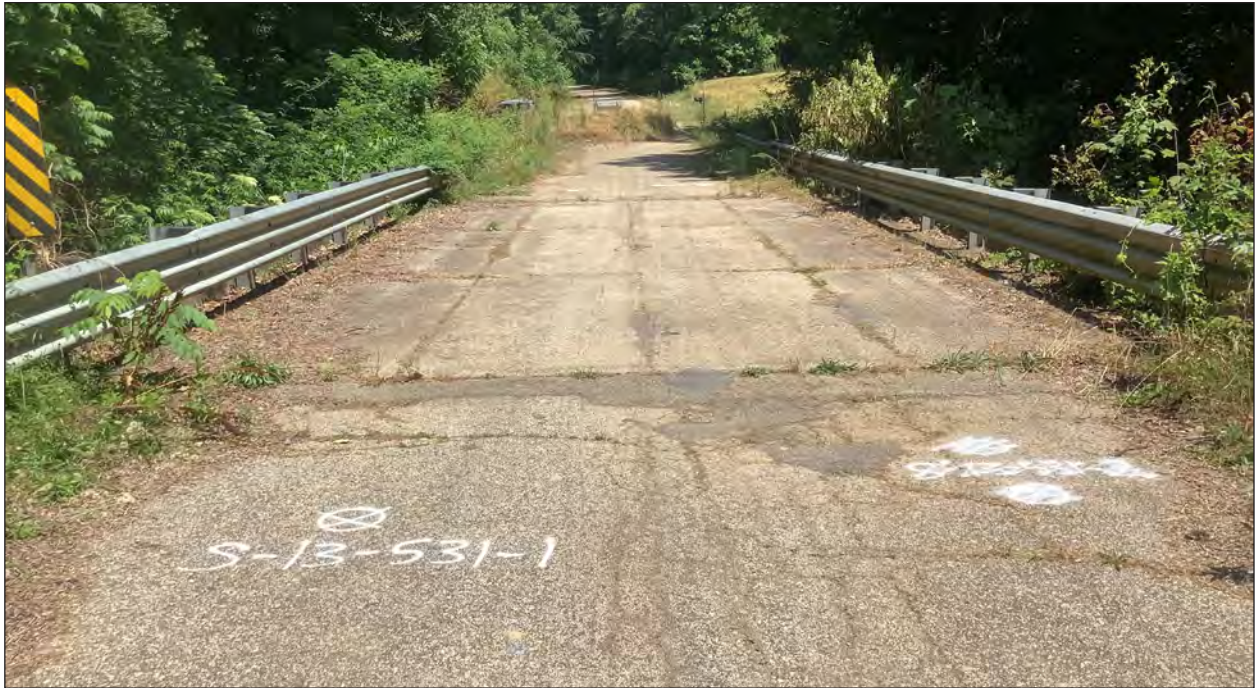
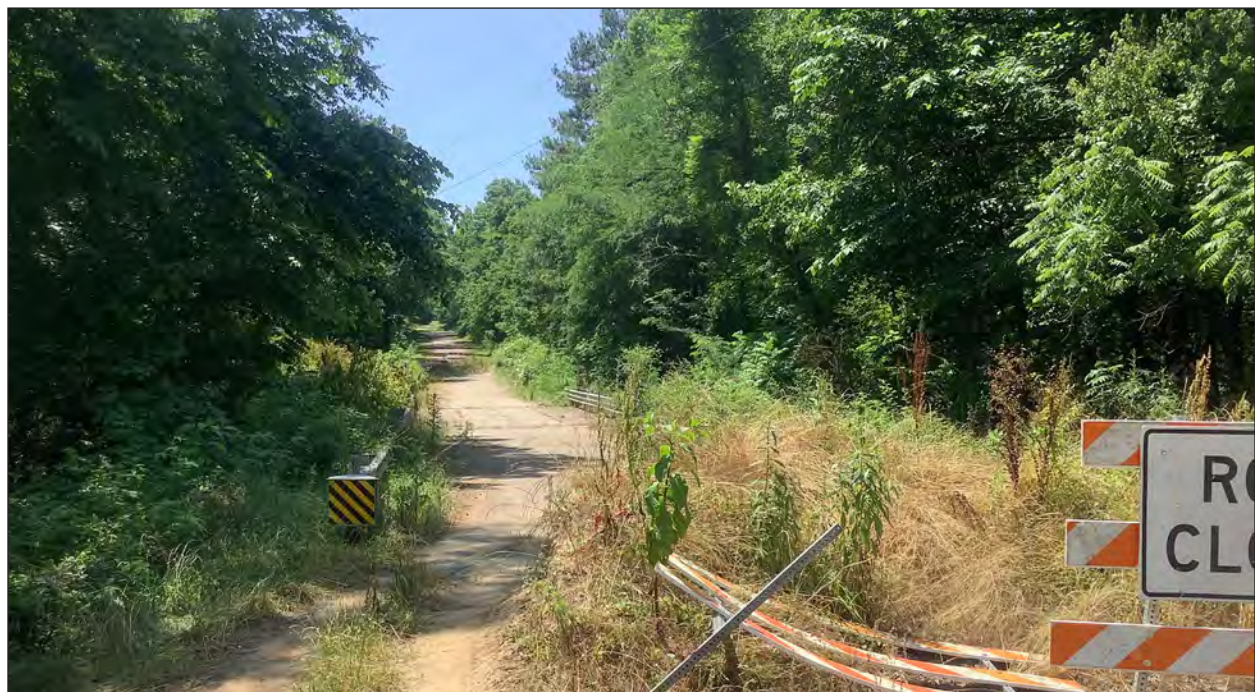
Figure 8.  
Bridge Carrying S-531 over Mangum Branch

A. Superstructure and Decking

B. Contextual

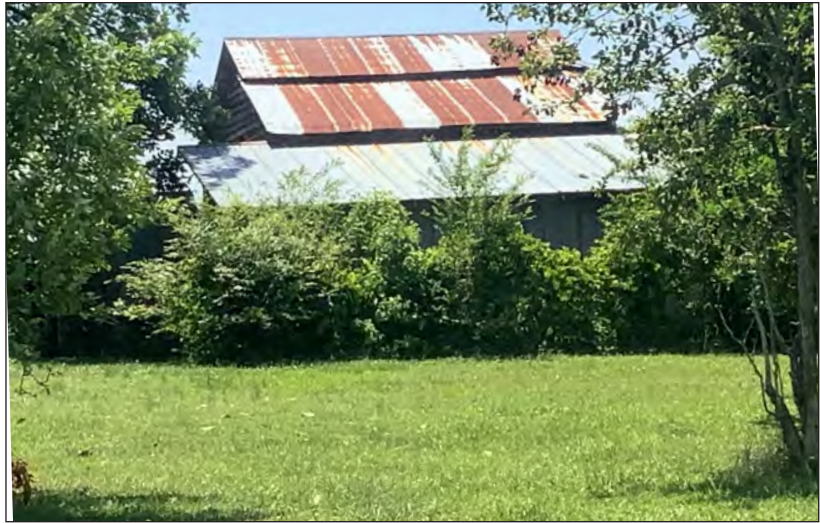
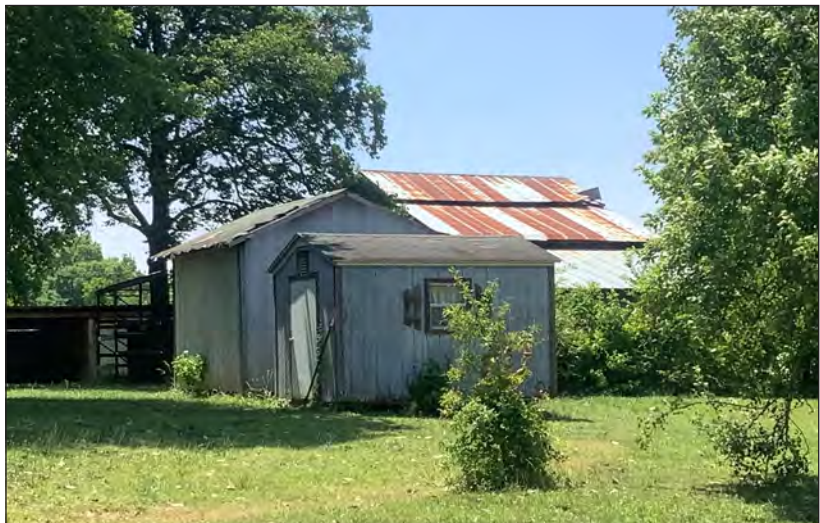
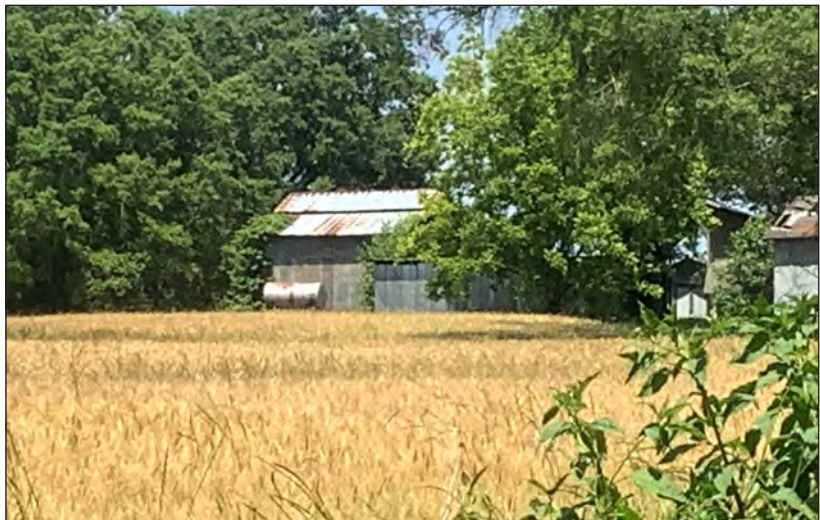
Figure 12.  
Resource 0721.01 (402 Henry Funderburk Road - Barn)

Resource 0721.01 is located roughly 100 feet northwest of Resource 0721 (Figure 12). This front-gabled barn is visible on the 1956 aerial photograph and is consistent with a circa 1950 construction date in type and materials. The barn is simple in design with corrugated metal walls and roofing material. The roofline is broken but does not form a full monitor; it is unclear whether this is due to venting at the roofline or additions to the building. A shed roofed porch has been added to the east side of the building. Resource 0721.02 is located approximately 20 feet southwest of Resource 0721.01 (Figure 13). The historic core of this agricultural outbuilding is visible in a 1956 aerial photograph. It is a frame building clad in corrugated metal siding with a corrugated metal shed roof. The building has exposed rafter tails. A large gabled addition has been made to it, more than doubling its size.

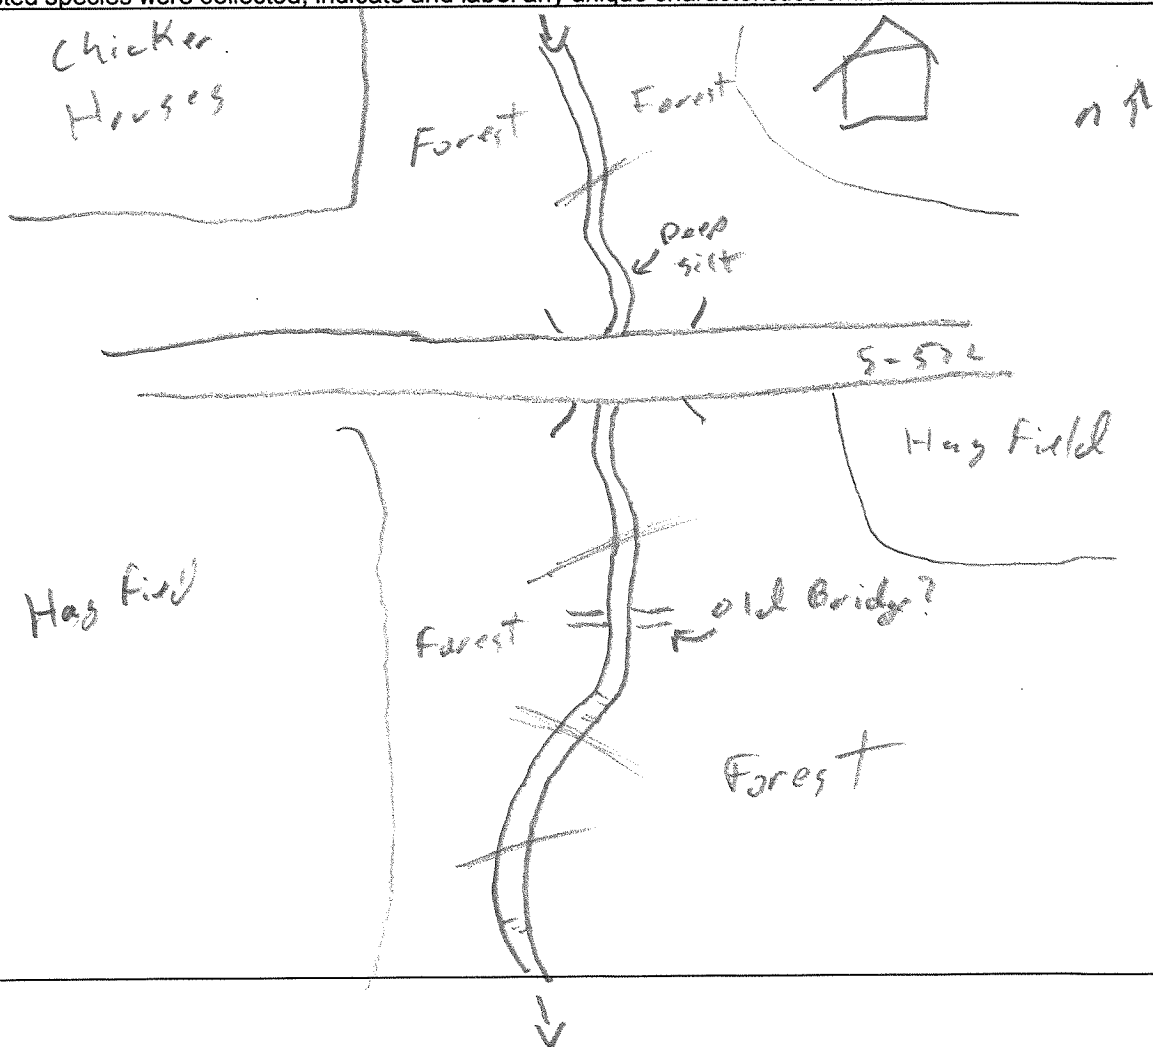
Include sketch map, using back of page if necessary. Include north arrow, flow directions, label any locations where listed species were collected, indicate and label any unique characteristics or instream structures.

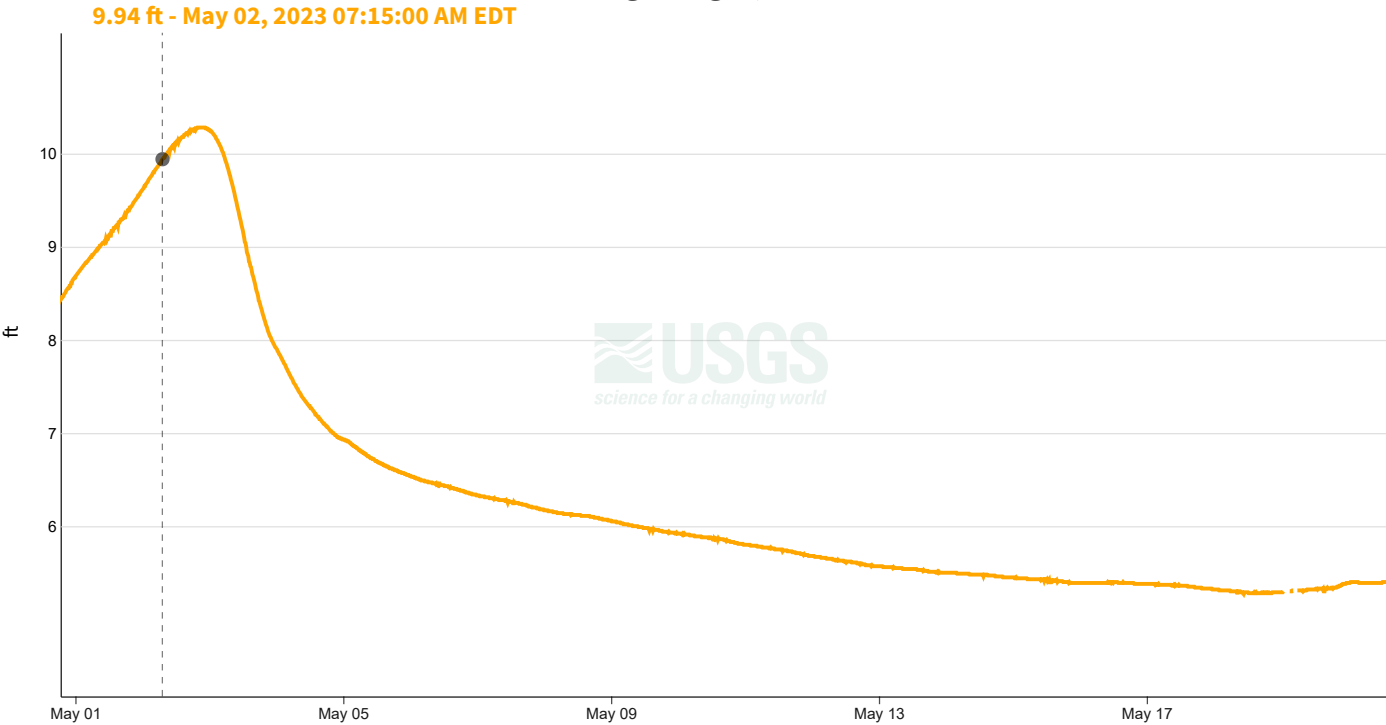
April 30, 2023 - May 20, 2023  
Gage height, ft

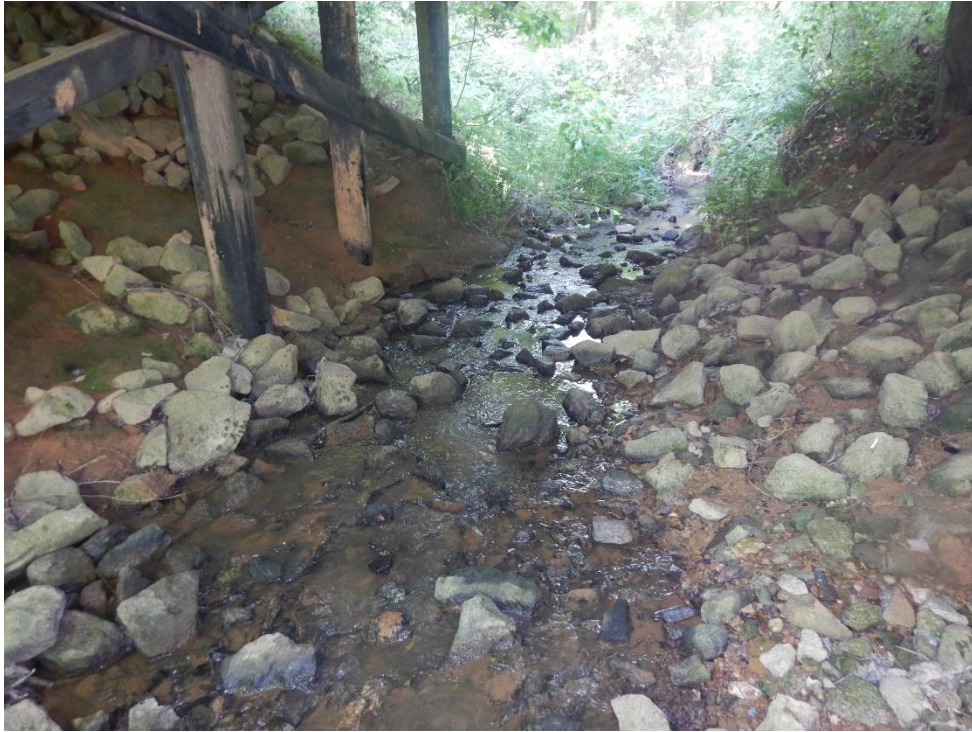
Photograph 1. At existing bridge facing upstream.

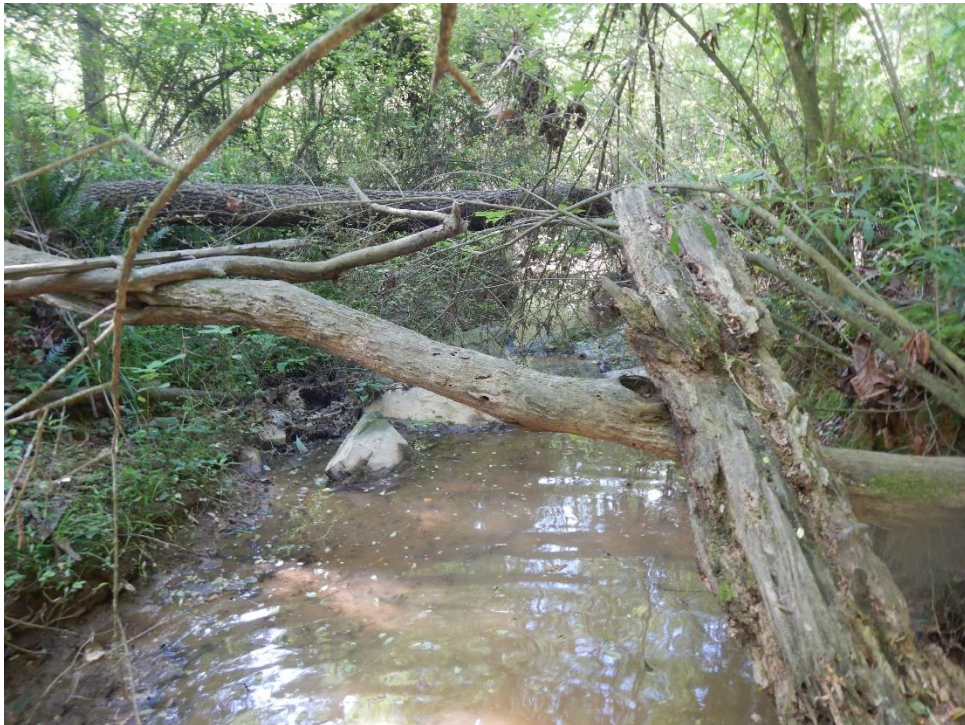
Photograph 2. 300 meters downstream of existing bridge facing downstream.

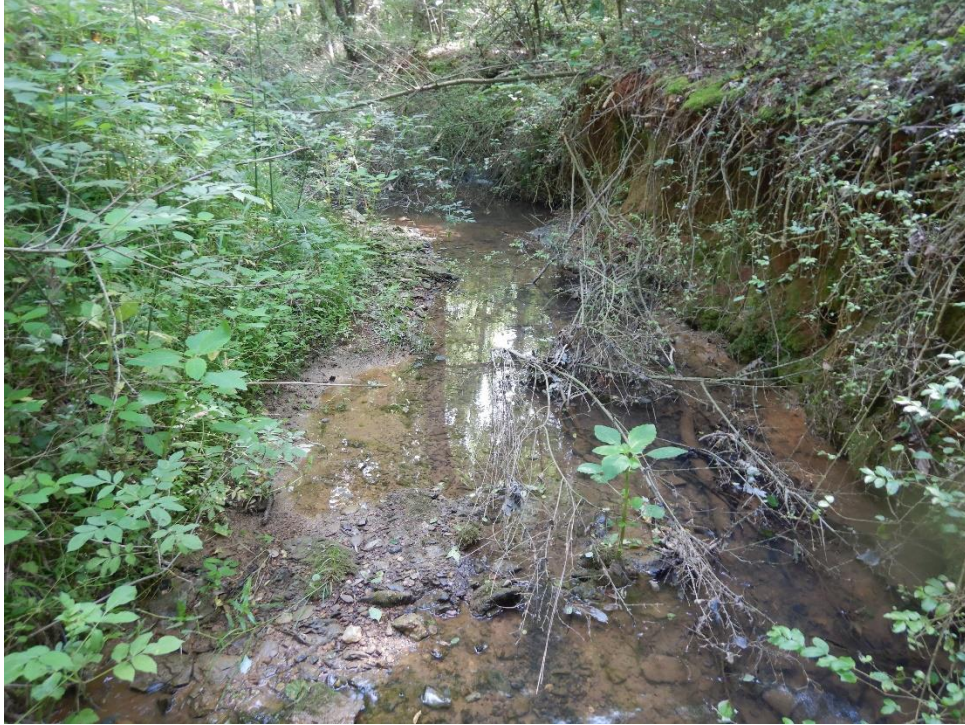
Photograph 3. 150 meters downstream of existing bridge facing upstream.

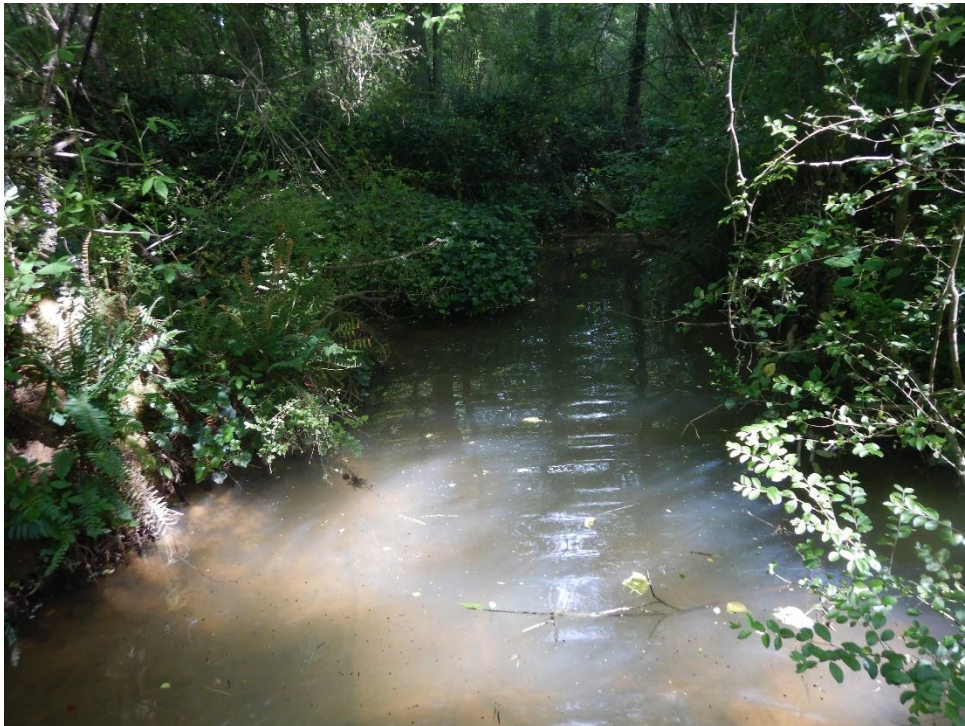
Photograph 4. 50 meters upstream of existing bridge facing upstream.
