# S-13-130 (Rudolph Sikes Road) Bridge Replacement over Clay Creek Chesterfield County, SC Geotechnical Baseline Report

August 21, 2023 (rev1) | SCDOT Project ID: P041956  
Terracon Project No.: 7323P100

Re: Geotechnical Baseline Report  
S-13-130 Bridge Replacement over Clay Creek  
Chesterfield County, South Carolina  
SCDOT Project ID.: P041956  
Terracon Project No.: 7323P100

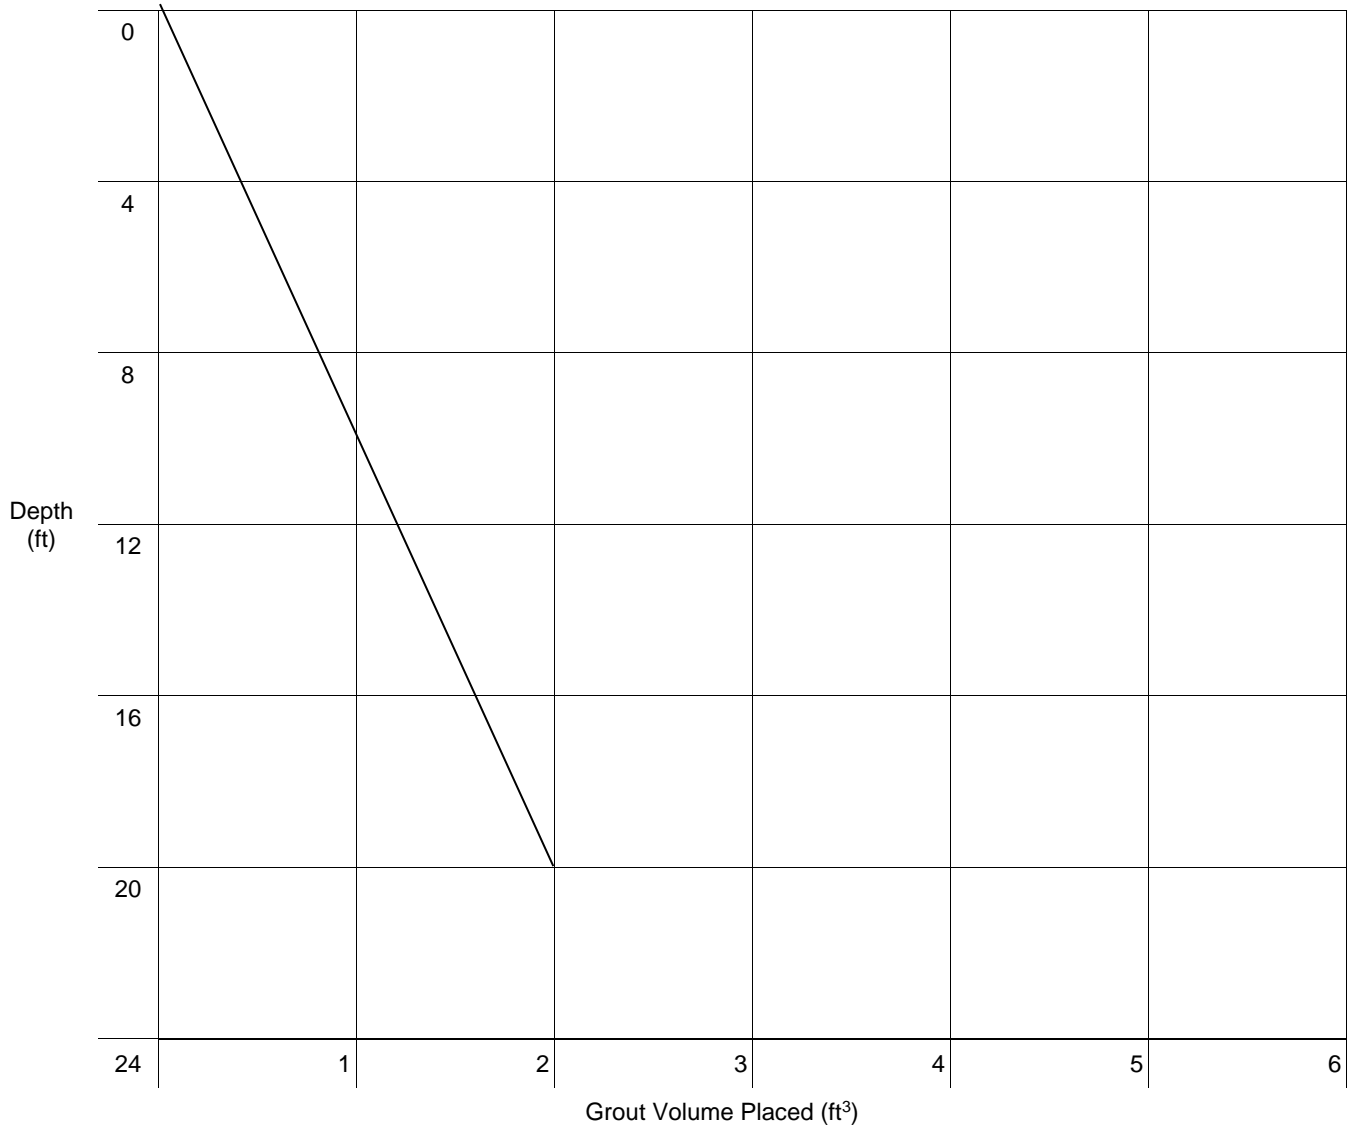
Grout Curve

Project Name:	S-13-130 BRO Clay Creek		Test Hole No.:	S-13-130-1
Project ID:	P041956		Station:	29+36.62
Consultant Firm:	Terracon Consultants, Inc.		Offset:	1.25 R
Grouted By (Driller's Name):	Truesdale	Date	6/23/23	
Notes:	Mix design: 1 pound cement, 1 pound bentonite, 6 pounds water

Number of Bags On-Site	20	ea.
Depth of Test Hole Grouted	20	ft.
Diameter of Test Hole	0.33	ft.
Area of Test Hole	0.09	ft²
Volume of Test Hole	1.74	ft³
Volume of Casing (If applicable)	-	ft³
Theoretical Volume of Test Hole	1.74	ft³
Number of Bags Used	2.5	ea.
Volume Placed	2	ft³

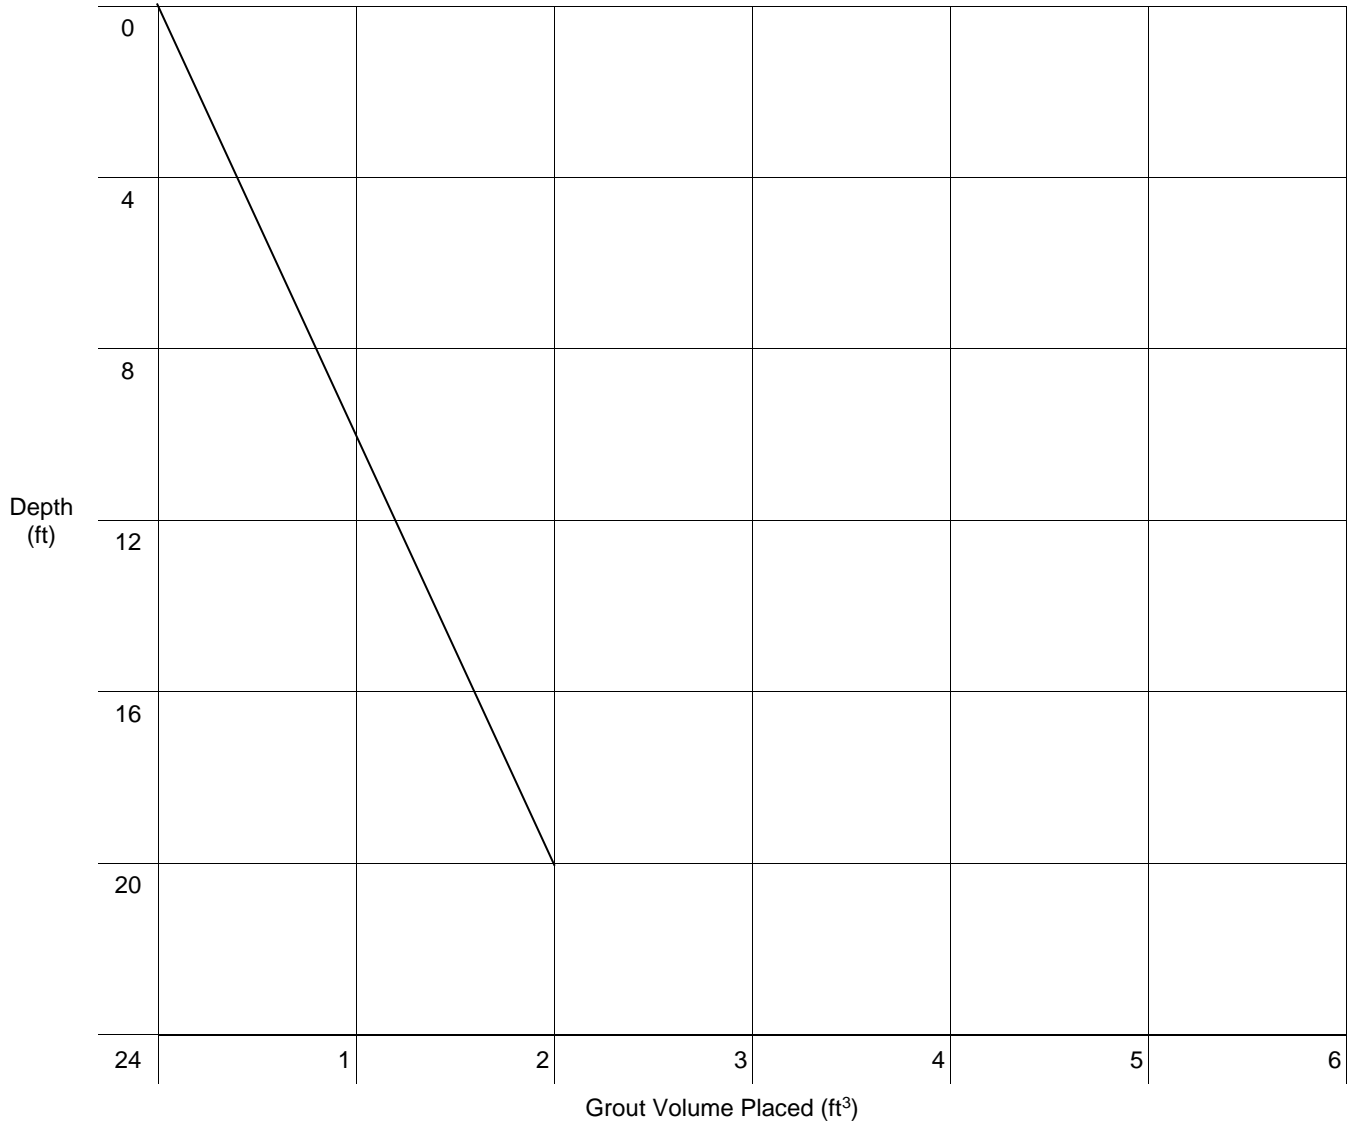
Grout Curve

Project Name:	S-13-130 BRO Clay Creek		Test Hole No.:	S-13-130-2
Project ID:	P041956		Station:	28+54.44
Consultant Firm:	Terracon Consultants, Inc.		Offset:	0.47R
Grouted By (Driller's Name):	Truesdale	Date	6/23/23	
Notes:	Mix design: 1 pound cement, 1 pound bentonite, 6 pounds water

Number of Bags On-Site	20	ea.
Depth of Test Hole Grouted	20	ft.
Diameter of Test Hole	0.33	ft.
Area of Test Hole	0.09	ft²
Volume of Test Hole	1.74	ft³
Volume of Casing (If applicable)	-	ft³
Theoretical Volume of Test Hole	1.74	ft³
Number of Bags Used	2.5	ea.
Volume Placed	2	ft³

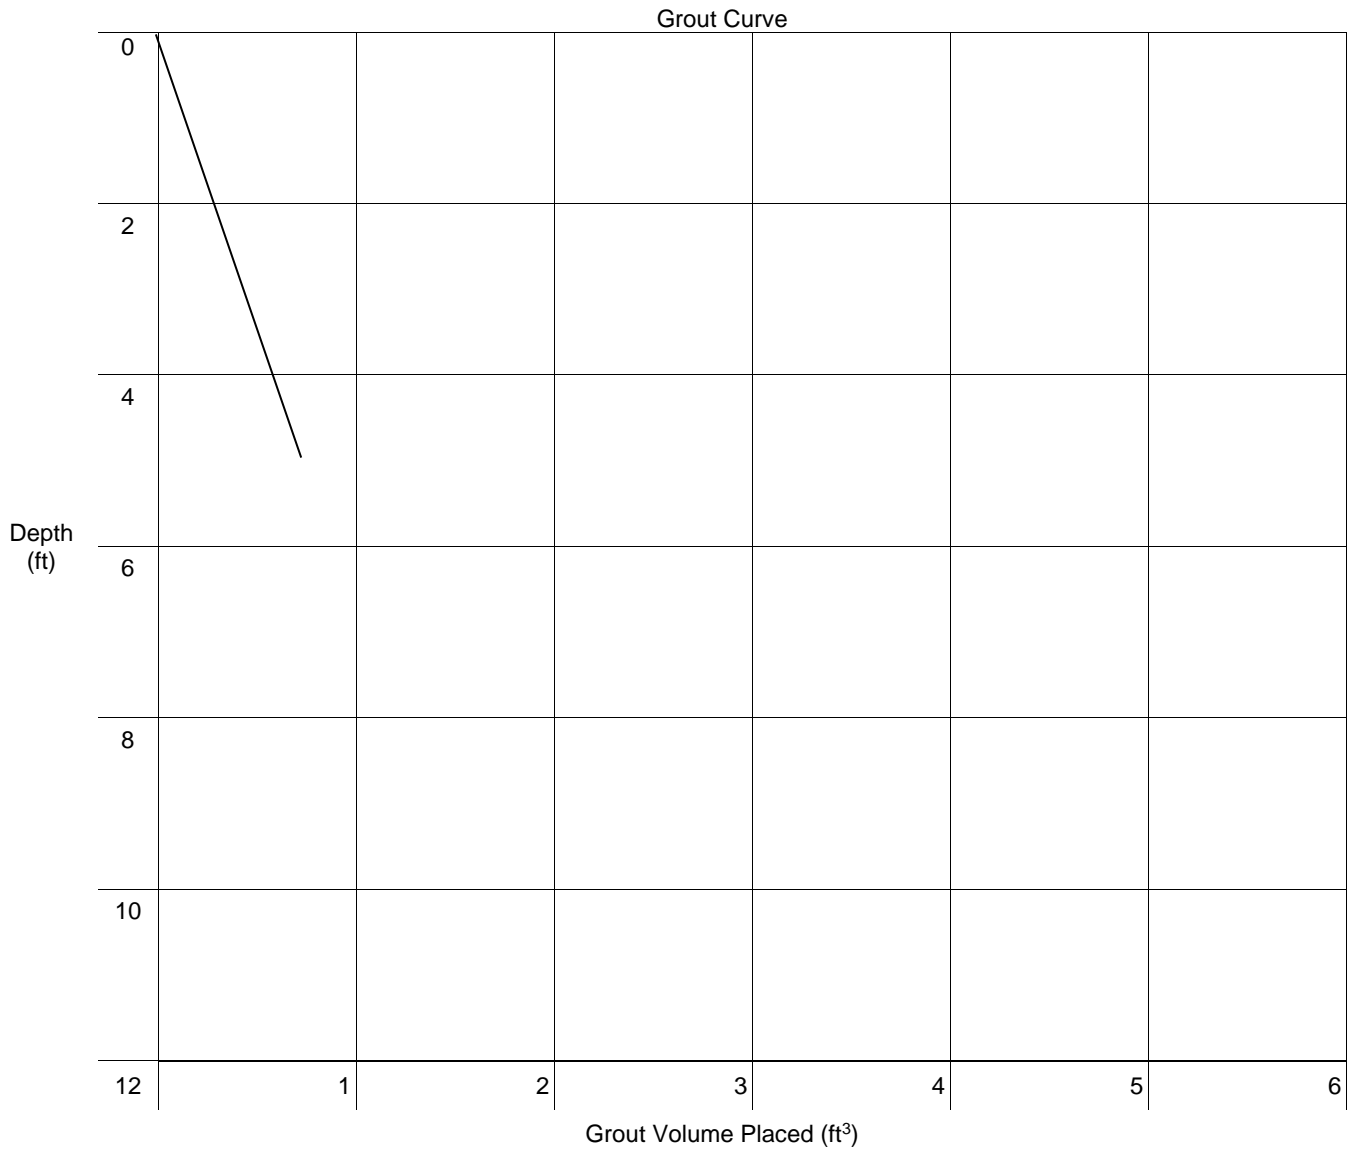
## GROUT LOG OF TEST HOLES FOR GEOTECHNICAL ON-CALL

Project Name:	S-13-130 BRO Clay Creek	Test Hole No.:	S-13-130-1
Project ID:	P041956	Station:	(BULK)
Consultant Firm:	Terracon Consultants, Inc.	Offset:	29+36.62
Grouted By (Driller's Name):	Truesdale	Date	6/22/23
Notes:	Mix design: 1 pound cement, 1 pound bentonite, 6 pounds water		1.25 R

Number of Bags On-Site	20	ea.
Depth of Test Hole Grouted	5	ft.
Diameter of Test Hole	0.5	ft.
Area of Test Hole	0.2	ft <sup>2</sup>
Volume of Test Hole	1.0	ft <sup>3</sup>
Volume of Casing (If applicable)	-	ft <sup>3</sup>
Theoretical Volume of Test Hole	1.0	ft <sup>3</sup>
Number of Bags Used	1.5	ea.
Volume Placed	0.7	ft <sup>3</sup>

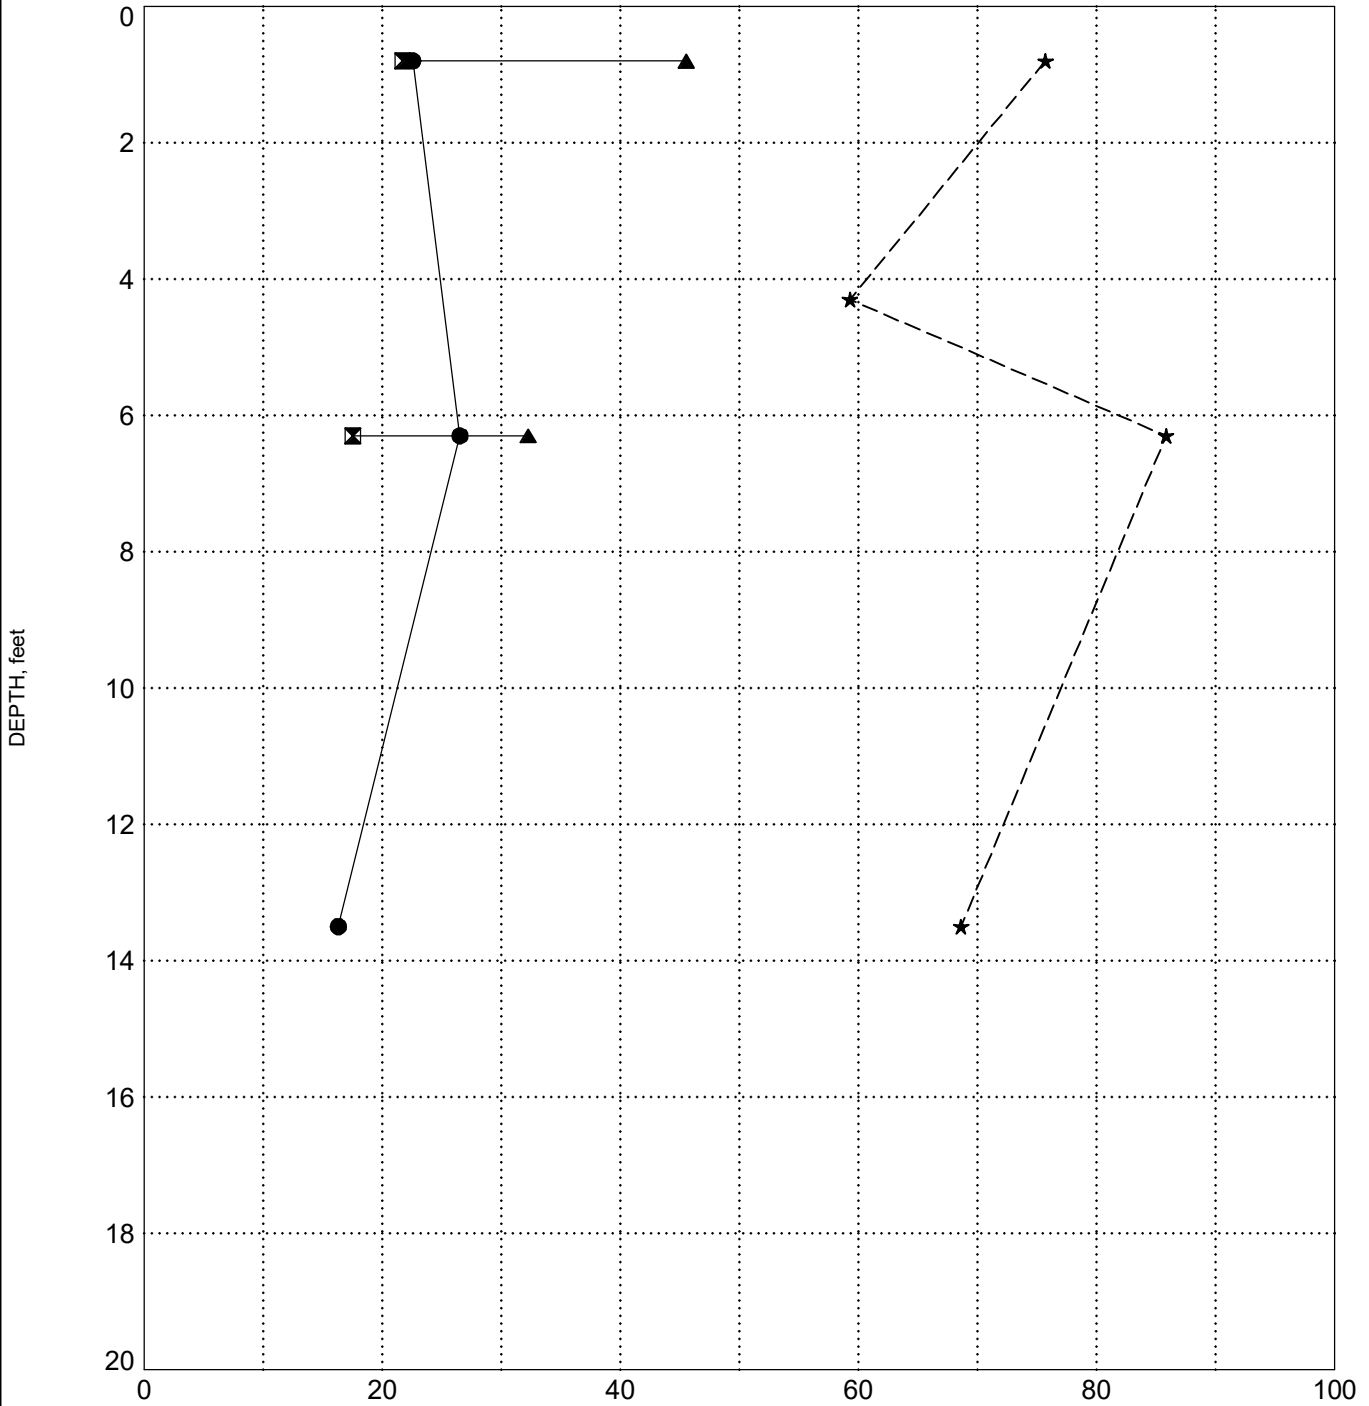
## BORING S-13-130-1

SURFACE ELEVATION: 313.2

LEGEND	
●	Water Content
⊠	Plastic Limit
▲	Liquid Limit
★	Fines

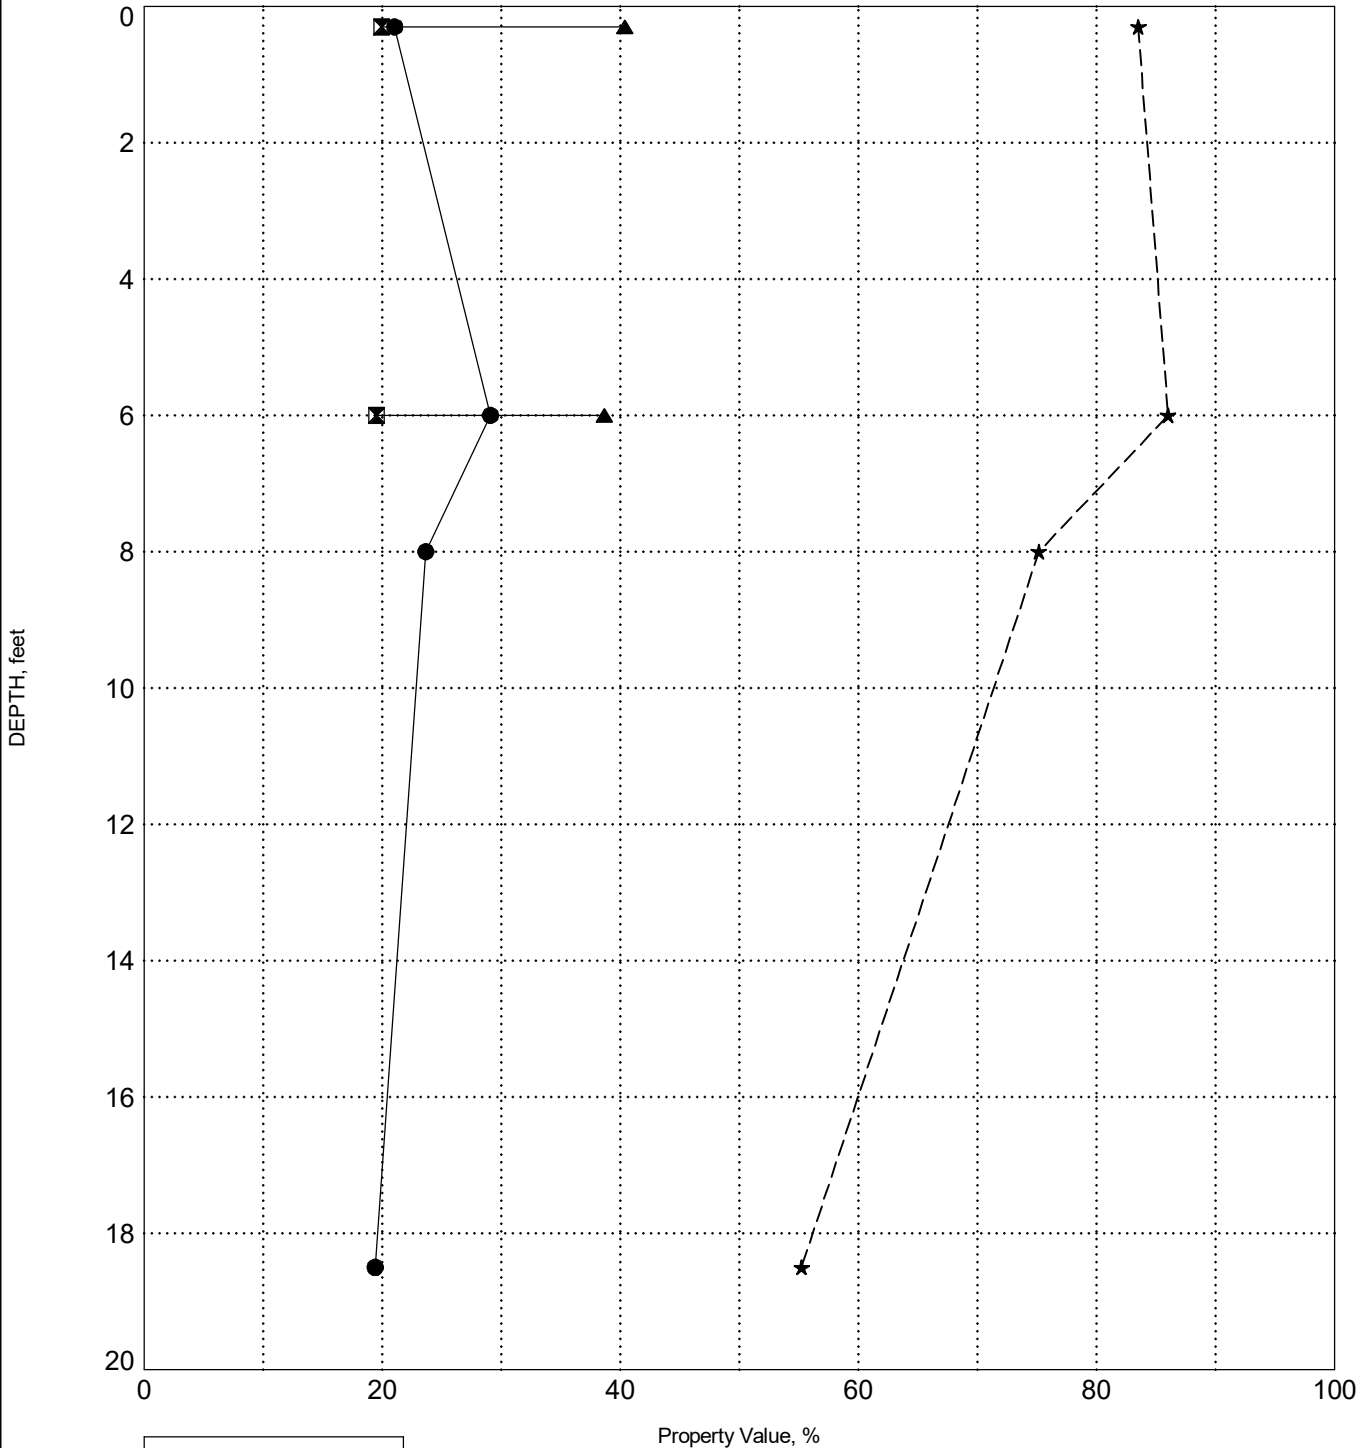
## BORING S-13-130-2

SURFACE ELEVATION: 313.3

LEGEND	
●	Water Content
⊠	Plastic Limit
▲	Liquid Limit
★	Fines

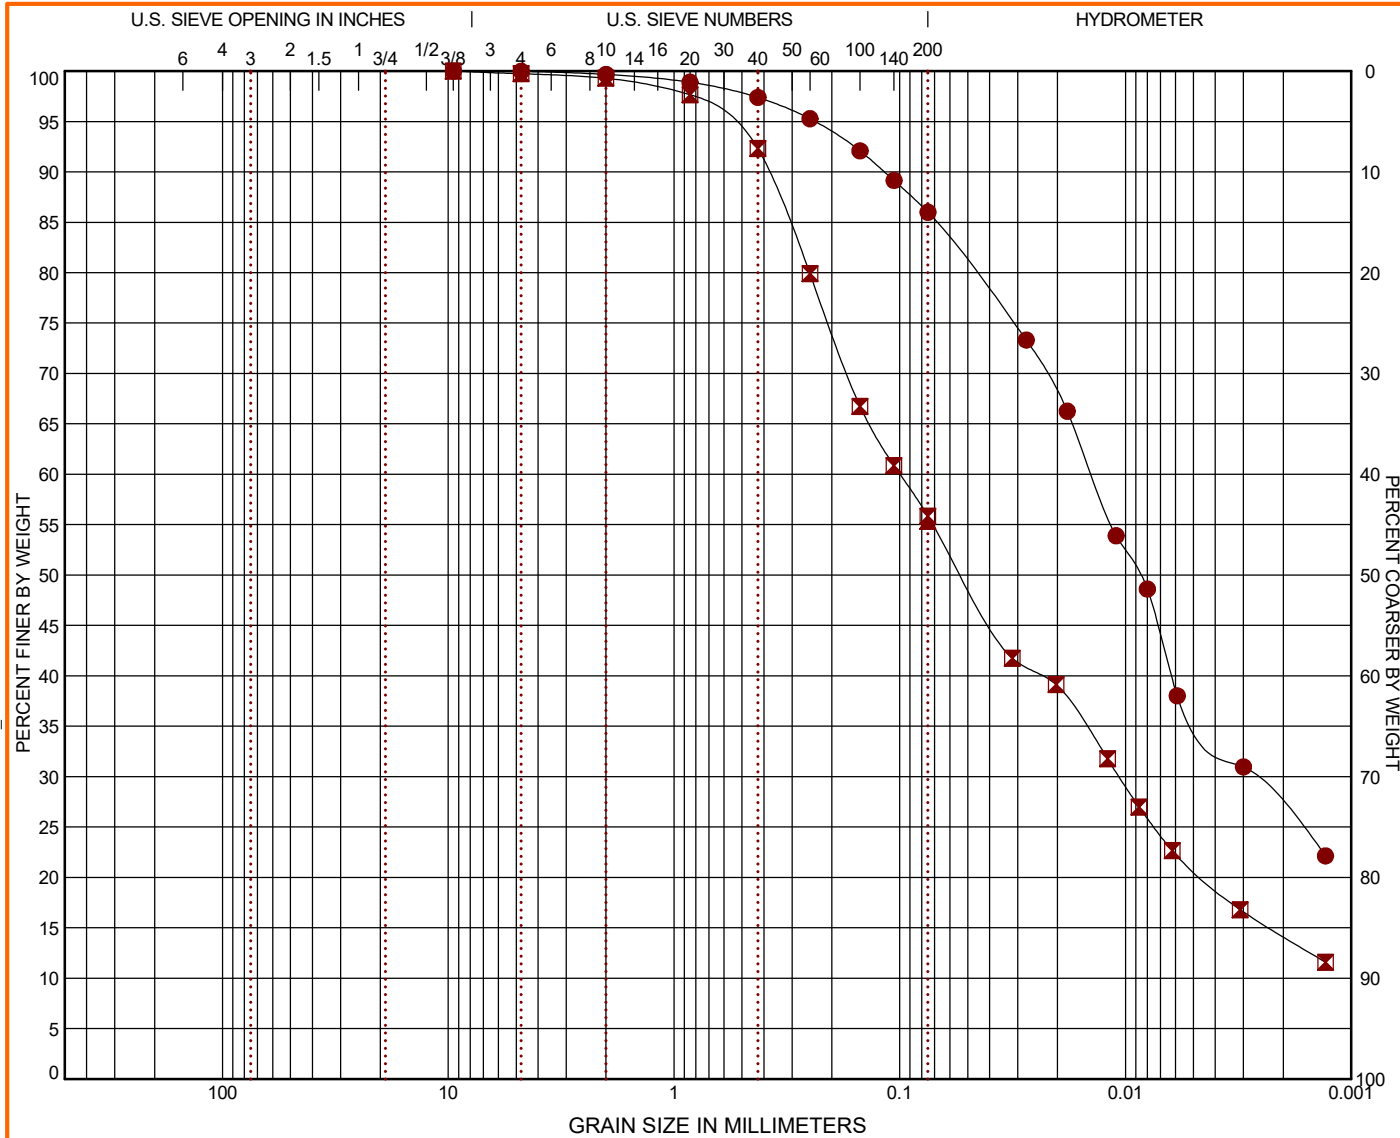
COBBLES	GRAVEL		SAND			SILT OR CLAY
	coarse	fine	coarse	medium	fine

BORING ID	DEPTH	% COBBLES	% GRAVEL	% SAND	% SILT	% FINES	% CLAY	USCS
● S-13-130-2	6 - 8	0.0	0.0	14.0	49.7		36.3	CL
✕ S-13-130-2	8 - 10	0.0	0.3	43.9	35.0		20.8	
▲ S-13-130-2	18.5 - 20					55.2

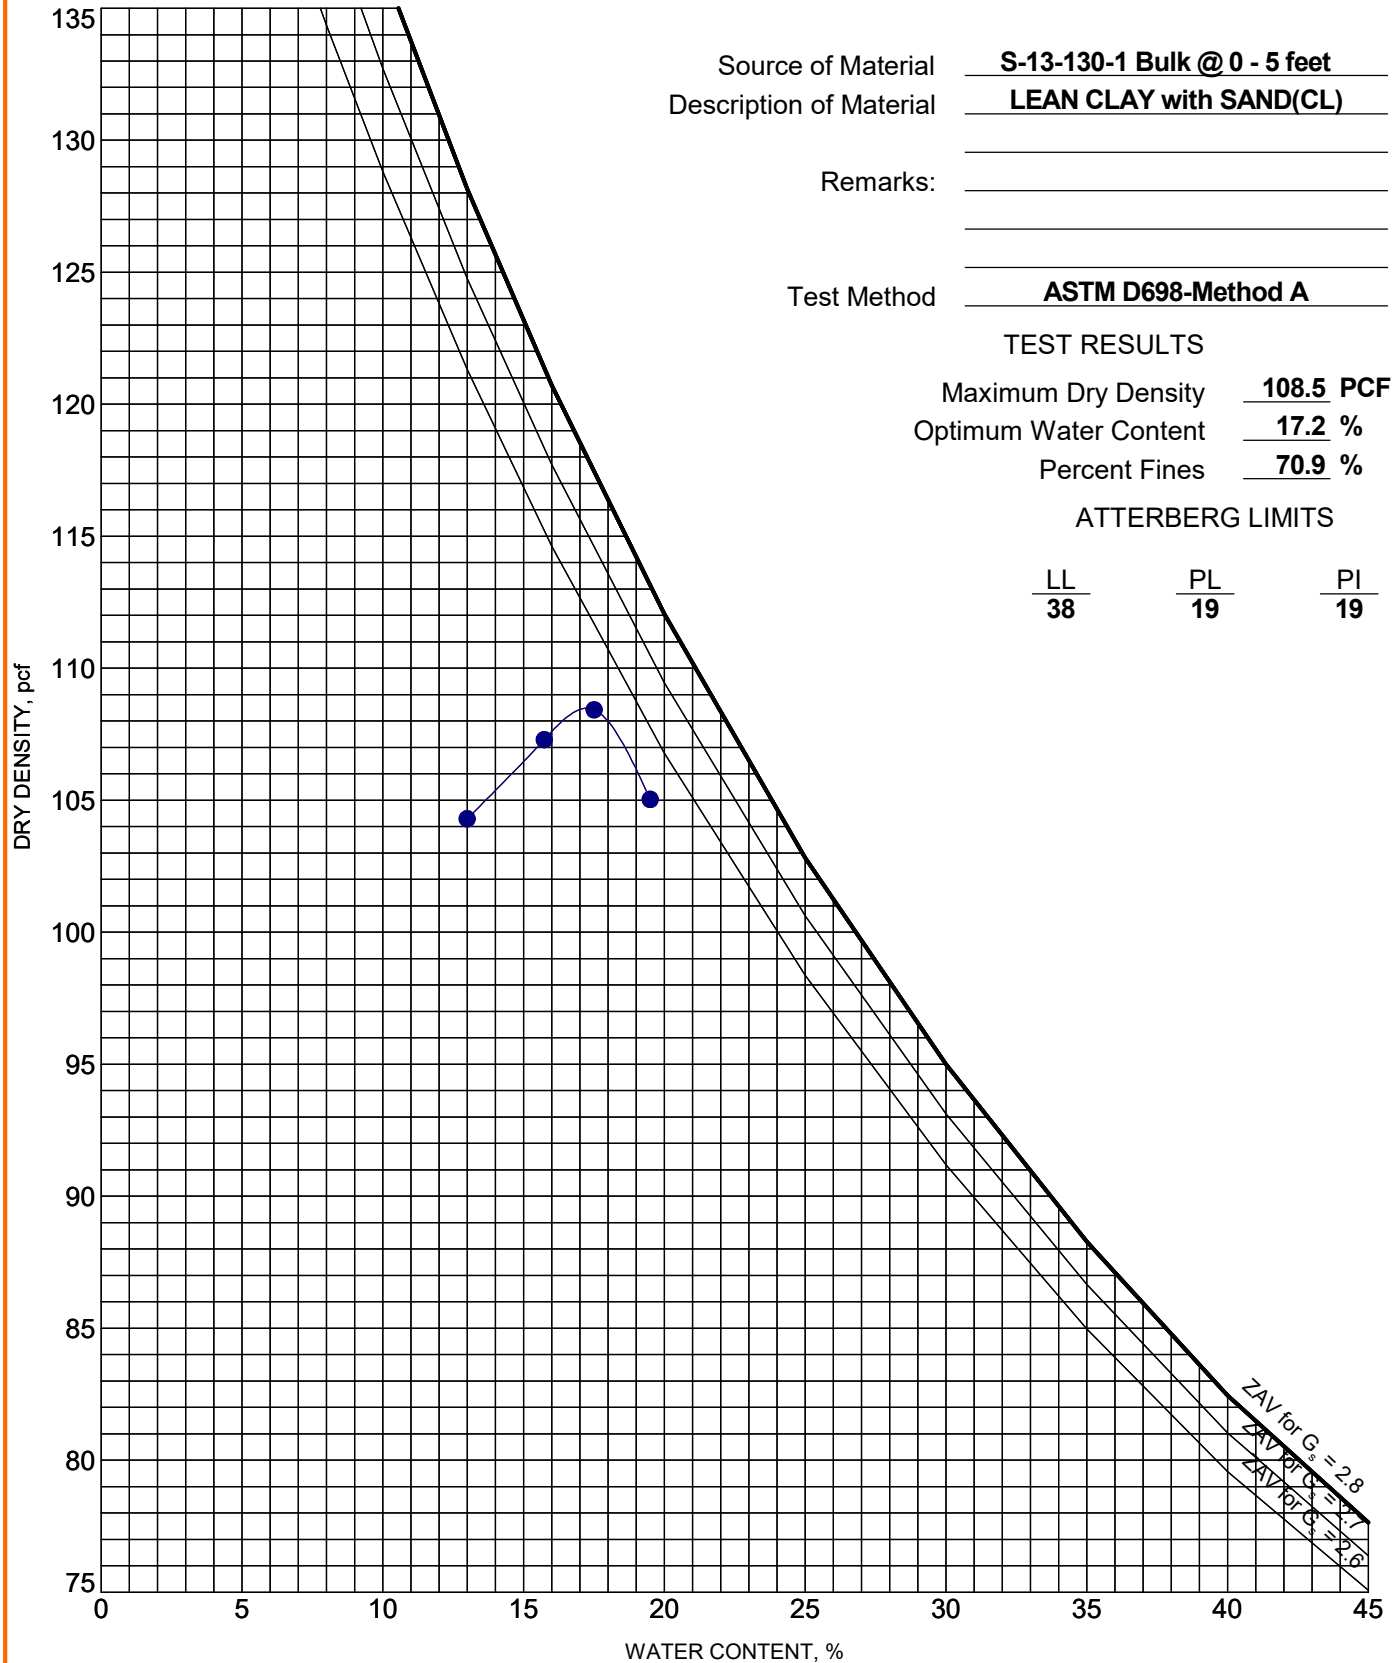
# MOISTURE-DENSITY RELATIONSHIP

ASTM D698/D1557

Sample No.	Station	Offset (ft)	Sample Depth (ft)	USCS Soil Type	Compaction		Shear Strength <sup>1</sup>	
					Optimum Moisture (%)	Max Dry Density (pcf)	c', c (psf)	φ', φ (°)
S-13-130-1	29+36.62	1.25 R	0 – 5	CL	17.2	108.5	187, 778	32, 6

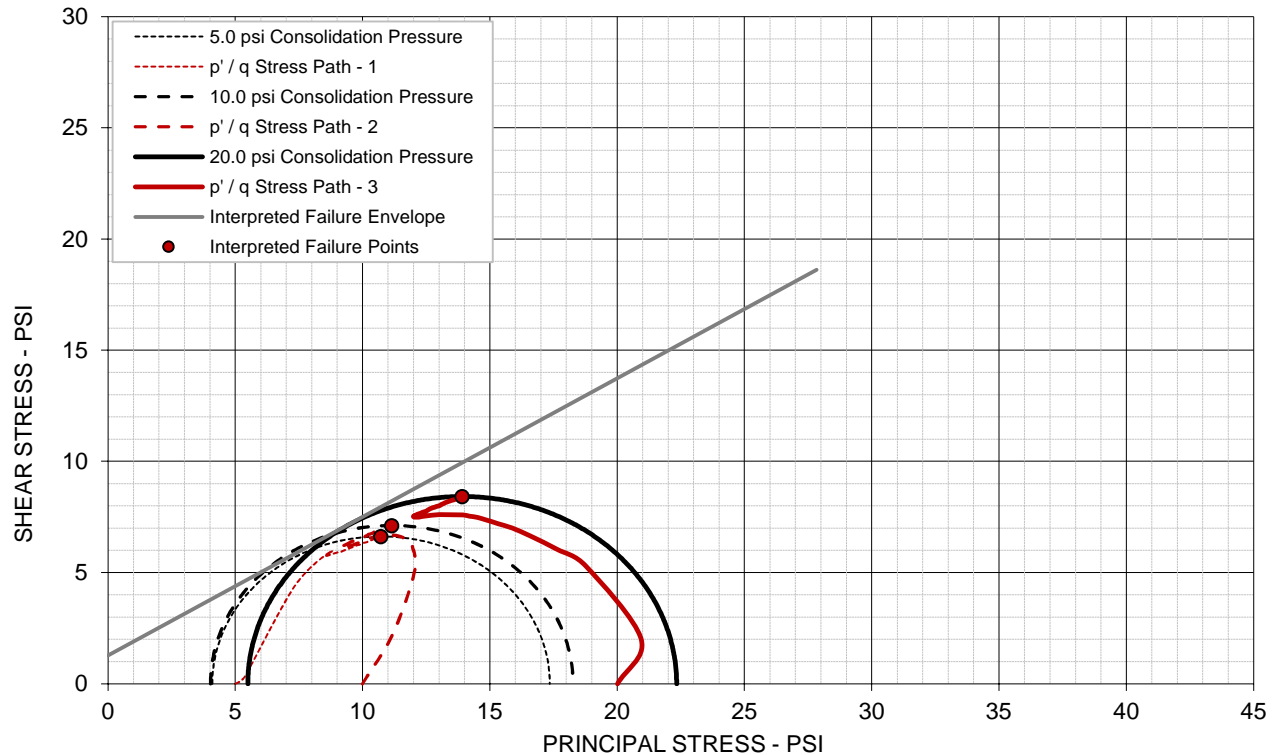
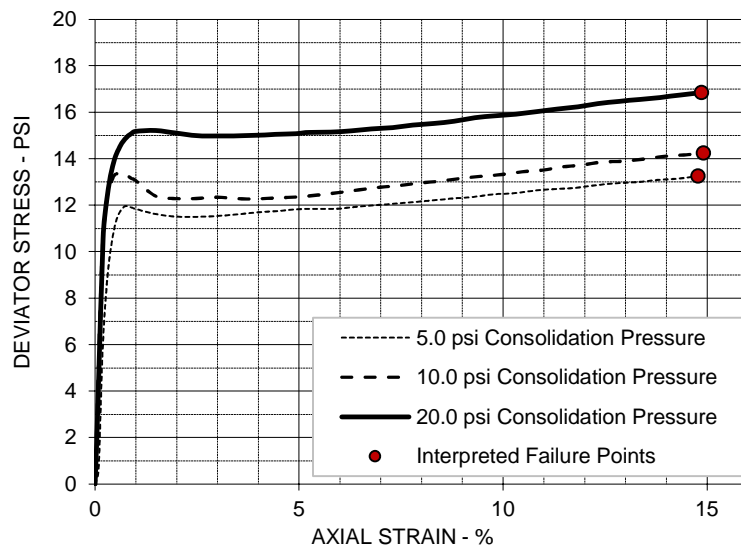
## ASTM D4767 / AASHTO T297

Failure Criteria: Max Deviator Stress

### EFFECTIVE STRESS PARAMETERS

$\phi' = 31.9$  deg  $c' = 1.3$  psi

Final Moisture - %	21.7	21.1	20.5
Dry Density - pcf	103.2	103.6	104.3
Calculated Diameter (in.)	2.84	2.85	2.83
Height - inches	5.97	5.98	5.94
Effect. Consol. Stress - psi	5.0	10.0	20.0
Failure Stress - psi	13.26	14.24	16.84
Total Pore Pressure - psi	80.9	86.0	94.5
Strain Rate - %/min.	0.0334	0.0331	0.0336
Failure Strain - %	14.8	14.9	14.9
$\sigma_1'$ Failure - psi	17.35	18.26	22.33
$\sigma_3'$ Failure - psi	4.09	4.03	5.49

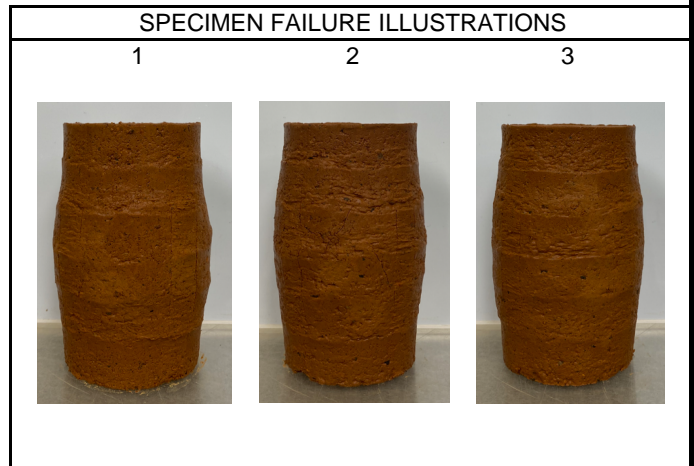
EFFECTIVE STRESS PARAMETERS	R <sup>2</sup> = 0.99	α = 27.9 deg	a = 1.1 psi
PROJECT: S-13-130 BRO Clay Creek		ISOTROPICALLY CONSOLIDATED, UNDRAINED TRIAXIAL COMPRESSION TEST	
LOCATION: Chesterfield County, SC		CLIENT: HNTB	
SAMPLE ID: S-13-130-1 Bulk 0-5'		<div>521 Clemson Road Columbia, SC</div> <div>

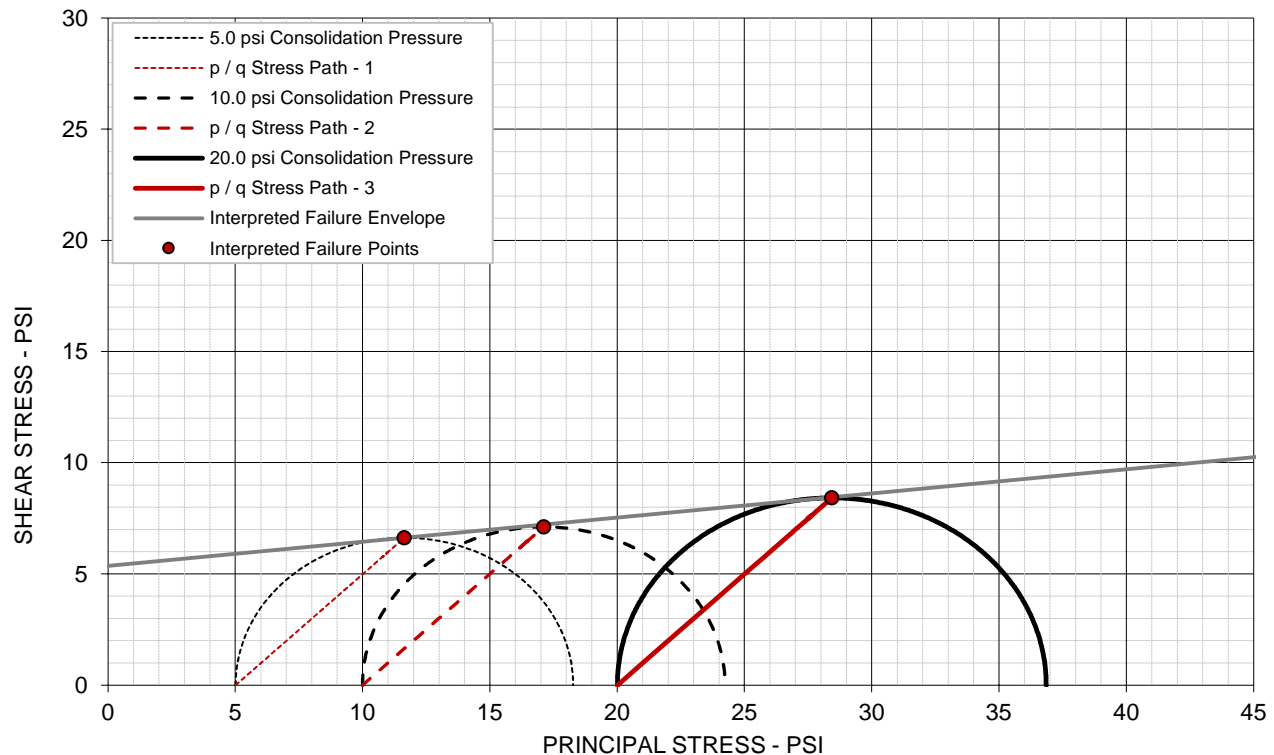
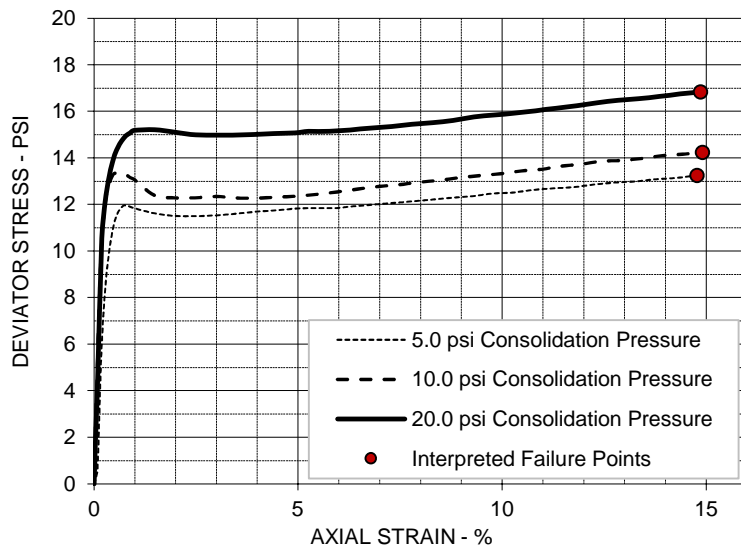
# ICU TRIAXIAL COMPRESSION TEST ASTM D4767 / AASHTO T297

Failure Criteria: Max Deviator Stress

## TOTAL STRESS PARAMETERS

$\phi = 6.2$  deg  $c = 5.4$  psi

SPECIMEN NO.	1	2	3
INITIAL			
Moisture Content - %	17.1	17.1	17.1
Dry Density - pcf	103.1	103.2	103.2
Diameter - inches	2.86	2.86	2.86
Height - inches	6.00	6.00	6.00
AT TEST			
Final Moisture - %	21.7	21.1	20.5
Dry Density - pcf	103.2	103.6	104.3
Calculated Diameter (in.)	2.84	2.85	2.83
Height - inches	5.97	5.98	5.94
Effect. Consol. Stress - psi	5.0	10.0	20.0
Failure Stress - psi	13.26	14.24	16.84
Total Pore Pressure - psi	80.9	86.0	94.5
Strain Rate - %/min.	0.0334	0.0331	0.0336
Failure Strain - %	14.8	14.9	14.9
$\sigma_1$ Failure - psi	18.27	24.23	36.85
$\sigma_3$ Failure - psi	5.01	9.99	20.01

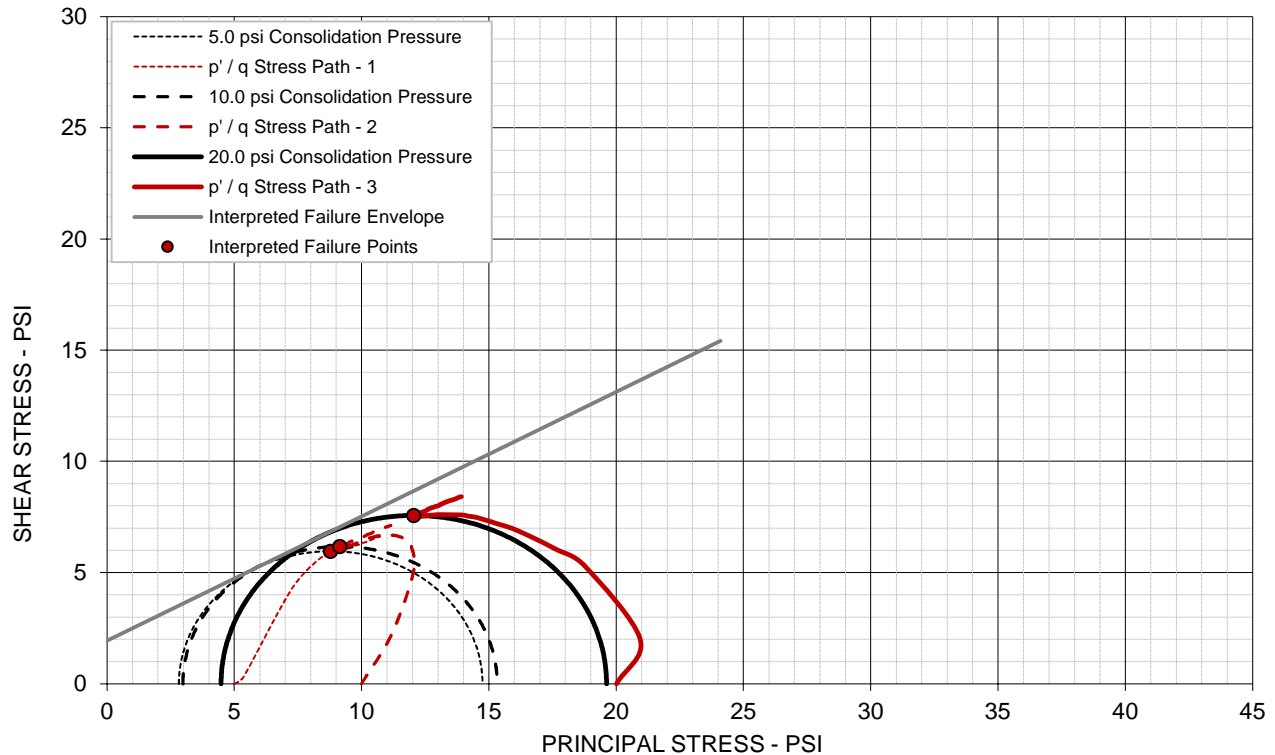
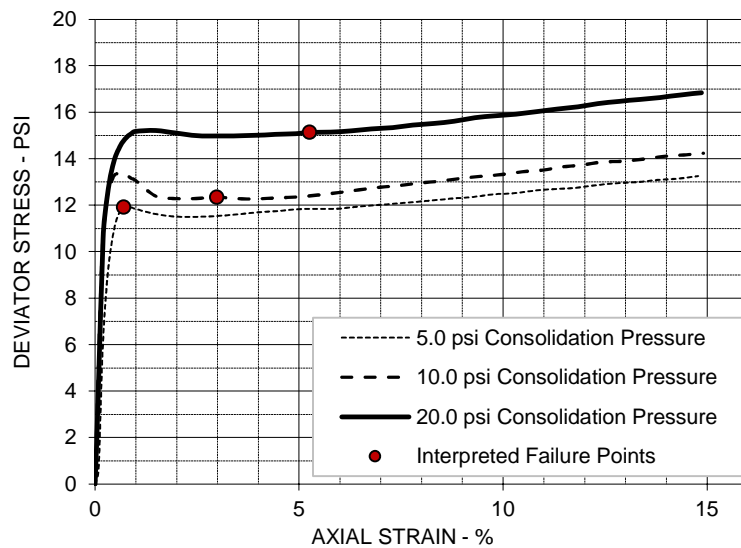
## ASTM D4767 / AASHTO T297

Failure Criteria: Max Obliquity (s1': s3')

### EFFECTIVE STRESS PARAMETERS

$\phi' = 29.2$  deg

$c' = 1.9$  psi

Final Moisture - %	21.7	21.1	20.5
Dry Density - pcf	103.2	103.6	104.3
Calculated Diameter (in.)	2.84	2.85	2.83
Height - inches	5.97	5.98	5.94
Effect. Consol. Stress - psi	5.0	10.0	20.0
Failure Stress - psi	11.92	12.35	15.14
Total Pore Pressure - psi	82.2	87.0	95.5
Strain Rate - %/min.	0.0334	0.0331	0.0336
Failure Strain - %	0.7	3.0	5.3
$\sigma_1'$ Failure - psi	14.75	15.33	19.62
$\sigma_3'$ Failure - psi	2.82	2.98	4.48

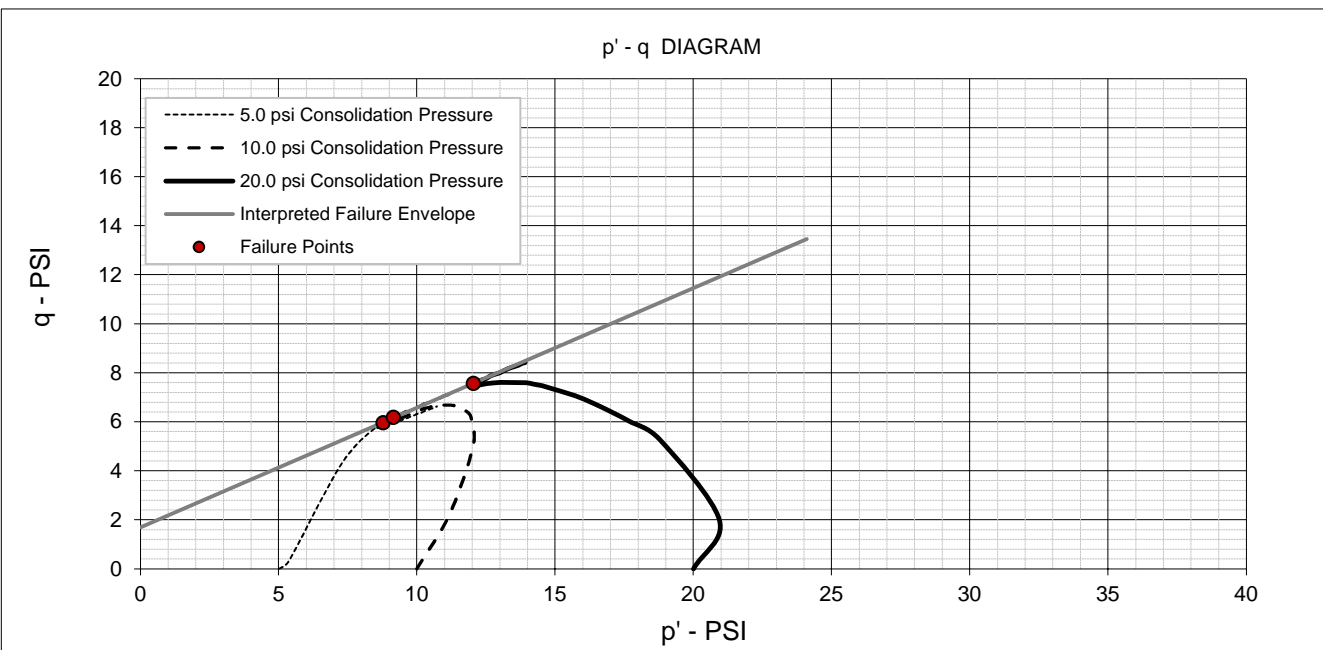
EFFECTIVE STRESS PARAMETERS		R <sup>2</sup> = 1.00	α = 26.0 deg	a = 1.7 psi
PROJECT: S-13-130 BRO Clay Creek			ISOTROPICALLY CONSOLIDATED, UNDRAINED TRIAXIAL COMPRESSION TEST	
LOCATION: Chesterfield County, SC			CLIENT: HNTB	
SAMPLE ID: S-13-130-1 Bulk 0-5'			<div>521 Clemson Road Columbia, SC</div> <div>

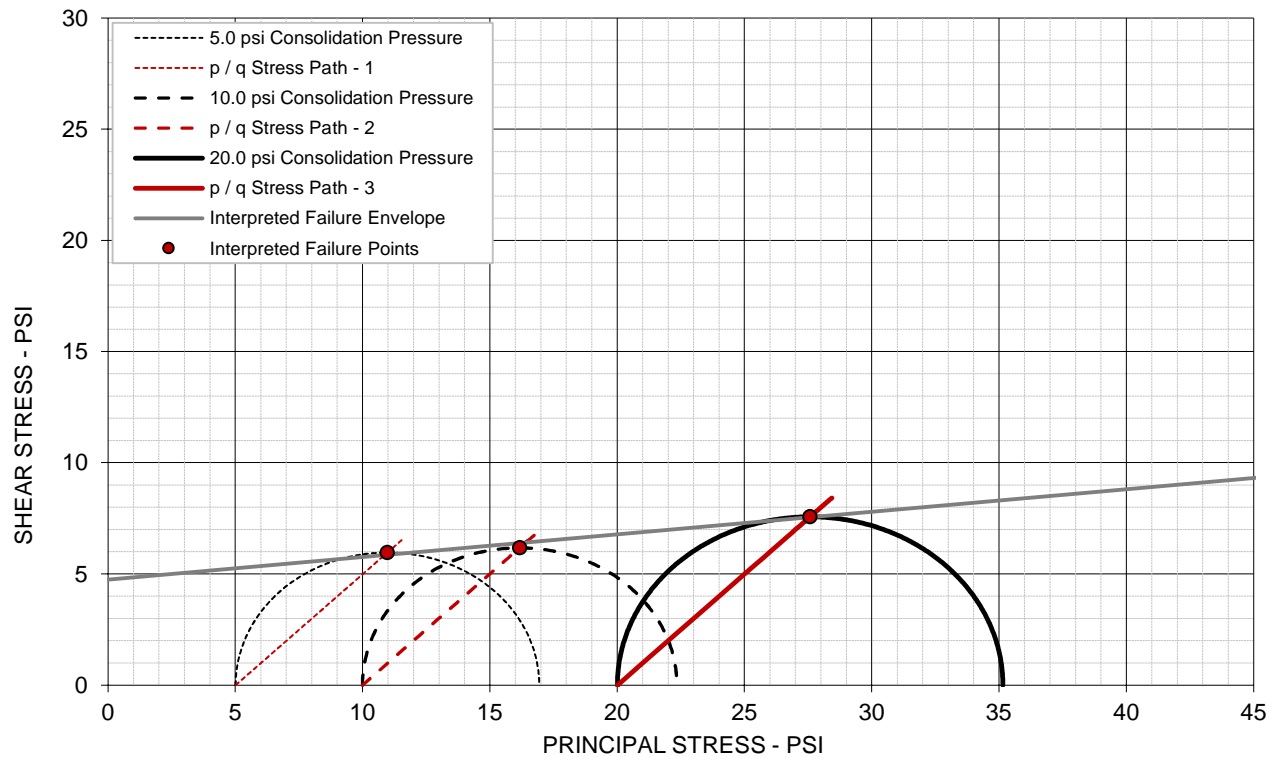
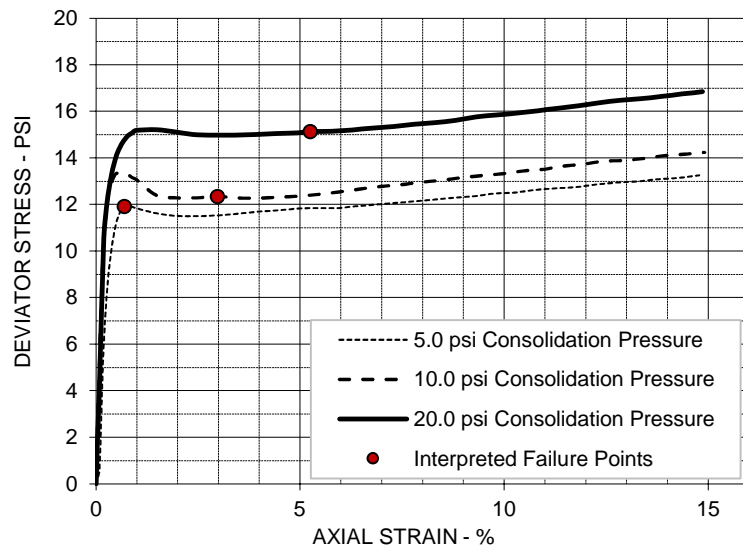
## ASTM D4767 / AASHTO T297

Failure Criteria: Max Obliquity (s1': s3')

### TOTAL STRESS PARAMETERS

$\phi = 5.8$  deg  $c = 4.8$  psi

Final Moisture - %	21.7	21.1	20.5
Dry Density - pcf	103.2	103.6	104.3
Calculated Diameter (in.)	2.84	2.85	2.83
Height - inches	5.97	5.98	5.94
Effect. Consol. Stress - psi	5.0	10.0	20.0
Failure Stress - psi	11.92	12.35	15.14
Total Pore Pressure - psi	82.2	87.0	95.5
Strain Rate - %/min.	0.0334	0.0331	0.0336
Failure Strain - %	0.7	3.0	5.3
$\sigma_1$ Failure - psi	16.94	22.34	35.15
$\sigma_3$ Failure - psi	5.01	9.99	20.01
