PROCESSING FORM FOR PROGRAMMATIC CATEGORICAL EXCLUSIONS NON MAJOR FEDERAL ACTIONS

- 1	IES O.											
Proje	ct ID	P042879	Route	SC 83	County	County Marlboro						
Part 1 - Project Description												
Include the Project Name/Description												
SC Bridge Replacement over the Little Pee Dee River												
Bridge Replacement - SC 83 Little Pee Dee River, Marlboro County. Bridge is packaged together with S-58 over Beaverdam Creek in Dillon County as a part of Bridge Package 27. Asset ID 0814. Project Rank: 2014-17												
The purpose of this project is to correct the load restriction placed on the bridge and restore all components to good condition. This bridge was constructed in 1937 and was recently inspected in June of 2024 and found to be in a condition that was unsuitable for vehicular traffic and was subsequently closed to traffic. NEPA studies revealed no significant impacts or effects to resources within the project study area.												
				Part 2	2 - PCE Type

TITLE: Cultural Resources Survey of the SC 83 over Little Pee Dee River Bridge Replacement Project, Marlboro

PROJECT: SC 83 over Little Pee Dee River Bridge Replacement Project

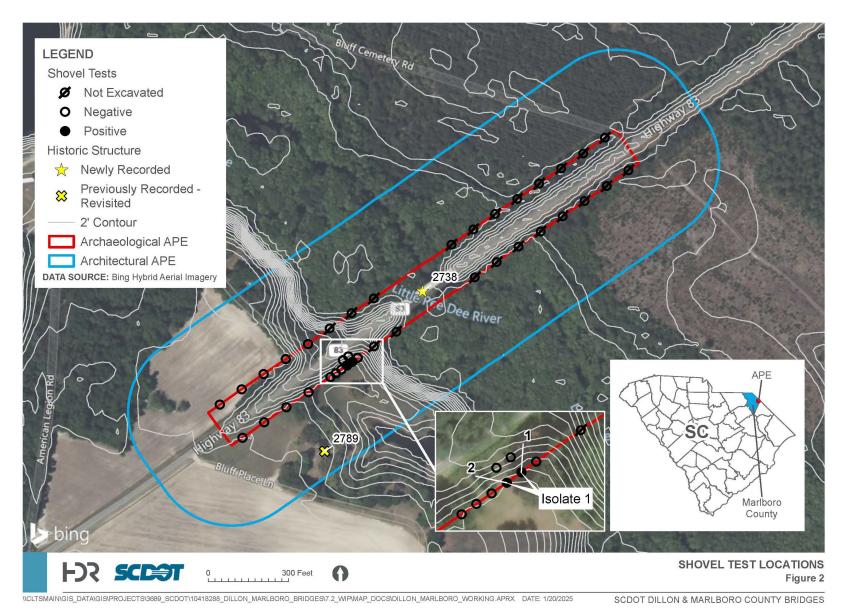
Figure 2. Aerial image showing shovel test locations and newly recorded cultural resources.

ARCHAEOLOGICAL SURVEY: Investigators conducted an intensive archaeological survey on December 5, 2024. The archaeological survey consisted of intensive shovel testing within upland areas. No shovel tests were excavated within wetland areas or areas with steep slope. All shovel test locations were visited, and visual inspection was conducted within areas that displayed good ground surface visibility. Figure 2 presents the locations of shovel tests and identified archaeological resources in the APE on a modern aerial photograph. Figures 3-5 present typical views of the project area.

Investigators traversed a total of four shovel test transects, one in each of the four quadrants surrounding the bridge. The transects were placed approximately 75 feet from the road centerline. Shovel tests were excavated at 100-foot intervals along each transect, where possible. Investigators visited 32 shovel test locations and excavated a total of 11 shovel tests. The shovel tests were excavated to an average depth of 55 centimeters below surface (cmbs) and ranged from 50 to 60 cmbs in depth. Shovel tests generally exposed a 10YR5/2 grayish brown sandy loam from 0 to 15 cmbs, over a 10YR 6/8 brownish yellow sandy loam from 15 to 40 cmbs, underlain by a 10YR8/6 yellow compact fine sand subsoil at 40 to 60-plus cmbs. The fill from these tests was sifted through 0.25-inch (0.635-cm) mesh hardware cloth. Investigators identified one isolated find (Isolate 1) during the survey.

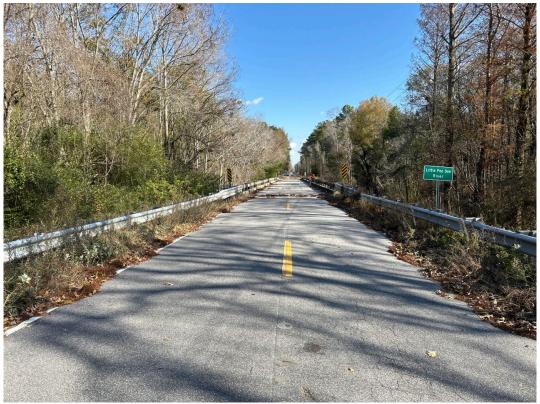
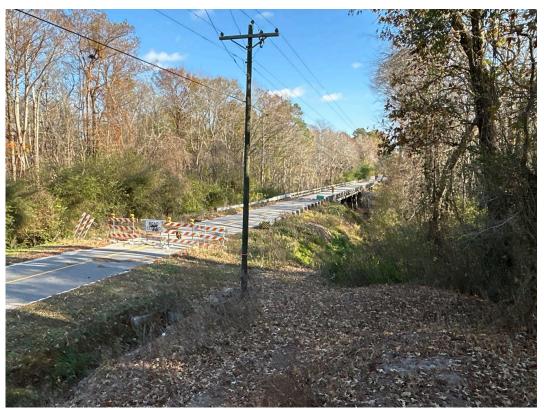
Figure 3. View of SC 83 and the bridge, looking east.

Figure 4. View of SC 83 and the bridge, looking northeast.

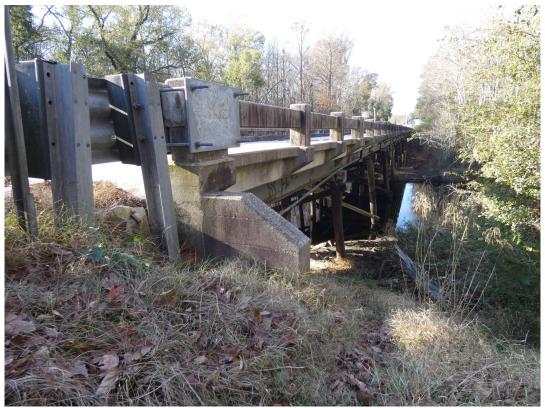
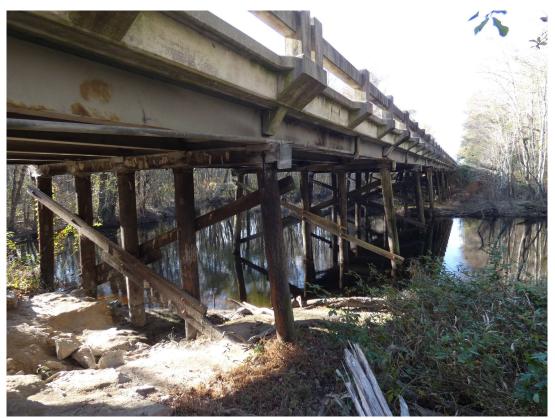
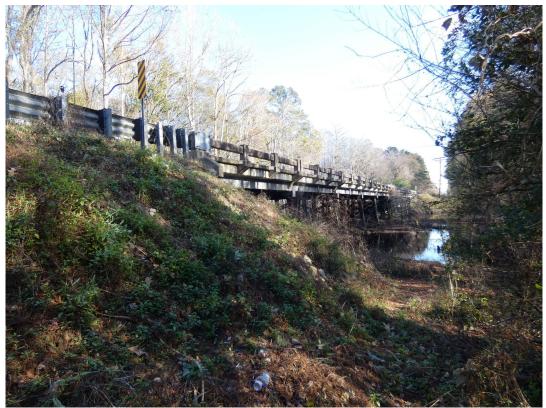
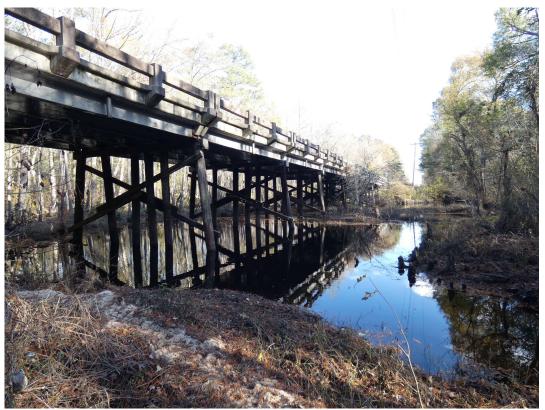
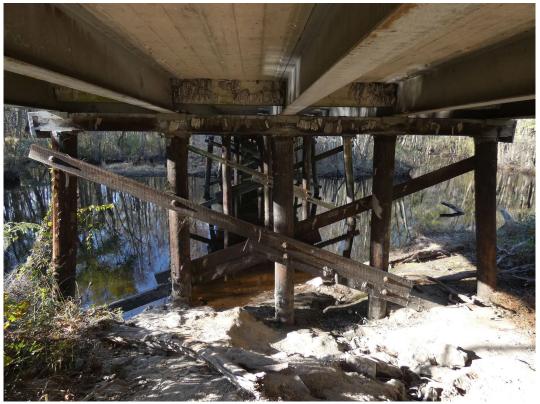
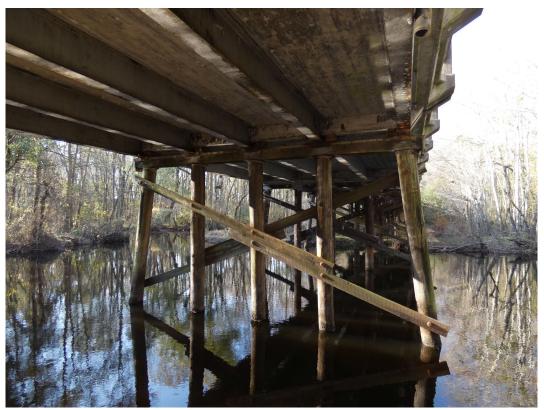
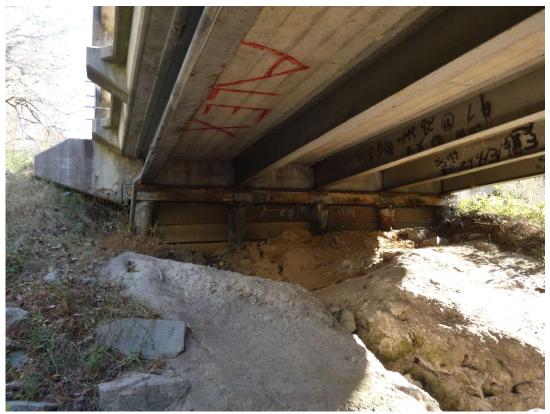
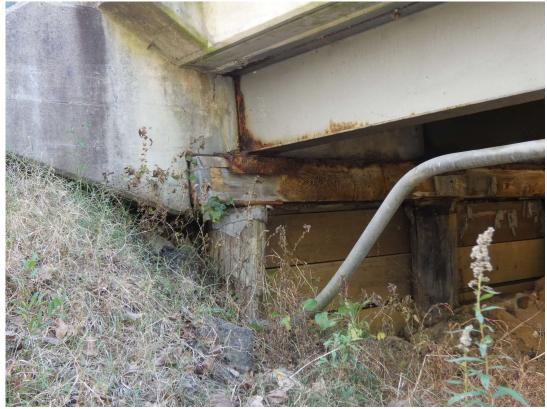
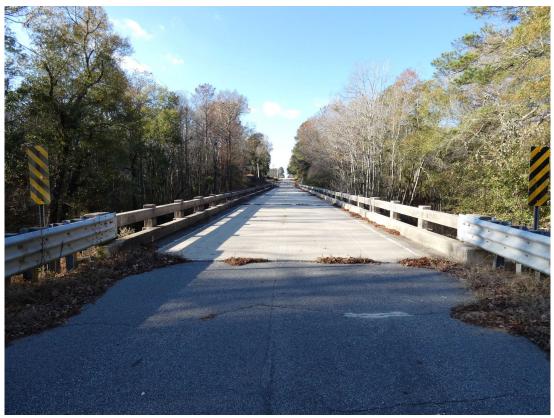
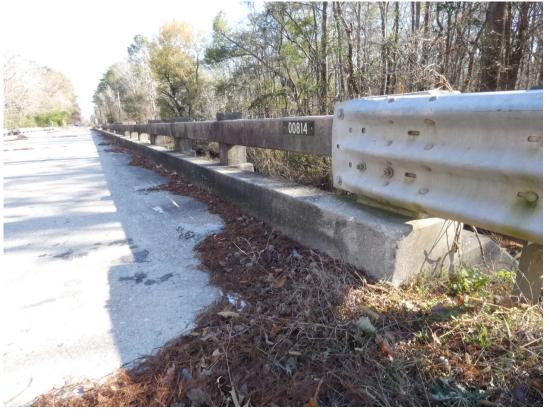
SHPO Site Number 2738

Figure 7. SHPO Site Number 2738, looking southwest.

Figure 8. SHPO Site Number 2738, looking southwest.

Figure 9. SHPO Site Number 2738, looking northeast.

Figure 10. SHPO Site Number 2738, looking northeast.

Figure 11. SHPO Site Number 2738, looking southwest.

Figure 12. SHPO Site Number 2738, looking southwest.

Figure 13. SHPO Site Number 2738, looking east.

Figure 14. SHPO Site Number 2738, looking east.

Figure 15. SHPO Site Number 2738, looking southwest.

Figure 16. SHPO Site Number 2738, looking east.

The bridge (Asset ID 814; SCDOT Structure Number # 3540008300100) carrying SC 83 over the Little Pee Dee River (Figure 7 through Figure) was built in 1937. Due to its age, the bridge, assigned SHPO Site Number 2738, does not qualify for streamlined review under the Federal Highway Administration's Post-1945 Bridges Program Comment. SCDOT previously evaluated the bridge as not eligible in its historic bridge survey, but the structure was not formally recorded.

The 10-span steel beam bridge measures 251 feet in length (25.5 feet per span) and has a width of 22 feet from curb to curb. The bridge has a cast-in-place concrete deck supported by spans comprising five 18-inch-wide steel beams (stringers). The substructure consists of 11 timber pile bents, which are in-kind replacements of the original material, per SCDOT records. Each abutment comprises a concrete wing wall, timber back wall, and a timber bent. The bridge has concrete curb railings supported by concrete brackets positioned atop cantilevered deck sections.

While the subject bridge is technically 10 spans given the number of substructure units, the superstructure consists of five 50-foot-long segments, based on a standardized design for continuous steel stringer bridges adopted by South Carolina's Bridge Division in 1930. This plan—Standard Plan No. S-314—was for a continuous two-span bridge, with each span measuring 25 feet long, for an overall length of 50 feet. The two-span, continuous units could be multiplied as many times as necessary to achieve the desired length of crossing. The economical bridge design, which could be adapted for roadways of varying widths, called for a concrete deck supported by timber pile bents; the design remained a state standard through the mid-1950s.

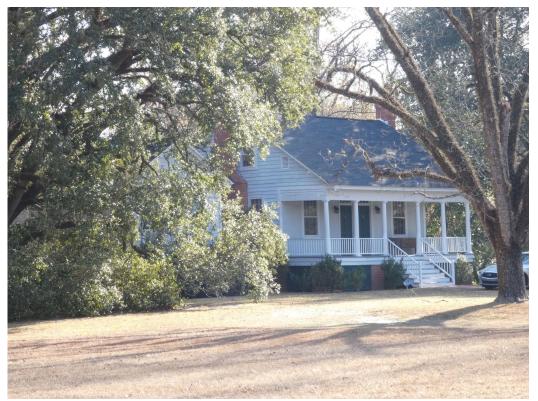
Figure 17. SHPO Site Number 2739, looking northeast.

SHPO Site Number 2739, the Willis–McDonald House (Figure 17 through Figure 20), was built ca. 1837 (ca. 1840 in some sources) and moved to its current location in 1975. The dwelling was recorded in a countywide survey conducted in 1978 but was not assigned a SHPO Site Number until this investigation. It was unevaluated for NRHP eligibility prior to this survey. During this investigation, the dwelling was surveyed from the ROW and, due to the distance, it was difficult to determine materials.

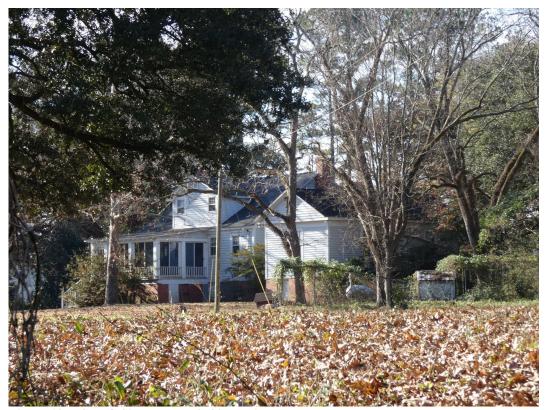
Figure 18. SHPO Site Number 2739, looking east.

The 1.5-story dwelling is situated approximately 575 feet (0.11 miles) south of the southwestern abutment of the bridge carrying SC 83 over the Little Pee Dee River (SHPO Site Number 2738). The dwelling, which faces southwest, consists of a primary, side-gabled volume, with a rear gable-roofed dormer. A front-gabled wing with a rectangular footprint is attached to the western elevation of the primary volume (Figure 18 through Figure 20). The
