S-36-167 (Parr Road) Bridge Over I-26
Newberry County, South Carolina

Asbestos and Lead-Based Paint
Survey Report

ARM Project #16-326-16

May 25, 2017

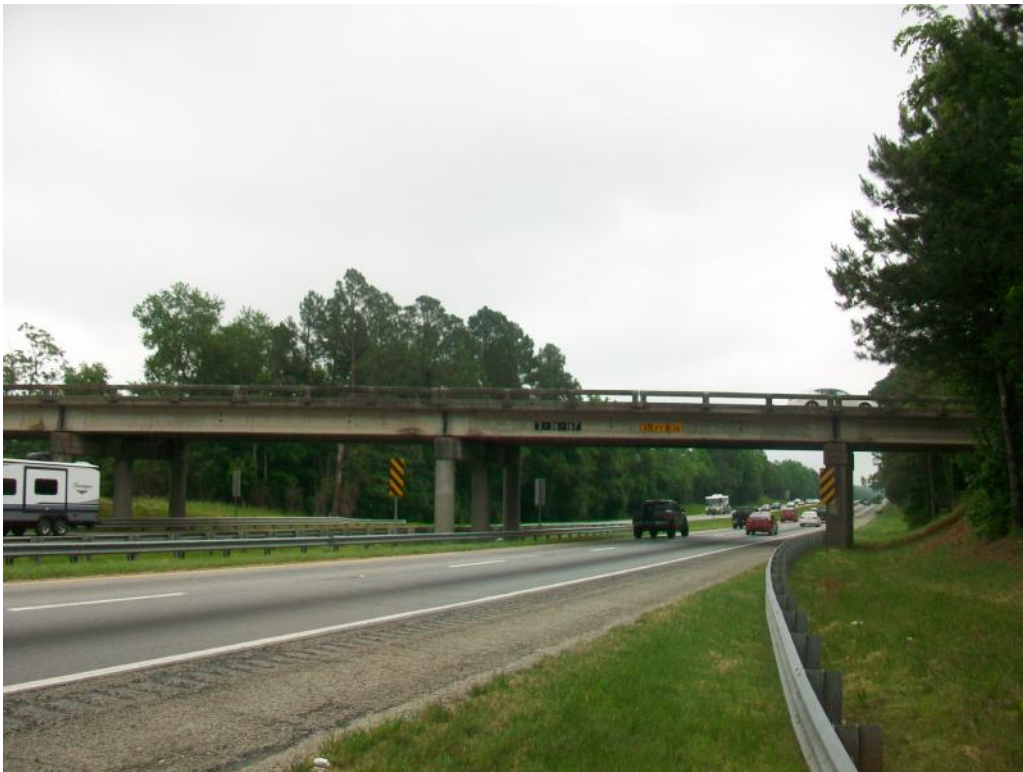
Photograph 1 – Side view of S-36-167 bridge over I-26.

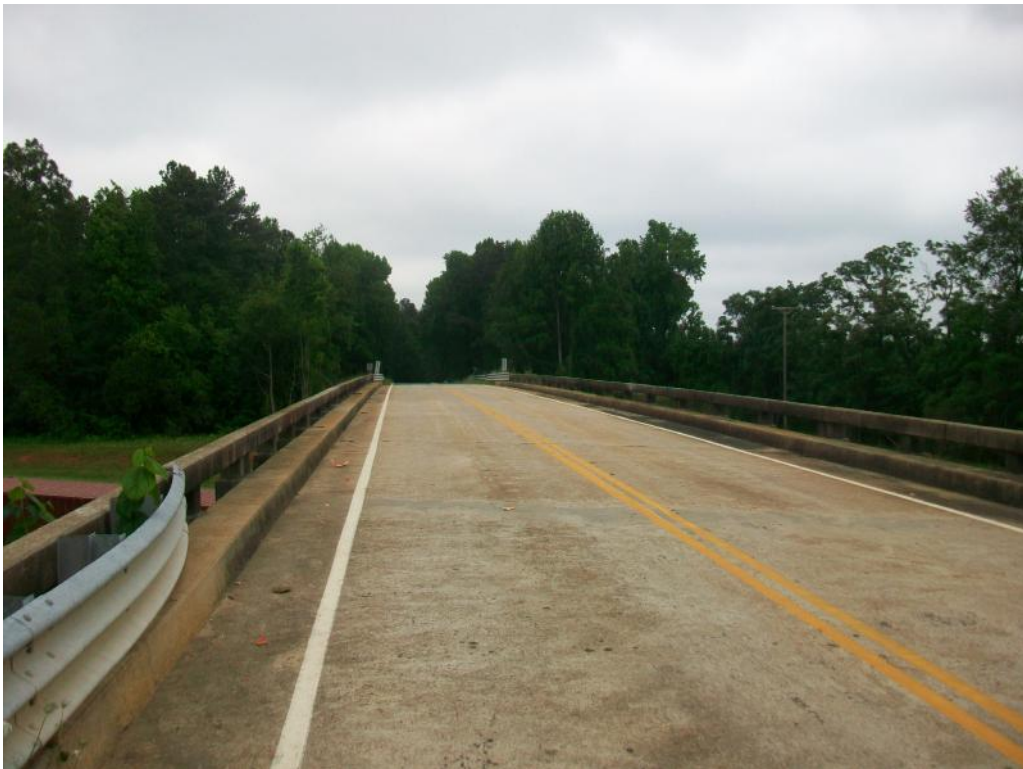
Photograph 2 – Top view of the S-36-167 bridge over I-26.

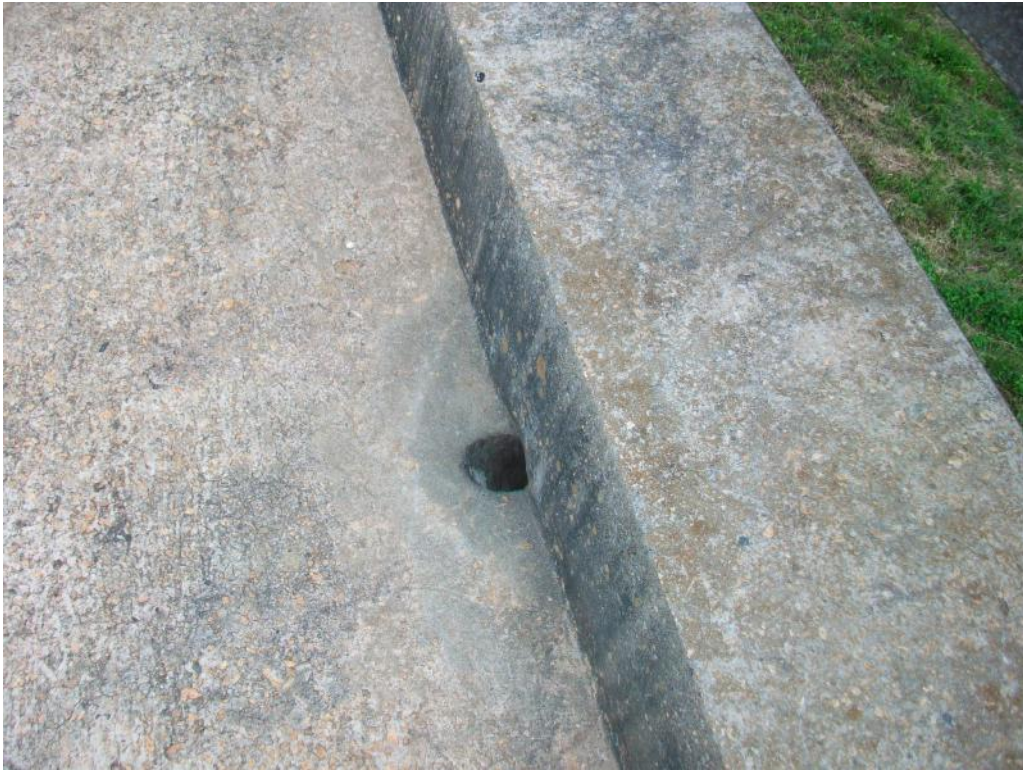
The sample results indicated that the bridge drain pipe material contains asbestos. The laboratory results are included in Appendix C of this report.

An asbestos inspection was performed for a structure, the S-36-167 Bridge located over I-26, in Newberry County, South Carolina. **The results of the asbestos survey indicate that the transite bridge drains are an asbestos containing material (ACM).** In its present condition, and without significant disturbance, there is a low potential for significant concentrations of asbestos fibers to be released from this material. However, it is recommended that this material be removed prior to any renovation, demolition, or other process that might disturb the material, or render it friable. SCDHEC regulations will not allow for a Category II ACM such as this to be left in place during demolition activities. Based on the potential for the ACM to be rendered friable during the removal process, it is recommended that the removal of this material be conducted by a licensed abatement contractor. No other asbestos containing materials were identified on the bridge structure.

Photograph 3 – Typical view of asbestos containing transite drain pipe located on the bridge structure.

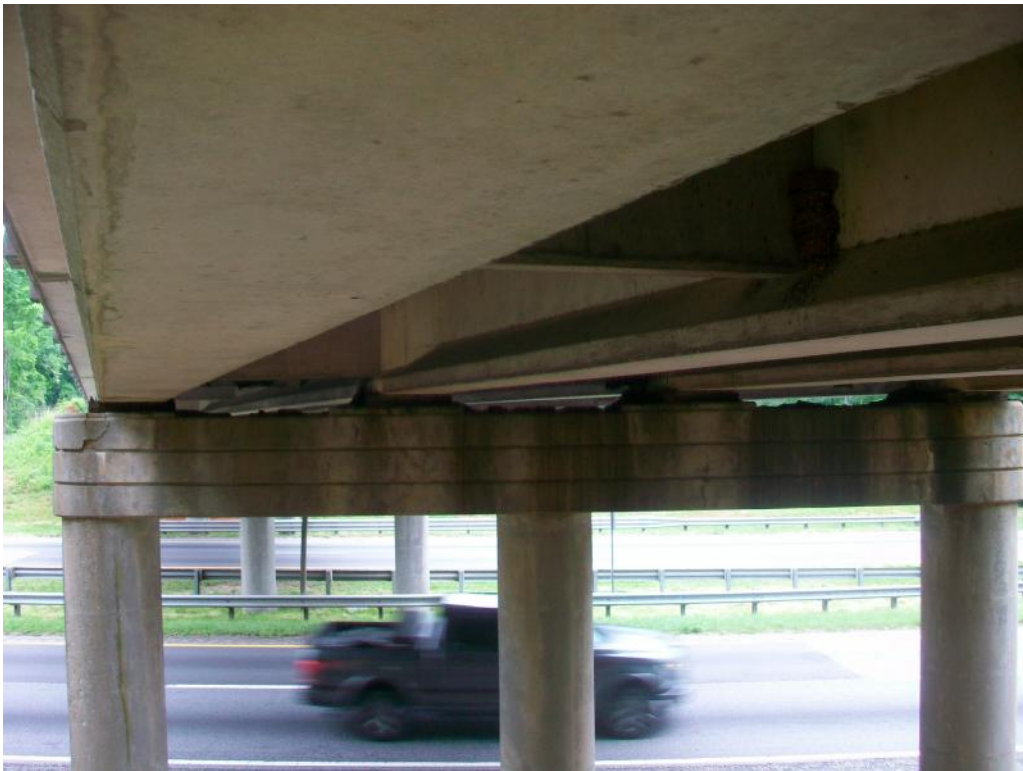
The results of these analyses indicate that the metal components of the bridge structure, except for the galvanized metal approach guard rails, tested positive for lead-based paint. The XRF data results are presented in Appendix D. Photographs of the site are located in Appendix F.

A lead-based paint survey was performed for the S-36-167 Bridge over I-26 in Newberry County, South Carolina. **The results of the XRF analyses indicate that all of the metal components of the bridge structure, except for the galvanized metal guard rails are coated with lead based paint. These materials include the anchor bolt plates and bolts and the bridge shoes.** If these bridge components are disturbed during renovation or demolition, contractors and workers should be informed as to the presence of lead-based paint and appropriate work practices and personal protective equipment should be used to prevent exposure to lead dust/fumes or spreading lead contamination from the work site. The building components containing lead based paint should be disposed of in accordance with federal and state regulations. All waste debris coated with lead-based paint equal to or greater than 0.7mg/cm² must be disposed of in an approved Class Two (C&D) or Class Three (MSWLF) landfill or approved metal recycler. The OSHA lead standard for construction work (29CFR 1926.62) would apply to all demolition or renovation activities that disturb any of the materials containing lead.

Photograph 4 – View of the underside of the bridge. All metal bridge components, except for the galvanized metal guardrails are coated with lead based paint.
