LEAD-BASED PAINT INVESTIGATION REPORT

**S-32-49 BRIDGE OVER I-26
SCDOT #327004900200
LEXINGTON COUNTY, SOUTH CAROLINA**

Re.: Lead-Based Paint Investigation Report
S-32-49 Bridge over I-26
SCDOT #327004900200
Lexington County, South Carolina
F&ME Project No.: E5350.02

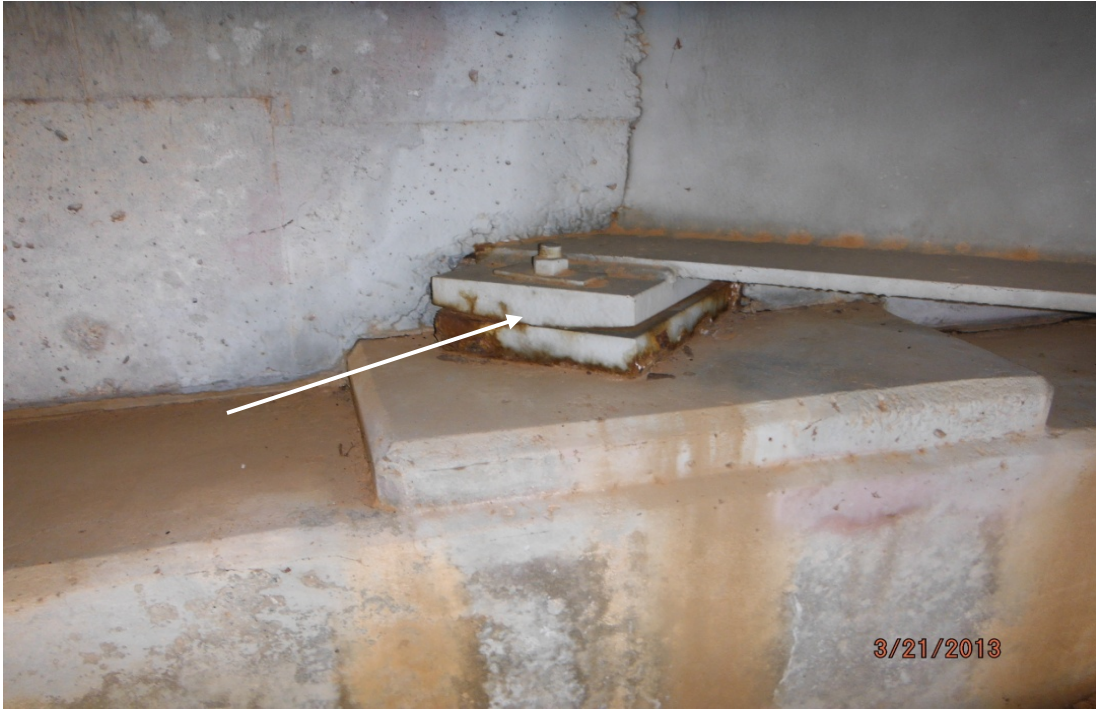
Beam Seat Plates

During the investigation, the following three (3) paints/coatings were identified as suspect materials: grey and green paint on the bridge beams, diaphragms, and beam seat plates and the green paint on the scupper drain pipes. The XRF determined that these materials were negative for lead content with the action level set at 0.7 mg/cm². See Appendix A for photographs of the subject bridge and components and the XRF Data (Table I).

The results of this LBP investigation determined that there are no lead-based paints or coatings associated with the subject bridge structure. During demolition and/or renovation activities, some painted surfaces may be exposed. If paint is exposed and it is determined to contain levels of lead ≥ 0.7 mg/cm², the coated/painted components will need to be handled and disposed of properly. Proper handling includes the avoidance of creating lead dust, as well as the creation of lead-contaminated soil hazards. Activities that would generate lead dust include abrasion, scraping, or sanding. As previously stated, OSHA has not defined lead-containing paint, but states that paint having **any** measurable level of lead may pose a substantial exposure hazard during construction work, depending upon the work performed. In these cases, OSHA regulations and procedures should be followed in order to protect the personnel carrying out the work on a bridge component containing any amount of lead.
