Accident Analysis Report

**I-85 Widening Project MM 80 to MM 96
Spartanburg and Cherokee Counties, SC**

Prepared for:
South Carolina Department of Transportation

**Accident Analysis Report
I-85 Widening Project MM 80 – MM 96
Spartanburg and Cherokee Counties
South Carolina**

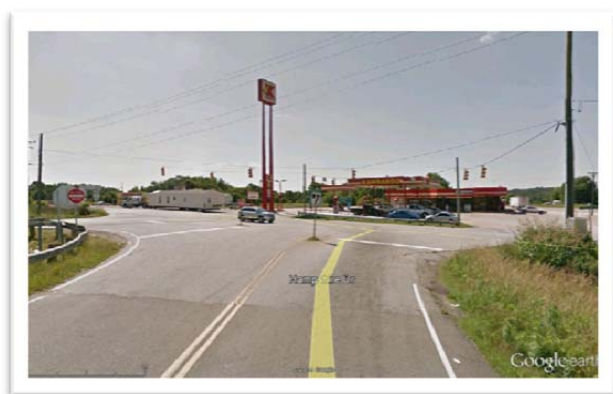
Photo: SC 18 at Hampshire Drive

On SC 18 from just east of Matthew Drive to the S-82 overpass there were 45 crashes during the study period, most of which

were angle or sideswipe. Most crashes were classified as property damage only; however, two angle crashes on SC 18 between Hampshire Drive and the S-82 overpass were classified as incapacitating crashes (INJ3). This photo shows the approach to SC 18 from Hampshire Drive. As can be seen, this intersection is a nonstandard four-leg intersection with driveways that form two additional entry points to the intersection. The redesign of the SC 18 corridor including this intersection along with the intersections at Fatz Drive and Matthew Road would improve operations in this area.

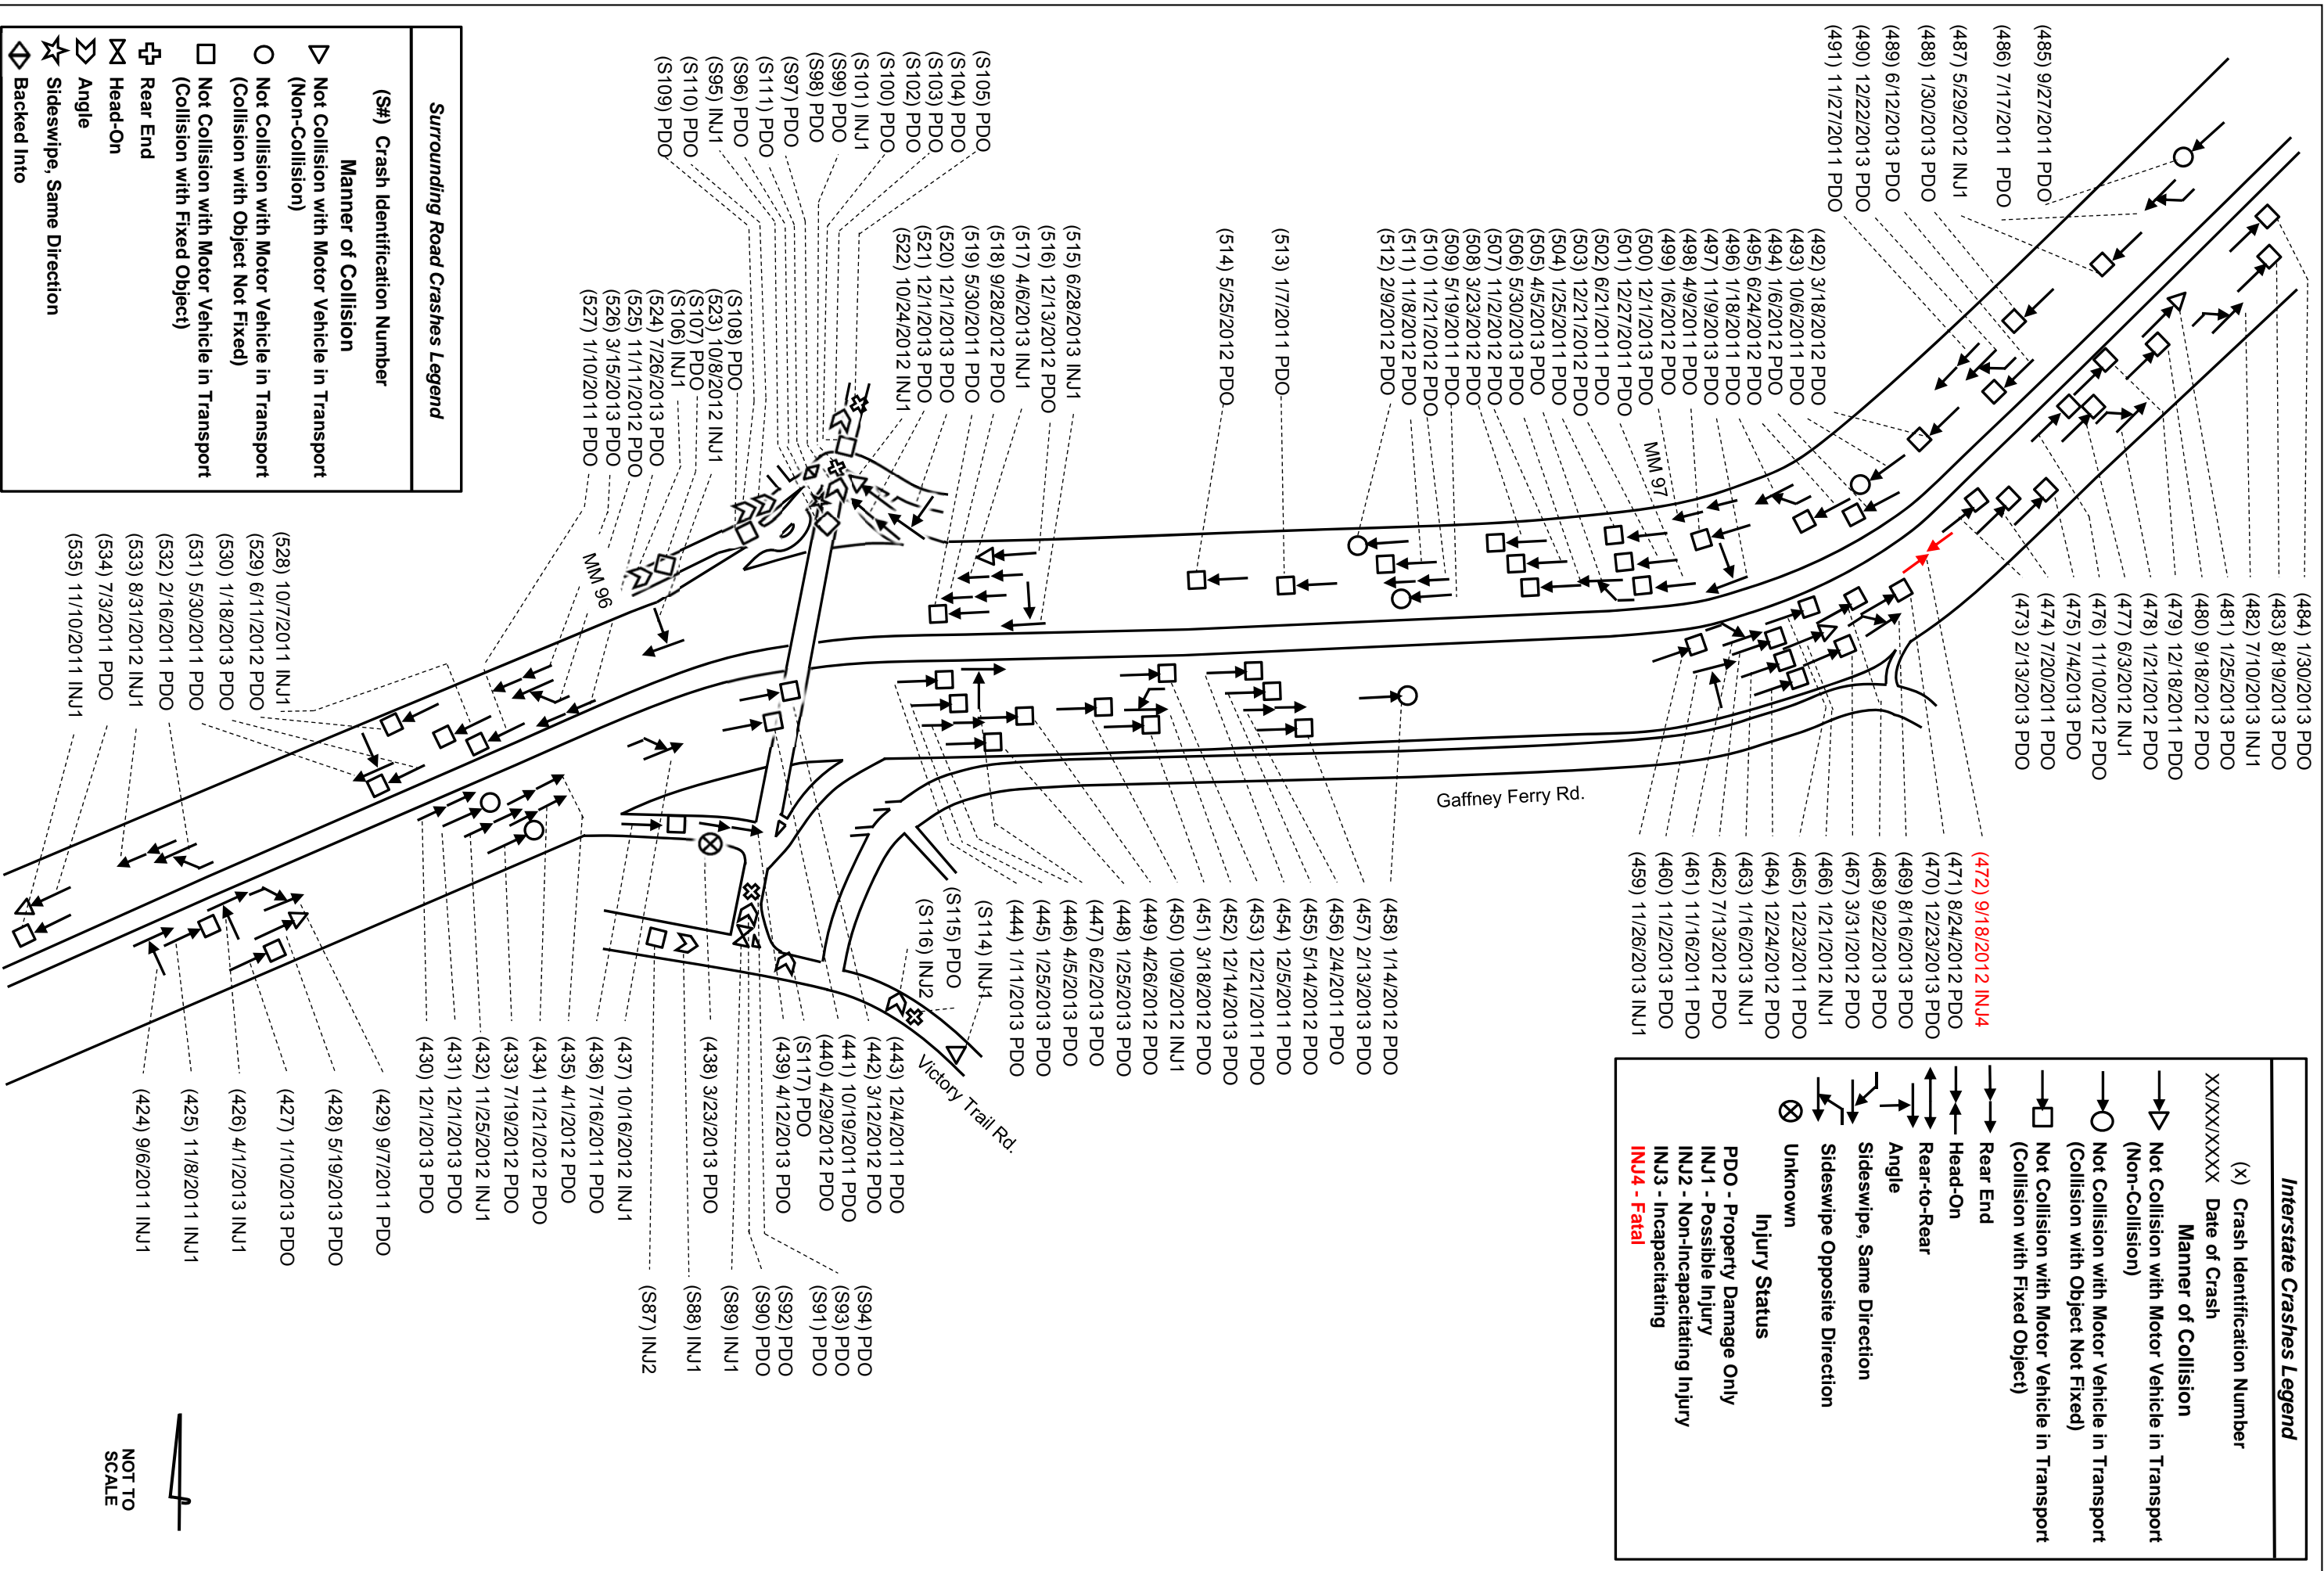
There was one head-on collision on I-85 northbound (MM 97.196) near the Gaffney Ferry Road on-ramp. The crash occurred on wet pavement; no other mitigating factors were available.

The vertical curve at Sta 1709+25 – Sta 1711+95 (MM 96.11 – MM 96.17) does not meet the minimum standards for a 65 mph design speed. Based on a review of the available data, there were no accidents in this section of the roadway.
