Video Pipe Detail Report

M&H Project Number:	R3286900-141416.01
Client / State Project Number:	
Project Name:	I-85 CHEROKEE COUNTY DB PREP-(MM 80-96)
Project Address:	CHEROKEE COUNTY, SC
Client:	SCDOT

Pipe ID:	1330+50 NB	**Date of Inspection:**	4/27/2015
Length of Pipe (ft):	66	**Type of Pipe:**	RCP
Pipe Diameter (in):	24	**Pipe Location:**	See Pipe ID

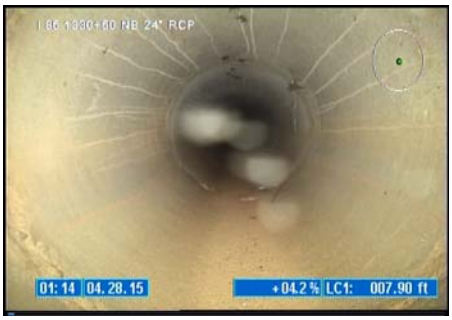
Damage Type:	**N/A**
Location of Damage (ft):	**4**
Crack/Break Width (in):	**N/A**
Video Cue Time:	**0:00:10**

Comments: **Start of pipe**
