Video Pipe Detail Report

M&H Project Number:	R3286900-141416.01
Client / State Project Number:	
Project Name:	I-85 CHEROKEE COUNTY DB PREP-(MM 80-96)
Project Address:	CHEROKEE COUNTY, SC
Client:	SCDOT

Pipe ID:	1623+00	**Date of Inspection:**	4/14/2015
Length of Pipe (ft):	128	**Type of Pipe:**	RCP
Pipe Diameter (in):	18	**Pipe Location:**	See Pipe ID

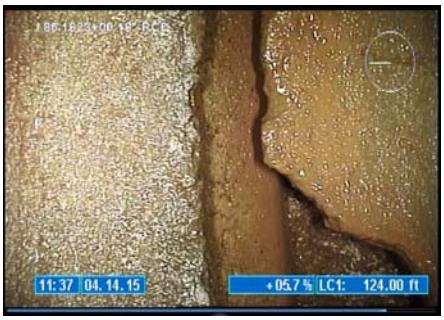
Damage Type:	**Gapped Joint**
Location of Damage (ft):	**124**
Crack/Break Width (in):	**5**
Video Cue Time:	**0:17:15**

Comments: **Broken bell. Approx. 5" of soil can be seen.**
