Stormwater Management Design Report

I-77 Widening Design-Build Preparation On-Call

From Percival Road to Killian Road

May 2015

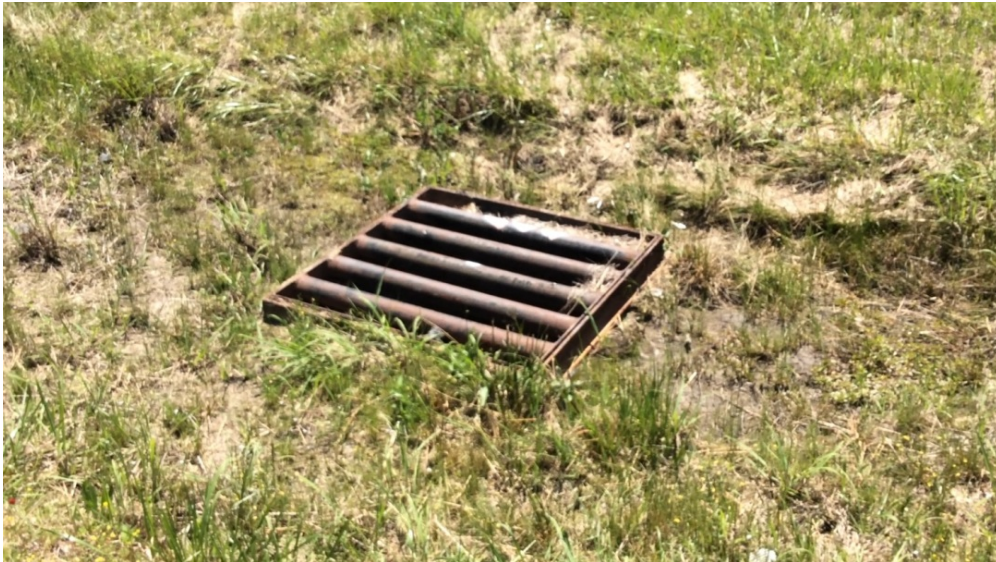
The surrounding ground adjacent to EX-0801 appears to have sunken in to roughly 4” to 6” below the rim of the inlet. No evidence of this issue was found in the video survey inspection (detailed in the next section) of connecting existing pipe EP-0801, which was in good condition.

If this inlet is to be retained, the existing ground should be brought up to the rim elevation in order to reduce ponding. A paved apron could also be installed at this inlet.

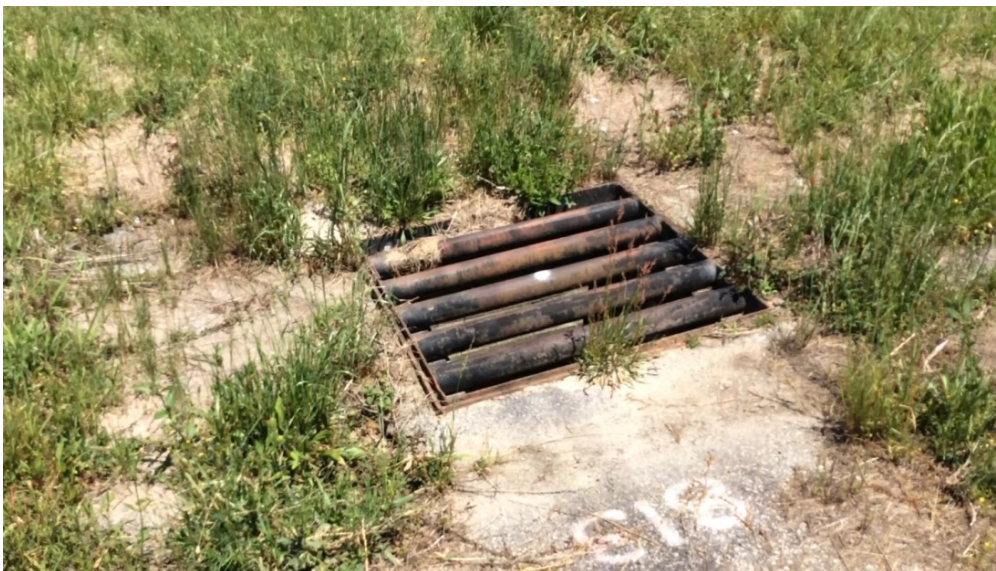
Median Inlet EX-0901

I-77 Sta. 1270+50 (See Plan Sheet 9)

The paved apron for EX-0901 has some minor cracking. If this inlet is retained, the apron should be repaired or replaced.

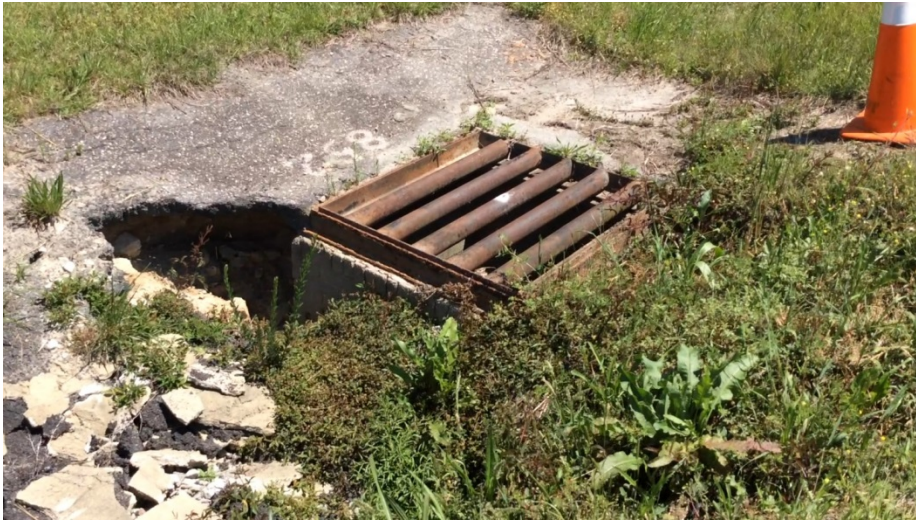
Median Inlet EX-1404

A severe collapse of the paved apron and subgrade has occurred at EX-1404, and a large cavity is visible adjacent to the box. No evidence of this issue was found in the video survey inspection of connecting existing pipes EP-1404 & EP-1405, which were in good condition at the inlet. In the video inspection of EP-1406, it appears that the first segment of pipe (upstream from the inlet) is slightly offset from the second segment. This offset appears to be related to the apron collapse.

If this inlet is to be retained, the subgrade adjacent to the box should be excavated and replaced, and the paved apron should be removed and replaced. The pipe video inventory survey detailed in the next section contains recommendations for the connecting pipe.

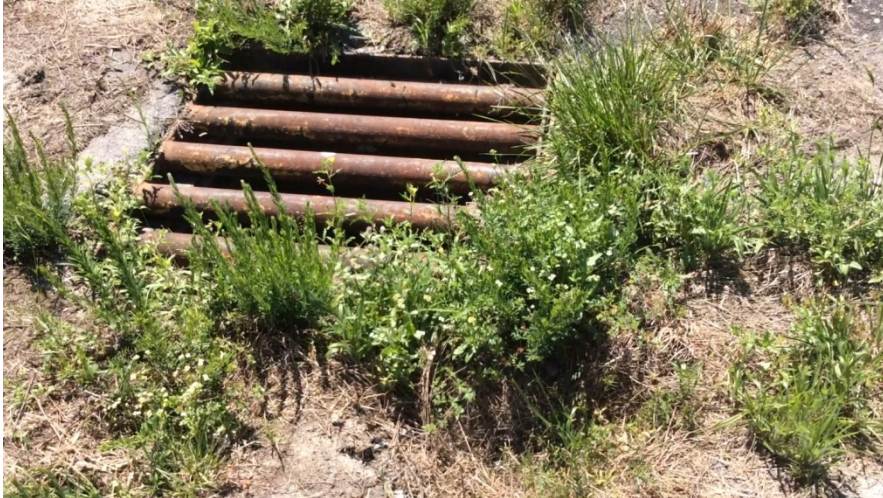
Median Inlet EX-1501

The paved apron of EX-1501 has a significant hole in its northeast corner, where the subgrade has apparently collapsed. No evidence of this issue was found in the video survey of connecting existing pipe EP-1501, which was in good condition.

If this inlet is to be retained, the subgrade adjacent to the box should be excavated and replaced, and the paved apron should be removed and replaced, at least in the northeast corner where the hole was found.

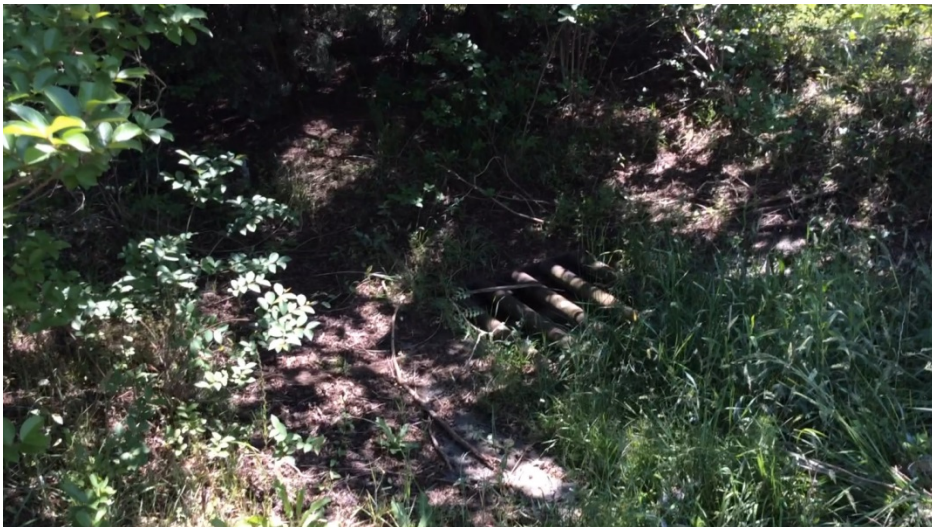
Median Inlet EX-1607

There has been significant vegetative growth adjacent to EX-1607 that could possibly impede flow to the inlet. In the pipe video survey, major root issues were found in connecting existing pipes EP-1608 & EP-1609 on either side of the box.

If this inlet is to be retained, the area adjacent to the inlet should be cleared and grubbed. A paved apron could also be installed at this inlet. The pipe video inventory survey detailed in the next section contains recommendations for the connecting pipes.

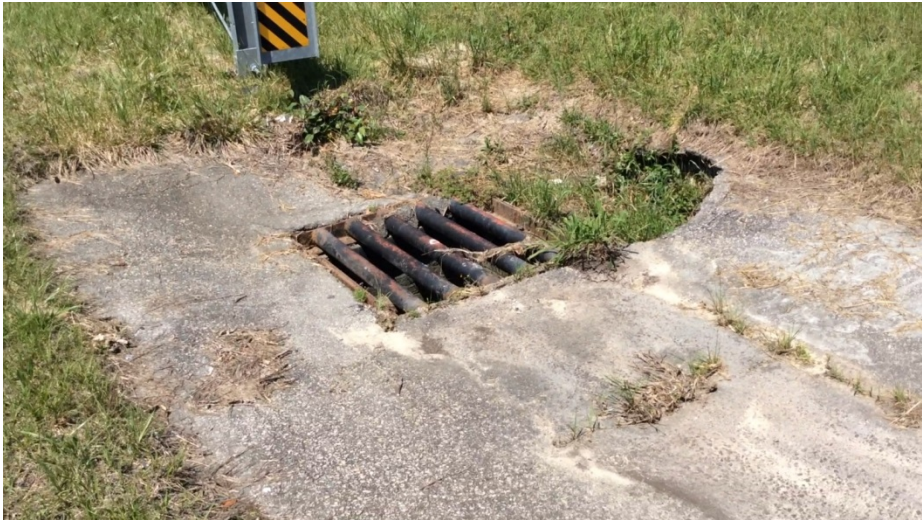
Median Inlet EX-1701

A significant collapse of the paved apron and subgrade has occurred at EX-1404. No evidence of this issue was found in the video survey inspection of connecting existing pipe EP-1701, which was in good condition at the inlet.

If this inlet is to be retained, the subgrade adjacent to the box should be excavated and replaced, and the paved apron should be removed and replaced.

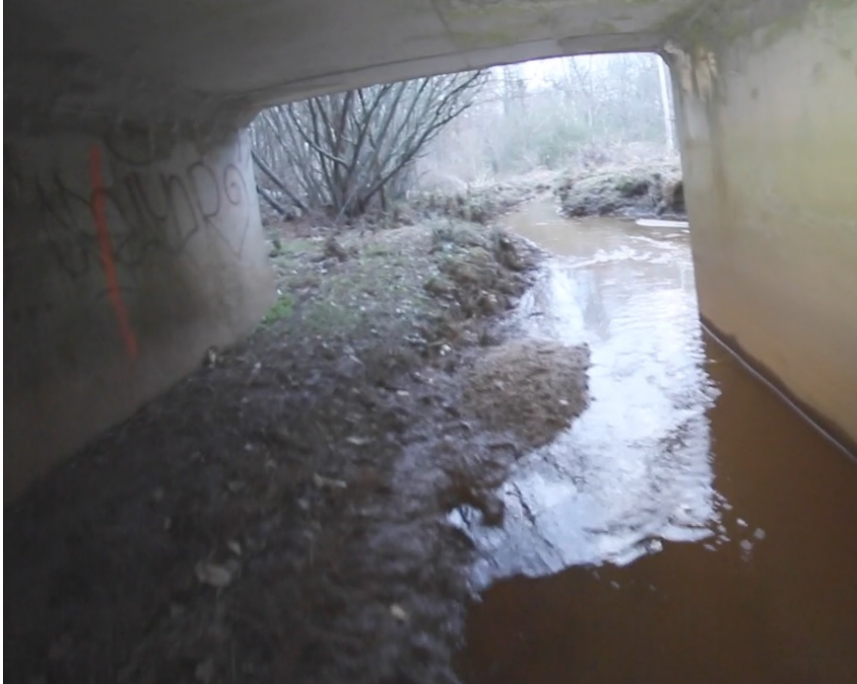
OP-0100 (Outfall of existing 8' x 6' concrete box culvert EC-0211)
Approx. Sta. 1151+85, Offset 188' RT

The inlet of box culvert EC-0211 is adjacent to the WB Percival Road ramp onto I-77 NB. This culvert and two others (EC-0102 & EC-0103) outfall at OP-0100 into an unnamed tributary of Gill's Creek to the south of the interchange. At the time of a field visit, the existing outfall beyond the culvert was clear, but the box itself had accumulated sediment for approximately 75' into the culvert, and should be cleaned out as noted in the previous section.

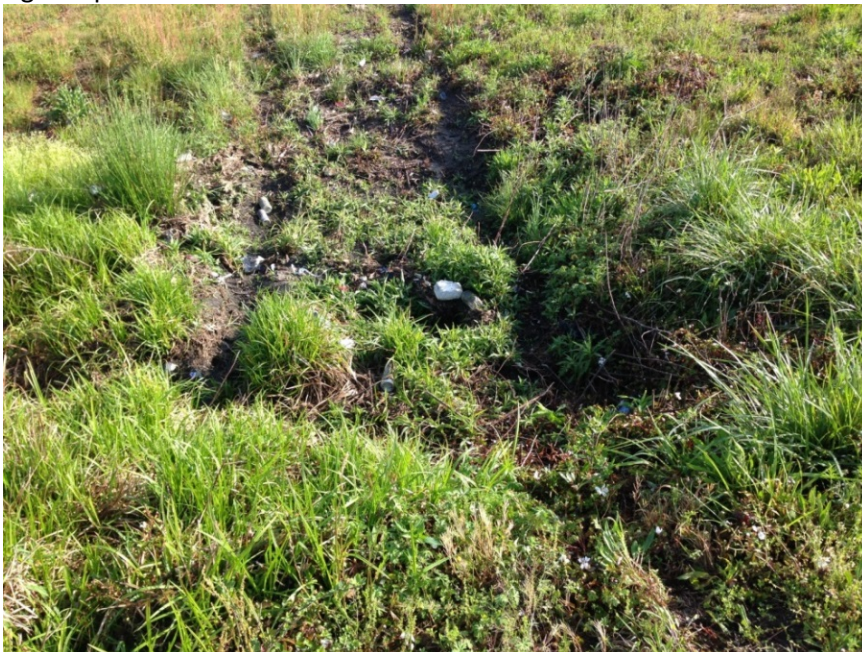
OP-0286 (Outfall of existing 18" RCP EP-0289)
Approx. Sta. 1167+30, Offset 146' RT

EP-0289 crosses the I-77 NB off-ramp loop to WB Percival Road. At the time of the field visit, the end of the pipe was buried. The outfall should be excavated for several feet to ensure positive drainage from the pipe. There are no concerns associated with right-of-way for this outfall as it is located within the interchange loop.

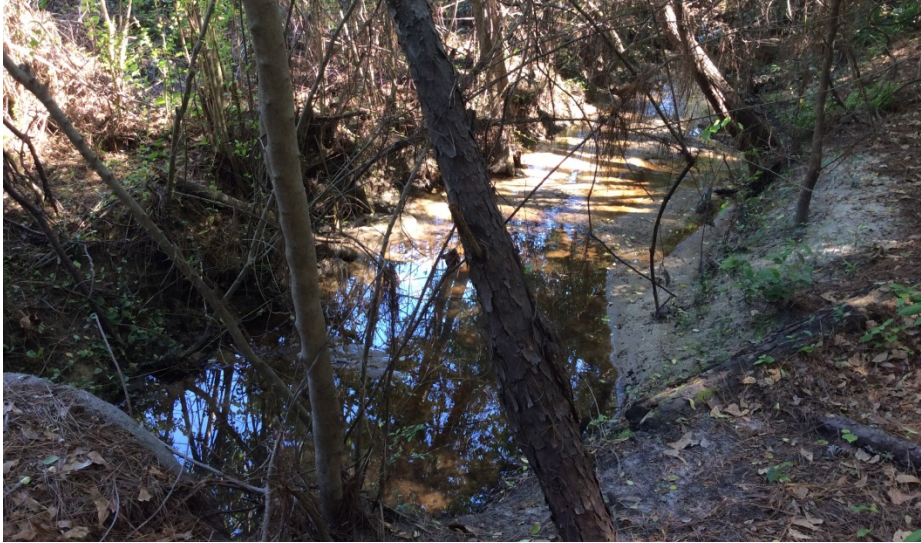
OP-0394 (Outfall of existing 48" RCP EP-0303)
Approx. Sta. 1177+35, Offset 118' LT

EP-0303 parallels I-77 SB and outfalls approximately 200' after the beginning of the taper for the Percival Road exit. At the time of the field visit, standing water was observed. The existing ditch that parallels I-77 SB, into which EP-0303 outfalls, should be cleared of debris as necessary to restore downstream flow. There should not be any right-of-way issues associated with clearing the ditch.

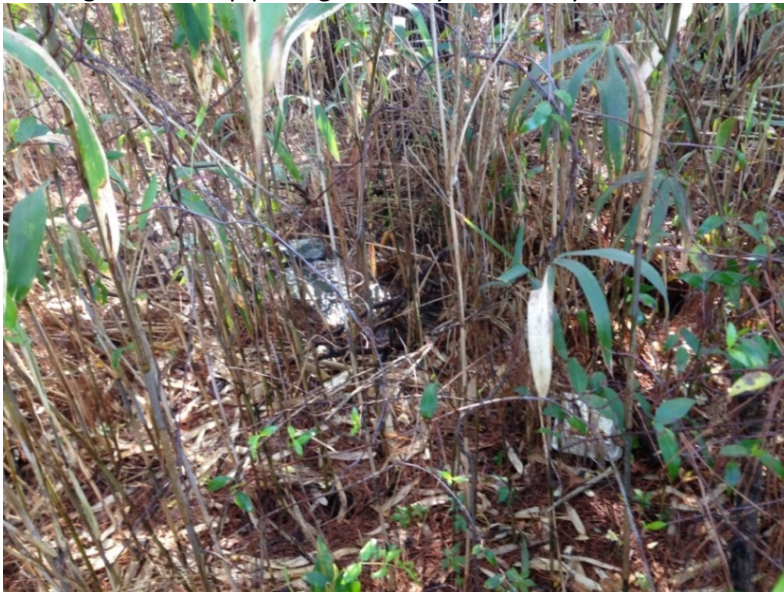
OP-0398 (Outfall of existing 18" RCP EP-0301)
Approx. Sta. 1171+30, Offset 200' RT

EP-0301 crosses the WB Percival Road ramp onto I-77 NB and outfalls just to the southeast of EX-0308 (inlet of EC-0211). At the time of the field visit, the pipe was mostly buried and the outfall ditch was covered in vegetation. The outfall should be excavated and cleared of debris for several feet to ensure positive drainage from the pipe. Right-of-way issues may exist downstream of this outfall.

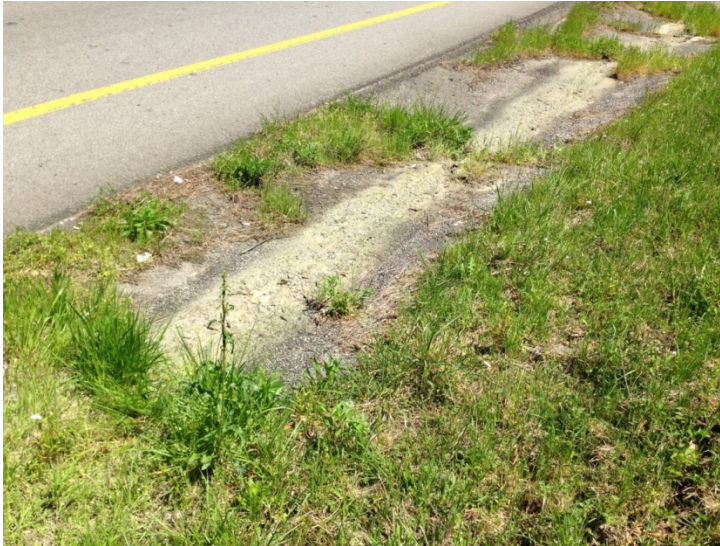
OP-0683 (Outfall of existing 18" RCP EP-0612)
Approx. Sta. 1224+45, Offset 115' RT

EP-0612 parallels the loop ramp from I-20 WB / Alpine Road onto I-77 SB beneath the I-77 NB bridge overpass. The outfall was not located in the field and is assumed to be buried. The outfall needs to be located. If the outfall location is where the asbuilts imply, the outfall should be excavated to ensure positive drainage. There are no concerns with right-of-way for this outfall as it is located well within the interchange.

OP-0683 (not located, assumed as buried)

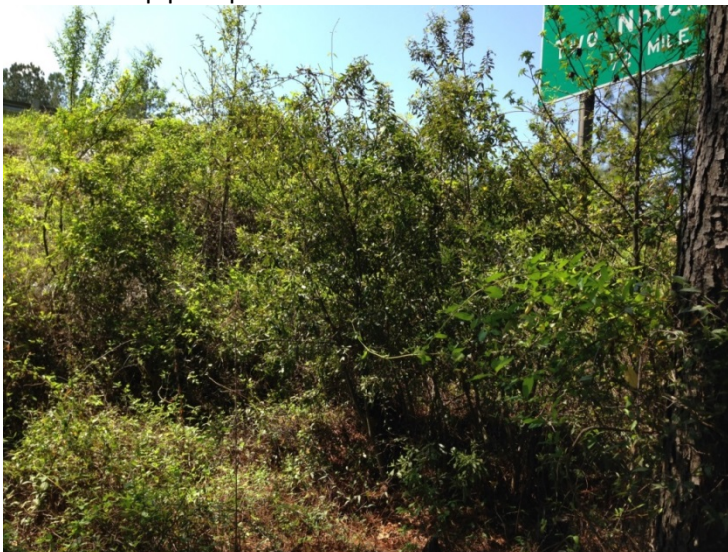
OP-0798 (Outfall of existing 18" RCP EP-0702)
Approx. Sta. 1246+60, Offset 155' RT

EP-0702 crosses I-77 NB approximately 50' before the I-77 bridge over Windsor Lake. The pipe has collapsed, and therefore the outfall was not located. The pipe should be replaced due to the collapse and other issues found during the video inspection. There should not be any right-of-way issues associated with the pipe replacement.

OP-0798 (not located, collapsed)

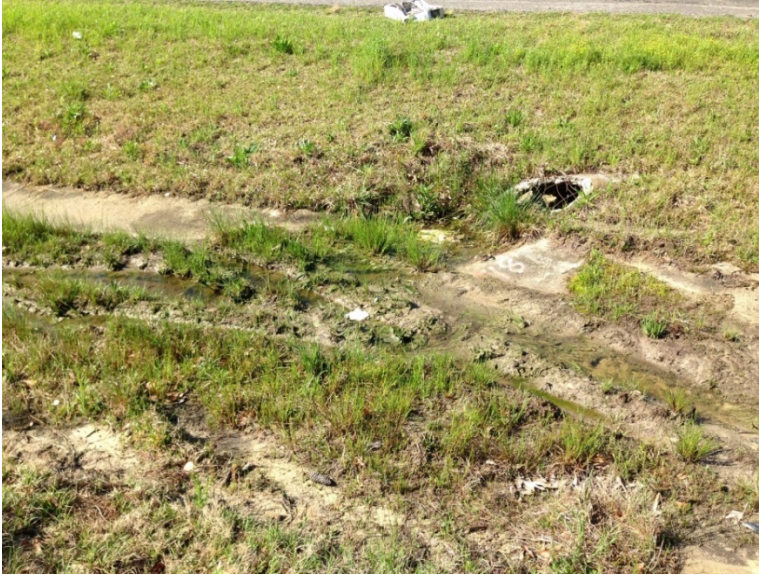
OP-0897 (Outfall of existing 18" RCP EP-0803)
Approx. Sta. 1259+70, Offset 93' RT

EP-0803 crosses I-77 NB approximately 1,000' after the I-77 bridge over Windsor Lake. At the time of the field visit, the existing concrete channel downstream of the outfall had accumulated sediment, causing water to pond. The concrete channel should be cleaned for approximately 470'. There should not be any right-of-way issues associated with clearing the channel.

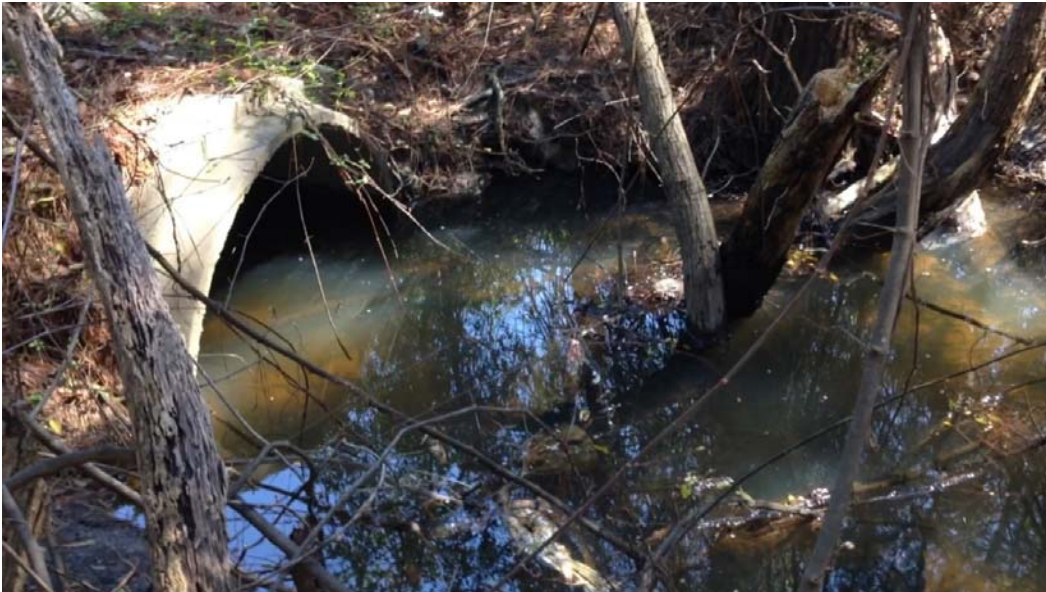
OP-0995 (Outfall of existing 36" RCP EP-0907)
Approx. Sta. 1278+00, Offset 119' LT

EP-0907 crosses I-77 SB approximately 500' before the Trenholm Road bridge over I-77. At the time of the field visit, the pipe outfall and associated ditch were fill with vegetation and debris and will require cleaning. The ditch should be cleared and re-excavated to the edge of the right-of-way.

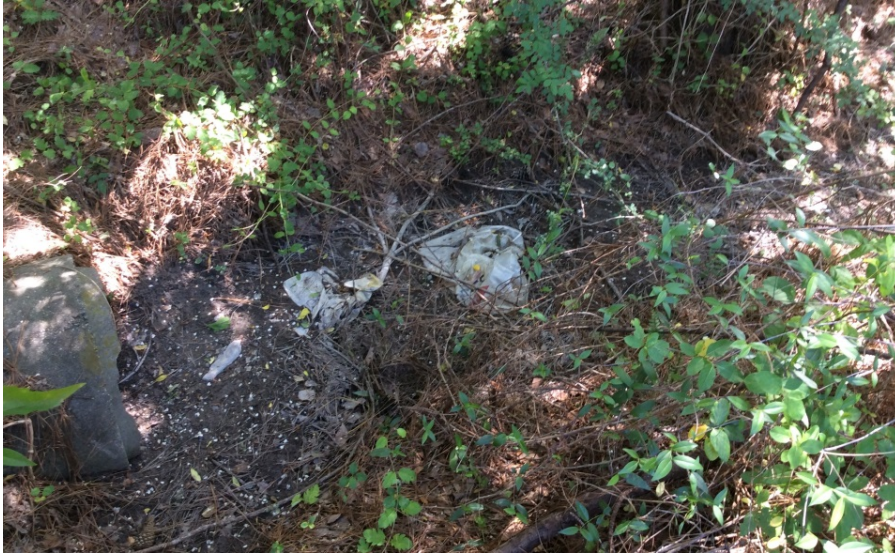
OP-0999 (Outfall of existing 18" RCP EP-0901)
Approx. Sta. 1271+65, Offset 118' LT

EP-0901 crosses I-77 SB approximately 1,250' before the Trenholm Road bridge over I-77. At the time of the field visit, standing water was observed. The pipe outfall and associated ditch were partially silted in and will require cleaning. The ditch should be cleared and re-excavated to the edge of the right-of-way.

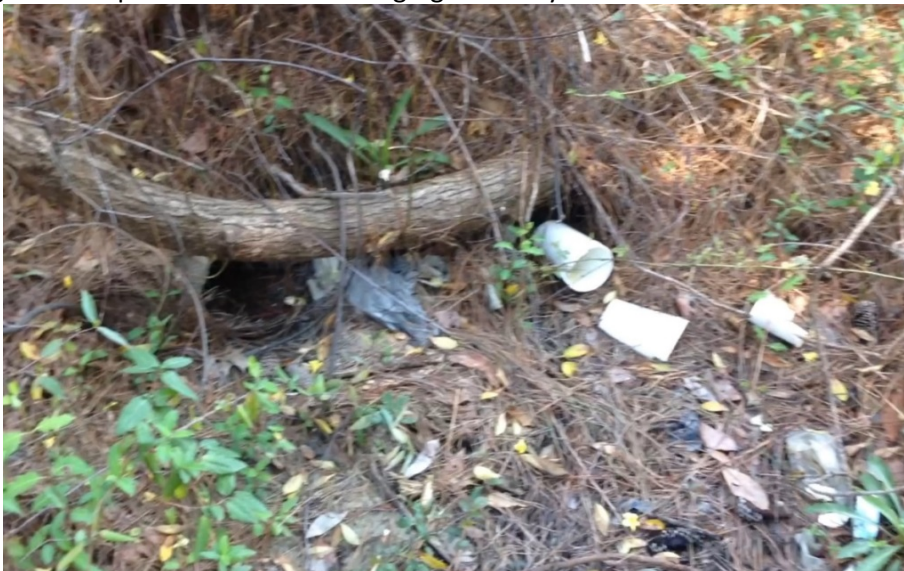
OP-1010 (Outfall of existing 30" RCP EP-1010)
Approx. Sta. 1281+80, Offset 117' LT

EP-1010 parallels I-77 SB beneath the Trenholm Road bridge overpass and outfalls approximately 75' south of the bridge. At the time of the field visit, the pipe outfall and associated ditch were partially silted in and had accumulated debris. Cleaning will be required and re-excavate the ditch as necessary. Clearing can take place within the existing right-of-way.

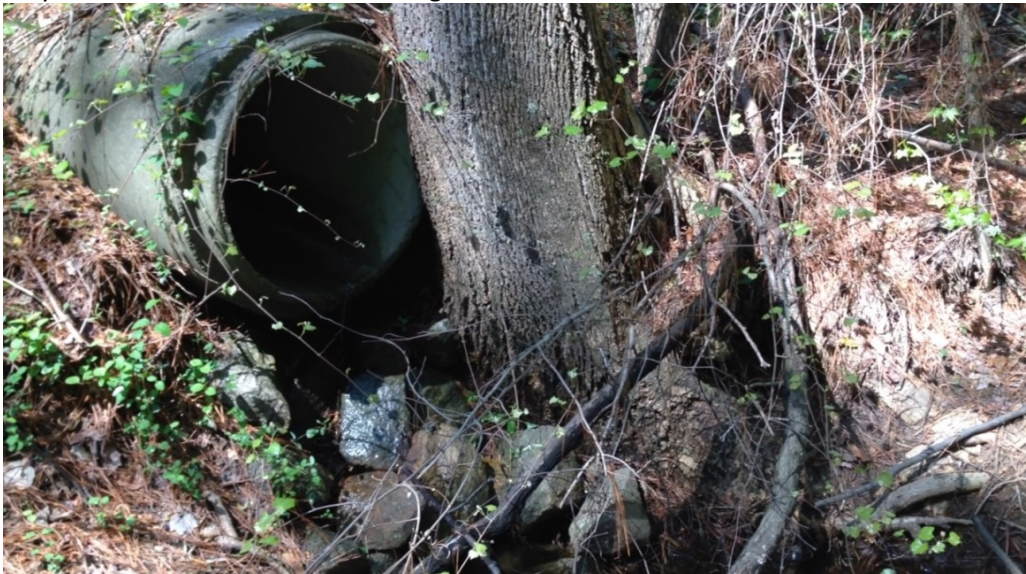
OP-1396 (Outfall of existing 24" RCP EP-1301)
Approx. Sta. 1332+10, Offset 166' RT

EP-1301 crosses I-77 NB approximately 50' after the I-77 bridge over Little Jackson Creek / Edgewater Drive. At the time of the field visit, a tree was growing immediately downstream of the outfall. This tree should be removed to prevent future damage and/or blockage to the pipe. There should not be any right-of-way issues associated with removing the tree.

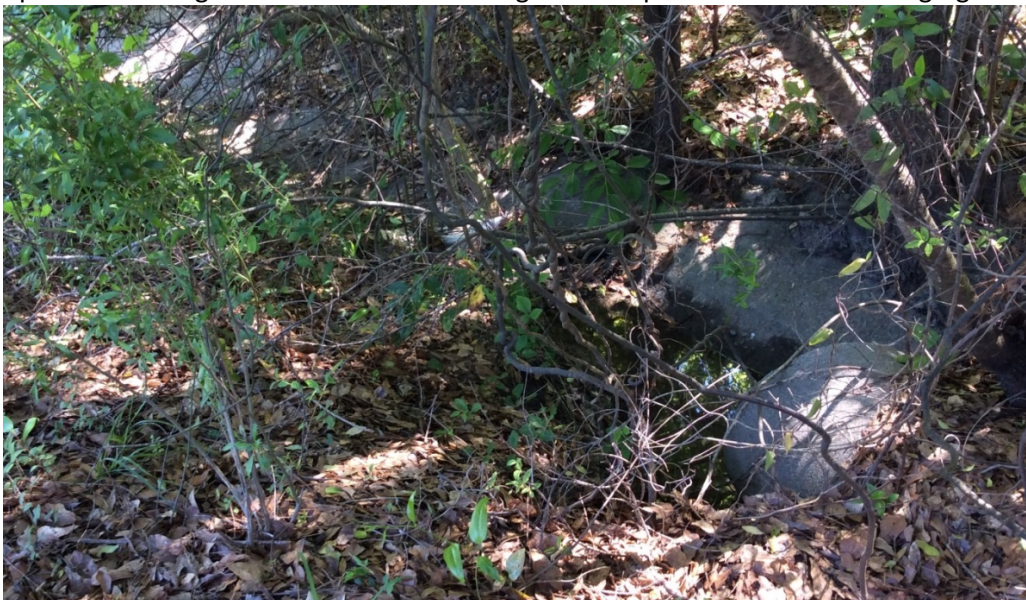
OP-1499 (Outfall of existing 18" RCP EP-1401)
Approx. Sta. 1347+75, Offset 134' LT

EP-1401 crosses I-77 SB in the merging lane from the EB Farrow Road onramp. At the time of the field visit, the outfall ditch for the pipe was overgrown with vegetation and will need to be cleared to re-establish positive drainage from the outfall. Clearing can take place within the existing right-of-way.

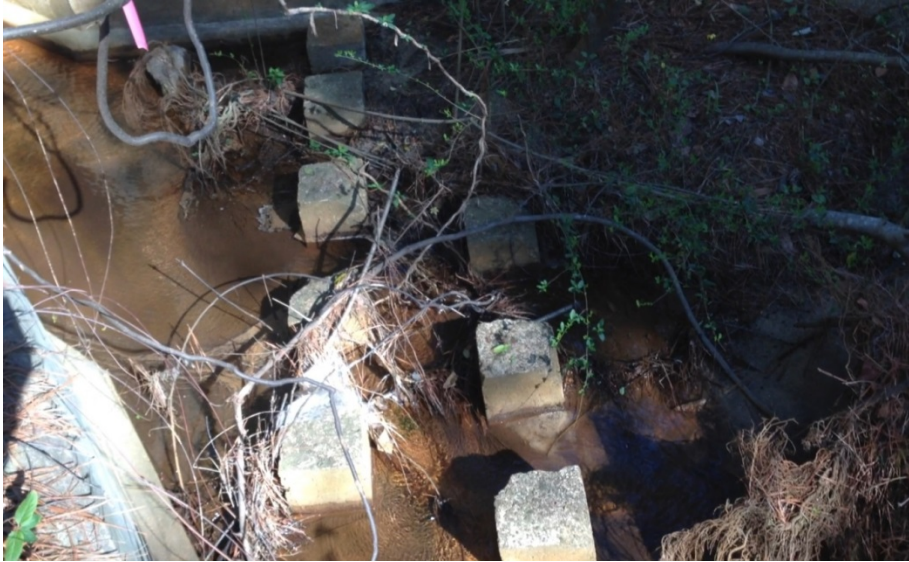
OP-1598 (Outfall of existing 4' x 4' concrete box culvert EC-1503)
Approx. Sta. 1364+80, Offset 129' RT

EC-1503 outfalls between I-77 NB and the ramp from SC-277 EB. At the time of the field visit, debris had collected at the baffles along the concrete outlet apron of this box culvert and could further accumulate to impede flow. The baffles should be cleared of debris. This outfall is within the I-77 / SC-277 interchange area, and all clearing can take place within the existing right-of-way.

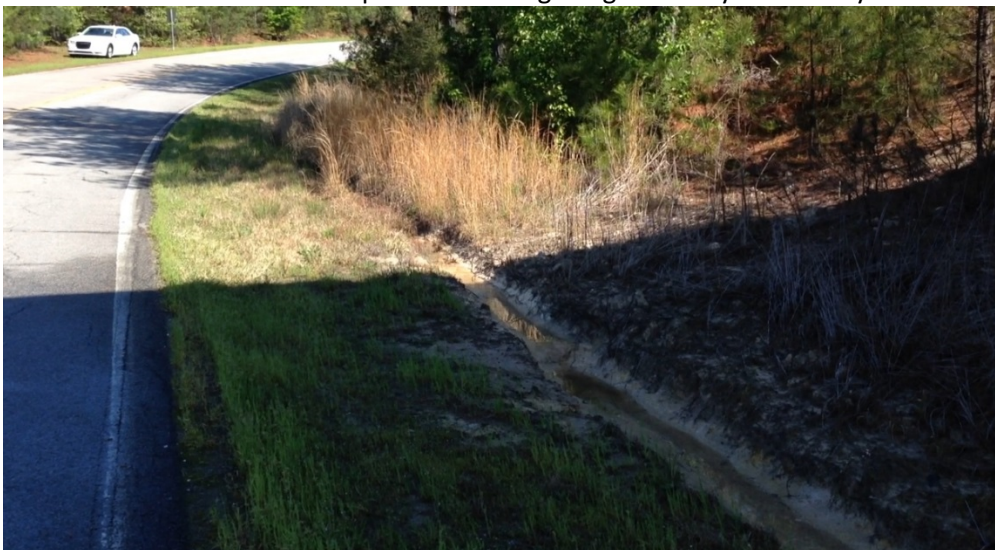
OP-1699 (Outfall of existing 36" RCP EP-1605)
Approx. Sta. 1379+05, Offset 263' RT

There is some uncertainty regarding the location of this outfall. EP-1605 is assumed to cross under Legrand Road approximately 100' after the railroad bridge over I-77. It was not located in the field and is assumed to be buried. The outfall needs to be located. If the outfall location is where assumed, the outfall should be excavated to ensure positive drainage. Right-of-way issues may exist near this outfall.

OP-1698 (not located, assumed as buried)

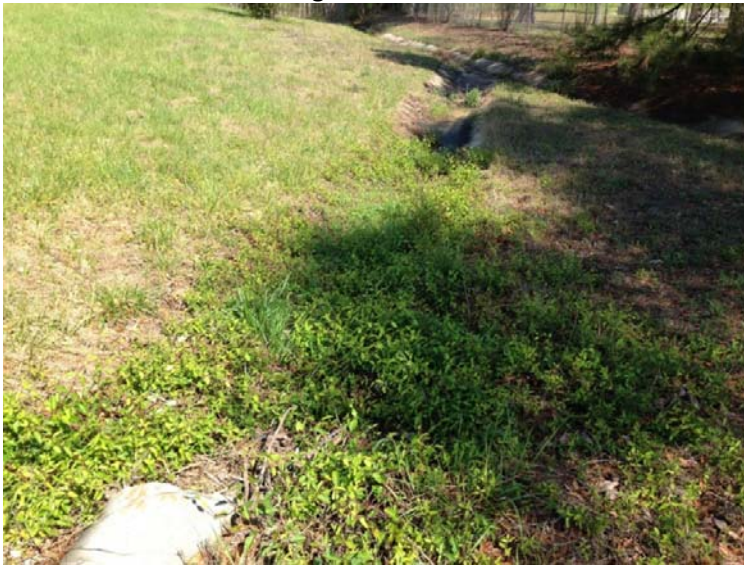
OP-1799 (Outfall of existing 24" RCP EP-1799)
Approx. Sta. 1396+05, Offset 201' RT

EP-1799 crosses the ramp from Farrow Road to I-77 NB. At the time of the field visit, the end of the pipe was partially buried and the outfall ditch was silted in. The ditch should be excavated for approximately 25' between the pipe end and the concrete lined channel downstream. There should not be any right-of-way issues associated with clearing the ditch.

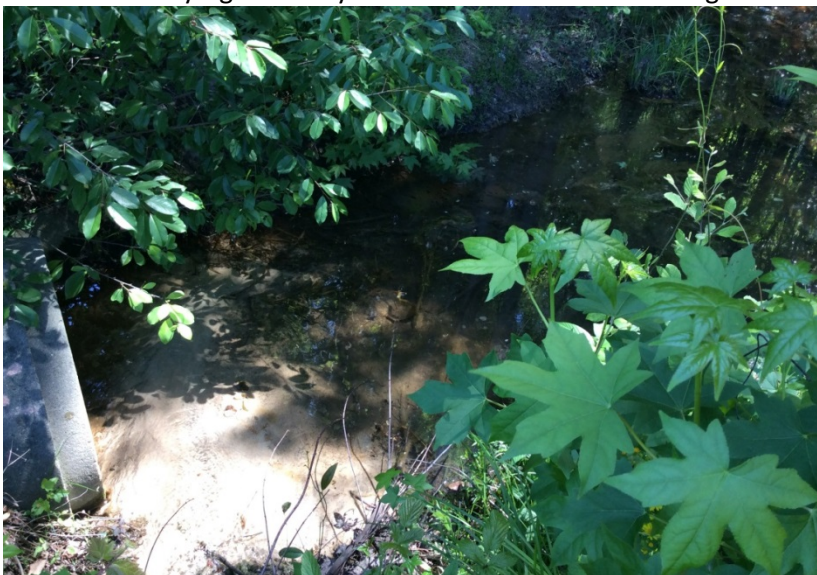
OP-1895 (Outfall of existing 30" RCP EP-1803)
Approx. Sta. 1423+20, Offset 148' LT

EP-1803 crosses I-77 SB approximately 1,050' before the Hard Scrabble Road bridge over I-77. At the time of the field visit, the outfall was silted in and retaining water at the pipe end. The outfall ditch should be excavated for approximately 20' between the pipe end and the receiving ditch downstream. There should not be any right-of-way issues associated with clearing the ditch.

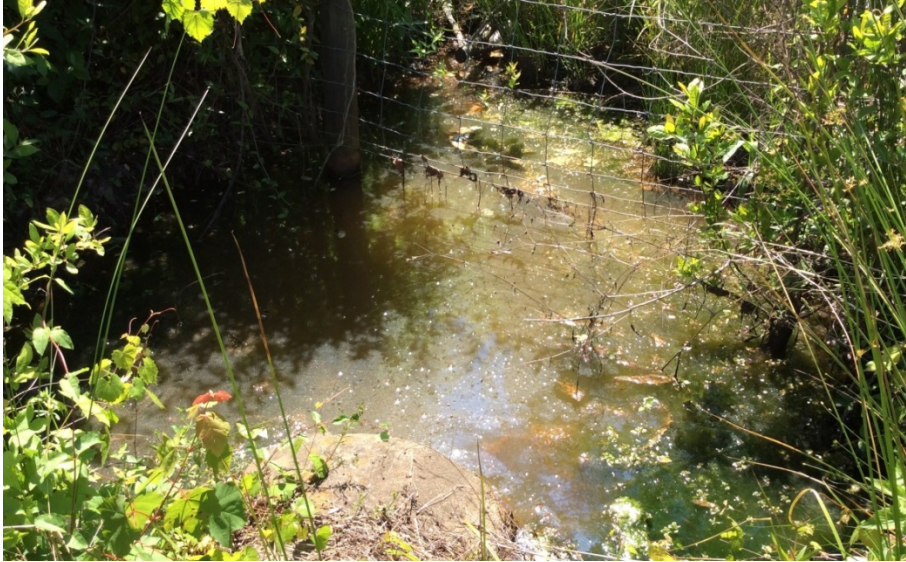
OP-1896 (Outfall of existing 24" RCP EP-1801)
Approx. Sta. 1451+70, Offset 170' LT

EP-1801 crosses I-77 SB approximately 1,800' before the Hard Scrabble Road bridge over I-77. At the time of the field visit, the outfall ditch was silted in and retaining water at the pipe end. The outfall should be excavated to ensure positive drainage from the pipe. The pipe outfall is located only a couple of feet from right-of-way and permissions may be needed for excavation.

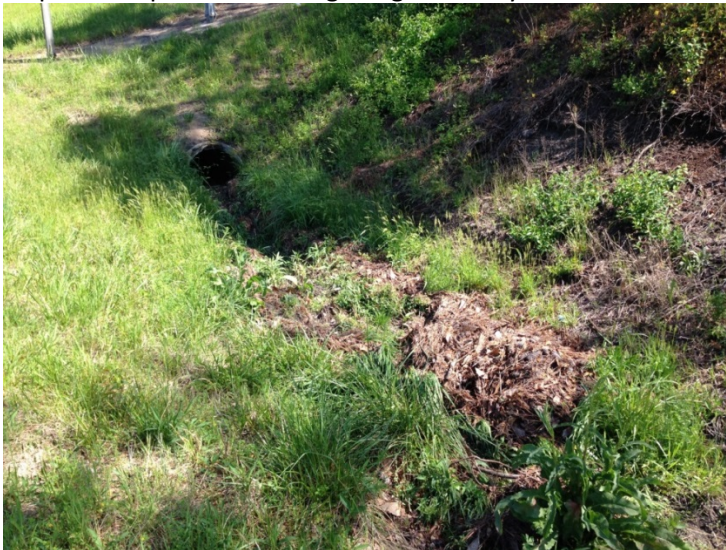
OP-1998 (Outfall of existing 30" RCP EP-1998)
Approx. Sta. 1433+15, Offset 123' RT

EP-1998 parallels I-77 NB beneath the Hard Scrabble Road overpass and outfalls approximately 75' south of the bridge. At the time of the field visit, the outfall ditch was filled with debris and needs to be cleaned to promote positive drainage. Right-of-way is not an issue in this area.

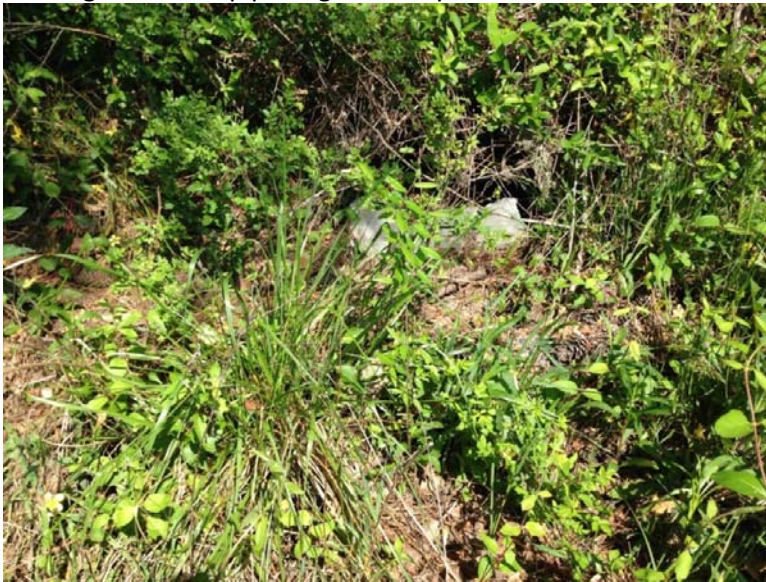
OP-1999 (Outfall of existing 24" RCP EP-1999)
Approx. Sta. 1433+10, Offset 121' LT

EP-1999 parallels I-77 SB beneath the Hard Scrabble Road overpass and outfalls approximately 75' south of the bridge. At the time of the field visit, the pipe was partially buried and the outfall ditch was covered in vegetation and debris. The outfall should be excavated and cleared of debris to ensure positive drainage from the pipe. Right-of-way is not an issue in this area.

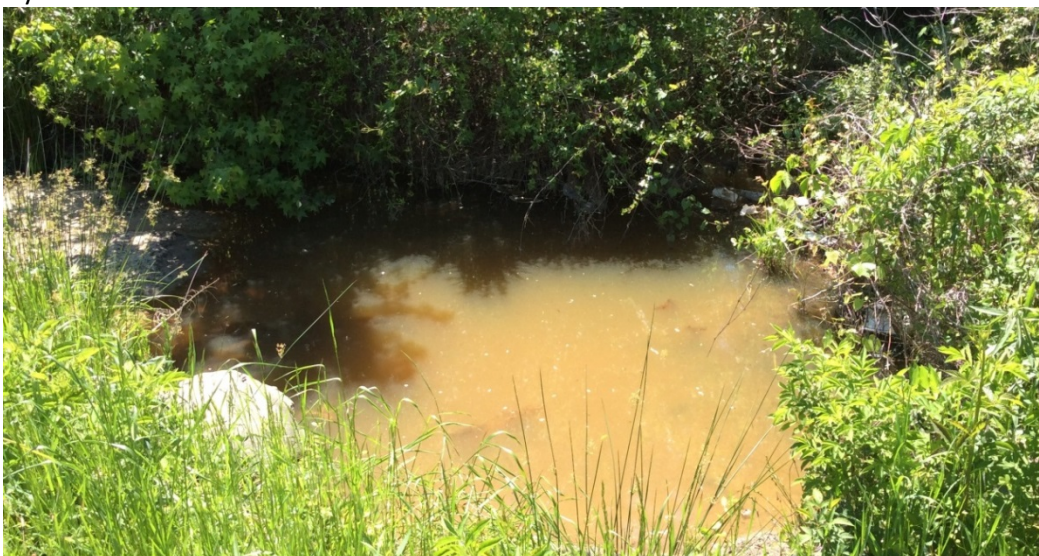
OP-2199 (Outfall of existing 36" RCP EP-2102)
Approx. Sta. 1459+55, Offset 162' LT

EP-2102 crosses I-77 SB approximately 2,550' after the Hard Scrabble Road bridge over I-77. At the time of the field visit, standing water was observed. The outfall was partially buried and the downstream channel was filled with silt. The outfall needs to be excavated to ensure positive drainage. Right-of-way issues may exist downstream of this outfall.

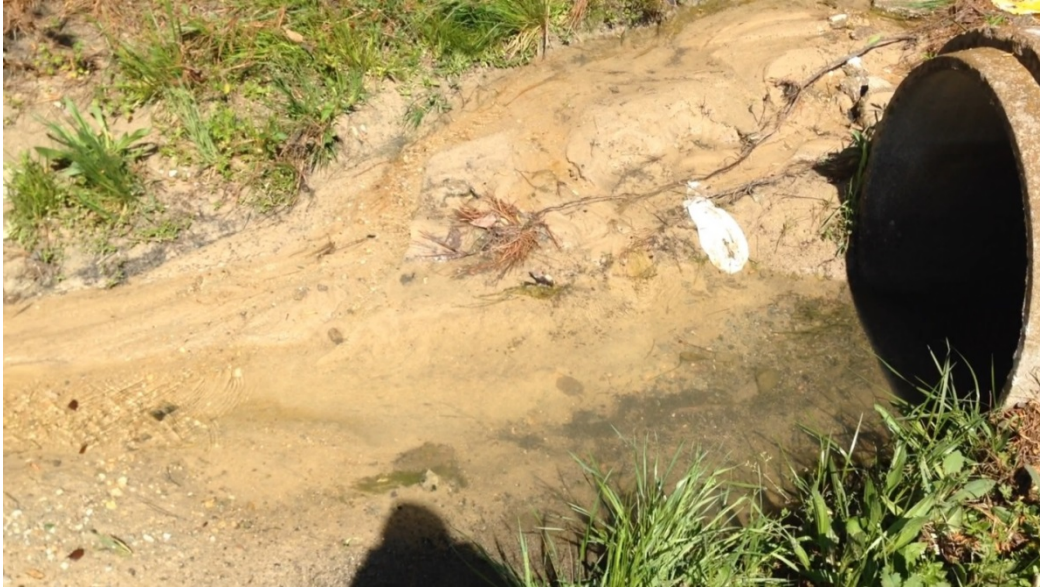
OP-2298 (Outfall of existing 36" RCP EP-2203)
Approx. Sta. 1459+55, Offset 162' LT

EP-2203 crosses I-77 SB approximately 2,650' before the Killian Road bridge over I-77. At the time of the field visit, the outfall was slightly silted in with minimal positive drainage. The outfall ditch should be excavated as necessary to restore downstream flow. Right-of-way may be a concern if excavation occurs for several feet.

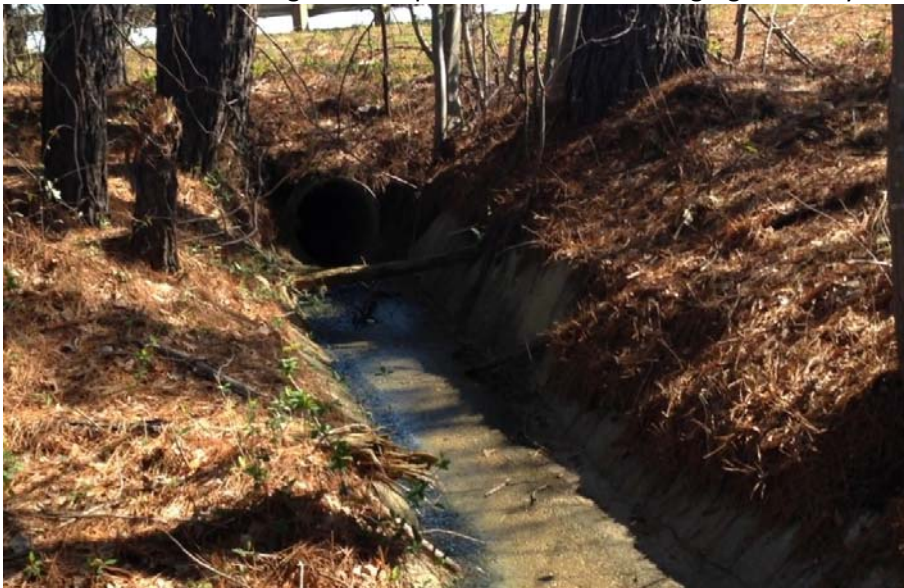
OP-2299 (Outfall of existing 24" RCP EP-2201)
Approx. Sta. 1474+60, Offset 114' LT

EP-2201 crosses I-77 SB approximately 3,600' before the Killian Road bridge over I-77. A fallen tree limb is currently draped over the outfall ditch of this pipe. While it is not currently impeding flow, it should be cleared from the outfall. Clearing can take place within the existing right-of-way.

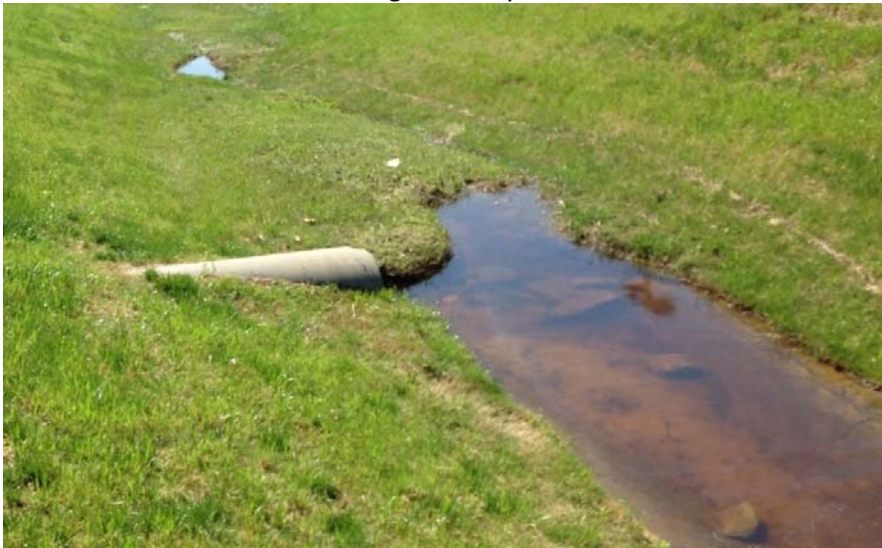
OP-2396 (Outfall of existing 18" RCP EP-2305)
Approx. Sta. 1505+50, Offset 310' LT

EP-2305 crosses the onramp from Killian Road to I-77 SB, approximately 570' before Killian Road bridge. At the time of the field visit, standing water was observed and the downstream channel was silted and established with grass. The channel should be excavated for several feet to restore downstream flow. There are no concerns associated with right-of-way in this area.

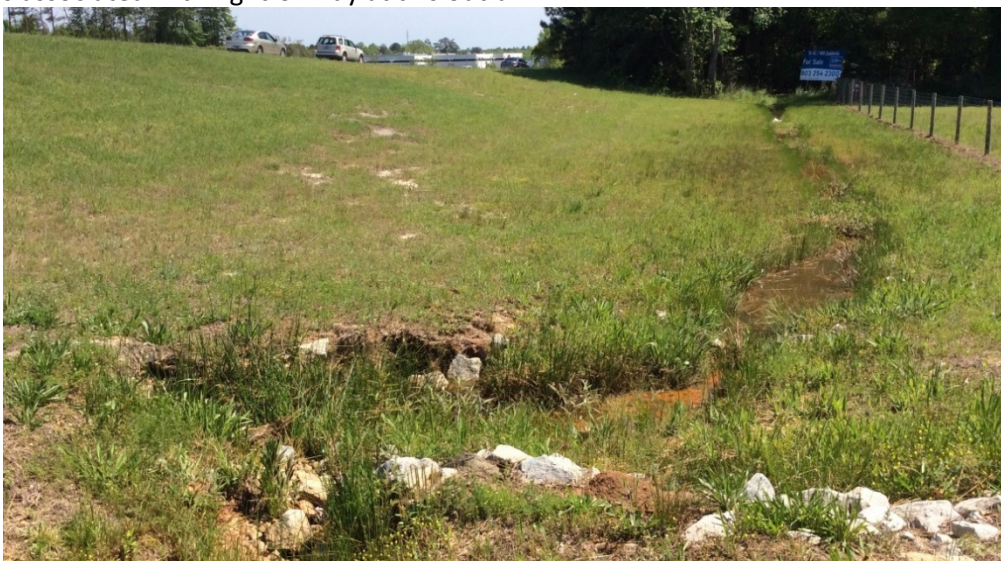
OP-2397 (Outfall of existing 18" RCP EP-2303)
Approx. Sta. 1503+15, Offset 239' LT

EP-2303 crosses the onramp from Killian Road to I-77 SB, approximately 800' before Killian Road bridge. At the time of the field visit, standing water was observed and the downstream channel was silted and filled with vegetation. In addition, the pipe end is slightly damaged. The outfall should be excavated for to restore positive drainage and the last pipe joint may need to be repaired or replaced. There are no concerns associated with right-of-way at this outfall.

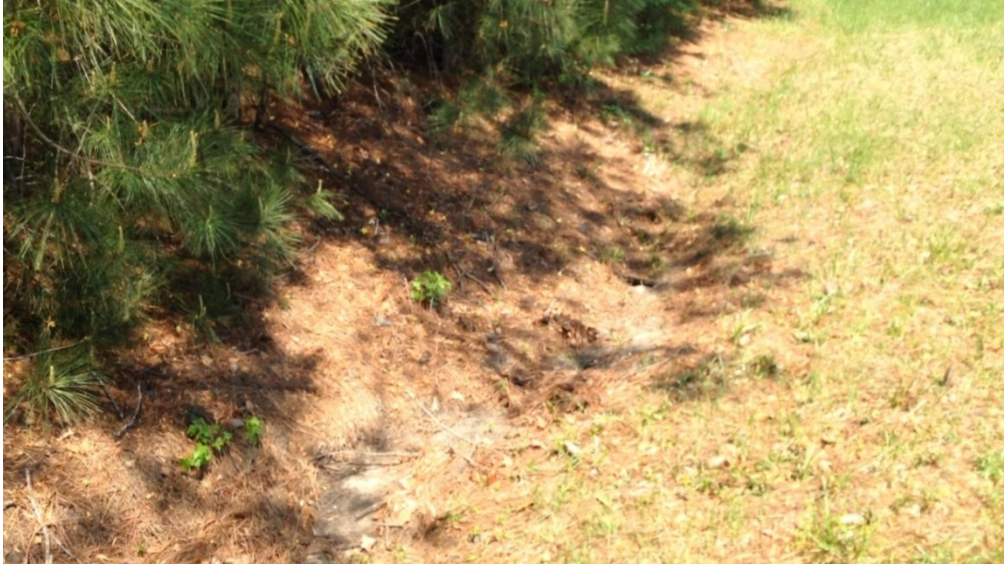
OP-2398 (not located, assumed as buried)

OP-2398 (Outfall of existing 18" RCP EP-2304)
Approx. Sta. 1499+65, Offset 175' LT

EP-2304 crosses the onramp from Killian Road to I-77 SB, approximately 1,150' before the Killian Road bridge. The outfall was not located in the field and is assumed to be buried. The outfall needs to be located. If the outfall location is where assumed, the pipe end should be excavated to ensure positive drainage. There are no concerns associated with right-of-way at this outfall.

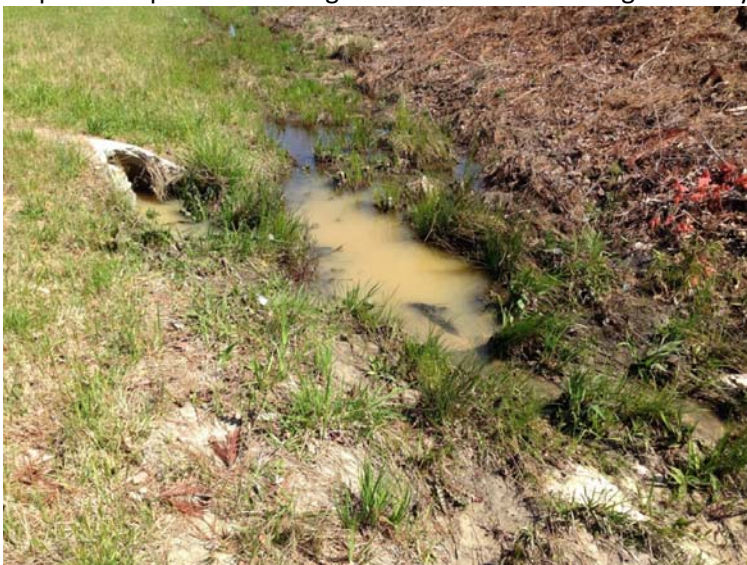
OP-2399 (Outfall of existing 24" RCP EP-2301)
Approx. Sta. 1500+30, Offset 147' RT

EP-2301 crosses the Killian Road exit off-ramp from I-77 NB, approximately 1,090' before Killian Road bridge. At the time of the field visit, the outfall was partially buried and the downstream ditch was silted had accumulated sediment, causing water to pond. The outfall and ditch should be excavated and cleaned to promote positive drainage. There should be no right-of-way issues in this area.

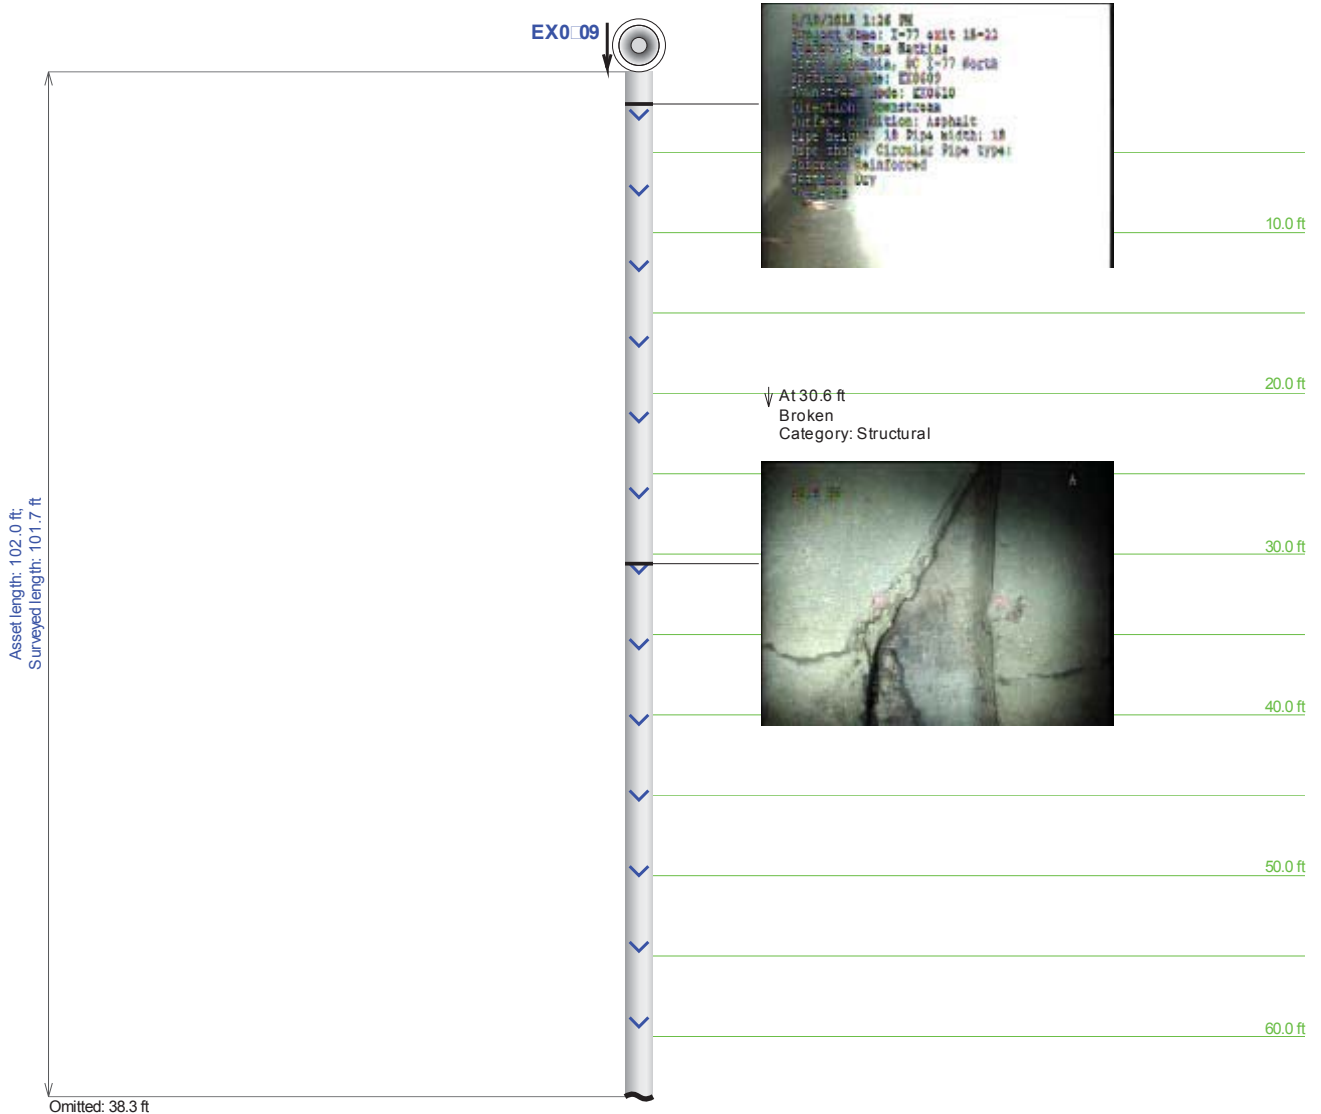
At 2.0 ft
 START WITH FLOW - Start Inspection With the Flow
 Category: Miscellaneous
