**I-85 / I-385 Interchange Pipe Inventory Summary**

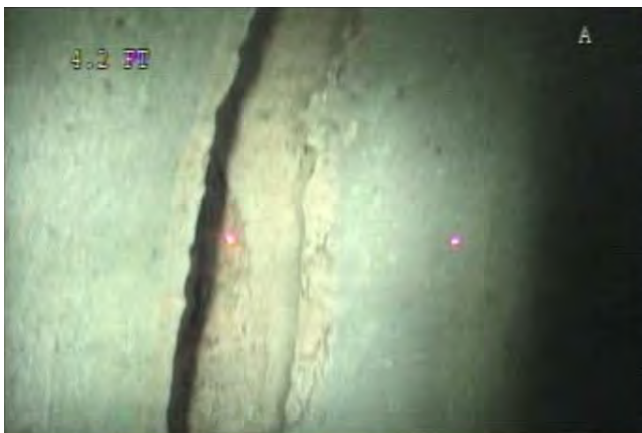
Joint - Separated at 4 ft

Based on Video Pipe Inspection and Hydraulic Information, retain 70' of the existing pipe from the median catch basin. Replace the last 8', which is affected by joint separation.

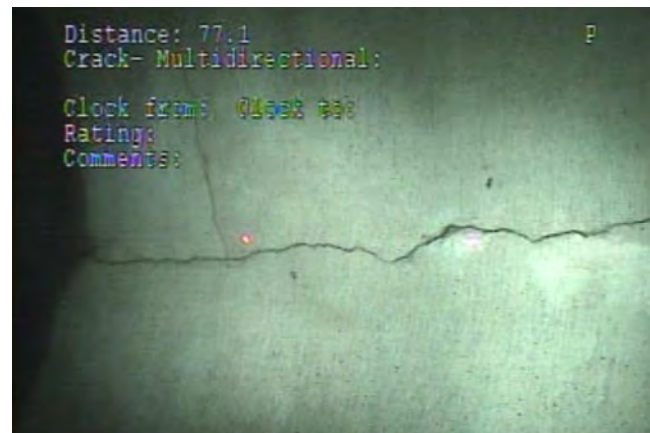
Multidirectional crack at 77 ft

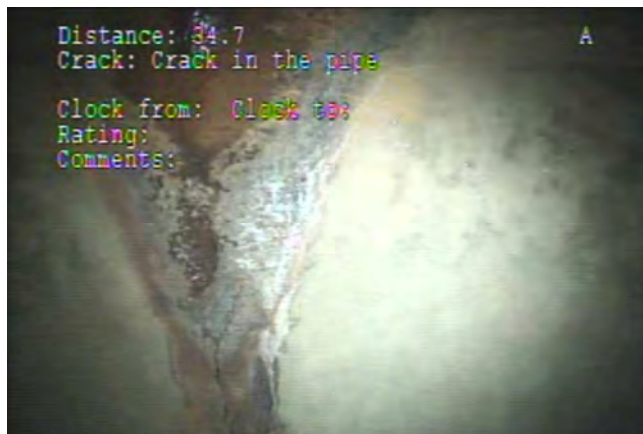
Cracks at 35, 100, and 152 ft; Joint issue at 71 ft; Corrosion at 198 ft

Crack at 35 Ft

Based on Video Pipe Inspection and Hydraulic Information, the existing 4' X 6' reinforced concrete box culvert (A8) should be cleaned, cracks and holes (corrosion areas) should be grouted, and culvert should be retained.

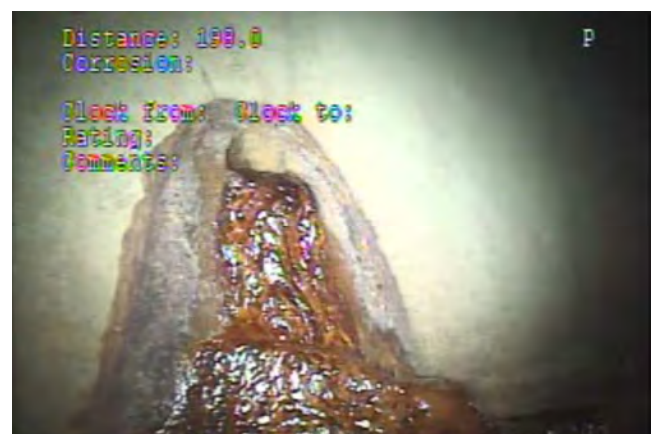
Corrosion at 198 ft

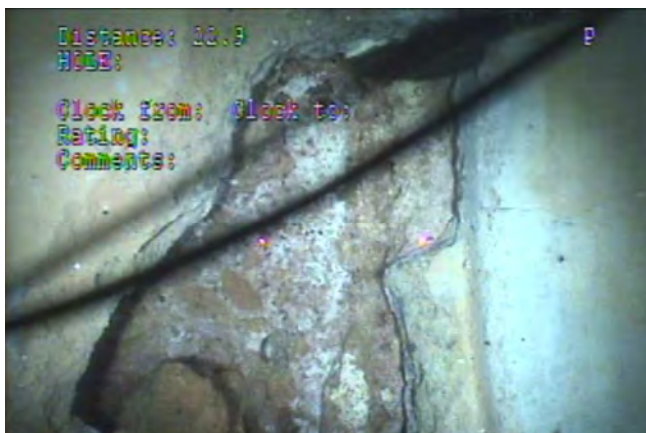
Hole at 23 ft; Chipped at 40 ft and 48 ft; Joint - Gasket at 40 ft  
Crack - Multidirectional at 48 ft, Joint Offset at 52 ft; Joint - Separated at 60 ft  
Debris at 61 ft

Hole at 23 ft

Based on the Video Pipe Inspection, Pipe A13 should be slip lined if retained due to deficiencies. Capacity should be verified with slip lined pipe.

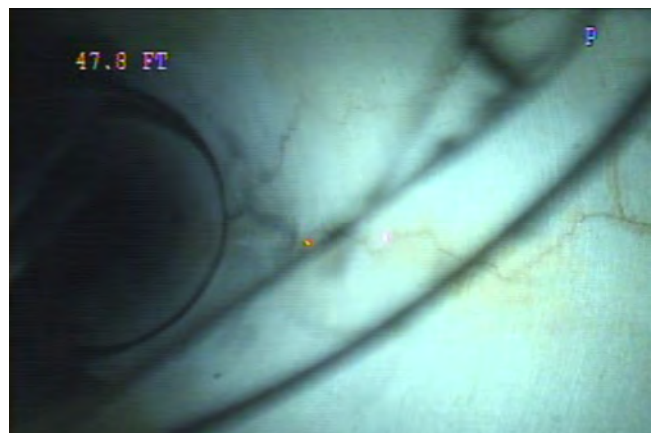
Multidirectional crack at 48 ft

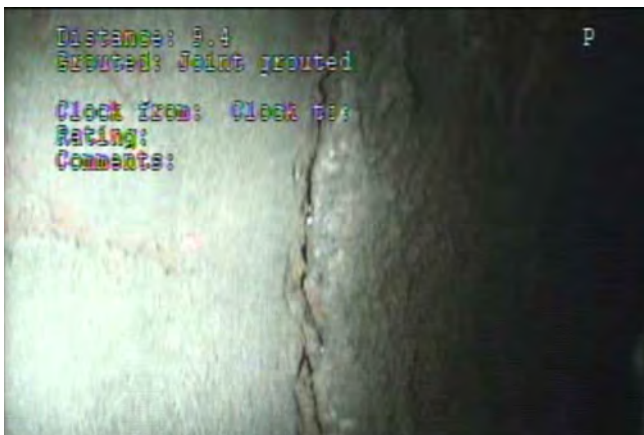
Joint Grouted at 9 ft

Based on Video Pipe Inspection and Hydraulic Information, Pipe B1 should be cleaned and retained.

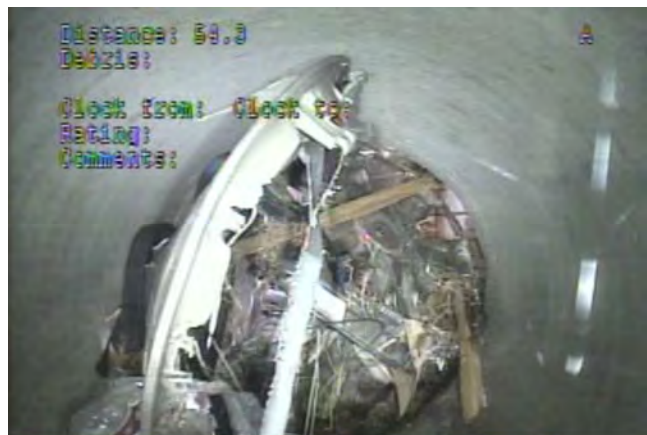
Debris at 54 ft

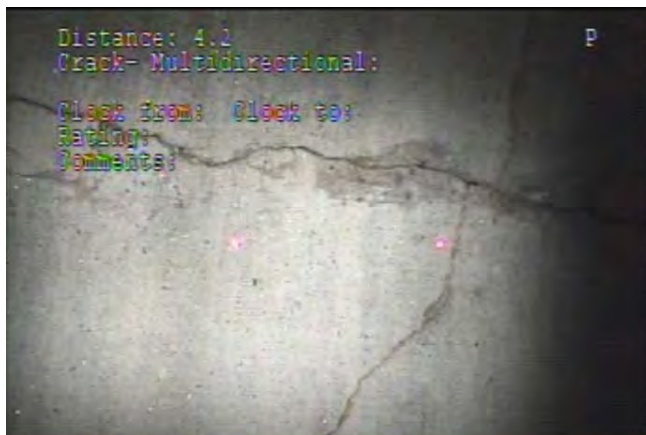
Crack - Multidirectional at 4 ft and 8 ft; Joint - Separated at 8 ft and 88 ft;  
Debris at 22 ft

Multidirectional crack at 4 ft

Based on the Video Pipe Inspection, Pipe B2 should be slip lined if retained due to deficiencies. Capacity should be verified with slip lined pipe. Concept Plans remove the existing 18" R.C. Pipe.

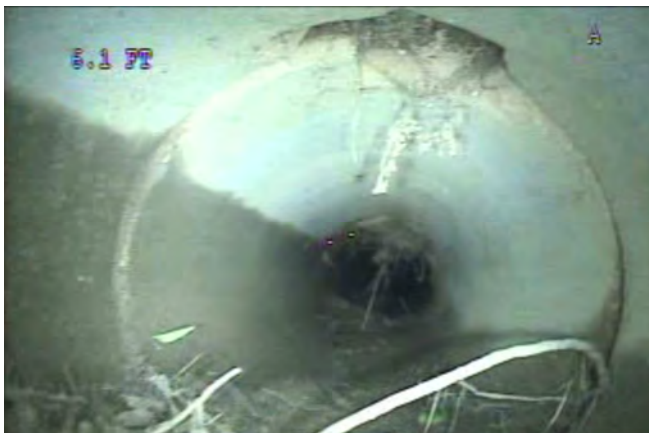
Broken at 11 ft; Hole at 16 ft  
Obstruction at 34 ft; VPI incomplete

Broken above at 11 ft

Based on the Video Pipe Inspection, Pipe B4 should be slip lined due to deficiencies. Capacity should be verified with slip lined pipe.

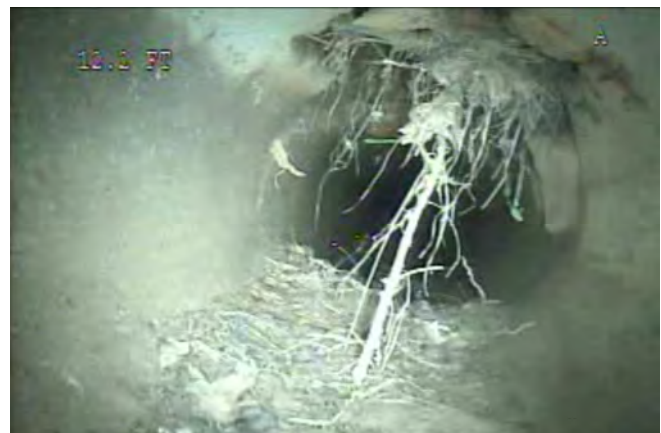
Hole above at 16 ft

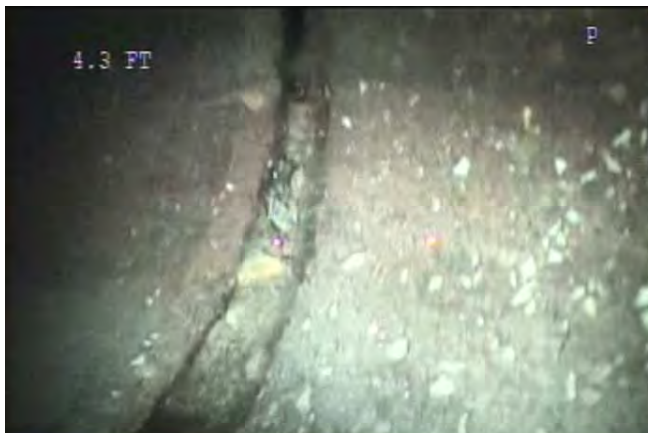
Joint - Separated at 4 ft (left) and 17 ft (right); other joint separations similar

Based on the Video Pipe Inspection, Pipe B5 should be slip lined due to deficiencies. Capacity should be verified with slip lined pipe.

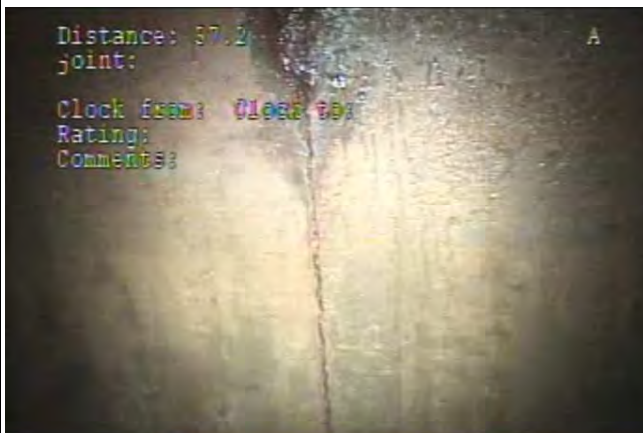
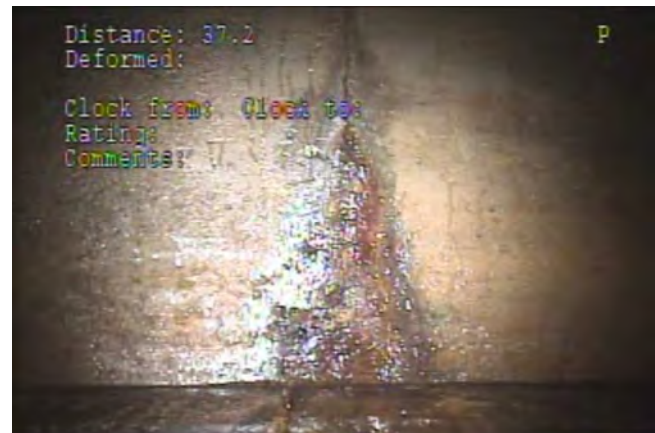
Joint issues/deformed at 37 ft

The Video Pipe Inspection captured approximately 60% of the length finding only minor deficiencies. Based on the Video Pipe Inspection and hydraulic information, the existing 5 X 5 RCBC should be retained.

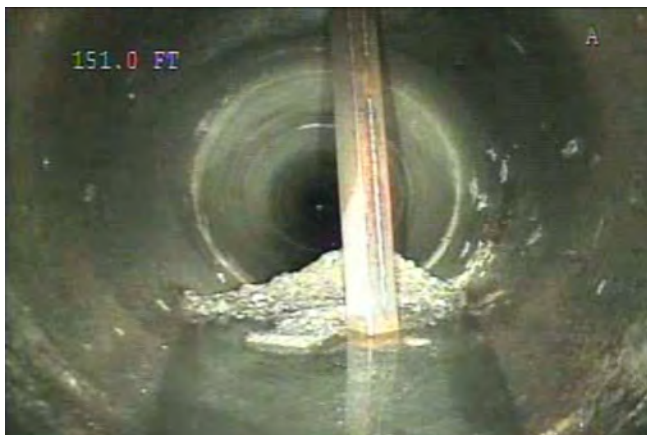
Debris at 154 ft (Left: looking ahead; Right: looking up)

Based on the Video Pipe Inspection, it appears as though the obstruction is located at the median CB and should be able to be removed. Also up until 154', the pipe appears to be in good shape. Remove obstruction at catch basin, clean and retain pipe.

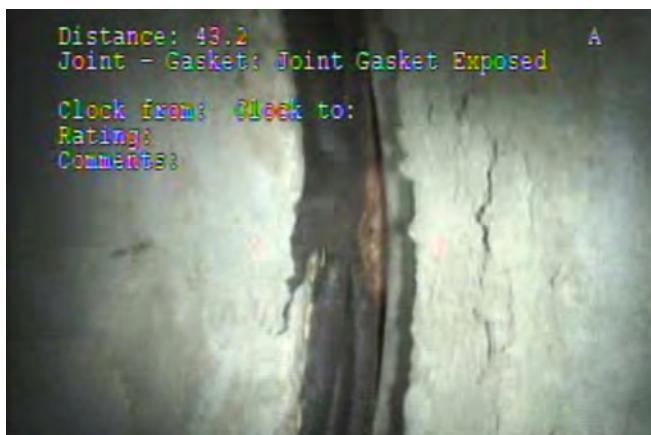
Joint - Gasket at 43, 47, and 57 ft; Crack at 60 ft

Joint - Gasket at 43 ft

Based on the Video Pipe Inspection and Hydraulic Analysis, Pipe B24 should be retained.

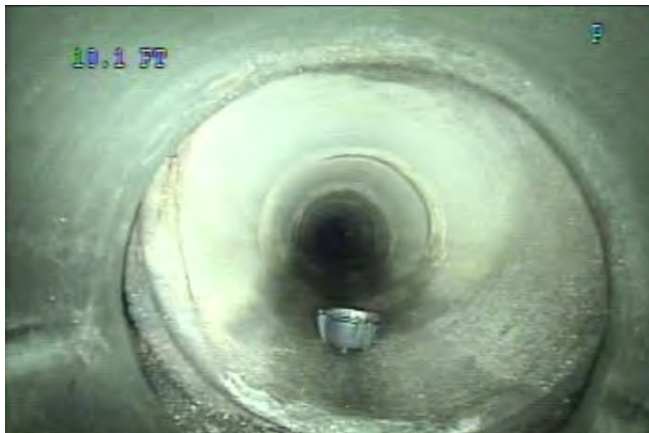
Joint Offset at 13 ft; Grouted at 20 ft; Debris at 72 ft;  
Crack at 74 ft; VPI incomplete

Joint Offset at 13 ft

Based on Video Pipe Inspection and Hydraulic Information, 68' from the median catch basin could be cleaned and retained. Replace the last 13', which is affected by the joint offset and not located below the travelway.

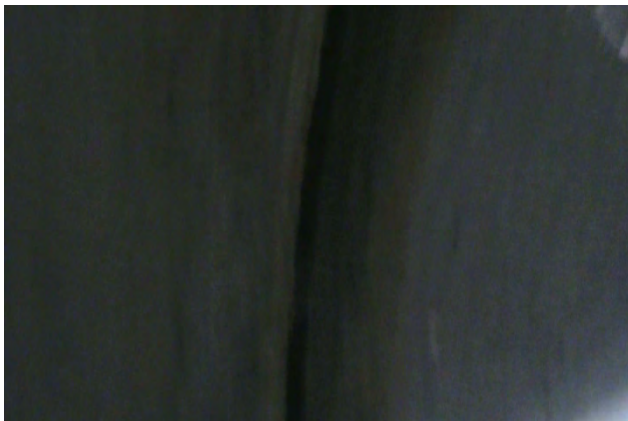
Joint Offset

Based on the Video Pipe Inspection, Pipe B29 could be retained.

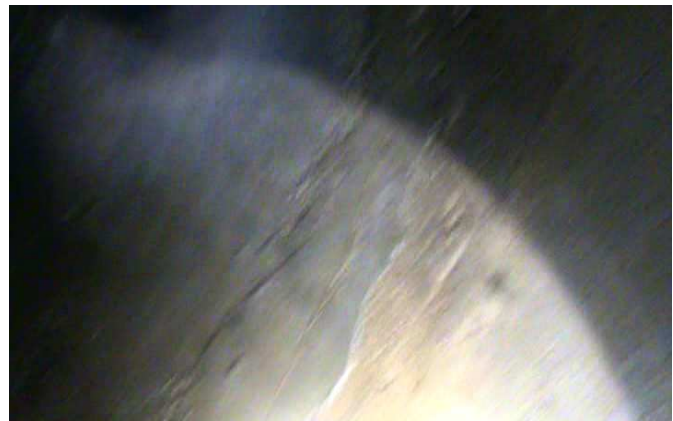
Typical grouted joint

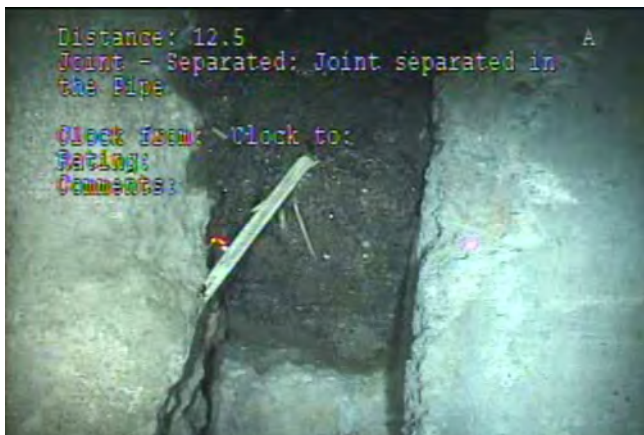
Joint Offset at 2 ft at 8 ft; Joint - Separated at 4 ft and 13 ft; Broken at 45 ft;

Joint - Separated at 13 ft

The pipe is no longer in use, but based on the video inspection of the pipe, there are large deficiencies under the travelway that could cause future problems. Also, Field surveys noted the presence of large amounts of sediment in the down stream catch basin. Pipe B36 should be removed or plugged & abandoned.

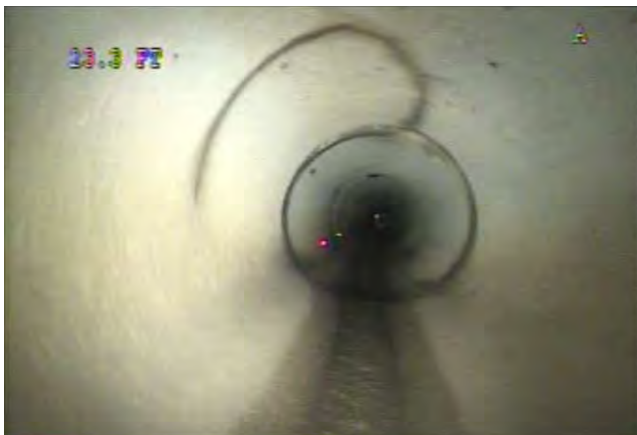
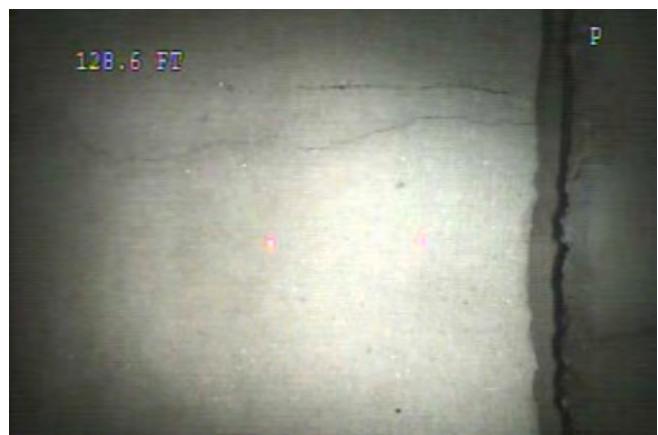
Crack - Multidirectional at 27, 39, and 45 ft; Joint - Gasket at 39 ft;

Crack at 127 ft

Cracks at 27 ft (left) and 127 ft (right)

Based on Video Pipe Inspection and the Hydraulic Information, Pipe B37 could be retained.

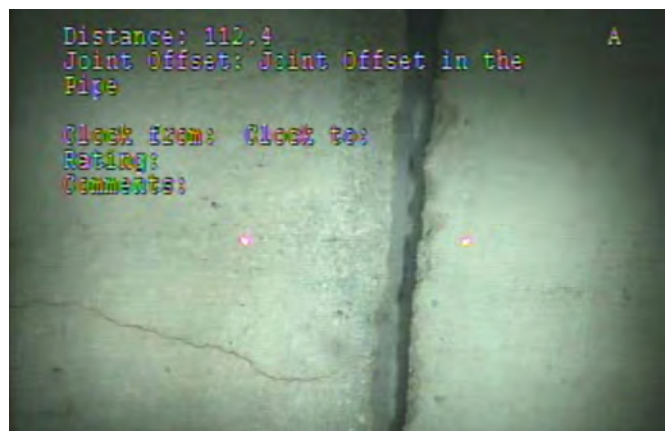
Crack - Longitudinal at 30, 38, and 112 ft; Joint Offset at 88 ft and 112 ft

Joint Offset and longitudinal crack at 112 ft; other offset and cracks similar

Based on the Video Pipe Inspection and Hydraulic Information, Pipe C1 should be retained.

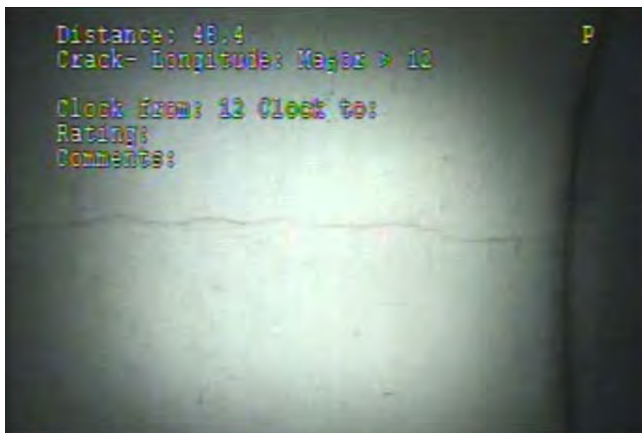
Crack - Longitudinal at 17, 48, 90, and 105 ft; Joint Offset at 154 ft;

50-ft long. crack at 48 ft; other cracks similar

Based on the Video Pipe Inspection, Pipe C2 should be slip lined due to deficiencies. Capacity should be verified with slip lined pipe.

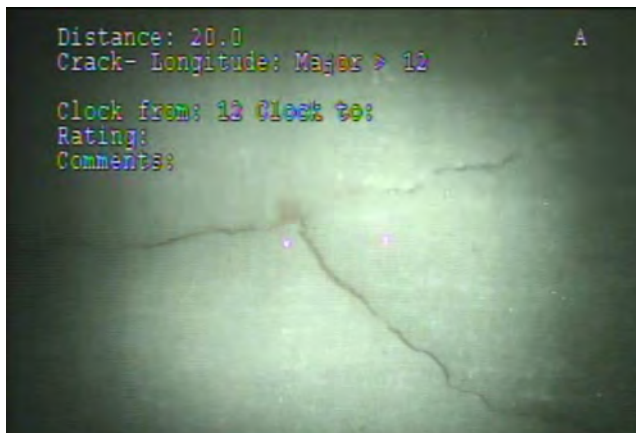
Crack - Longitudinal at 20 ft; Joint Offset at 47 ft

Longitudinal crack at 20 ft

Based on the Video Pipe Inspection and Hydraulic Information, retain 80' of the existing pipe from the median catch basin. Replace the last 47', which is affected by joint offset.

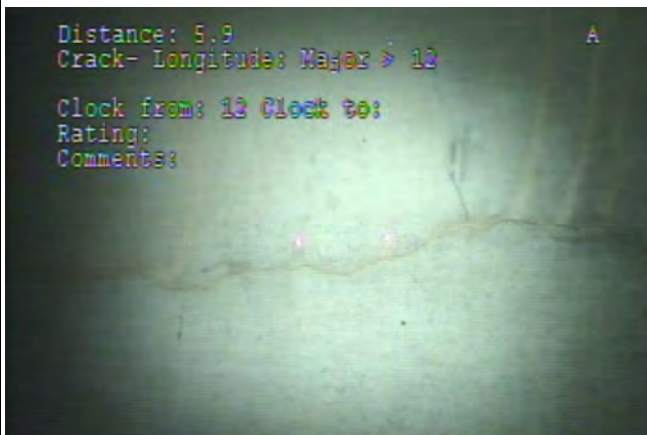
Crack - Longitudinal at 6 ft and 55 ft; Joint Offset at 28 ft and 76 ft;  
Crack - Multidirectional at 77 ft

Long. crack along top for most of the pipe length

Based on the video pipe inspection and hydraulic information, Pipe C4 could  
be retained.

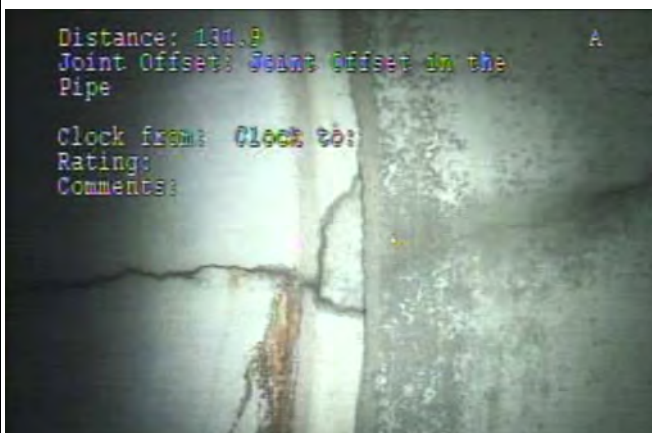
Joint Offset at 8, 25, 66, 98 and 132 ft; Crack - Longitudinal at 8, 49, and 95 ft;  
Crack - Circumferential at 61 ft and 95 ft; Crack - Multidirectional at 104 ft and 132 ft; Joint - Separated at 123, 156, 164, and 213 ft

Multidirectional crack & Joint Offset at 132 ft

Based on Video Pipe Inspection, Pipe C5 should be slip lined due to deficiencies. Capacity should be verified with slip lined pipe. The Concept Plan only retains the section of C5 between 24' and 94' in the VPI which shows minimum deficiencies and could be retained.

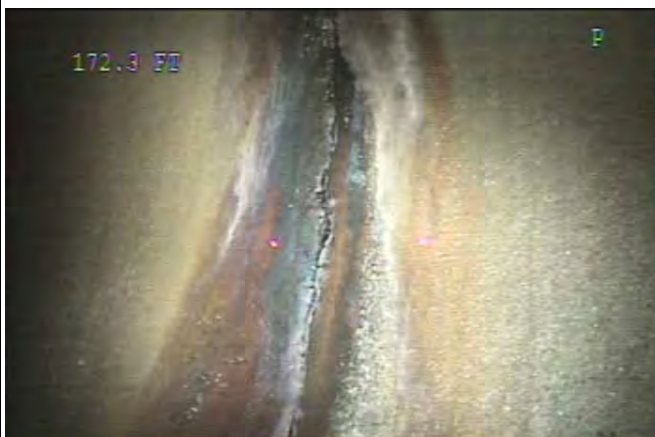
Crack - Longitudinal at 20, 232, 237, 270, and 344 ft; Joint Offset at 34, 82, 124,  
164, 213, and 302 ft; Crack - Circumfrenclal at 103 ft; Joint - Alignment at 107  
and 172 ft; Joint - Separated at 286 and 360 ft

Joint - Alignment at 172 ft

Based on the Video Pipe Inspection, Pipe C7 should be slip lined due to  
deficiencies. Capacity should be verified with slip lined pipe. The Concept  
Plans plug & abandon the existing 30" R.C. Pipe.

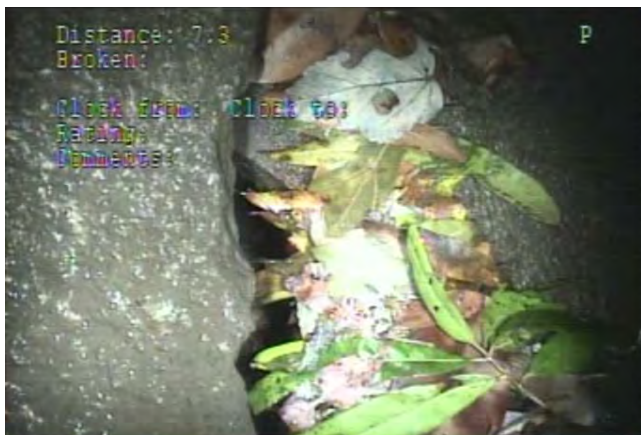
All joints offset; Broken at 7 ft;  
Change from RCP to corrugated pipe at 49 ft - Joint Failure; VPI incomplete

Broken at 7 ft

Based on Video Pipe Inspection and Hydraulic Information, Pipe C8 should be replaced and should not be used.

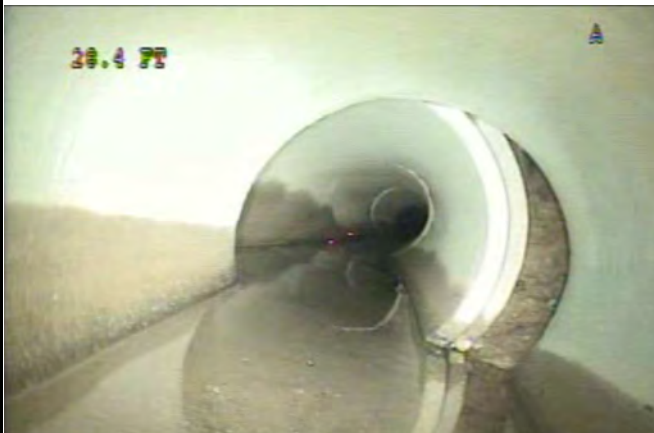
Joint - Separated at 7, 24, 31, 48, 57, and 88 ft; Root-in-joint at 8 ft; Collapsed  
at 31 ft and 88 ft; Joint Offset at 40, 72, 81, 102, 128, and 153 ft; Crack - Longi-  
tudinal at 81 ft; Joint - Gasket at 193 ft; Hole at 104 ft and 201 ft; Lateral at 88 ft

Collapsed at 31 ft

Based on the Video Pipe Inspection, Pipe C9 should not be used. Concept  
Plans plug & abandon the existing 18" R.C. Pipe.

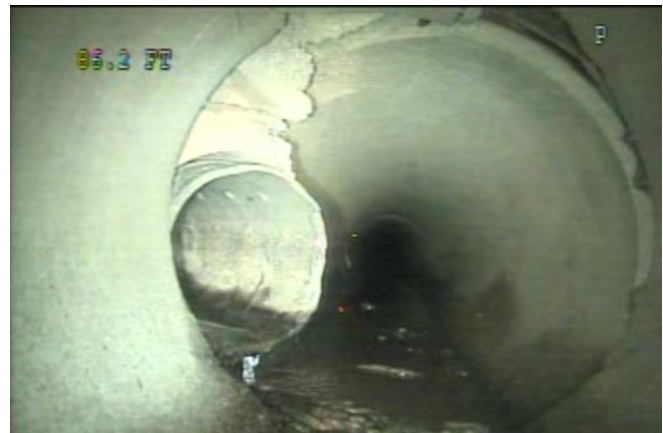
Collapsed at 88 with lateral pipe

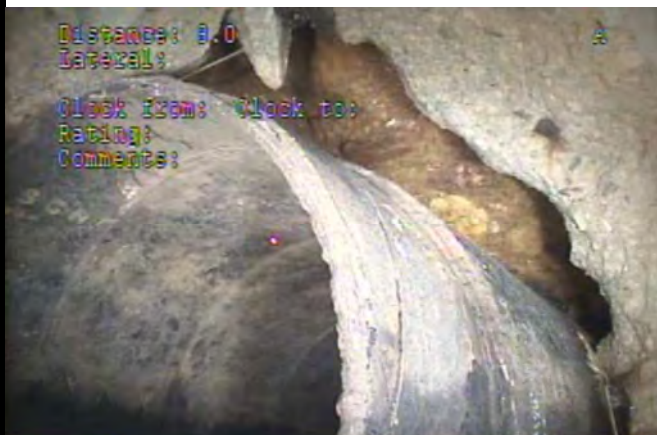
Lateral at 8.0 ft

Based on Video Pipe Inspection, Pipe C10 should not be used. Concept Plans replace the existing 18" R.C. Pipe.

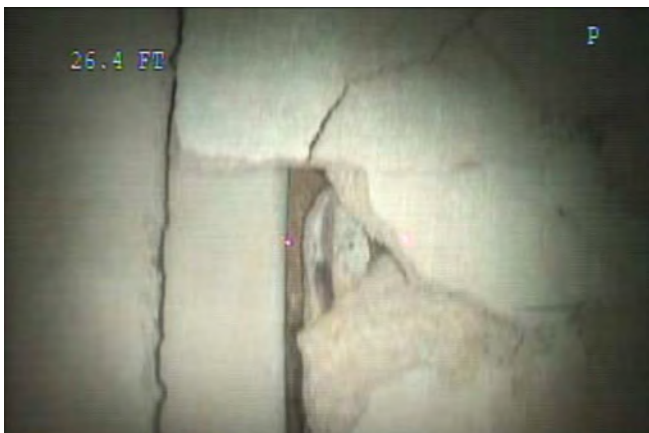
Joint - Separated and Multidirectional crack at 26 ft

Based on Video Pipe Inspection, Pipe C12 could be retained. Concept Plans remove the existing 24" R.C. Pipe.

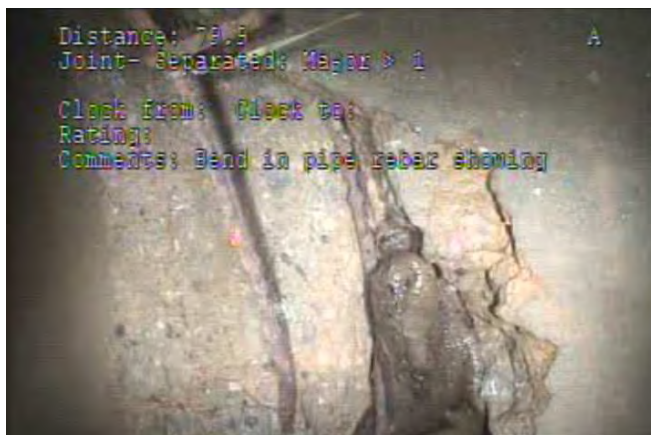
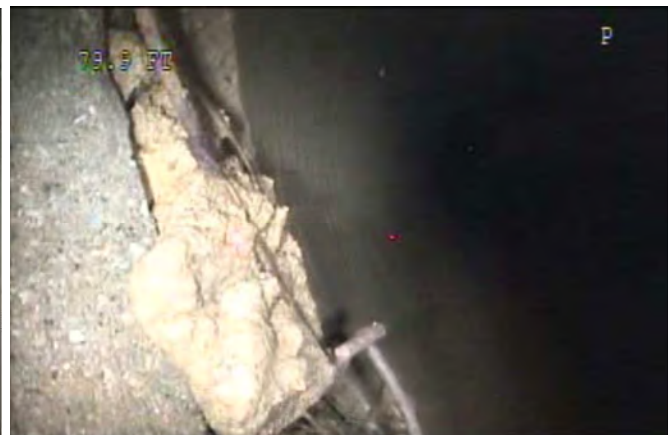
Joint - Separated at 80 ft

246' from the upstream inlet or the pipe could be slip lined. The Concept Plans

remove the existing 18" R.C. Pipe.

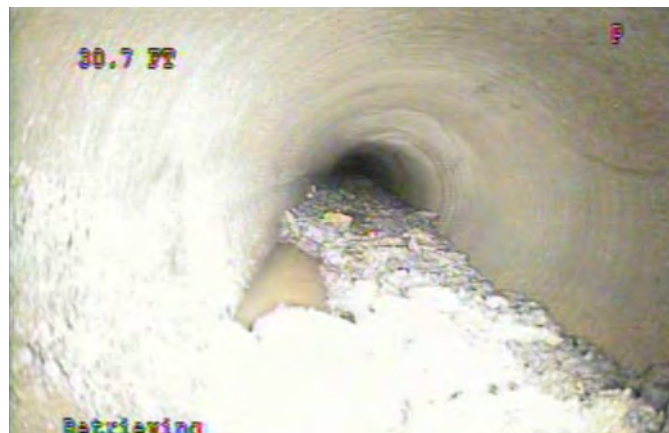
Debris at 33 ft

Based on the Video Pipe Inspection, Pipe D1 could be cleaned and retained.

The Concept Plans plug & abandon the existing 18" R.C. Pipe under the travelway and remove outside the travelway.

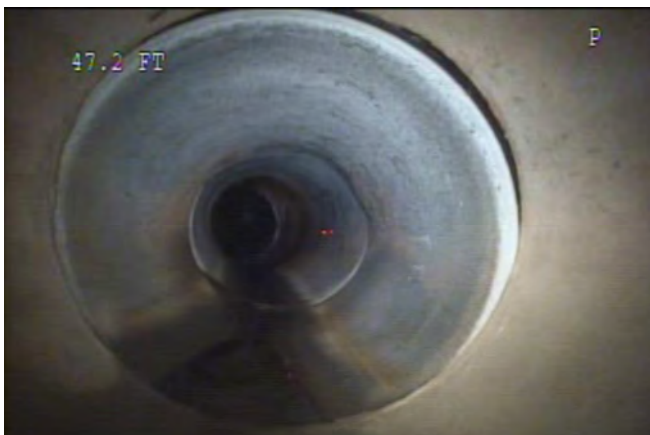
Joint - Separated at 53 ft (left) and 60 ft (right)

Based on the Video Pipe Inspection, Pipe D3 should be slip lined due to deficiencies. Capacity should be verified with slip lined pipe.

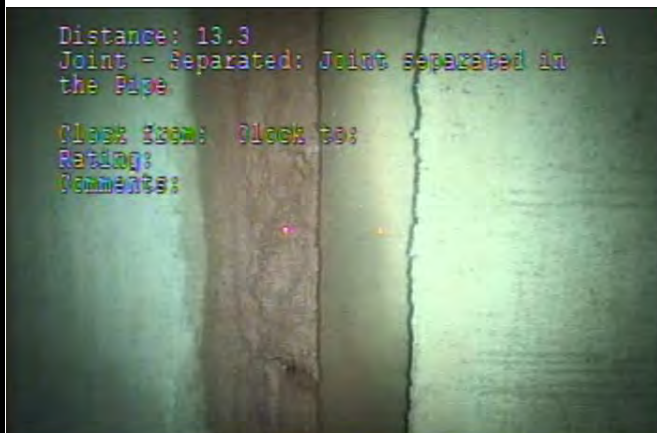
Joint - Separated at 13 ft

Based on the Video Pipe Inspection, Pipe D4 should be slip lined due to deficiencies. Capacity should be verified on slip lined pipes.

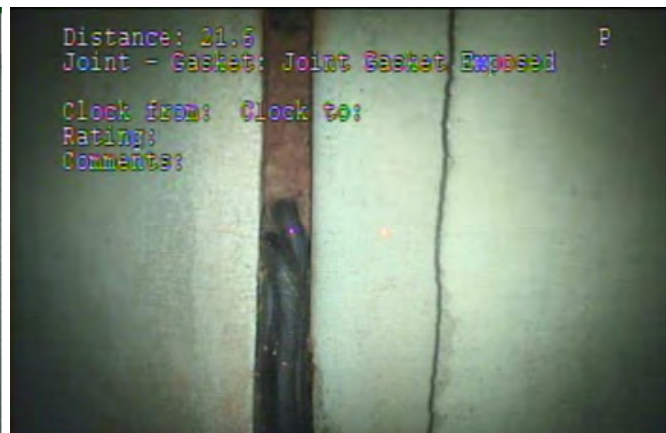
Joint - Gasket at 22 ft

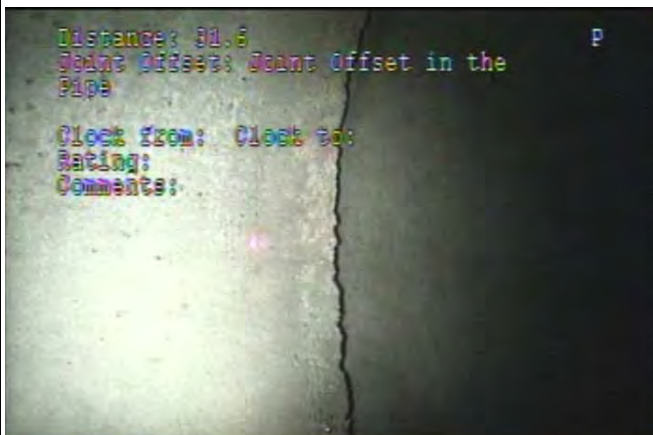
Joint Offset at 32 ft

Based on the Video Pipe Inspection and Hydraulic Information, Pipe D6 could be cleaned and retained.

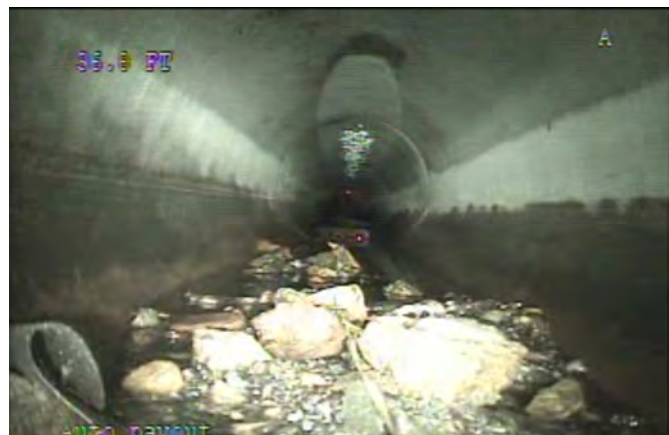
Debris at 41 ft

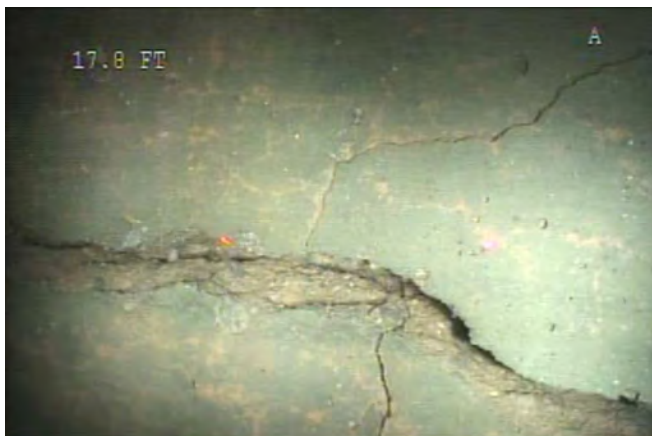
Broken at 18 ft (crushed under road); Joint - Separated at 36 ft and 43 ft;  
Joint failure - Change of pipe type at 43 ft

Broken at 18 ft

Based on the Video Inspection, Pipe F40 should not be used due to deficiencies.  
At 18', pipe ceiling is crushed and deformed. Pipe F40 should be removed or  
plugged & abandoned. The Concept Plans remove the existing 18" R.C. / C.M.  
Pipe.

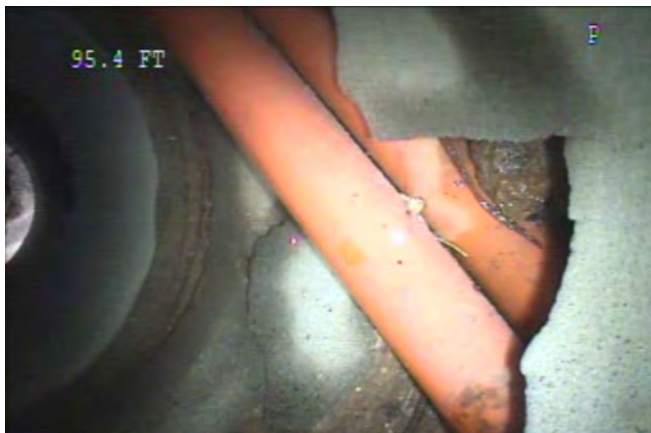
Utility conduit through pipe at 95 ft; Broken at 98 ft (near end of pipe)

Thru pipe at 95 ft

Based on the Video Pipe Inspection and Hydraulic Information, retain 92' from the outlet. Replace 8' at median catch basin due to deficiencies.

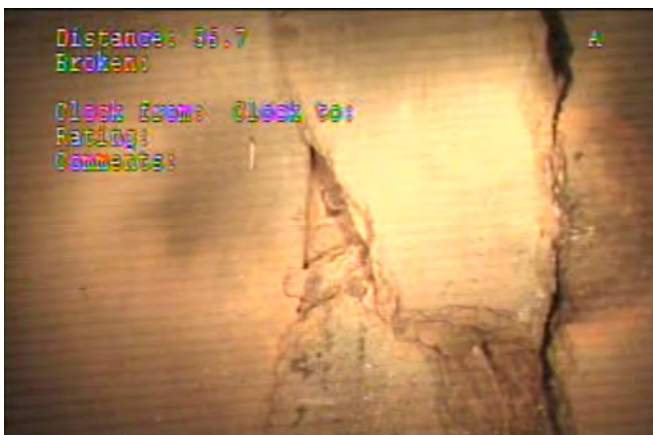
Joint - Separated at 20 ft; Broken at 28, 37, and 45 ft; Crack at 69 ft

Broken at 37 ft (left) and 45 ft (right)

due to deficiencies. Capacity should be verified for slip lined pipe. Concept

Plans do not retain existing 18" R.C. Pipe, and show removing outside of

pavement and plug & abandon under the travelway.

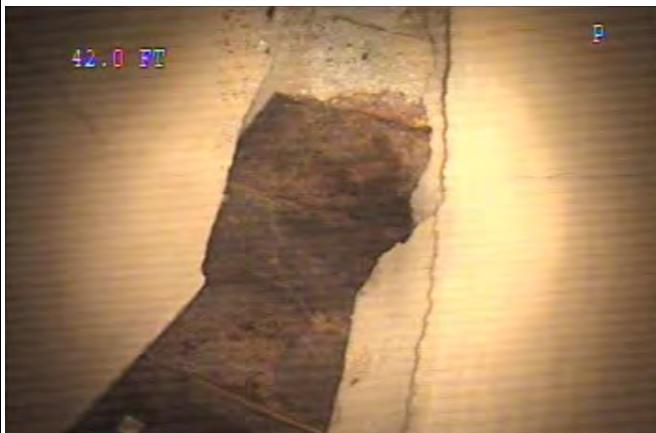
Cracked at 12, 42, and 143 ft; Joint - Separated at 42, 143, and 156 ft

Joint - Separated and cracked at 42 ft (left) and 143 ft (right)

Based on the Video Pipe Inspection, Pipe I9 should be slip lined to be retained due to deficiencies. Capacity should be verified for slip lined pipe. Concept Plans remove the existing 36" R.C. Pipe.

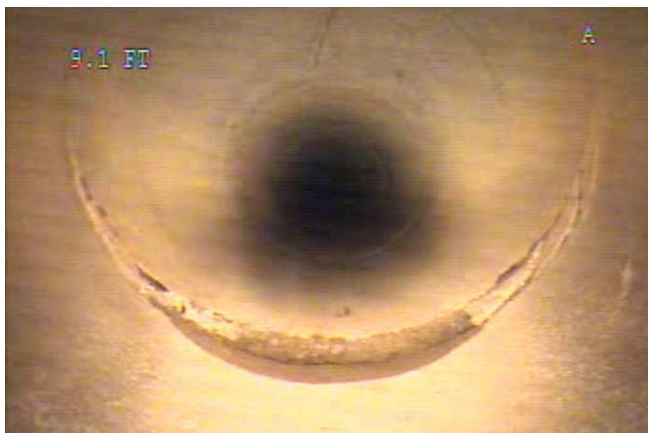
Cracked at 7, 13, 29, 39, and 76 ft; Joint - Separated at 13 ft; Broken at 119 ft

Joint - Separated and cracked (top) at 13 ft

Based on the Video Pipe Inspection, the broken pipe at 119' appears to be a hole created for the median catch basin to flow into the pipe (similar to 180' on the same VPI). However, the hole is clogged, which would affect the drainage at the median. Recommend replacing the drainage structure at the median to prevent clogging as seen in the VPI. Pipe I10 could be retained. Concept Plans remove existing 36" R.C. Pipe outside of the pavement structure and plug & abandon under the pavement structure.

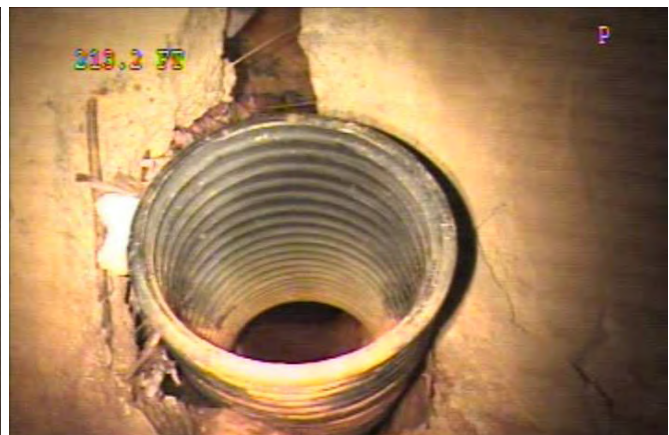
Lateral at 30 ft

Based on the Video Pipe Inspection and Hydraulic Information, Pipe I12 could be retained. However, a junction box should be placed at approximately 30 feet from the upstream side to remove the deficiencies found around the lateral line tie-in.

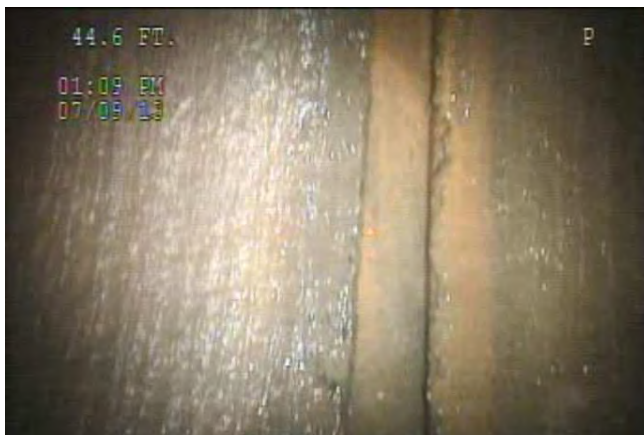
All joints separated; Joint Offset at 119 ft; Crack at 206 ft

Joint - Separated at 45 ft

Based on the Video Pipe Inspection, Pipe I17A should be slip lined if retained. Capacity should be verified on slip lined pipe. One point of concern from the VPI is the standing water at the end of the VPI on I17A, which should be further investigated if retained (17B-17D). Concept Plans replace the existing 36" R.C. Pipe due to the additional fill added by the current proposed design.

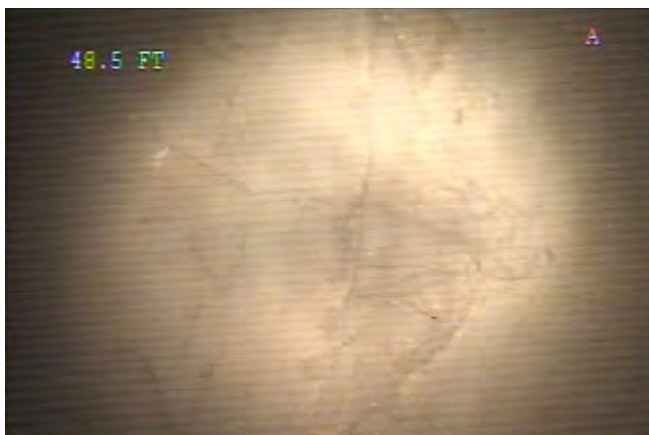
Crack at 2 ft and 49 ft

Crack at 49 ft

Based on Video Pipe Inspections, Pipe I20 should be slip lined if retained due to the joint deficiencies. Capacity should be verified for slip lined pipe. Concept Plans remove existing 30" R.C. Pipe.

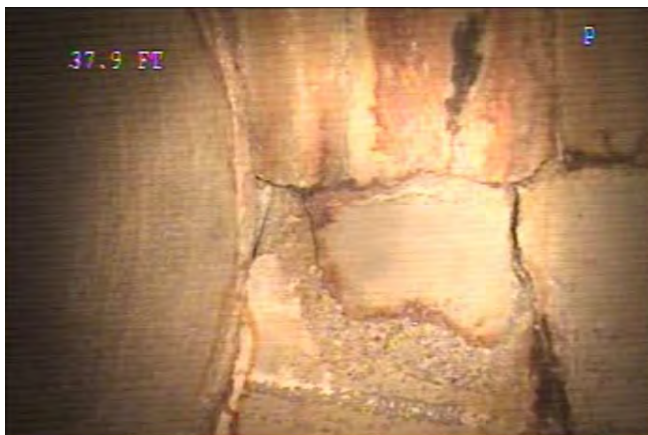
Crack at 39, 46, 80, 129, 331, 333, and 404 ft; Broken at 38 ft

Crack (broken) at 39 ft

Based on Video Pipe Inspections, Pipe I21 should be slip lined if retained due to the joint deficiencies. Capacity should be verified for slip lined pipe. Concept Plans remove existing 30" R.C. Pipe.

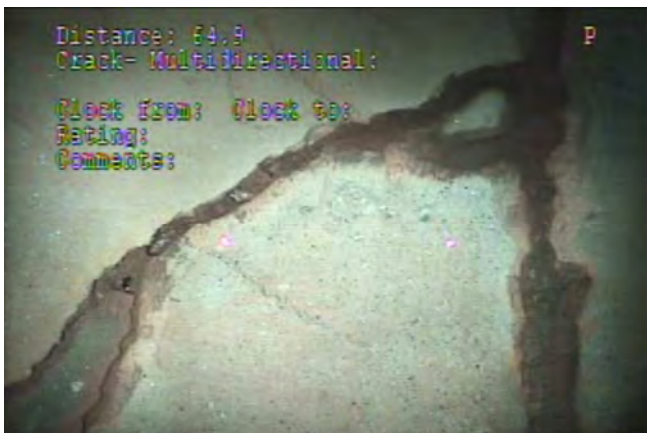
Crack - Multidirectional at 65 ft; Joint Offset at 97 ft

Multidirectional crack at 65 ft

Based on Video Pipe Inspection and Hydraulic Information, Pipe I23 should be slip lined if retained due to deficiencies. Capacity should be verified on slip lined pipe.

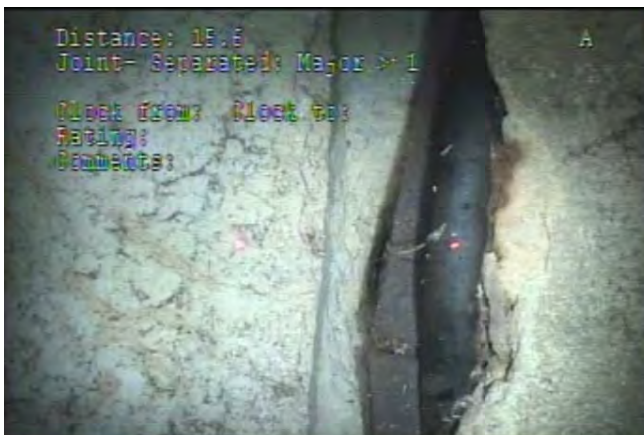
Joint - Separated at 16 ft; Joint Offset at 106 ft and 138 ft; Crack at 138 ft;

Joint - Separated at 16 ft

Based on Video Pipe Inspection and Hydraulic Information, Pipe I24 should be slip lined if retained due to deficiencies. Capacity should be verified on slip lined pipe.

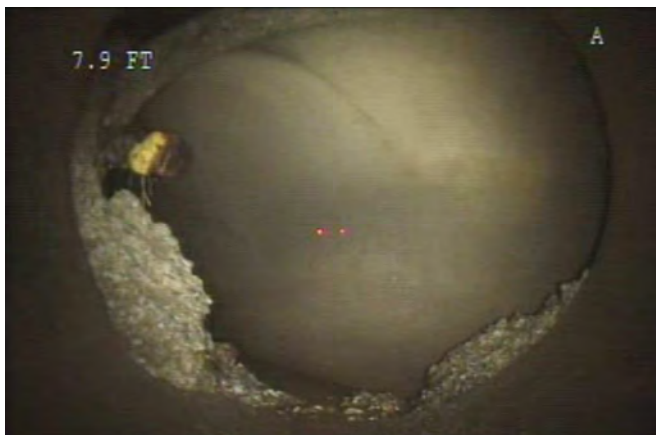
Joint - Separated (broken) at 12 ft

Based on Video Pipe Inspection and Hydraulic Information, Pipe I25 should be slip lined if retained due to deficiencies. Capacity should be verified on slip lined pipe.

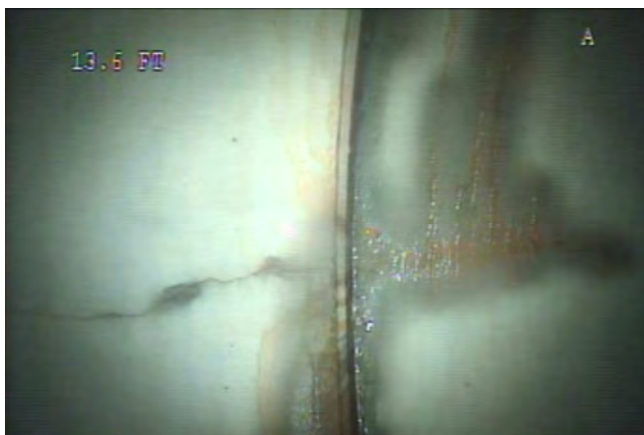
Crack at 14 ft; Hole at 74 ft (not in report)

Crack at 14 ft (runs for 63 ft length)

Based on the Video Pipe Inspection and Hydraulic Information, retain 72' from the upstream catch basin. The hole located at 74' allows the drop inlet to drain to the pipe. The pipe does not turn at the drop inlet, instead I26 bends to I25. Replace pipe from 72' to bend and place a structure to tie to I25.

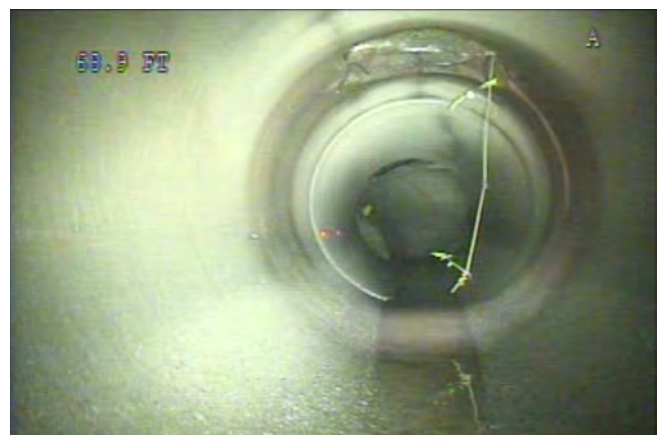
Hole above at 74 ft

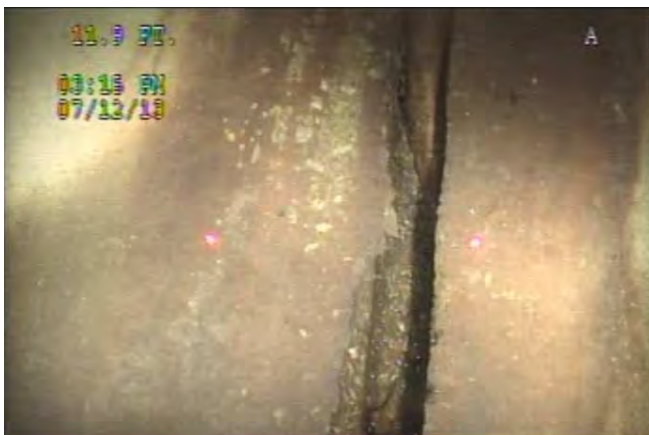
Joint - Separated at 12 ft

Based on the Video Pipe Inspection and Hydraulic Informaion, Pipe I28 should be slip lined if retained. Capacity should be checked on slip lined pipe. However, the structural integrity of the pipe should also be verified as the Concept Plans add approx. 36' of fill which would require the pipe not to be used. Concept Plans replace the existing 18" R.C. Pipe due to the additional fill.

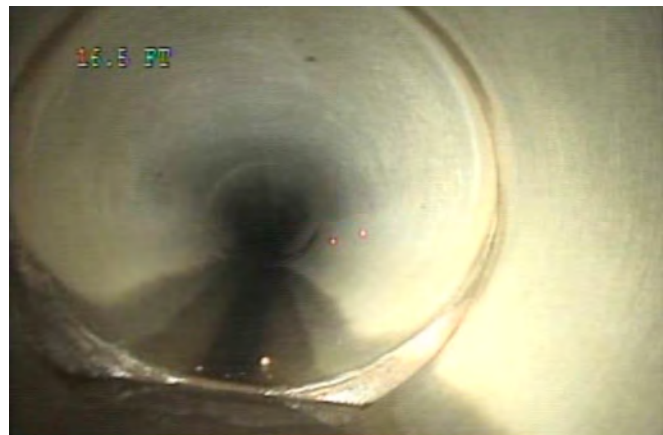
Joint Offset at 20 ft

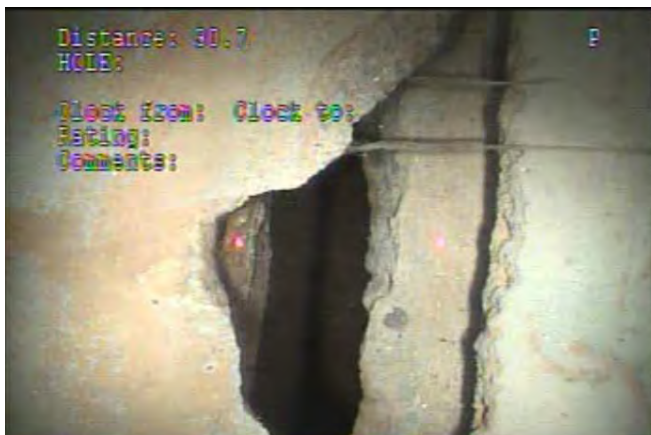
Crack - Multidirectional at 7 ft; Joint Offset at 7 ft and 23 ft; Hole at 31 ft;

Hole at 31 ft

Based on the Video Pipe Inspection, Pipe I30 should be slip lined if retained due to deficiencies. Capacity should be verified on slip lined pipe. Pipe I30 does not meet the free surface flow capacity, but meets all other SCDOT design criteria.

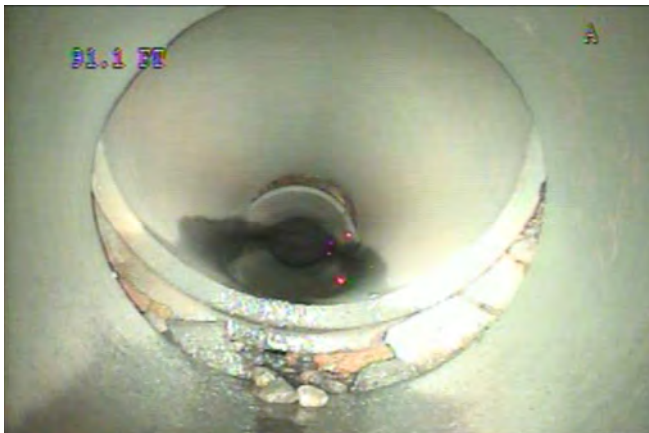
Joint Offset at 177 ft; other Joint Offsets similar

Based on the Video Pipe Inspection and the Hydraulic Information, Pipe I32 should not be used due to severe joint offsets and other deficiencies.

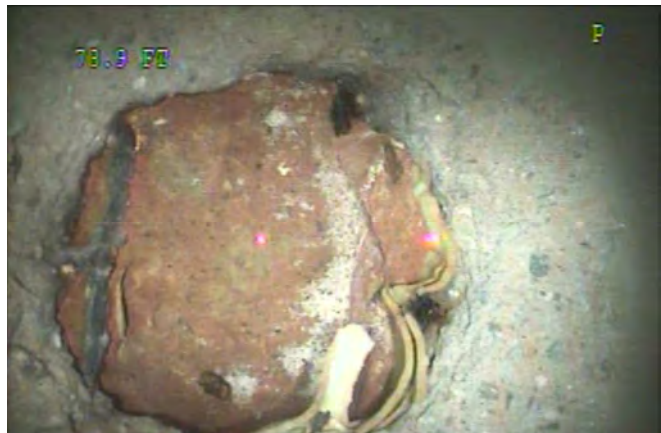
1 hole at 170 ft; other hole similar

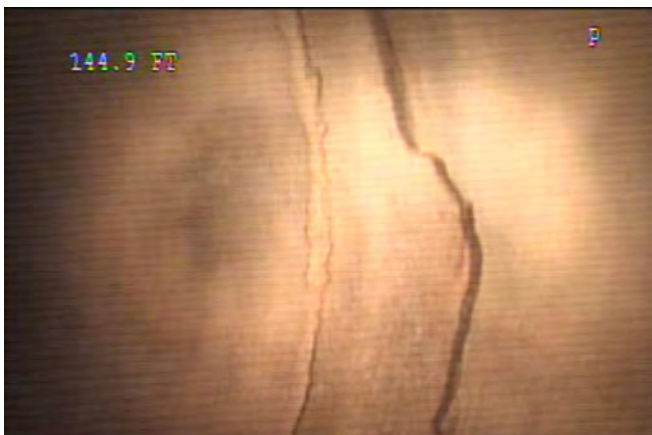
Crack at 50, 145, and 161 ft; Joint - Separated at 89, 162, and 194 ft;  
Joint Offset at 145 ft;  
Obstruction (rock) at 200 ft; VPI incomplete

Joint Offset at 145 ft

Based on the Video Pipe Inspection, Pipe I34 should be slip lined if retained due to joint deficiencies. Capacity should be verified on slip lined pipe.  
Concept Plans remove existing 15" R.C. Pipe.

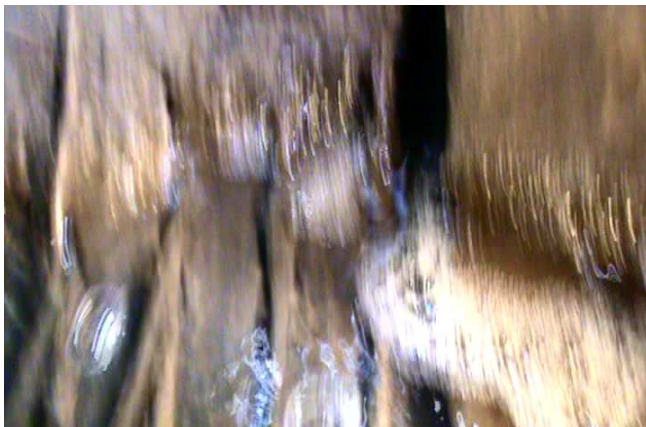
Joint-separated in several locations, chipped everywhere, many longitudinal cracks, circumfrenical crack, bottom of pipe is broken with rebar exposed for most of the pipe length

Typical broken piece at bottom

Based on the Video Pipe Inspection, Pipe I39 should be slip lined if retained due to deficiencies. Capacity should be verified on slip lined pipe.

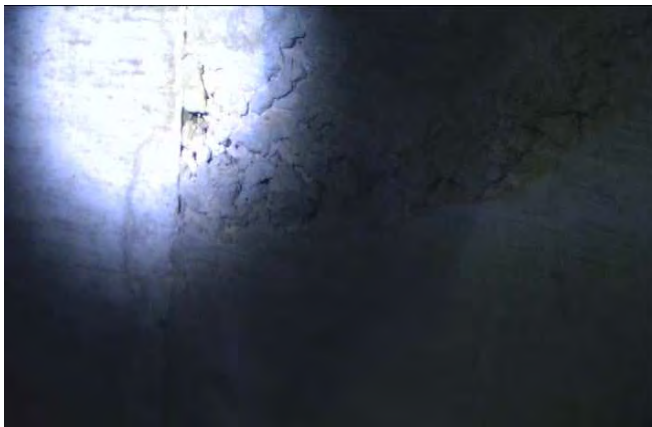
Typical chipping/scaling

Based on the Video Pipe Inspection and Hydraulic Information, Pipe I40 could be retained with maintenance. Repair culvert at all voids and exposed rebar.

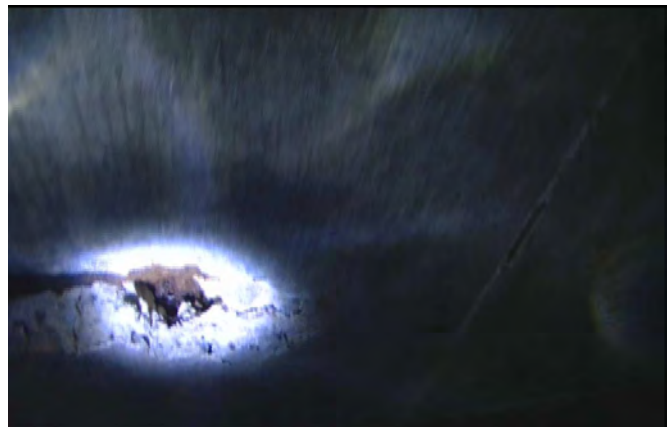
(corrosion in one spot due to void)

Corroded rebar due to void
