Video Pipe Detail Report

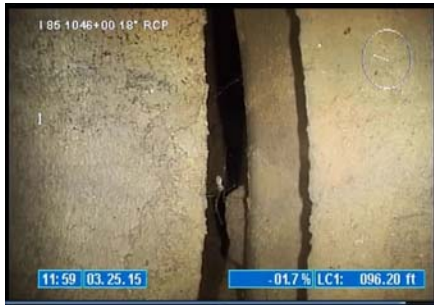
Damage Type:	Dislocation
Location of Damage (ft):	96
Crack/Break Width (in):	N/A
Video Cue Time:	0:16:19

Comments: This is under the frontage road on south bound side.

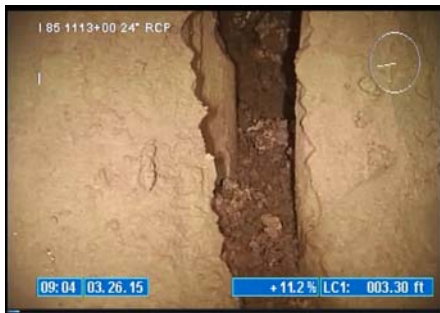
Damage Type:	Dislocation
Location of Damage (ft):	4
Crack/Break Width (in):	N/A
Video Cue Time:	0:00:12

Comments: Between Frontage Rd & I-85

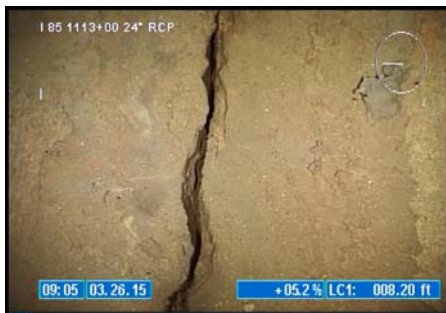
Damage Type:	Dislocation
Location of Damage (ft):	8
Crack/Break Width (in):	N/A
Video Cue Time:	0:01:12

Comments: Between Frontage Rd & I-85

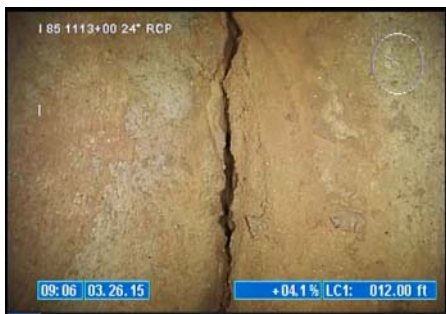
Damage Type:	Dislocation
Location of Damage (ft):	12
Crack/Break Width (in):	N/A
Video Cue Time:	0:02:00

Comments: Between Frontage Rd & I-85

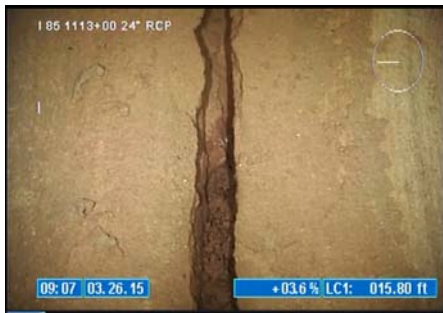
Damage Type:	Dislocation
Location of Damage (ft):	16
Crack/Break Width (in):	N/A
Video Cue Time:	0:02:27

Comments: Between Frontage Rd & I-85

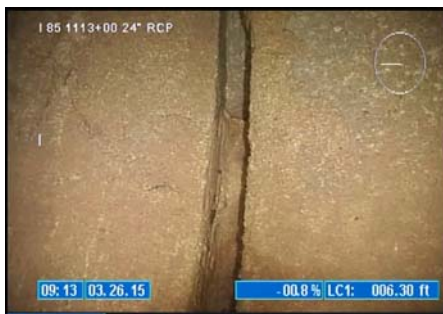
Damage Type:	Cracks
Location of Damage (ft):	2
Crack/Break Width (in):	0.92
Video Cue Time:	0:07:27

Comments: Pipe under I-85 crack

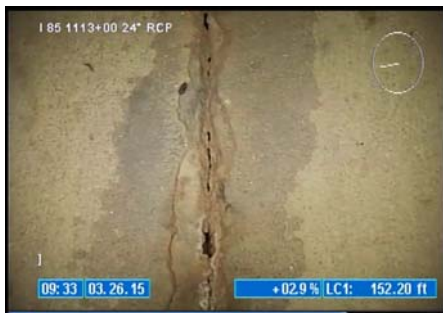
Damage Type: Cracks
Location of Damage (ft): 154
Crack/Break Width (in): N/A
Video Cue Time: 0:27:55

Comments: Small cracks

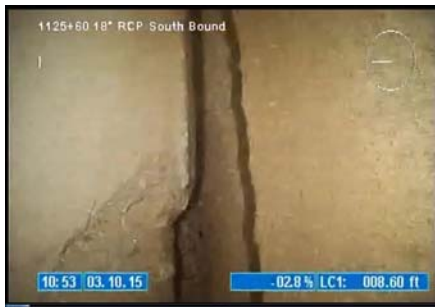
Damage Type:	Dislocation
Location of Damage (ft):	8
Crack/Break Width (in):	N/A
Video Cue Time:	0:00:30

Comments: Pipe is dislocated

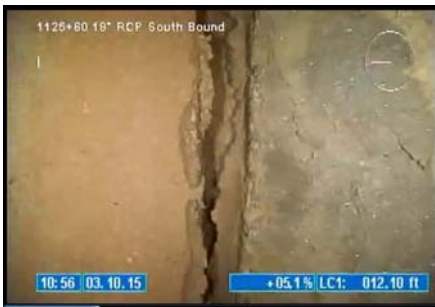
Damage Type:	Gapped Joint
Location of Damage (ft):	12
Crack/Break Width (in):	N/A
Video Cue Time:	0:03:15

Comments: Pipe joint gap

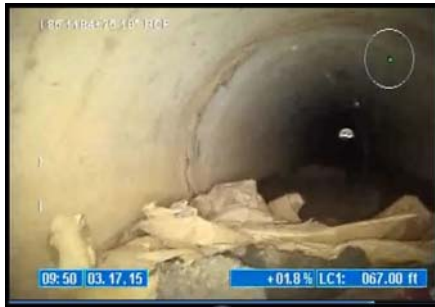
Damage Type:	<u>Sediment Build-up</u>
Location of Damage (ft):	<u>71</u>
Crack/Break Width (in):	<u>N/A</u>
Video Cue Time:	<u>11:04</u>

Comments: Sediment build-up.

41	A-73,A-74	1089+00	18"	160	3/25/2015	Remove pipe from 66' back from NB end.	Listed as 1189+00
42	A-75,A-76,A-77,A-100	1105+30	18"	184	3/26/2015	Replace line starting at 227'. Seal cracks at drop inlet.	Fiber line through pipe
43a	A-78,A-79,A-80,A-101	1113+00 (I-85)	24"	336	3/26/2015	Seal cracks and clean drop inlet.	
43b	A-78,A-79,A-80,A-101	1113+00	24"	336	3/26/2015	Slip line pipe due to joint issues.	
44a	A-81	1125+60 NB	18"	144	3/10/2015	Remove debris from pipe.	
44b	A-82	1125+60 SB	18"	144	3/10/2015	Slip line pipe due to joint issues and remove debris from pipe.	
45	A-83,A-84,A-87	1157+00	30"	144	3/26/2015	Clean drop inlet. Pipe in good condition.	
46	A-88,A-89,A-90,A-91	1166+50	24"	152	3/26/2015	Clean drop inlet. Pipe in good condition.	
47	A-92,A-93,A-94,A-95	1171+75	36"	240	4/2/2015	Replace section of pipe at failure under NB frontage road.	
48	B-1	1184+75	18"	176	3/17/2015	Clean pipe and drop inlet. Seal any cracks.

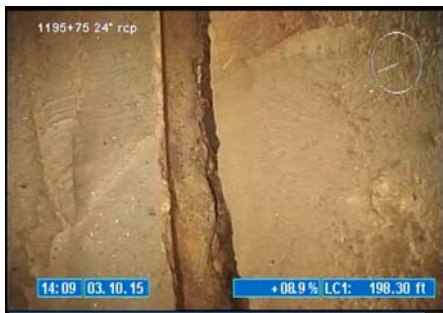
Damage Type:	Dislocation
Location of Damage (ft):	198
Crack/Break Width (in):	N/A
Video Cue Time:	0:32:00

49	B-2	1190+50	18"	184	3/10/2015	Pipe in good condition.	
50	B-3	1195+75	24"	208	3/10/2015	Slip line pipe due to joint issues.	
51	B-4	1208+25	18"	116	4/8/2015	Clean sediment from pipe and slip line pipe.	20ft needs to be cleaned, pipe intact
52	B-6	1219+25	18"	200	4/8/2015	Seal crack at broken bell.	
53	B-10	1244+25	30"	204	4/2/2015	Clean debris from pipe.	
54		1253+25	15"	268	4/2/2015	Clean debris from pipe.	
55a	B-11	1255+00 NB	18"	120	4/2/2015	Clean debris from pipe.	
55b	B-11	1255+00 SB	18"	120	4/2/2015	Clean drop inlet. Slip line pipe between drop inlets.

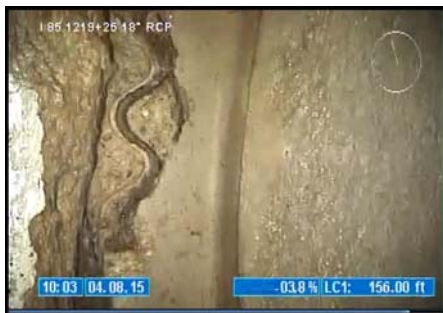
Damage Type:	Breaks
Location of Damage (ft):	156
Crack/Break Width (in):	N/A
Video Cue Time:	0:21:22

Comments: Bell broken. Pipe appears to be functioning.

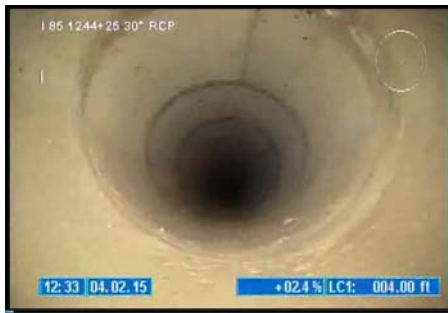
Damage Type:	N/A
Location of Damage (ft):	4
Crack/Break Width (in):	N/A
Video Cue Time:	0:00:00

Comments: Start of pipe

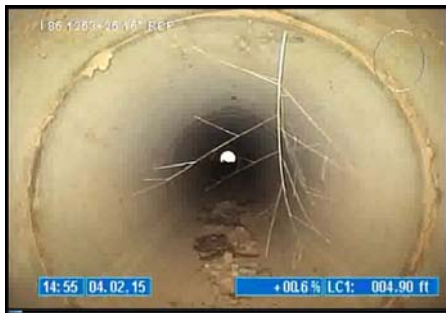
Damage Type:	N/A
Location of Damage (ft):	4
Crack/Break Width (in):	N/A
Video Cue Time:	0:00:00

Comments: Start of pipe

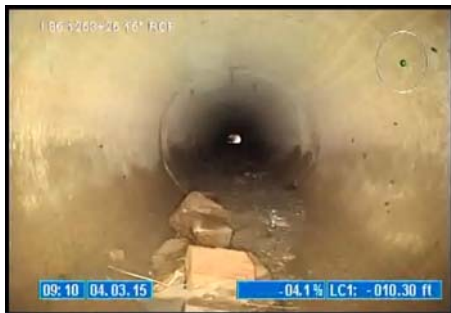
Damage Type:	N/A
Location of Damage (ft):	4
Crack/Break Width (in):	N/A
Video Cue Time:	0:00:23

Comments: Start of pipe

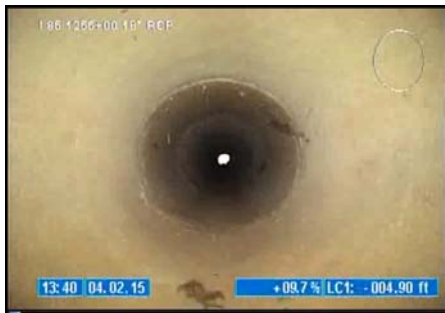
Damage Type:	N/A
Location of Damage (ft):	4
Crack/Break Width (in):	N/A
Video Cue Time:	0:00:08

Comments: Start of pipe

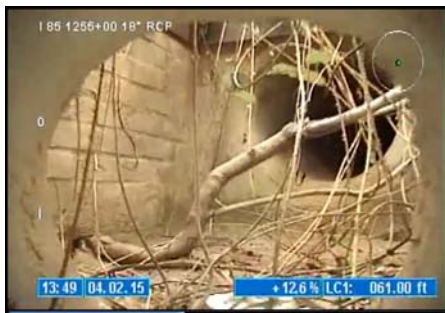
Damage Type:	N/A
Location of Damage (ft):	64
Crack/Break Width (in):	N/A
Video Cue Time:	0:08:51

Comments: Drop Inlet

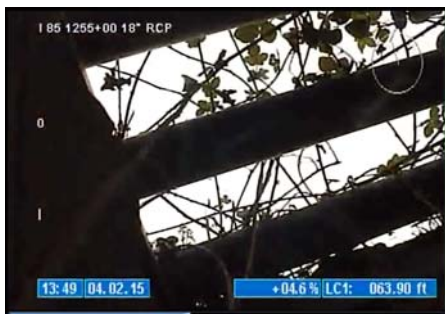
Damage Type:	N/A
Location of Damage (ft):	68
Crack/Break Width (in):	N/A
Video Cue Time:	0:09:00

Comments: Start of pipe from drop inlet

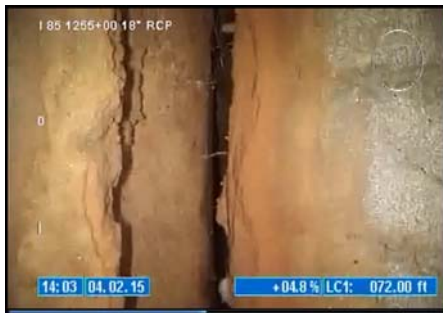
Damage Type:	Dislocation
Location of Damage (ft):	72
Crack/Break Width (in):	N/A
Video Cue Time:	0:09:49

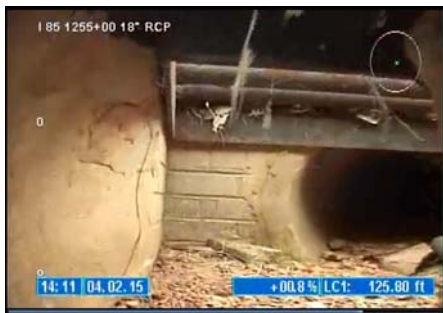
Damage Type:	N/A
Location of Damage (ft):	128
Crack/Break Width (in):	N/A
Video Cue Time:	0:18:25

Comments: Pipe end. Drop inlet in median of I-85.

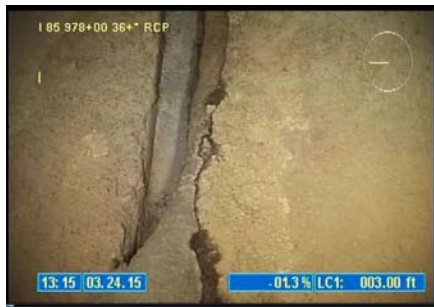
Damage Type:	N/A
Location of Damage (ft):	4
Crack/Break Width (in):	N/A
Video Cue Time:	0:00:07

Comments: Start of pipe

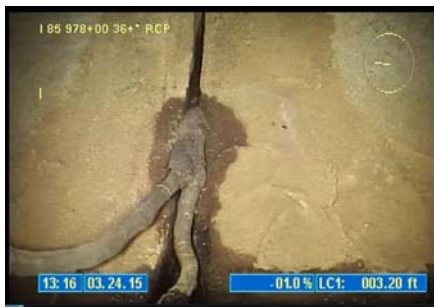
Damage Type:	Debris
Location of Damage (ft):	8
Crack/Break Width (in):	N/A
Video Cue Time:	0:01:00

Comments: Root in joint. 10ft into pipe at 9 o'clock.

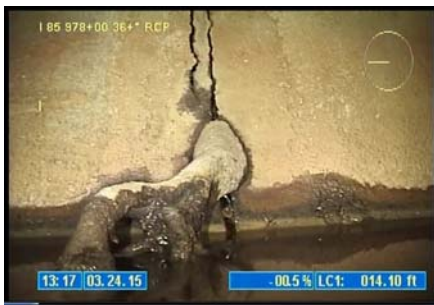
Damage Type:	N/A
Location of Damage (ft):	12
Crack/Break Width (in):	N/A
Video Cue Time:	0:02:30

Comments: Root in joint at 9 o'clock

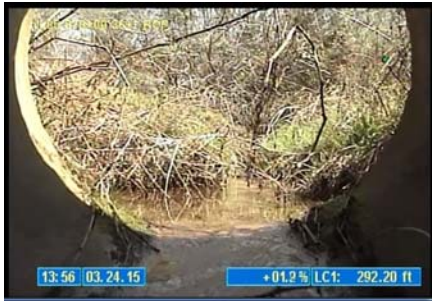
Damage Type:	N/A
Location of Damage (ft):	298
Crack/Break Width (in):	N/A
Video Cue Time:	0:40:30

Comments: End of pipe

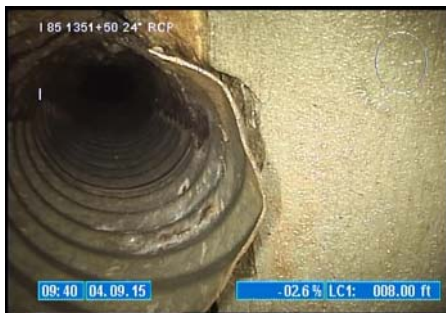
Damage Type: N/A

Comments: Side pipe at 3 o'clock

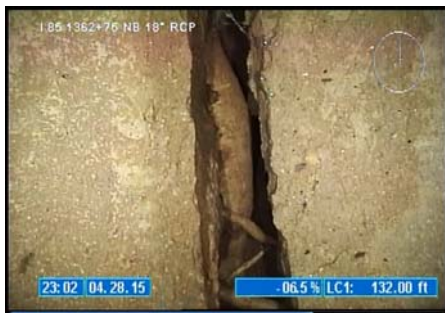
Damage Type: Dislocations

Location of Damage (ft): 132

Comments: Roots growing in joint and top of pipe is disjointed

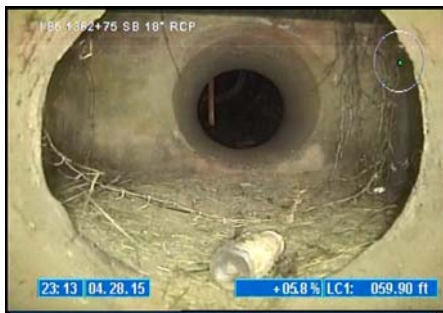
Damage Type:	N/A
Location of Damage (ft):	64
Crack/Break Width (in):	N/A
Video Cue Time:	0:22:50

Comments: End of pipe in shoulder box.

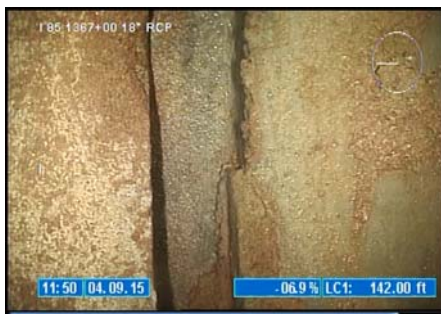
Damage Type:	Dislocation
Location of Damage (ft):	142
Crack/Break Width (in):	N/A
Video Cue Time:	0:18:40

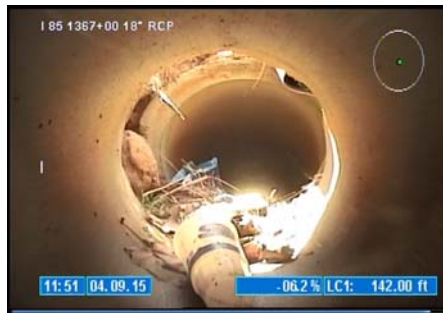
Damage Type:	Dislocation
Location of Damage (ft):	146
Crack/Break Width (in):	N/A
Video Cue Time:	0:20:12

Comments: Complete joint break

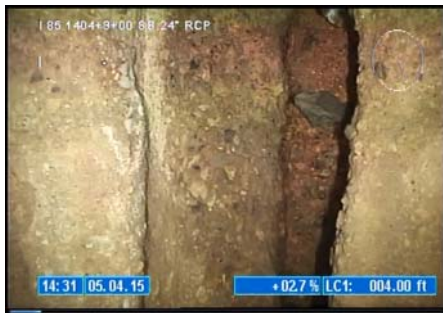
Damage Type:	Offset Joint
Location of Damage (ft):	4
Crack/Break Width (in):	N/A
Video Cue Time:	0:00:20

Comments: Due to slope, joint could not be measured. Soil can be seen at offset.

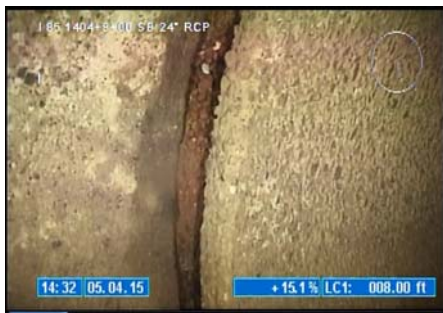
Damage Type:	Offset Joint
Location of Damage (ft):	8
Crack/Break Width (in):	N/A
Video Cue Time:	0:01:00

Comments: Due to slope, joint could not be measured. Soil can be seen at offset.

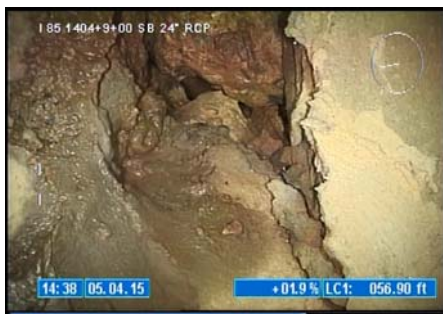
Damage Type:	Gapped Joint
Location of Damage (ft):	56
Crack/Break Width (in):	N/A
Video Cue Time:	0:08:15

Comments: Gapped joint that seems to be filled in with rock. Could not measure but appears to be 3" to 5".

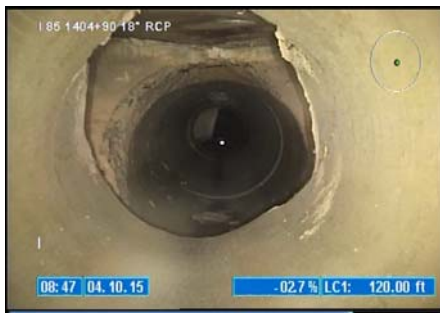
Damage Type:	N/A
Location of Damage (ft):	124
Crack/Break Width (in):	N/A
Video Cue Time:	0:14:20

Comments: Drop inlet that appears to be covered

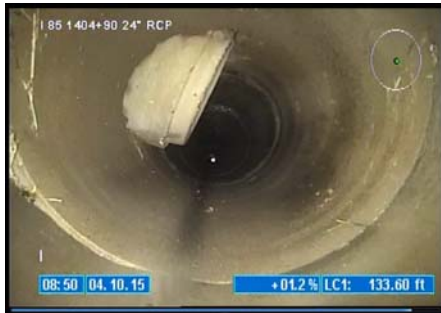
Damage Type:	N/A
Location of Damage (ft):	144
Crack/Break Width (in):	N/A
Video Cue Time:	N/A

Comments: Pipe entering from side of pipe.
Can't continue due to incoming pipe.

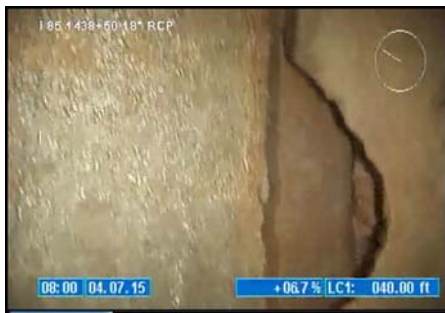
Damage Type:	N/A
Location of Damage (ft):	40
Crack/Break Width (in):	N/A
Video Cue Time:	0:06:19

Comments: Broken bell. Can't measure due to slope of pipe. Appears to be approx. 3".

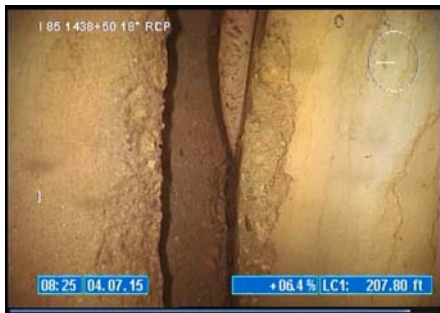
Damage Type:	Dislocation
Location of Damage (ft):	208
Crack/Break Width (in):	N/A
Video Cue Time:	0:31:40

Comments: Pipe is dislocated and can see soil.

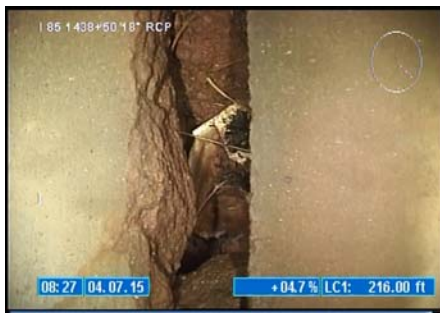
Damage Type:	Dislocations
Location of Damage (ft):	216
Crack/Break Width (in):	N/A
Video Cue Time:	0:33:00

Comments: Pipe is dislocated and can see soil.

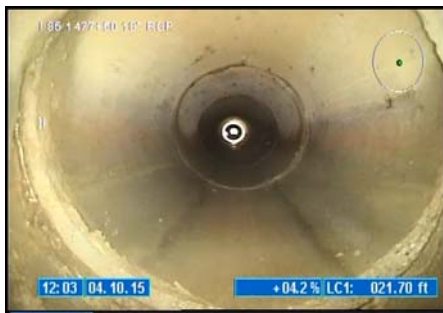
Damage Type: Offset Joint

Comments: Joint is not aligned correctly

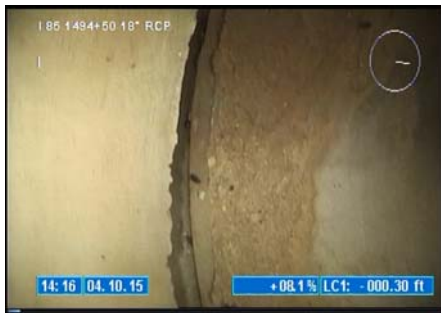
Damage Type:	Gapped Joint
Location of Damage (ft):	4
Crack/Break Width (in):	N/A
Video Cue Time:	0:00:00

Comments: Root growing through joint at 7 and 11 o'clock

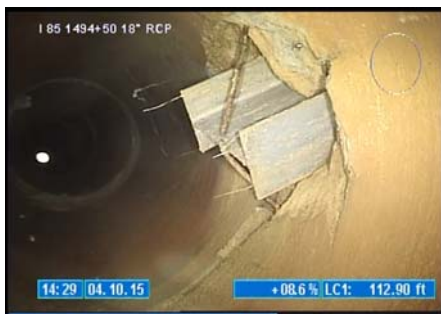
Damage Type:	Break
Location of Damage (ft):	114
Crack/Break Width (in):	N/A
Video Cue Time:	0:13:00

Comments: Guardrail post through pipe

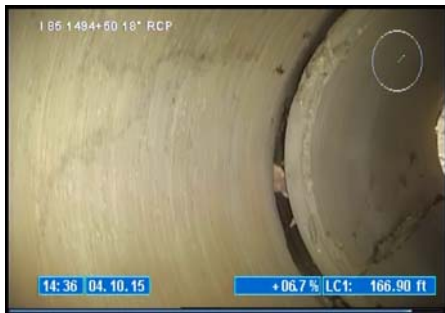
Damage Type:	Alignment
Location of Damage (ft):	170
Crack/Break Width (in):	N/A
Video Cue Time:	0:19:40

Comments: Pipe is misaligned. Soil could be infiltrating.

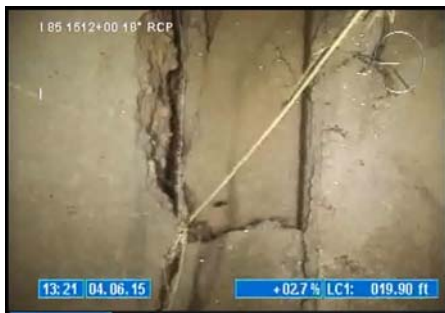
Damage Type:	Gapped Joint
Location of Damage (ft):	20
Crack/Break Width (in):	3.33
Video Cue Time:	0:02:25

Comments: Gap at joint.

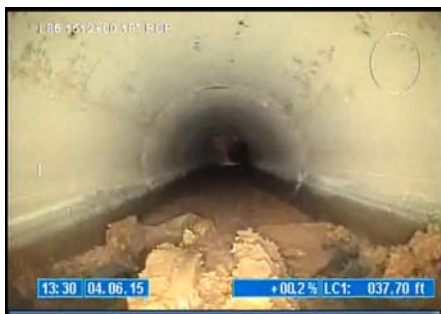
Damage Type:	N/A
Location of Damage (ft):	44
Crack/Break Width (in):	N/A
Video Cue Time:	0:11:37

Comments: Pipe filled with sediment. Requires cleaning.

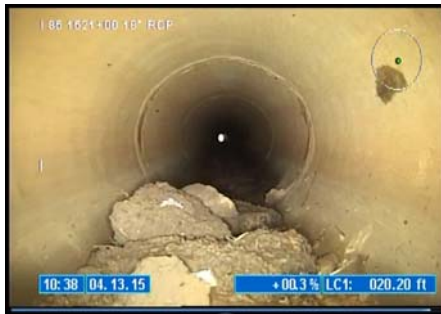
Damage Type:	N/A
Location of Damage (ft):	24
Crack/Break Width (in):	N/A
Video Cue Time:	0:04:50

Comments: Pieces of concrete are preventing the robot from continuing

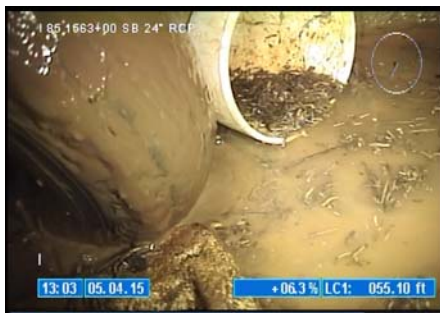
Damage Type:	N/A
Location of Damage (ft):	56
Crack/Break Width (in):	N/A
Video Cue Time:	0:09:40

Comments: Cannot continue due to sediment.

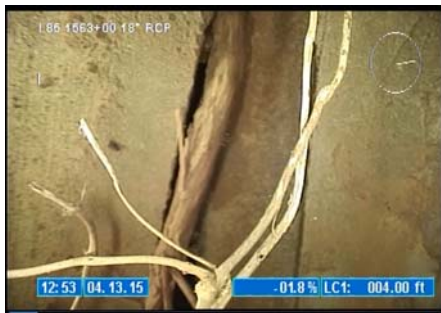
Damage Type:	Dislocation
Location of Damage (ft):	4
Crack/Break Width (in):	N/A
Video Cue Time:	0:00:10

Comments: Root through pipe.

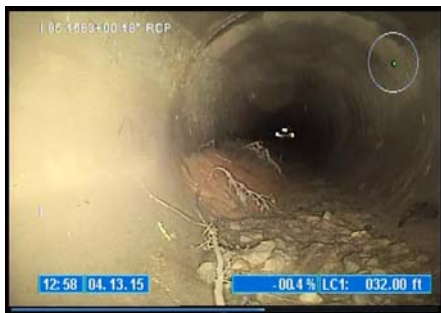
Damage Type:	N/A
Location of Damage (ft):	36
Crack/Break Width (in):	N/A
Video Cue Time:	0:05:55

Comments: Excessive amount of sediment present.

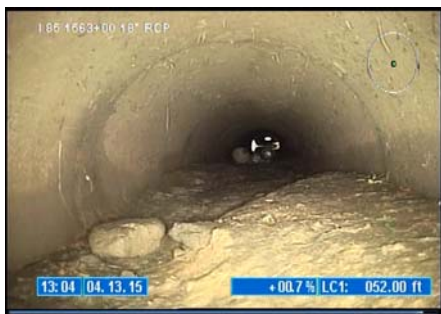
Damage Type:	N/A
Location of Damage (ft):	56
Crack/Break Width (in):	N/A
Video Cue Time:	0:09:38

Comments: Sediment build-up will not allow robot to continue.

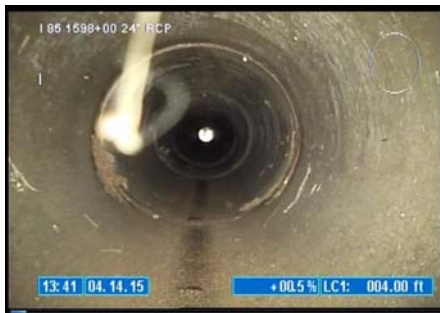
Damage Type: N/A

Location of Damage (ft): 4

Comments: Start of pipe

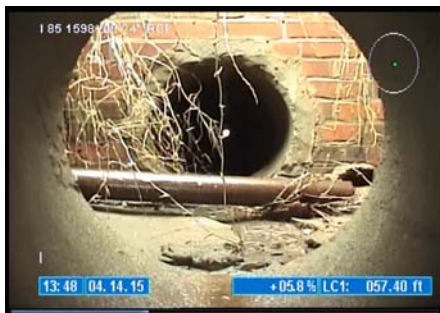
Damage Type: N/A

Location of Damage (ft): 60

Comments: Drop inlet needs to be cleaned

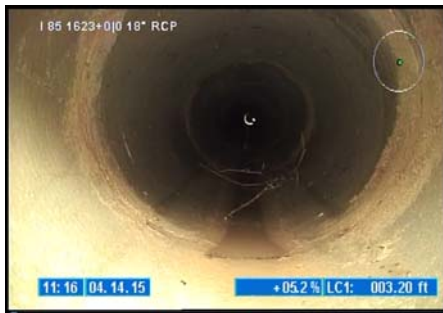
Damage Type:	N/A
Location of Damage (ft):	4
Crack/Break Width (in):	N/A
Video Cue Time:	0:00:08

Comments: Start of pipe

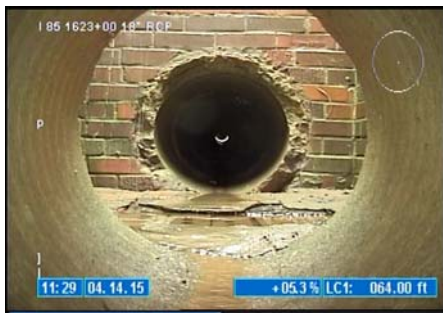
Damage Type:	N/A
Location of Damage (ft):	72
Crack/Break Width (in):	N/A
Video Cue Time:	0:09:55

Comments: Drop inlet

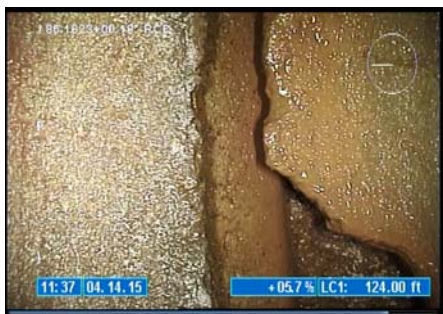
Damage Type:	Gapped Joint
Location of Damage (ft):	124
Crack/Break Width (in):	5
Video Cue Time:	0:17:15

Comments: Broken bell. Approx. 5" of soil can be seen.

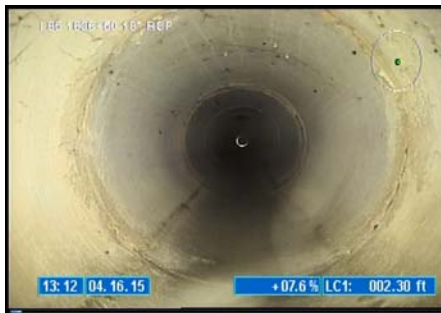
Damage Type: N/A

Location of Damage (ft): 4

Comments: Start of pipe

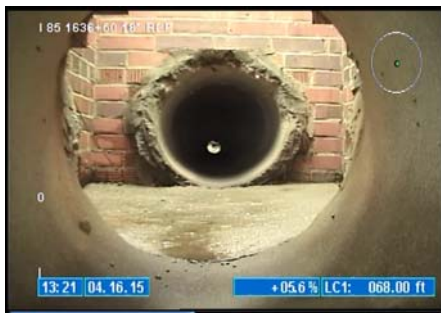
Damage Type: N/A

Location of Damage (ft): 68

Comments: Drop inlet

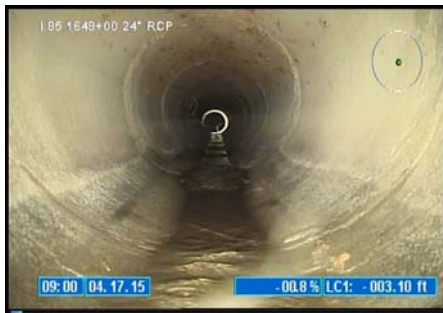
Damage Type: N/A

Location of Damage (ft): 4

Comments: Start of pipe

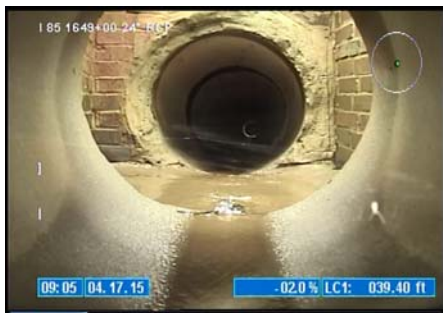
Damage Type: N/A

Location of Damage (ft): 44

Comments: Drop inlet under SB shoulder.

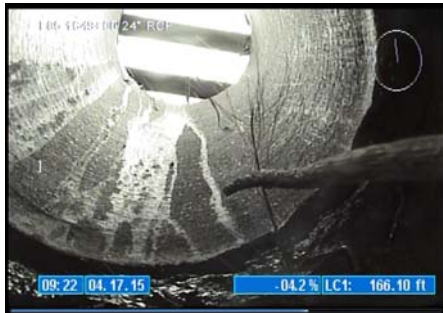
Damage Type:	N/A
Location of Damage (ft):	168
Crack/Break Width (in):	N/A
Video Cue Time:	0:23:15

Comments: North bound shoulder drop inlet.

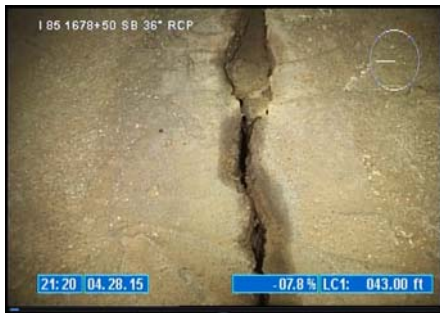
Damage Type:	Breaks
Location of Damage (ft):	4
Crack/Break Width (in):	N/A
Video Cue Time:	0:00:00

Comments: Joint break

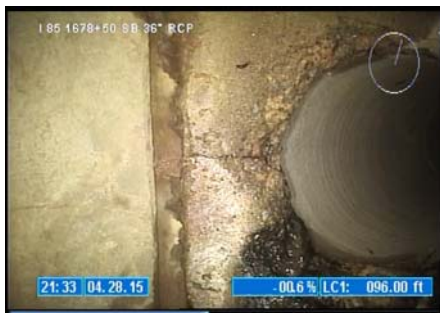
Damage Type:	N/A
Location of Damage (ft):	96
Crack/Break Width (in):	N/A
Video Cue Time:	0:12:45

Comments: Drop inlet from shoulder

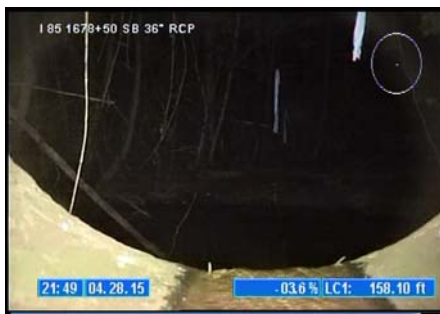
Damage Type:	N/A
Location of Damage (ft):	158
Crack/Break Width (in):	N/A
Video Cue Time:	0:27:19

Comments: End of pipe

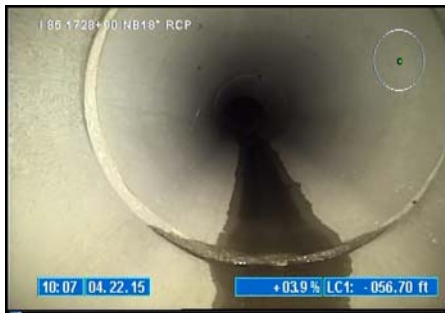
Damage Type: N/A

Location of Damage (ft): 4

Comments: Start of pipe

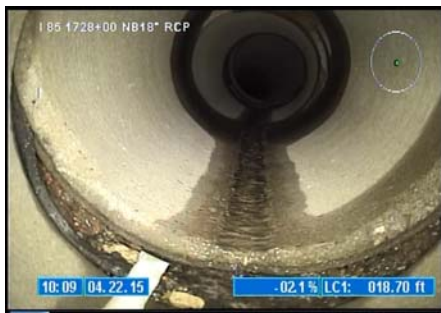
Damage Type: Dislocations

Location of Damage (ft): 20

Comments: Joint separation. Can't measure gap due to slope of pipe.

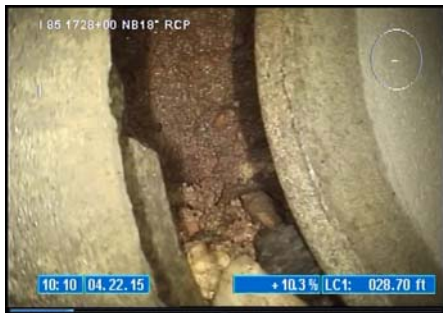
Damage Type:	Gapped Joint
Location of Damage (ft):	28
Crack/Break Width (in):	N/A
Video Cue Time:	0:03:07

Comments: Joint break with washout in process. Can't measure gap due to slope of pipe.

108	C-35	1729+50	15"	68	4/17/2015	Pipe in good condition.	
109		1736+50	15"	52		N/A	Not on survey. Unable to locate.
110	C-37	1750+40	18"	192	4/17/2015	Pipe in good condition.	
111	C-39	1763+00	18"	268	4/22/2015	Pipe in good condition.	
112	C-40	1773+00	18"	244		N/A	Not on survey. Unable to locate.
A1	C-8	1528+00	18"	64	7/19/2015	Clean sediment from pipe.	
A2	C-8A	1528+40	18"	N/A	7/19/2015	Access ends in box with buried top. No access.	
A3		1668+00	18"	N/A	7/19/2015	N/A	Could not be cleaned any further
A4		1739+50	18"	N/A	7/19/2015	Drop inlet is eroded. Rebuild drop inlet.	
A5		1760+00	18"	132	7/19/2015	Pipe in good condition.	
A6		1751+00	18"	N/A	7/19/2015	N/A	Could not be cleaned any further
A7a	C-5	1518+00 NB	18"	56	7/19/2015	Pipe in good condition.	
A7b	C-5	1518+00 SB	18"	N/A	7/19/2015	Clean sediment from pipe.

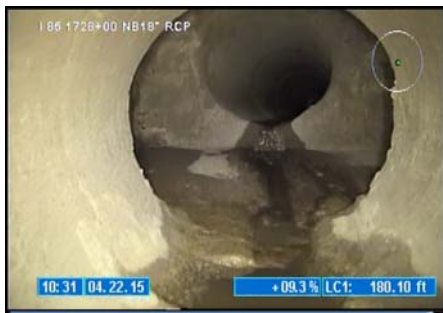
Damage Type:	N/A
Location of Damage (ft):	184
Crack/Break Width (in):	N/A
Video Cue Time:	0:24:00

Comments: End of pipe in drop inlet.

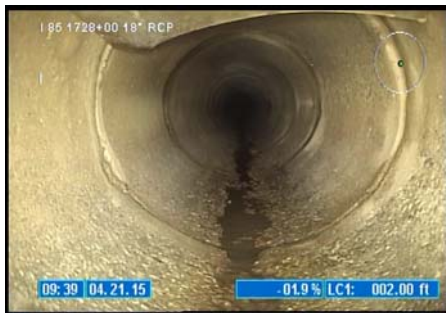
Damage Type: N/A

Location of Damage (ft): 2

Comments: Start of pipe

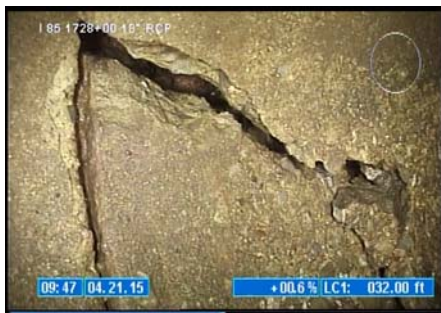
Damage Type: Breaks

Location of Damage (ft): 32

Comments: Broken pipe at 8 o'clock. Can see soil through break. Appears that a washout is occurring.

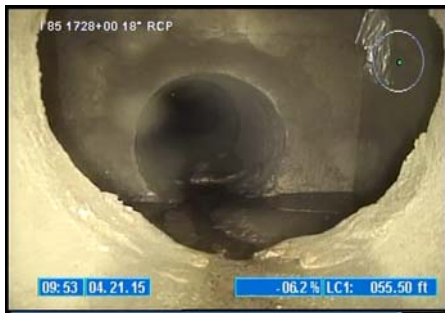
Damage Type:	N/A
Location of Damage (ft):	58
Crack/Break Width (in):	N/A
Video Cue Time:	0:14:51

Comments: SB pipe ends in box. Box has step-down NB side will be completed later. See 1728+00 NB.

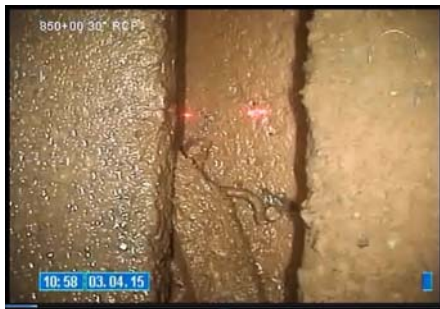
Damage Type:	Gapped Joint
Location of Damage (ft):	8
Crack/Break Width (in):	2.53
Video Cue Time:	2:00

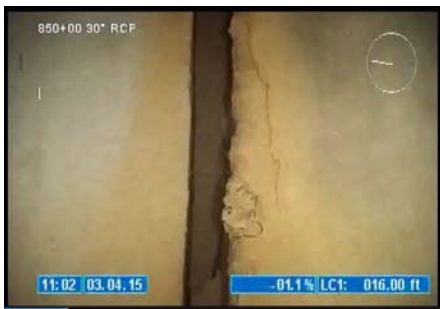
Damage Type:	Offset Joint
Location of Damage (ft):	16
Crack/Break Width (in):	N/A
Video Cue Time:	5:00

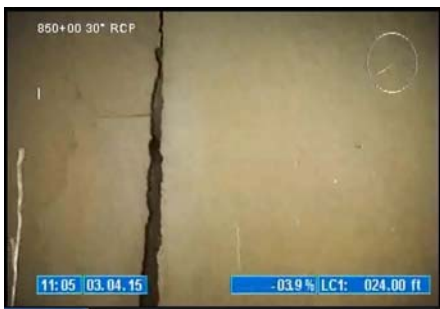
Damage Type:	Dislocations
Location of Damage (ft):	24
Crack/Break Width (in):	2.4
Video Cue Time:	7:01

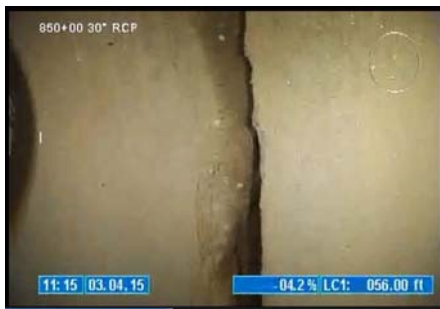
Damage Type:	N/A
Location of Damage (ft):	56
Crack/Break Width (in):	N/A
Video Cue Time:	14:48

Comments: Chipped bell at 4 o'clock

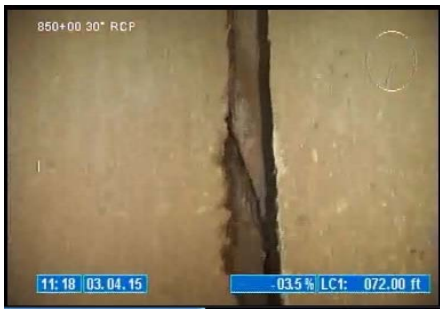
Damage Type:	N/A
Location of Damage (ft):	76
Crack/Break Width (in):	N/A
Video Cue Time:	18:00

Comments: 4 ft joint

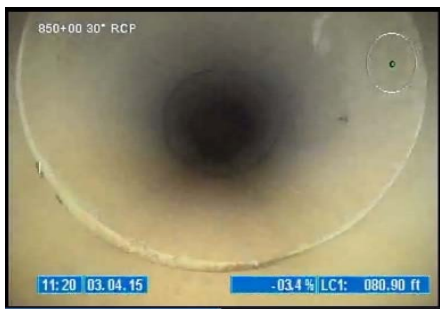
Damage Type:	N/A
Location of Damage (ft):	84
Crack/Break Width (in):	N/A
Video Cue Time:	19:24

Comments: Bell Damaged

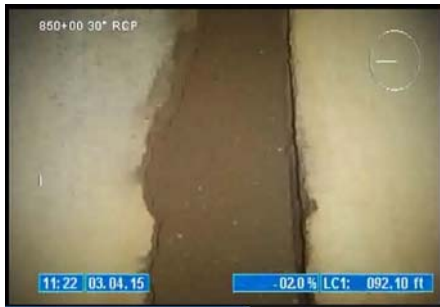
Damage Type:	Gapped Joint
Location of Damage (ft):	92
Crack/Break Width (in):	4.46
Video Cue Time:	21:52

Comments: Mortar in base of pipe

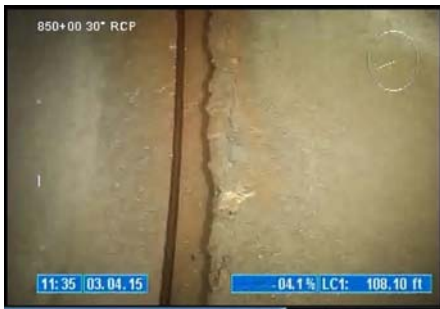
Damage Type:	N/A
Location of Damage (ft):	108
Crack/Break Width (in):	N/A
Video Cue Time:	1:15

Comments: Bell damaged at 6 oclock

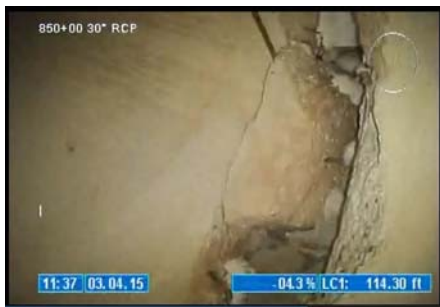
Damage Type:	N/A
Location of Damage (ft):	116
Crack/Break Width (in):	N/A
Video Cue Time:	3:22

Comments: Curved pipe sealed with mortared brick

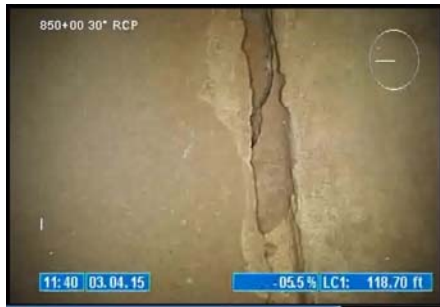
Damage Type:	N/A
Location of Damage (ft):	120
Crack/Break Width (in):	N/A
Video Cue Time:	0:30:22

Comments:	4 ft joint
-----------	------------

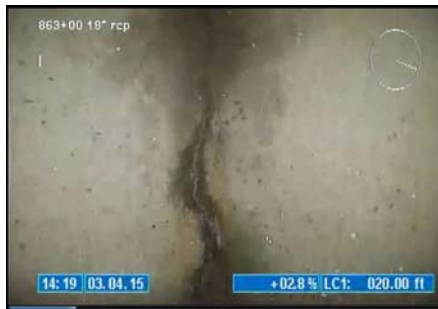
Damage Type:	Cracks
Location of Damage (ft):	20
Crack/Break Width (in):	N/A
Video Cue Time:	0:03:55

Comments: Crack in pipe at 9 to 11 o'clock

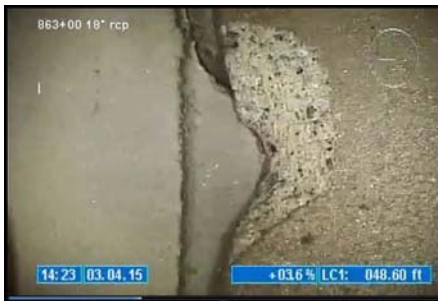
Damage Type:	Gapped Joint
Location of Damage (ft):	48
Crack/Break Width (in):	0.47
Video Cue Time:	0:08:20

Comments: Red sediment in pipe

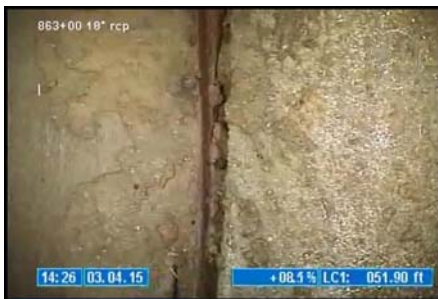
Damage Type:	Gapped Joint
Location of Damage (ft):	52
Crack/Break Width (in):	N/A
Video Cue Time:	0:11:34

Comments: 4ft joint. Gap appears to be 2"-4". Cant measure due to slope

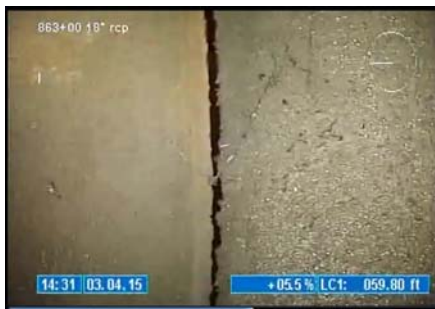
Damage Type:	Gapped Joint
Location of Damage (ft):	60
Crack/Break Width (in):	2.63
Video Cue Time:	16:00

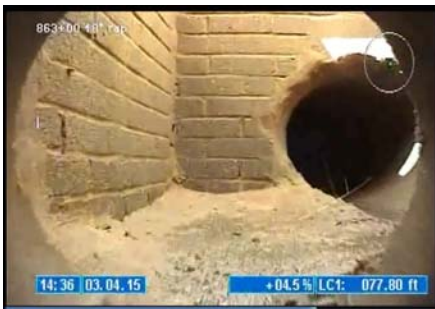
Damage Type:	N/A
Location of Damage (ft):	80
Crack/Break Width (in):	N/A
Video Cue Time:	0:20:30

Comments: Culvert Box

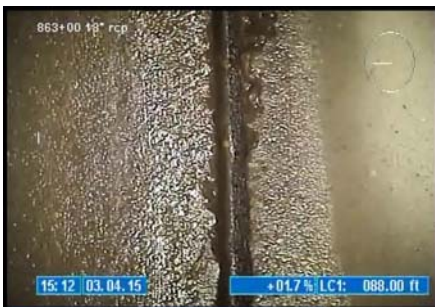
Damage Type:	N/A
Location of Damage (ft):	88
Crack/Break Width (in):	N/A
Video Cue Time:	0:21:00

Comments: 8ft joint

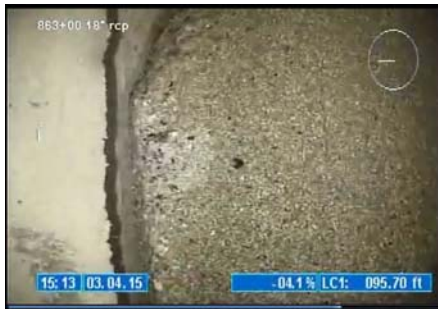
Damage Type:	Gapped Joint
Location of Damage (ft):	96
Crack/Break Width (in):	4.3
Video Cue Time:	0:22:00

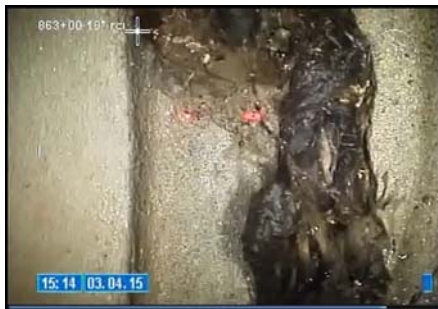
Damage Type:	Breaks
Location of Damage (ft):	99
Crack/Break Width (in):	N/A
Video Cue Time:	0:25:00

Comments: Complete joint failure. Sink hole may be forming.

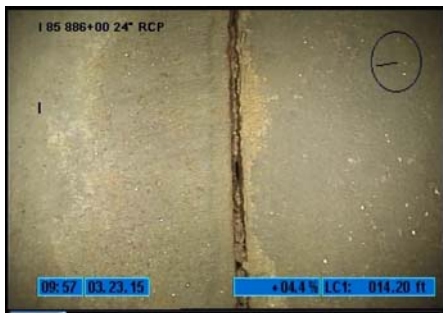
Damage Type:	Gapped Joint
Location of Damage (ft):	14
Crack/Break Width (in):	N/A
Video Cue Time:	0:01:00

Comments: Gap at joint

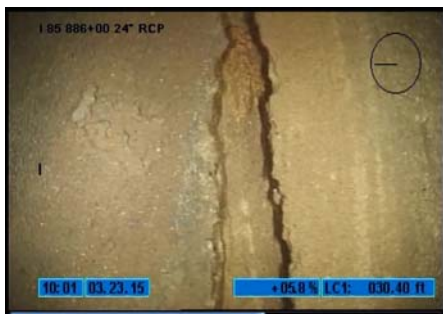
Damage Type:	Gapped Joint
Location of Damage (ft):	30
Crack/Break Width (in):	0.71
Video Cue Time:	0:05:20

Comments: Can see earth at 6 o'clock

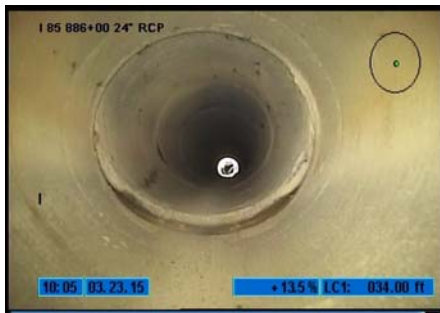
Damage Type:	Gapped joint
Location of Damage (ft):	38
Crack/Break Width (in):	N/A
Video Cue Time:	0:09:05

Comments: Joint is completely disconnected. It appears that material is washing away from outside of the pipe SB to be replaced and NB to be inspected

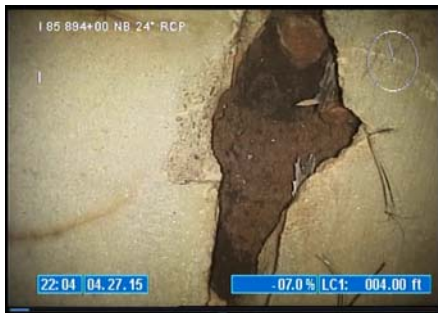
Damage Type:	Gapped Joint
Location of Damage (ft):	4
Crack/Break Width (in):	4.46
Video Cue Time:	0:00:21

Comments: Gap

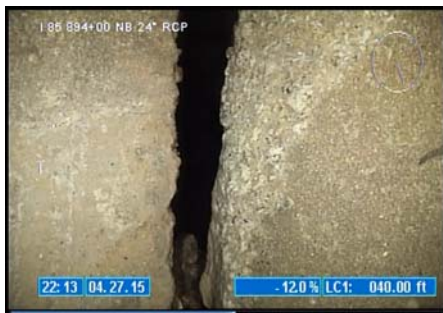
Damage Type:	Gapped Joint
Location of Damage (ft):	40
Crack/Break Width (in):	0.97
Video Cue Time:	0:09:26

Comments: Gap at 6 o'clock

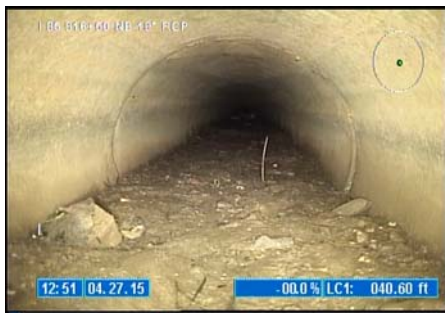
Damage Type:	N/A
Location of Damage (ft):	44
Crack/Break Width (in):	N/A
Video Cue Time:	0:08:41

Comments: Can't continue due to sediment.

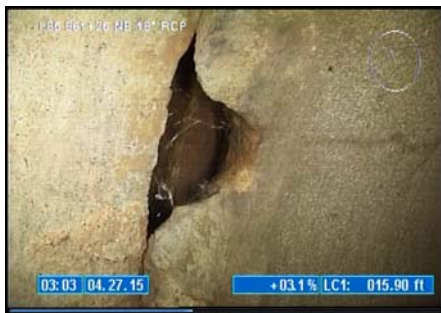
Damage Type: Gapped Joint
Location of Damage (ft): 16
Crack/Break Width (in): 1.68
Video Cue Time: 0:01:40

Comments: Gap at 11 o'clock.

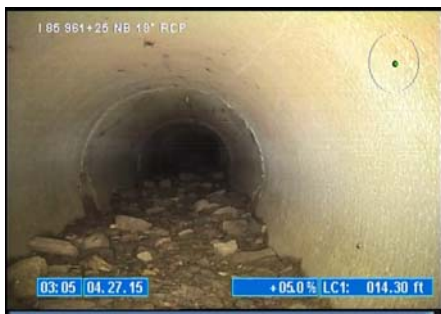
Damage Type: N/A
Location of Damage (ft): 20
Crack/Break Width (in): N/A
Video Cue Time: 0:04:15

Comments: Cannot continue due to sediment.

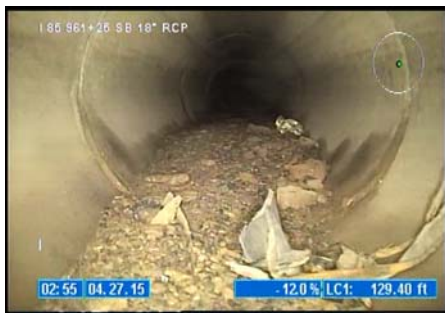
Damage Type: N/A
Location of Damage (ft): 132
Crack/Break Width (in): N/A
Video Cue Time: 0:15:28

Comments: Sediment observed in pipe

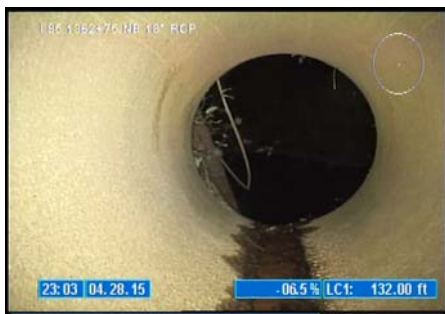
Damage Type: Dislocations

Location of Damage (ft): 132

Comments: Roots growing in joint and top of pipe is disjointed

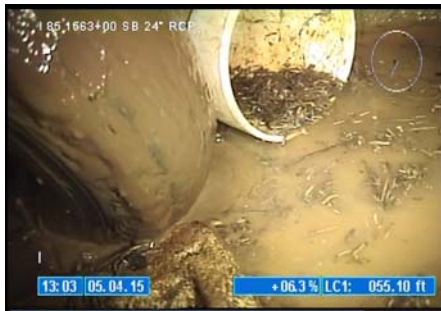
Damage Type: N/A
Location of Damage (ft): 56
Crack/Break Width (in): N/A
Video Cue Time: 0:09:40

Comments: Cannot continue due to sediment.

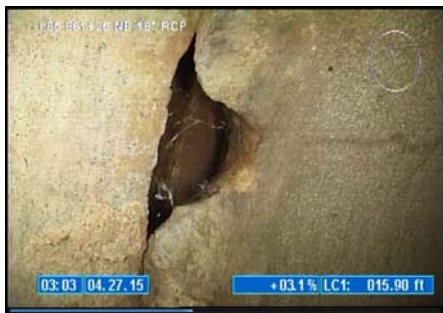
Damage Type:	Gapped Joint
Location of Damage (ft):	16
Crack/Break Width (in):	1.68
Video Cue Time:	0:01:40

Comments: Gap at 11 o'clock.

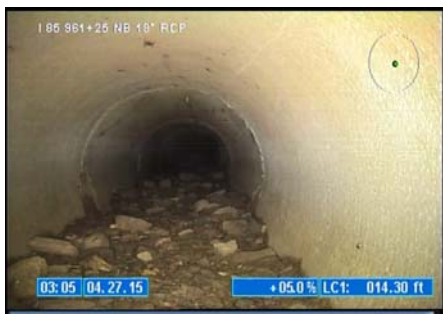
Damage Type:	N/A
Location of Damage (ft):	20
Crack/Break Width (in):	N/A
Video Cue Time:	0:04:15

Comments: Cannot continue due to sediment.
