# Bridge Assessment Report

## I-85 Over Thicketty Creek

Project ID: P027114

February 26, 2016

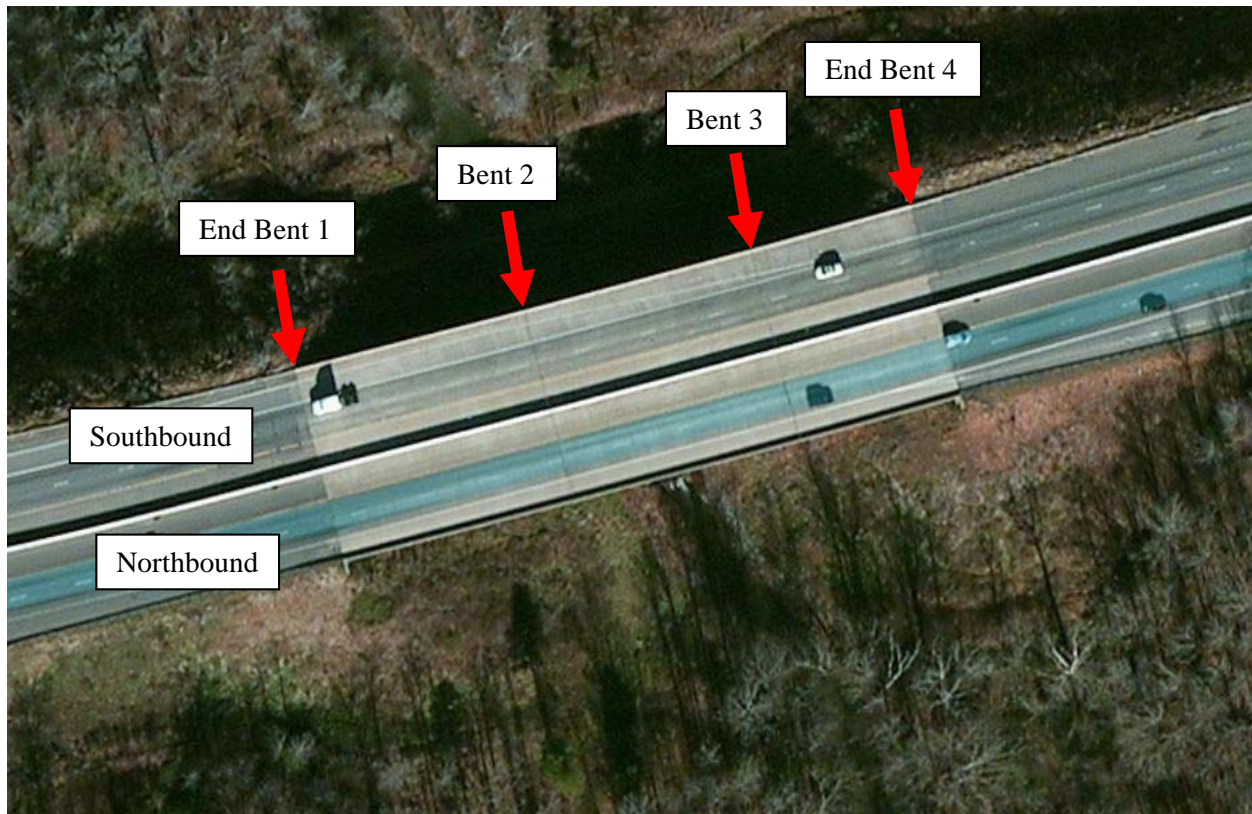
Figure 3 – Existing Bridge Layout

The existing bridge is a three (3) span, simply supported welded plate girder structure with an overall length of 383'-9"  $\pm$  C/C at the deflection joints (measured along the inside face of the southern exterior parapet). The existing bridge width is 116'-10"  $\pm$ . The substructure consists of concrete cap and columns/drilled shafts for the interior bents and concrete cap on steel piles for the end bents.

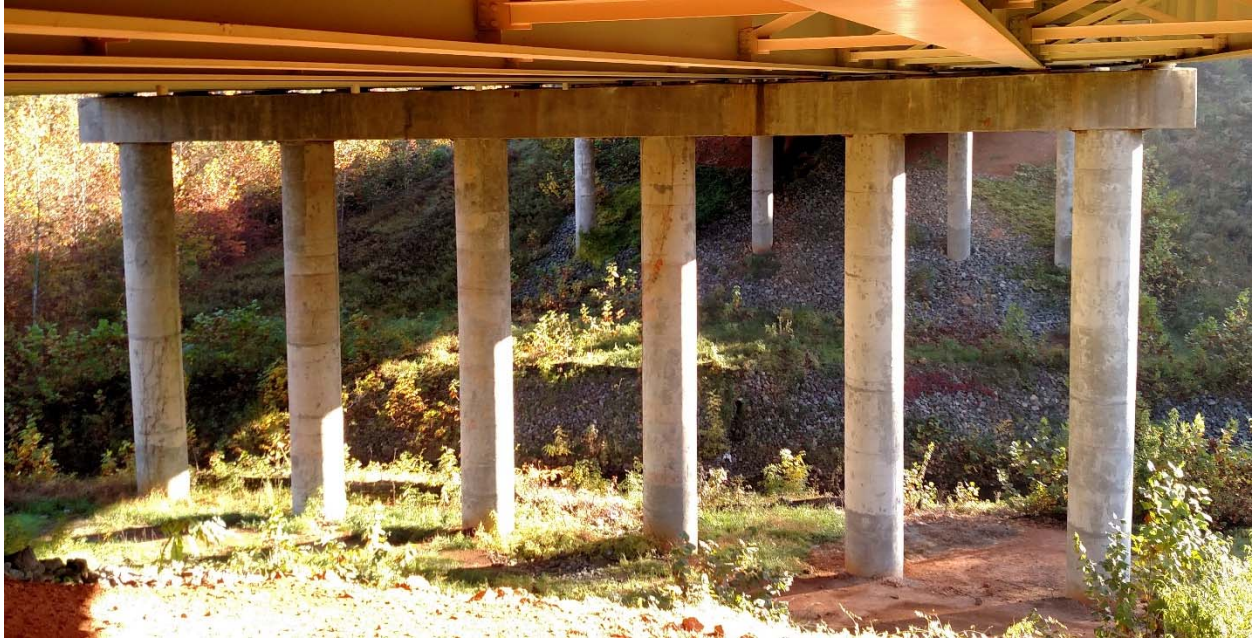
Figure 25 – Bent 2 (Looking North)

The existing piers are in good condition. The concrete caps for all piers have no noticeable deficiencies. Some staining of the pier caps has occurred and this is the result of the water penetration occurring at the failed expansion joints or the concrete deck closure pours (Figure 24). No delamination or spalling of the pier caps or columns was noticed. No work required at the interior bents.
