Re: Report of Permanent Pipe Camera Inspection - **REVISED**  
US 1 RBO I-20  
Lexington County, South Carolina  
SCDOT Project ID: P030711  
F&ME Project No.: G6018

US 1 Replace Bridge over I-20 - Pipe Culvert Inspection Recommendations

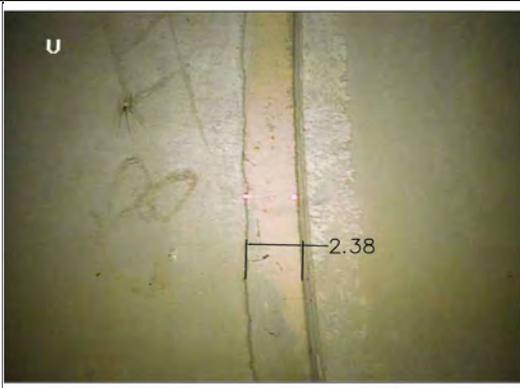
Distance	Fault Observation	Time	Picture
18.1	<p align="center"><b>General Observation</b>  <b>Severity: None</b>  <b>Remarks: HAD TO CLEAR ROCKS</b></p>	09:01	
18.4	<p align="center"><b>General Observation</b>  <b>Severity: None</b>  <b>Remarks: GAP OBSERVATION</b></p>	11:32

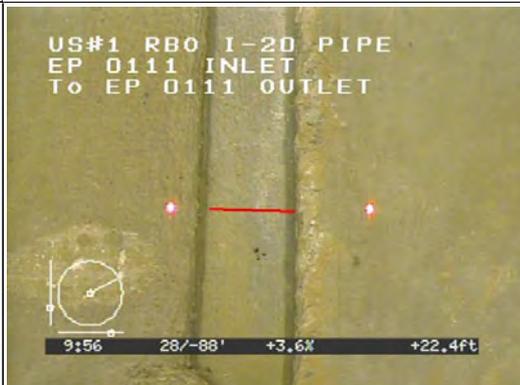
22.4	<p align="center"><b>General Observation</b>  <b>Severity: None</b>  <b>Remarks: 1.063</b></p>	12:54

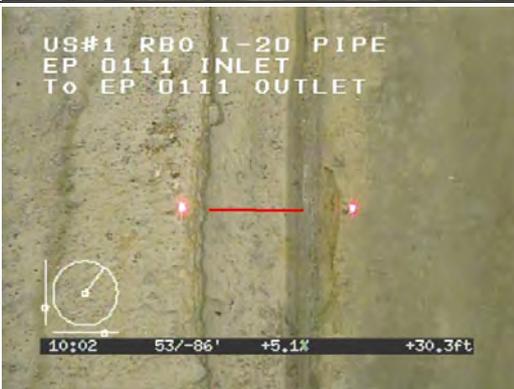
30.3	<b>General Observation</b> <b>Severity: None</b> <b>Remarks: 1.363</b>	17:45

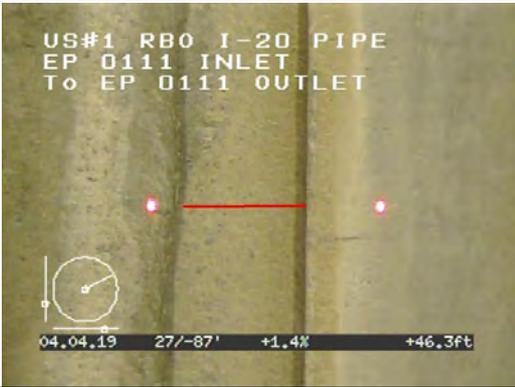
Distance	Fault Observation	Time	Picture
46.4	<p style="text-align: center;"><b>General Observation</b>  <b>Severity: None</b>  <b>Remarks: 1.329</b></p>	27:42

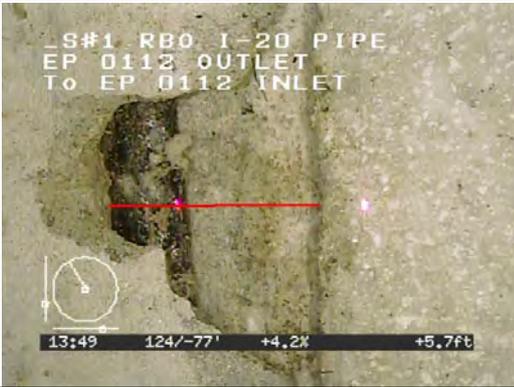
Distance	Fault Observation	Time	Picture
0.0	<p>Discharge Point Severity: None Remarks: EP 0112 OUTLET</p>	01:03	
0.0	<p>Water Level Severity: None Percent: 10</p>	01:16	
5.8	<p>Broken Position: 11 Severity: None Joint Remarks: CHIPPED SPIGOT TAR VISIBLE Struct Weight: 3</p>	02:43

Distance	Fault Observation	Time	Picture
5.8	<p style="text-align: center;"><b>General Observation</b>  <b>Severity: None</b>  <b>Remarks: 2.79</b></p>	02:59

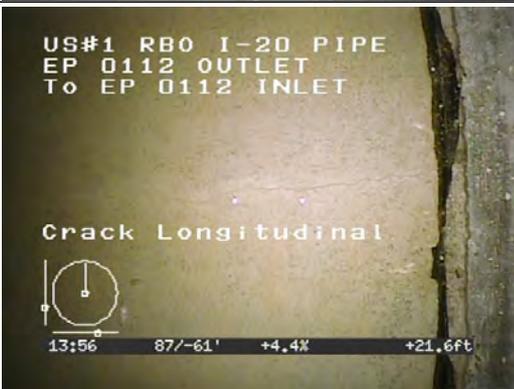
<p>_S#1 RBO I-20 PIPE EP 0112 OUTLET To EP 0112 INLET</p> <p>13:55 95/-108' +4.4% +21.6ft</p>
21.6	<b>Picture Number: 2</b> <b>Crack Longitudinal</b> <b>Position: 12</b>	0

<p>US#1 RBO I-20 PIPE EP 0112 OUTLET To EP 0112 INLET</p> <p>Crack Longitudinal</p> <p>13:56 87/-61' +4.4% +21.6ft</p>

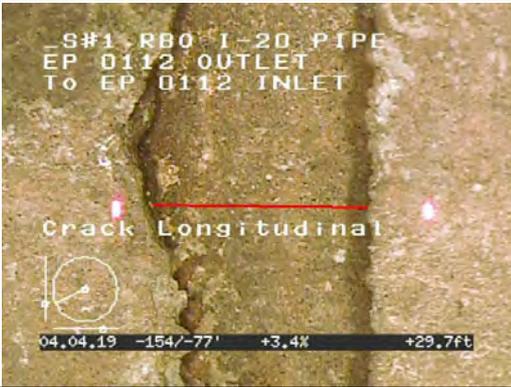
Distance	Fault Observation	Time	Picture
29.8	<p style="text-align: center;"><b>General Observation</b>  <b>Severity: None</b>  <b>Remarks: 1.712</b></p>	11:30

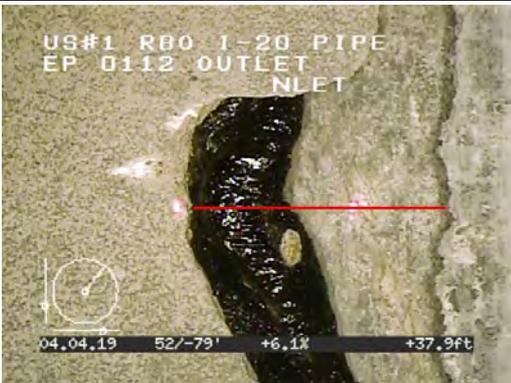
37.9	<p style="text-align: center;"><b>Intruding Sealing Ring</b>  <b>Position: 1 To 1</b>  <b>Severity: None</b>  <b>Percent: 5</b>  <b>Remarks: TAR VISIBLE AT CHIPPED SPIGOT</b>  <b>Maint Weight: 2</b></p>	12:43

37.9	<p style="text-align: center;"><b>General Observation</b>  <b>Severity: None</b>  <b>Remarks: 3.588</b></p>	13:50

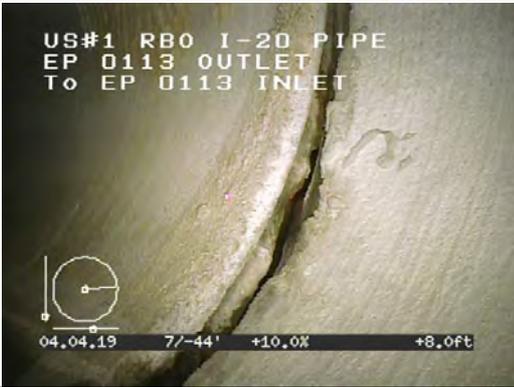
Distance	Fault Observation	Time	Picture
8.0	<p align="center"> <b>General Observation</b>  <b>Severity: None</b>  <b>Remarks: SLIGHT OFFSET</b> </p>	04:36

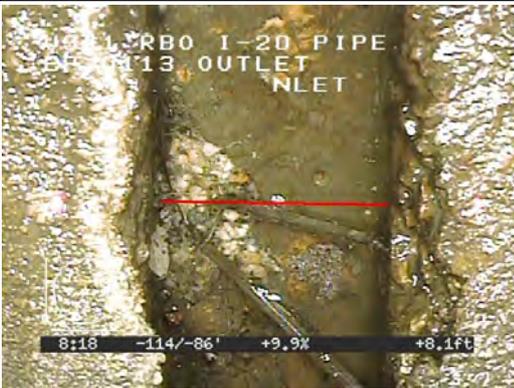
8.1	<p align="center"> <b>General Observation</b>  <b>Severity: None</b>  <b>Remarks: 1.334</b> </p>	06:03

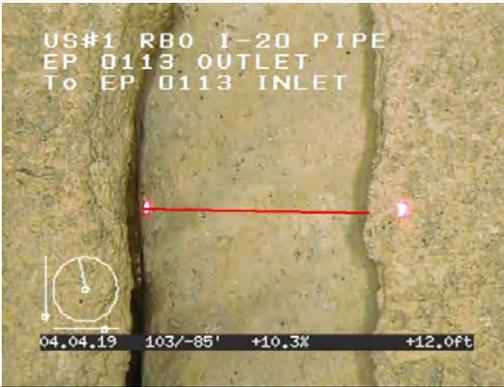
Distance	Fault Observation	Time	Picture
12.0	<p style="text-align: center;"><b>General Observation</b>  <b>Severity: None</b>  <b>Remarks: 2.215</b></p>	08:16

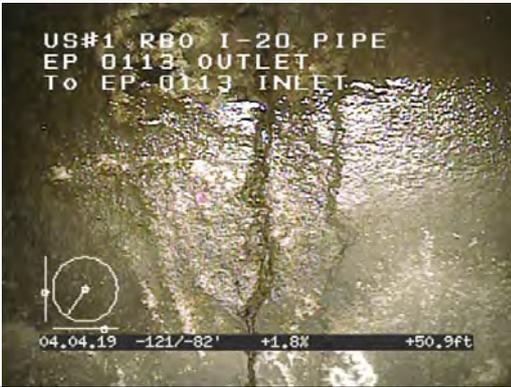
Distance	Fault Observation	Time	Picture
51.0	<b>Roots Fine Joint</b> <b>Position: 7</b> <b>Severity: None</b> <b>Joint</b> <b>Maint Weight: 1</b>	29:46

<p>US#1 RBO I-20 PIPE EP 0113 OUTLET To EP 0113 INLET</p> <p>04,04,19 -121/-82' +1.8% +50.9ft</p>
51.0	<b>Roots Fine Joint</b> <b>Position: 4 To 5</b> <b>Severity: None</b> <b>Joint</b> <b>Maint Weight: 1</b>	30:09

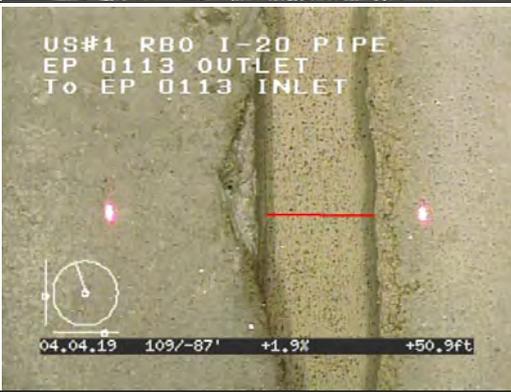
<p>US#1 RBO I-20 PIPE EP 0113 OUTLET To EP 0113 INLET</p> <p>8:43 -35/-90' +1.9% +50.9ft</p>
51.0	<b>General Observation</b> <b>Severity: None</b> <b>Remarks: 0.851</b>	30:51

<p>US#1 RBO I-20 PIPE EP 0113 OUTLET To EP 0113 INLET</p> <p>04,04,19 109/-87' +1.9% +50.9ft</p>

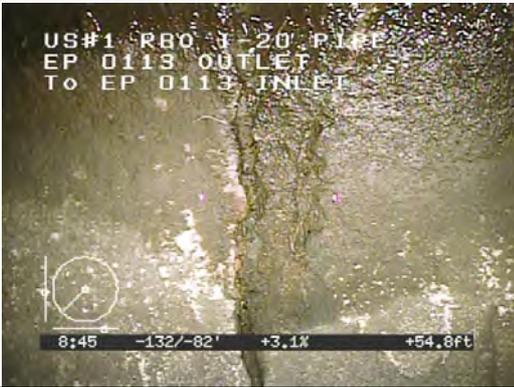
Distance	Fault Observation	Time	Picture
54.8	<b>Roots Fine Joint</b> <b>Position: 7</b> <b>Severity: None</b> <b>Joint</b> <b>Maint Weight: 1</b>	32:07

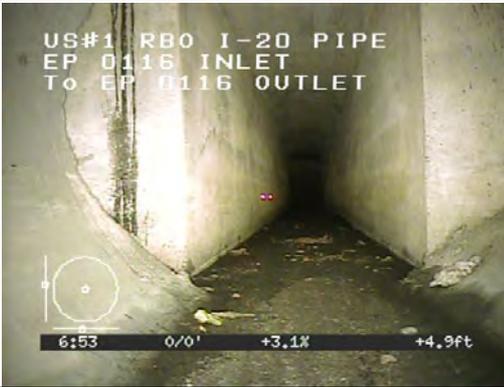
Distance	Fault Observation	Time	Picture
5.0	<p><b>Obstacle Other</b>  <b>Position: 5 To 7</b>  <b>Severity: None</b>  <b>Cont Defect: S01</b>  <b>Percent: 10</b>  <b>Remarks: DIRT IN PIPE</b>  <b>Maint Weight: 2</b></p>	04:35

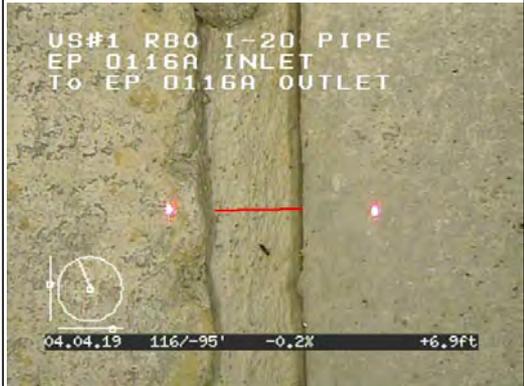
Distance	Fault Observation	Time	Picture
0.0	Discharge Point Severity: None Remarks: EP 0116A INLET	21	
0.0	Water Level Severity: None Percent: 0	39	
6.9	General Observation Severity: None Remarks: 1.049	03:22
