## 5. Appendix

## 5.1 Miscellaneous Outfall Analysis Notes

## 5.2 Miscellaneous Cross-Line Analysis Notes

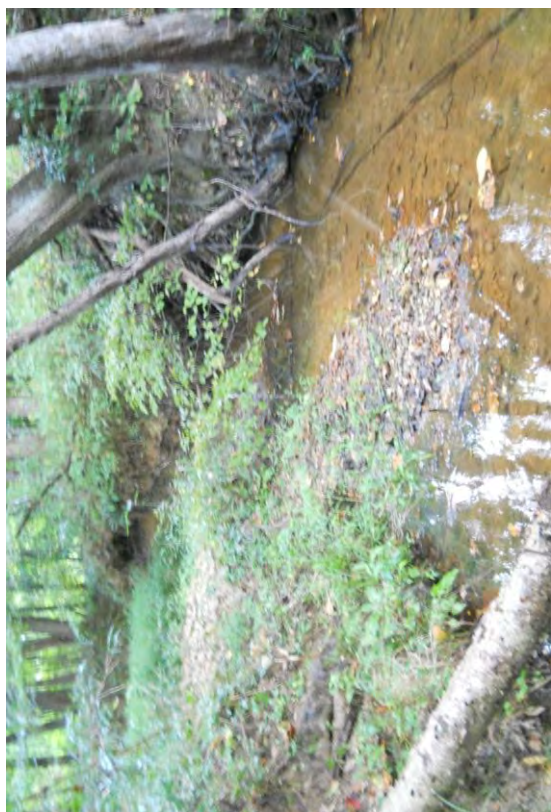
D/S large scour hole. Broken PVC pipe crossing just below outlet.

Clear vegetation U/S of culvert. Repair downstream scour hole and construct energy dissipator.

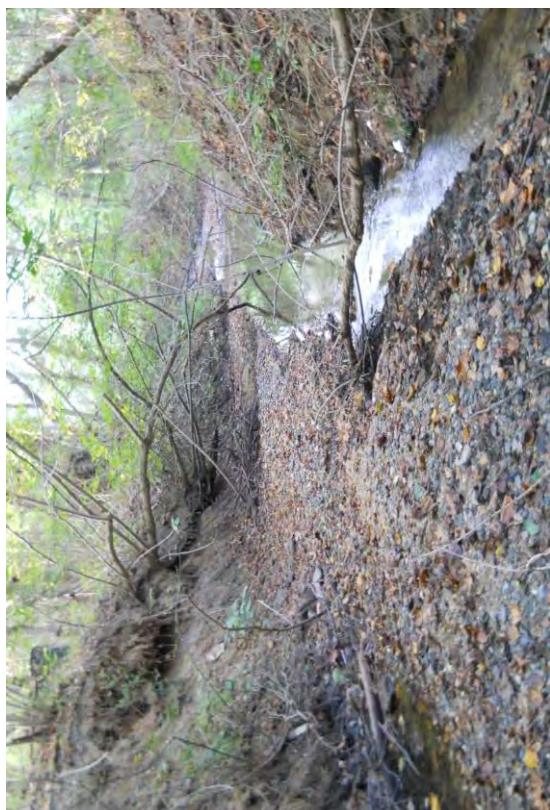
Difficult to find or distinguish between Site 22 and 23. U/S 22 was not found but D/S 22 was located as 80% filled 48".

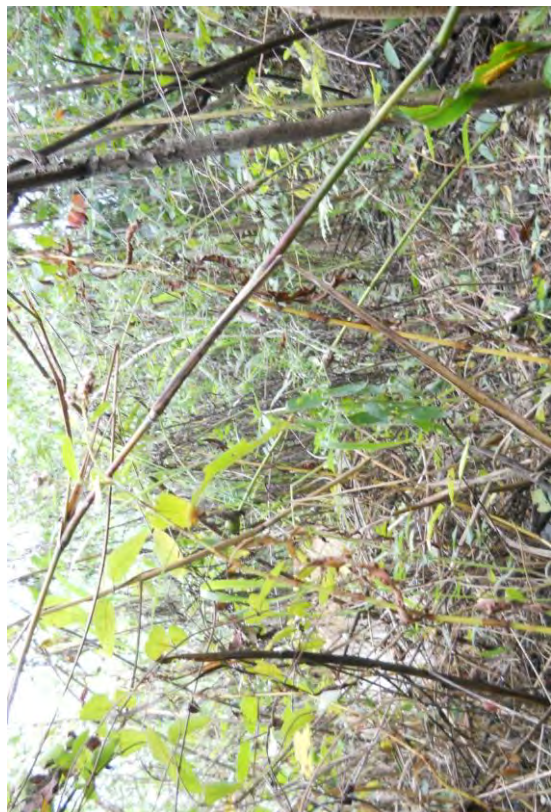
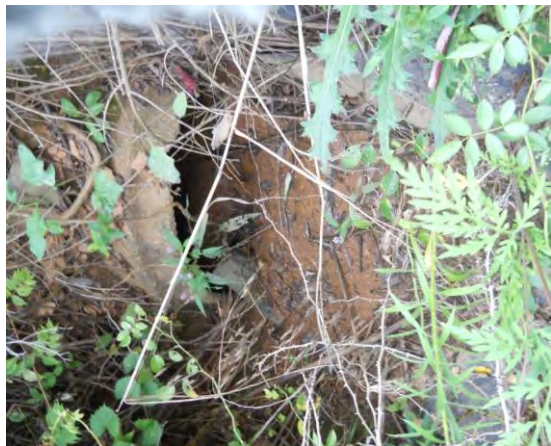
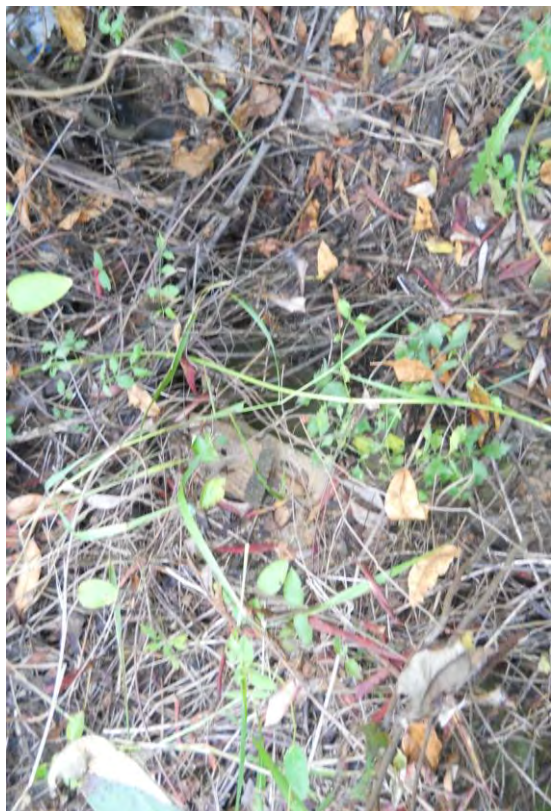
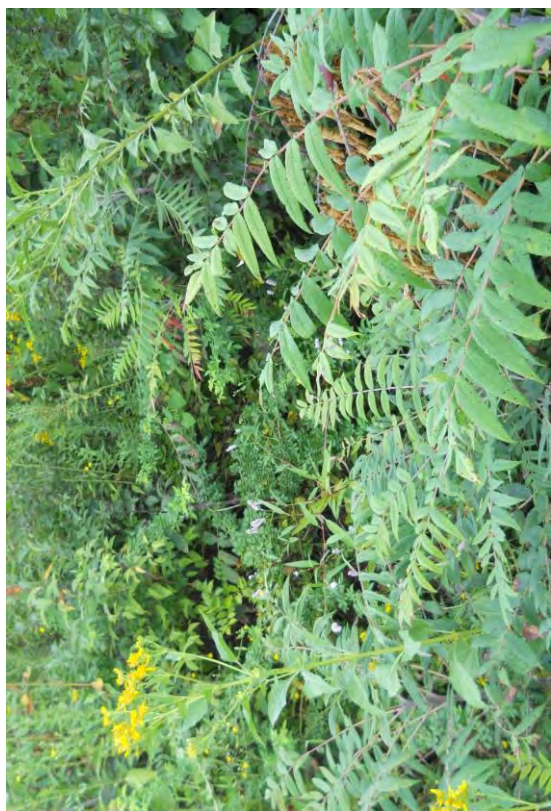
Site No. 42 PHOTO

Not surveyed and no inlet/outfall found U/S or D/S.

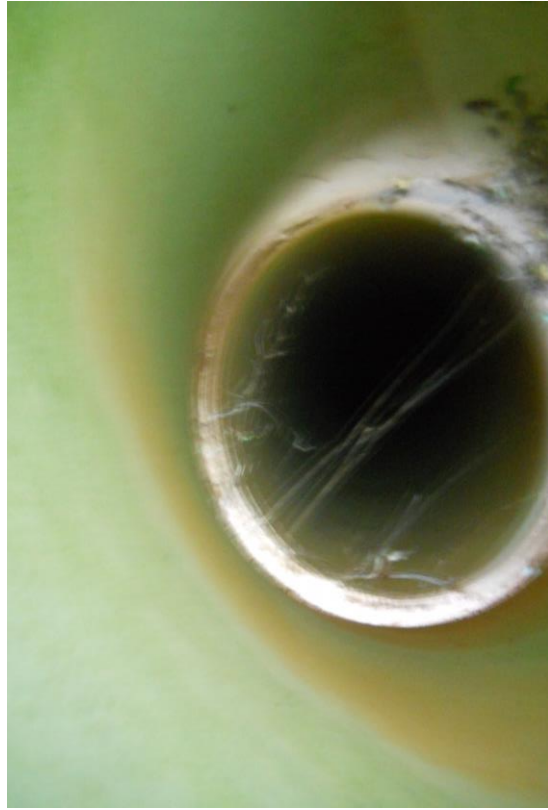
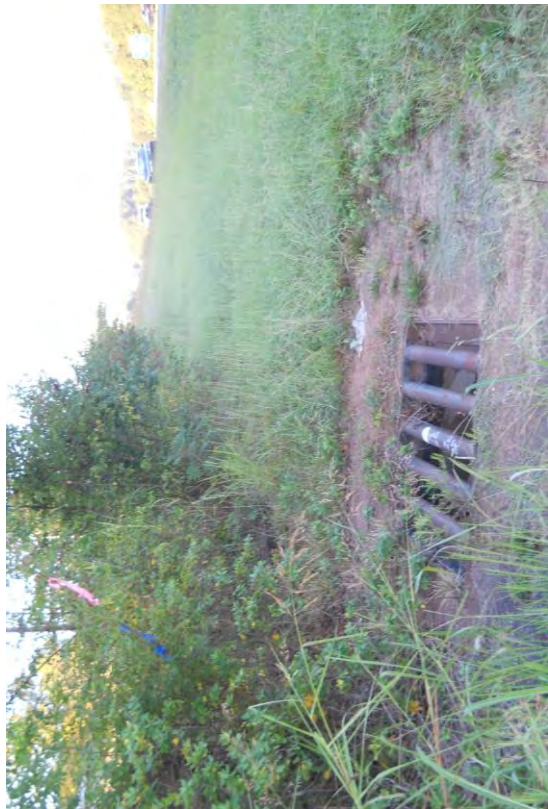
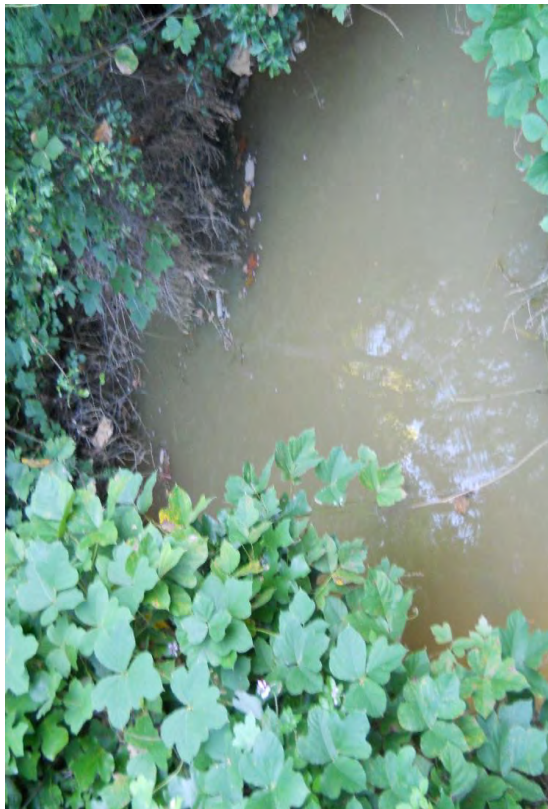
D/S ponded water with scour., could not see very far downstream to comment on downstream conditions due to heavy vegetation. D/S pipe separation.

Clean outfall. Stabilize downstream outlet and construct energy dissipator. Repair joint separation.

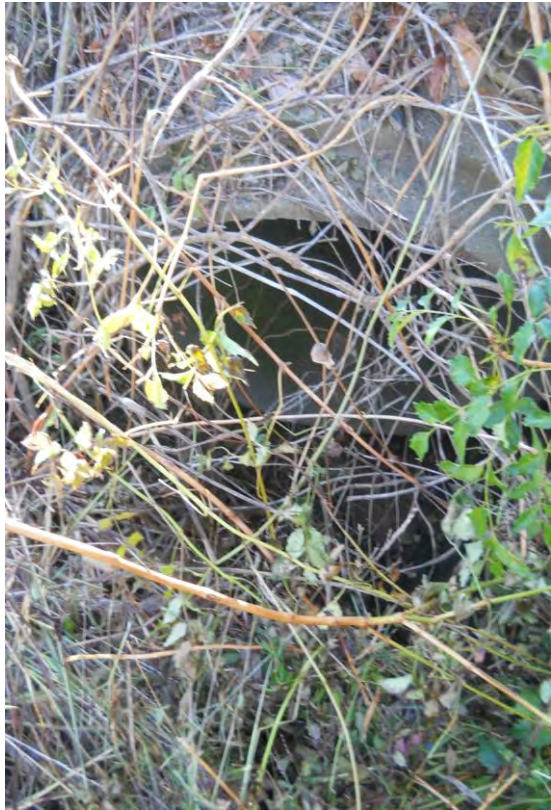
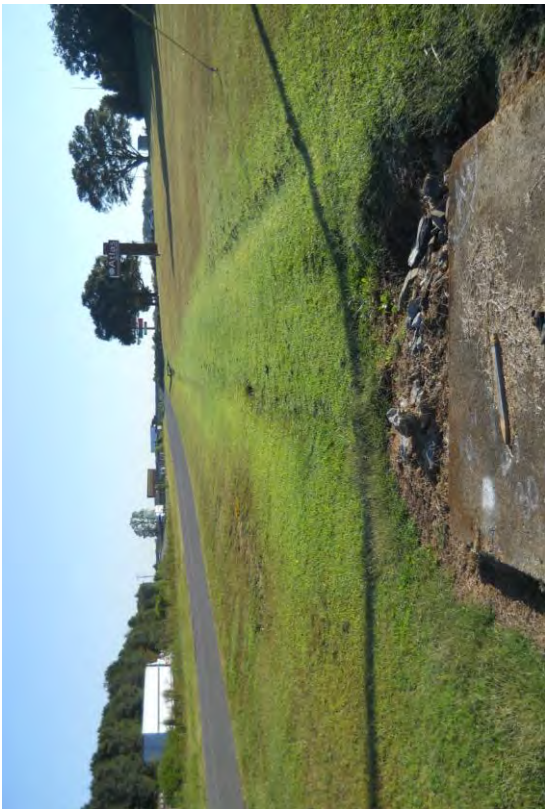
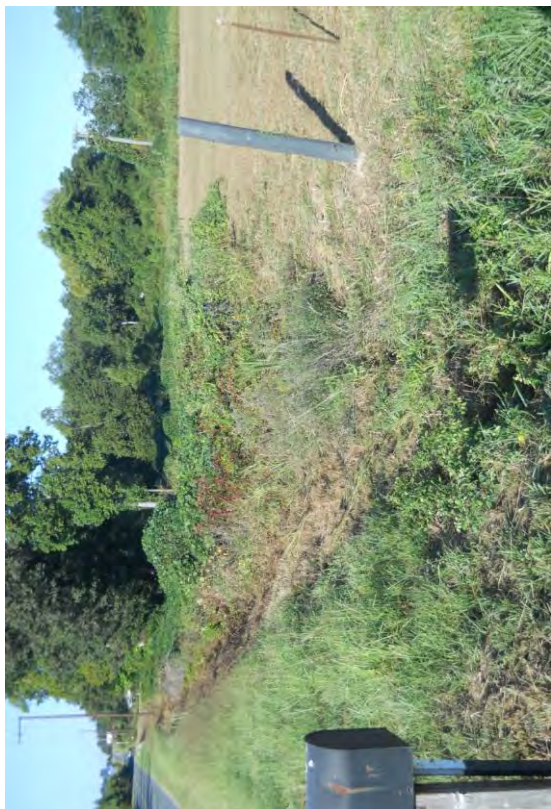
D/S scour &amp; heavy vegetation. Some type of broken concrete at pipe end, assuming not part of drainage system

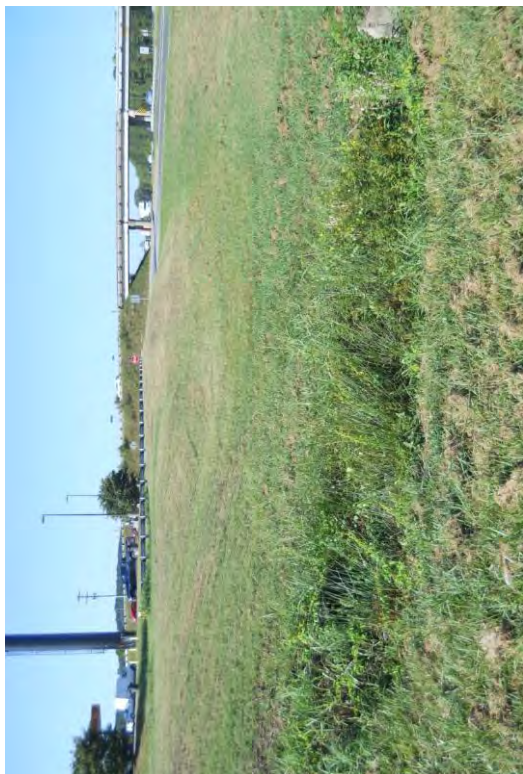
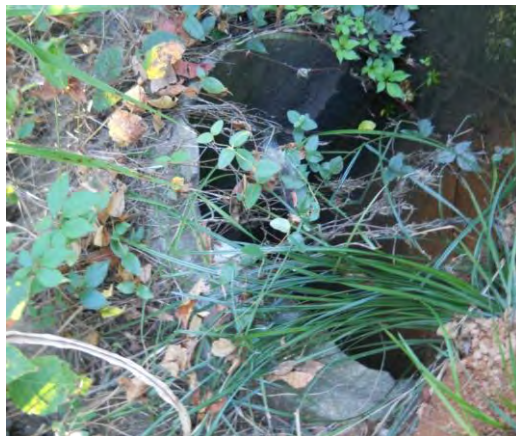
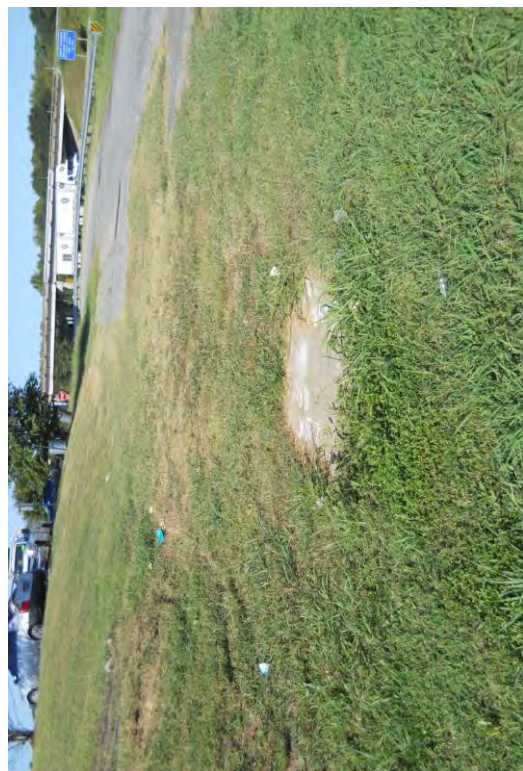
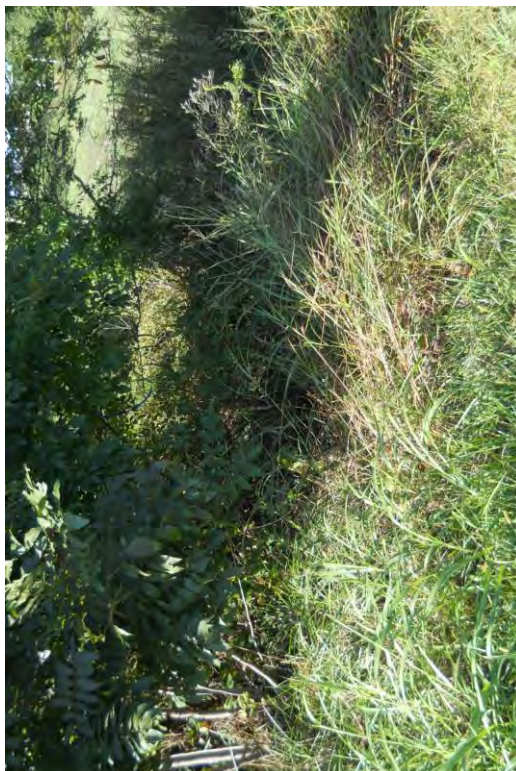
Site No. 60 PHOTO

Part of a system from Love's gas station. Pipes between inlets are 18"->24"->24"->30" (site 60). Site 60 begins after a short grass channel on road side. U/S edge is damaged, most likely from mower.

D/S has damaged edge

Check location of open end pipe, confirm clear zone. Clean U/S channel, above site 60 pipe. Clean D/S outfall channel.
