Video Pipe Inspection Report

I-85 Widening Phase III – Cherokee County
From MM 98 to MM 106

Cherokee County, South Carolina
February 24, 2017

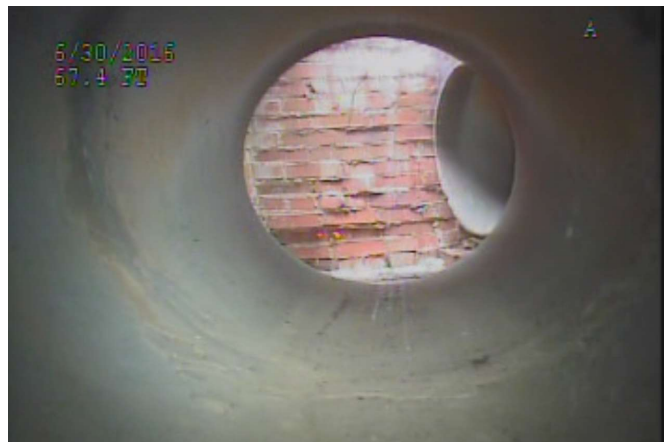
DEFICIENCIES
There were no deficiencies observed during the inspection.

Pipe is in good condition

RECOMMENDATION
Based on the Video Pipe Inspection, Pipe 11B should be retained.

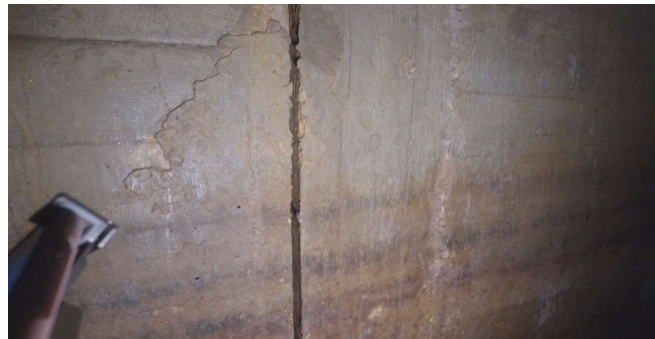
DEFICIENCIES
108' - Wide Displaced Seam

108' - WIDE DISPLACED SEAM (LT.)

RECOMMENDATION
Based on the Video Pipe Inspection, Pipe 24 should be cleaned and retained.
Repair the wide displaced seam at 108'.

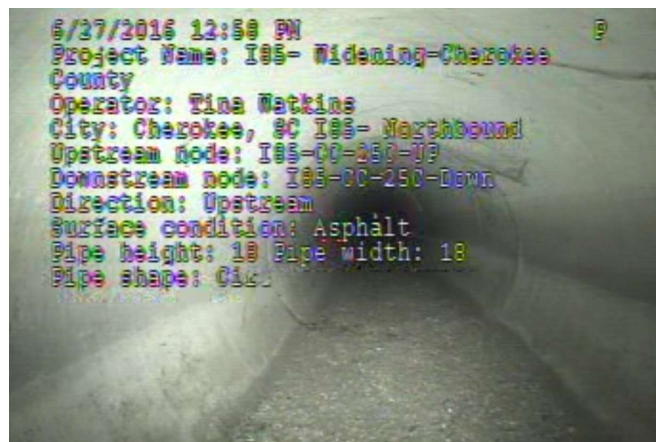
PIPE 25C BEGIN - DOWNSTREAM END

DEFICIENCIES
DEBRIS NEAR THE DOWNSTREAM END.

RECOMMENDATION
Pipe is located in existing paved median, clean and retain.

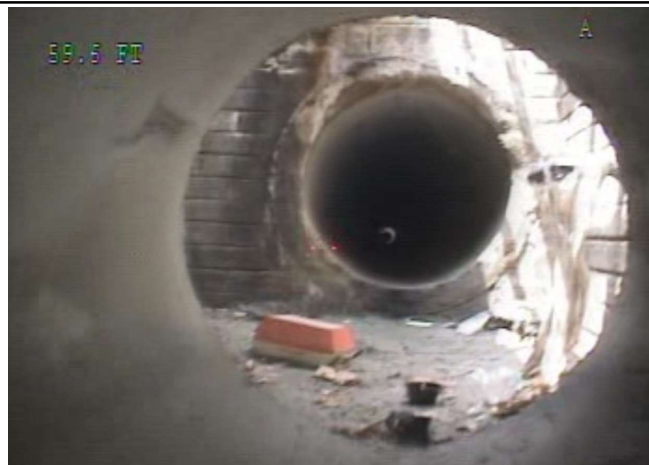
DEFICIENCIES
DEBRIS NEAR THE DOWNSTREAM END.

63.4' - PIPE 25F END - UPSTREAM END

RECOMMENDATION
Pipe is located in existing paved median. Clean and retain.

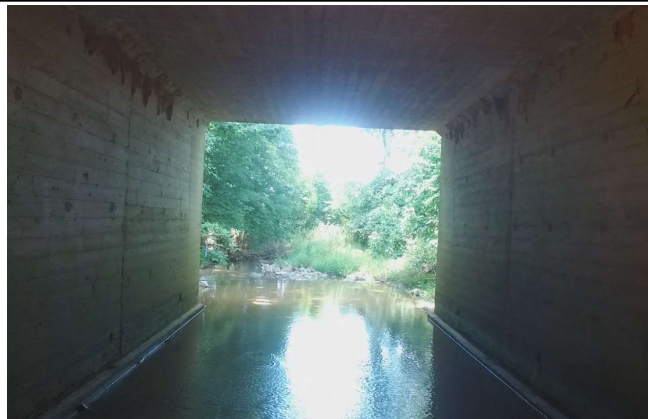
PIPE 29 BEGIN - DOWNSTREAM OUTLET

DEFICIENCIES
There were no deficiencies observed during the inspection.

RECOMMENDATION
Retain culvert

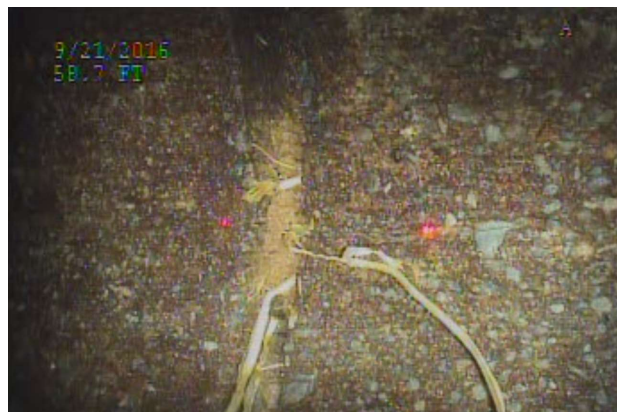
DEFICIENCIES
58.7' - Root in Joint

58.7' - Root in Joint

RECOMMENDATION
Based on the Video Pipe Inspection, Pipe 30 should be cleaned and retained.

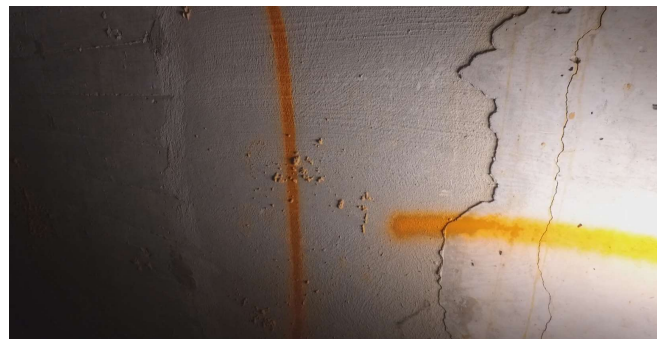
DEFICIENCIES
SEWER PIPE RUNS THE LENGTH OF THE CULVERT ON THE BOTTOM LEFT.
29' - CRACK IN THE RT. WALL, TOP, AND LT. WALL.
59' - CRACK IN THE RT. WALL, TOP, AND LT. WALL.
121' - 125' - REBAR IS EXPOSED AT THE TOP.

59' - CRACK (RT. WALL - TOP - LT. WALL)

RECOMMENDATION
Repair cracks. Retain Culvert.

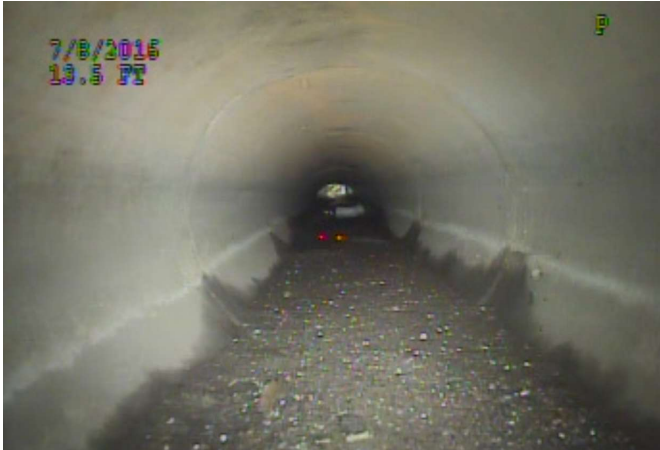
DEFICIENCIES
GENERAL - DEBRIS THROUGHOUT

Debris throughout

RECOMMENDATION
Clean and Retain. Pipe is in good condition.

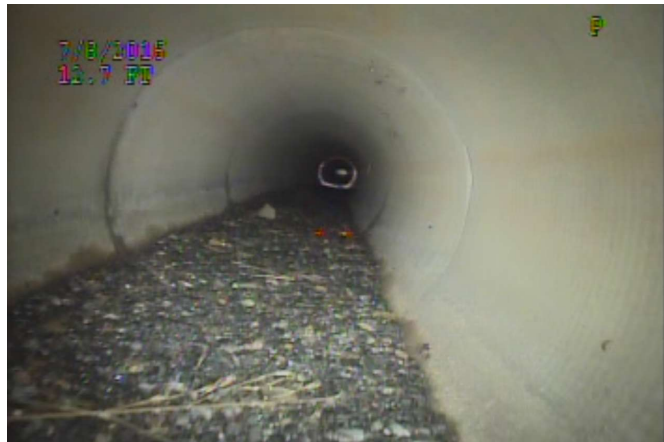
DEFICIENCIES
GENERAL - DEBRIS THROUGHOUT

GENERAL - DEBRIS THROUGHOUT

RECOMMENDATION
Clean and Retain. Pipe is in good condition.

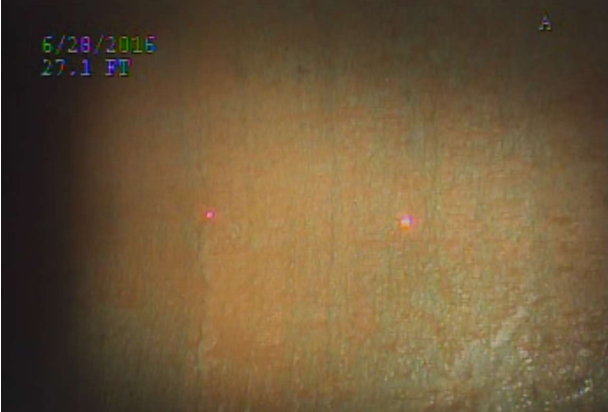
DEFICIENCIES
27.1' - CIRCUMFERENTIAL CRACK
38.3' - CIRCUMFERENTIAL CRACK
50.7' - CIRCUMFERENTIAL CRACK
55.4' - CIRCUMFERENTIAL CRACK

27.1' - CIRCUMFERENTIAL CRACK

RECOMMENDATION
No apparent issues from cracking. Retain pipe.

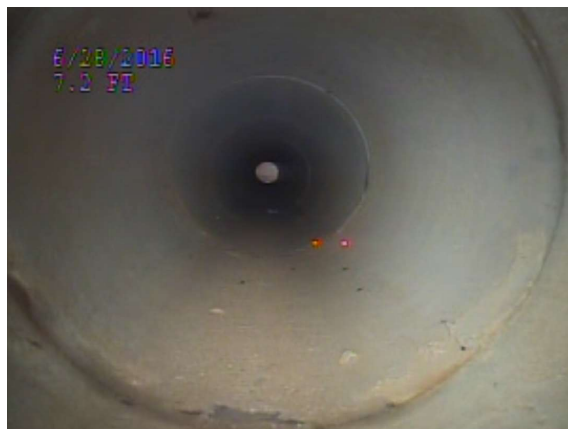
DEFICIENCIES
There were no deficiencies observed during the inspection.

Pipe is in good condition

RECOMMENDATION
Based on the Video Pipe Inspection, Pipe 38B should be retained.

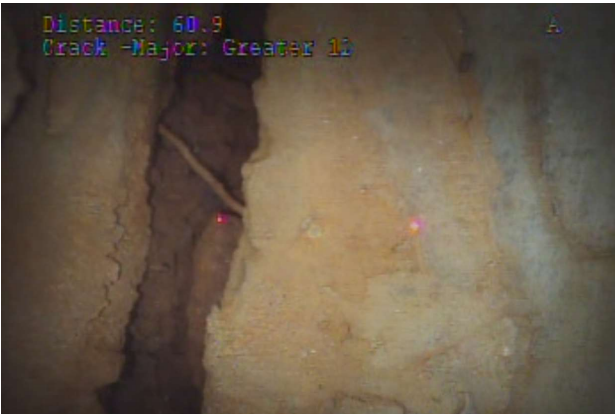
DEFICIENCIES
2' - Joint Separated
60.9' - Joint Separated > 1"

60.9' - Joint Separated > 1"

RECOMMENDATION
Joint separations located outside of roadway pavement. Replace separated sections. Retain remainder.

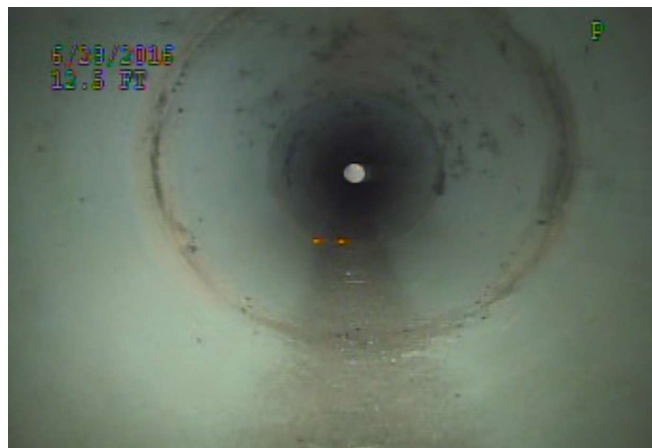
DEFICIENCIES
There were no deficiencies observed during the inspection.

Pipe is in good condition

RECOMMENDATION
Pipe is in good condition.

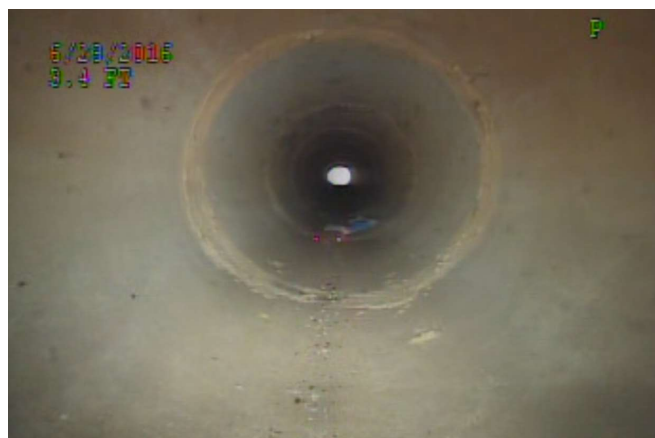
DEFICIENCIES
There were no deficiencies observed during the inspection.

Pipe is in good condition

RECOMMENDATION
Pipe is in good condition.

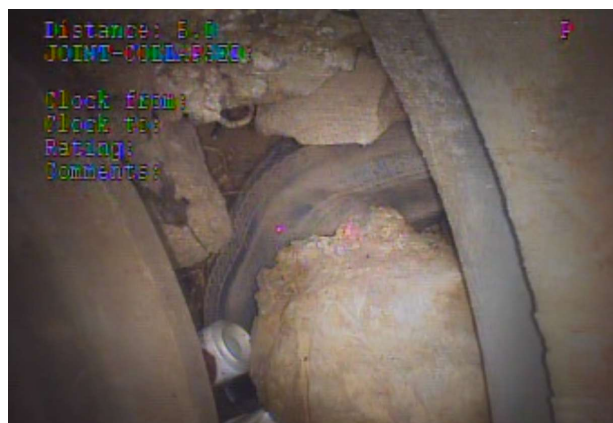
DEFICIENCIES
5' - Joint Collapsed; 84.4' - Broken Pipe; 90.6' - Joint Separated > 1";
106.8' - Multidirectional Crack; 141.5' - Crack > 12"; 150.7' - Crack > 12";
168.3' - Crack > 12"; 168.4' - Chip; 190.5' - Hole; 232.3' - Crack > 12"

5' - Joint Collapsed

RECOMMENDATION
Replace pipe due to structural issues.

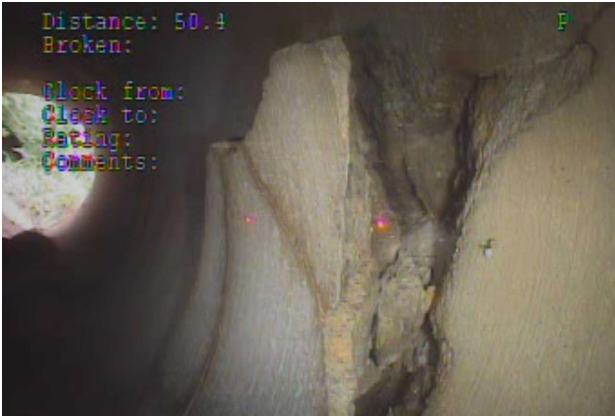
DEFICIENCIES
50.4' - Pipe Broken
53.8' - Joint Separated > 1"

50.4' - Pipe Broken

RECOMMENDATION
Replace broken pipe outside of roadway pavement.

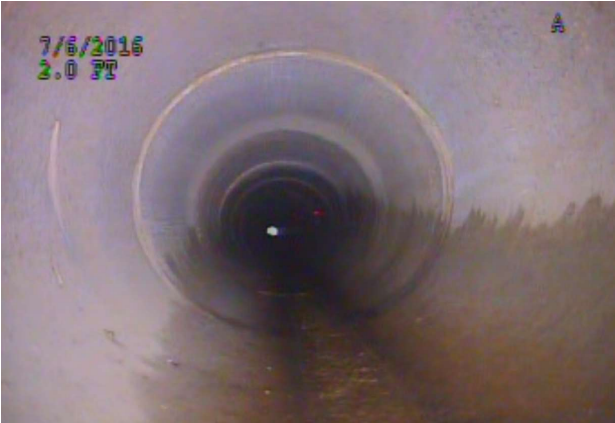
DEFICIENCIES
There were no deficiencies observed during the inspection.

Pipe is in good condition

RECOMMENDATION
Pipe is in good condition.

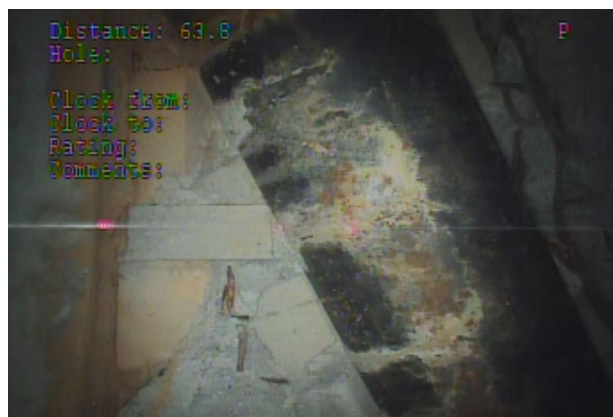
DEFICIENCIES
<u>11' - Aggregate Showing</u>
<u>63.7' - Hole</u>
<u>69.3' - Joint Offset</u>

63.7' - Hole

RECOMMENDATION
<u>Pipe is located under frontage road. Replace 15' of pipe due to structural issues at pipe end.</u>

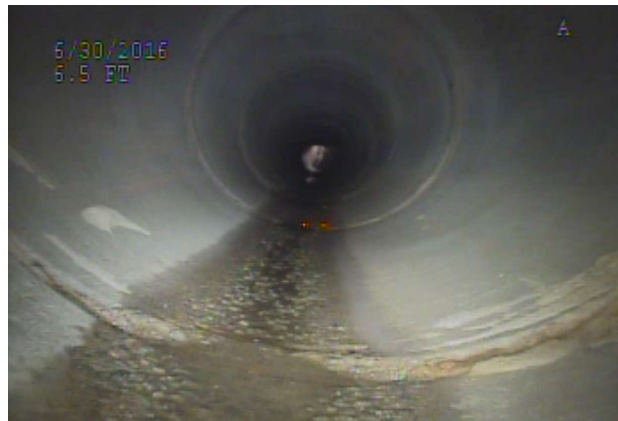
DEFICIENCIES
<u>8' - Aggregate Showing.</u>

8' - Aggregate Showing

RECOMMENDATION
<u>Pipe is in good condition.</u>

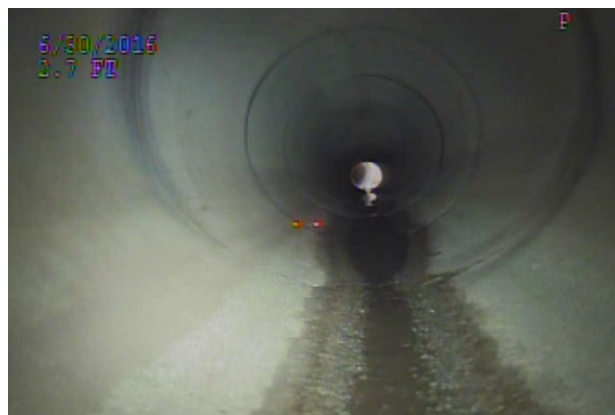
DEFICIENCIES
<u>There were no deficiencies observed during the inspection.</u>

Pipe is in good condition

RECOMMENDATION
<u>Pipe is in good condition.</u>

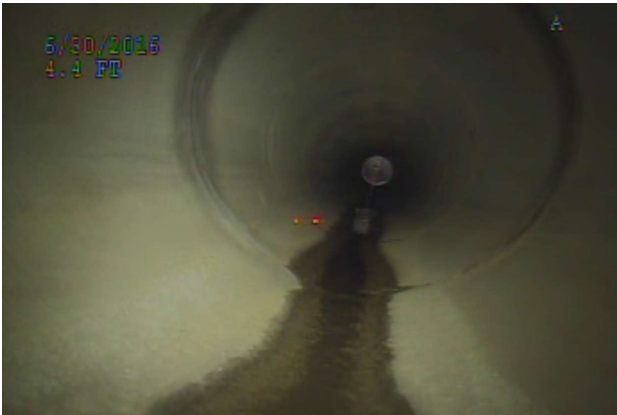
DEFICIENCIES
<u>There were no deficiencies observed during the inspection.</u>

Pipe is in good condition

RECOMMENDATION
<u>Pipe is in good condition.</u>

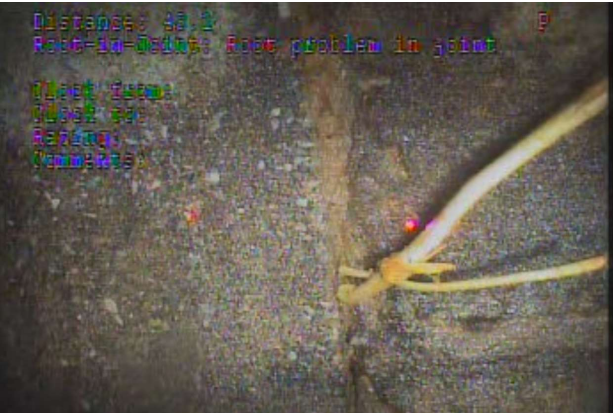
DEFICIENCIES
43' - Root in Joint
52' - Root in Joint

43' - Root in Joint

RECOMMENDATION
Pipe is in good condition.

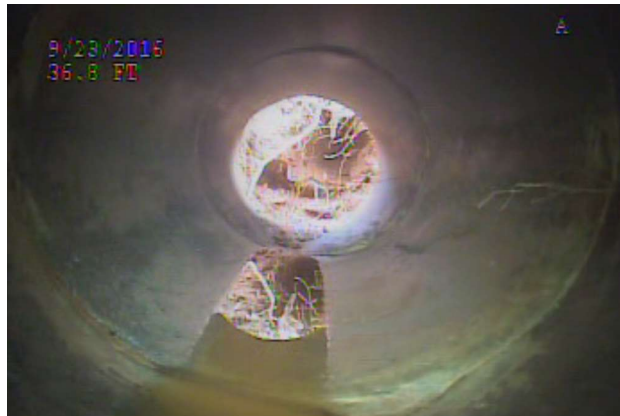
DEFICIENCIES
<u>38.7' - Root in Joint</u>
<u>38.7' - Chip</u>
<u>43.7' - Root in Joint</u>

38.7' - Root in Joint

RECOMMENDATION
<u>Pipe is in good condition.</u>

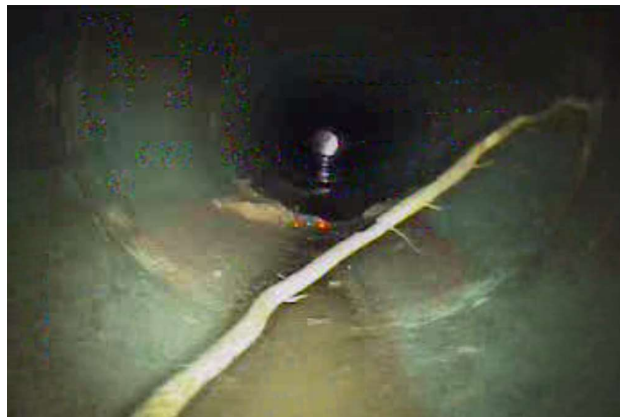
DEFICIENCIES
<u>5' - Root in Joint</u>
<u>54.5' - Joint is Misaligned; Root in Joint; Joint Separated</u>

5' - Root in Joint

RECOMMENDATION
<u>Deficiencies located outside of roadway pavement. Replace first and las section of pipe. Retain remainder.</u>

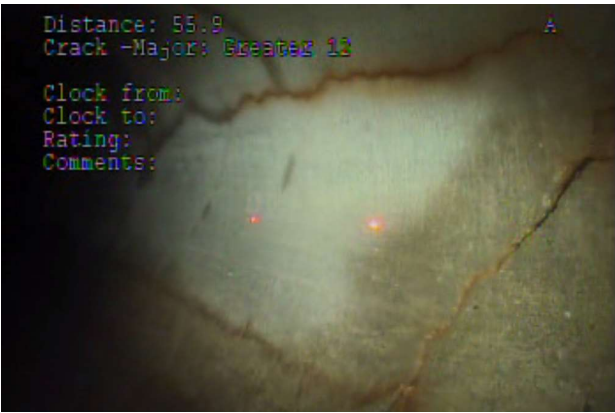
DEFICIENCIES
<u>2' - Joint Separated > 2"; Chip</u>
<u>4' - Joint Offset</u>
<u>56' - Chip; Crack > 12"</u>
<u>65' - Chip</u>

56' - Crack > 12"

RECOMMENDATION
<u>Pipe is located under I-85 NB. Slip line pipe due to cracking.</u>

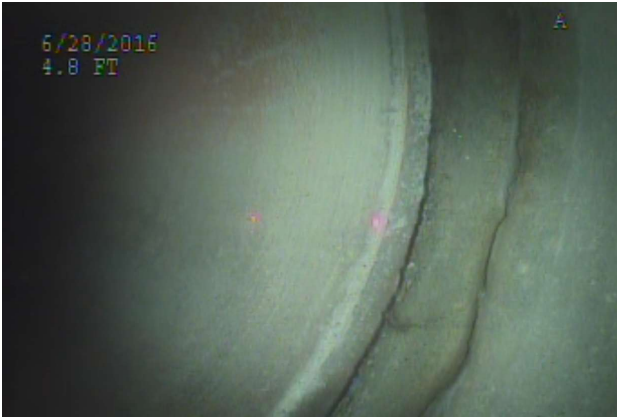
DEFICIENCIES
4.6' - Joint Separated > 1";
86.8' - Joint Offset/Gasket Exposed;
94.9' - Joint Offset

4.6' - Joint Separated > 1"

RECOMMENDATION
No apparent issues from joint offsets. Retain pipe.

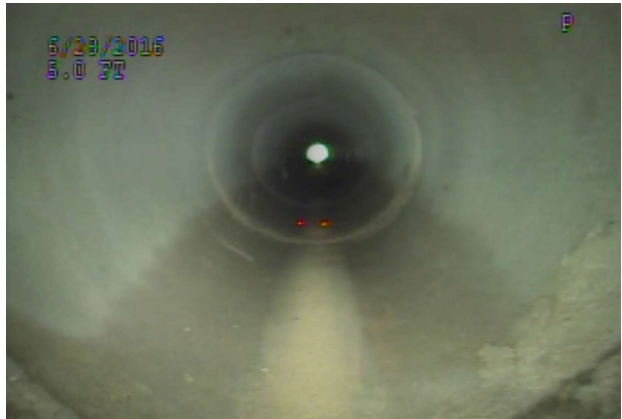
DEFICIENCIES
There were no deficiencies observed during the inspection.

Pipe is in good condition

RECOMMENDATION
Pipe is in good condition.

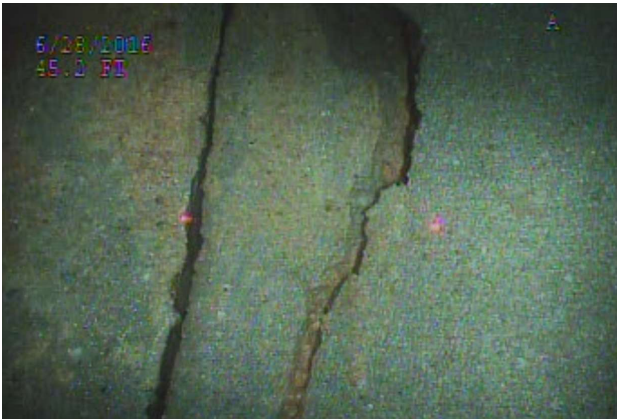
DEFICIENCIES
22.4' - Condensation;
45.2' - Circumferential Crack;
65.7' - Joint Separated > 1"

45.2' - Circumferential Crack

RECOMMENDATION
Pipe is in good condition. Replace last section of pipe due to separation.

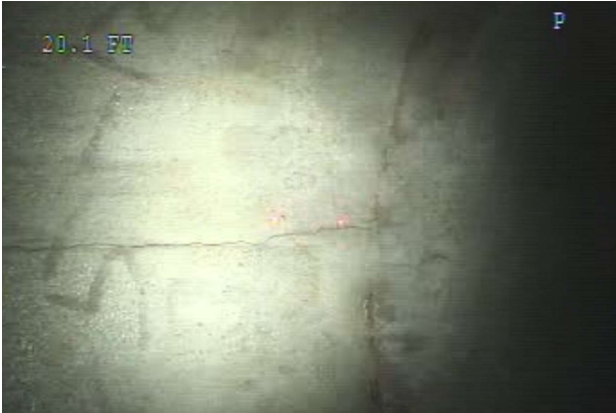
DEFICIENCIES
<u>20' - Crack > 12";</u>
<u>29.5' - Crack > 12";</u>
<u>123' - Crack > 12"</u>

20' - Crack > 12";

RECOMMENDATION
<u>No apparent issues due to cracks. Pipe is in good condition.</u>

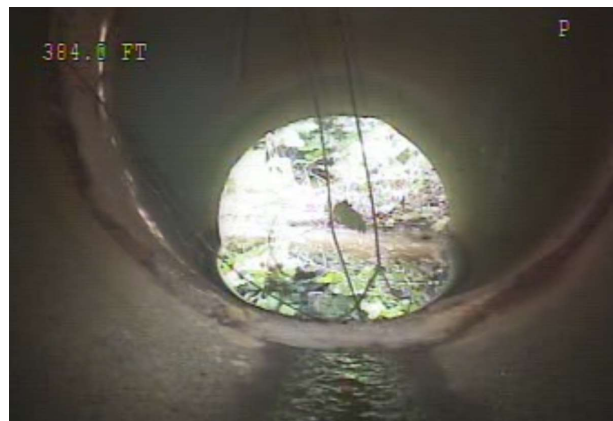
DEFICIENCIES
<u>63.8' - Joint Offset; 68.8' - Joint Offset; 69.6' - Rebar Exposed;</u>
<u>70.2' - Crack > 12"; 81.8 - Crack > 12"; 131.6' - Crack > 12";</u>
<u>338.6' - Crack > 12"; 373.9 - Joint Offset; 388.4 - Pipe Collapsed</u>

388.4' - Pipe collapsed

RECOMMENDATION
<u>Pipe collapse is located in LT shoulder. Replace last section of pipe. No apparent issues from cracking. Retain remainder of pipe.</u>

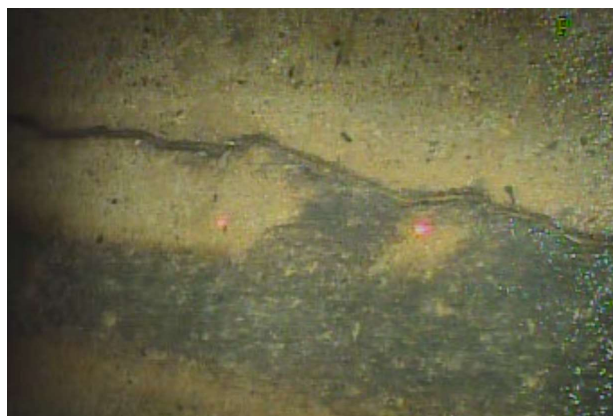
DEFICIENCIES
<u>Offset Joints - 2.8', 22.4', 35', 43',</u>
<u>Cracks > 12" - 67', 83', 96', 99'</u>

67' - Crack > 12"

RECOMMENDATION
<u>No apparent issues from joint offsets or cracking. Retain pipe.</u>

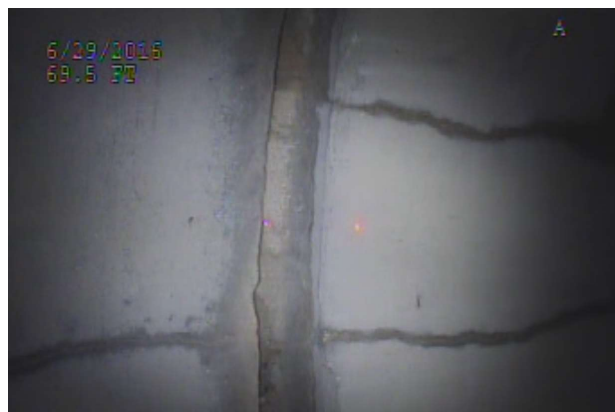
DEFICIENCIES
<u>70' - Multidirectional Crack;</u>
<u>70' - Joint Separated > 1"</u>

70' - Joint Separated > 1"/Multidirectional Crack

RECOMMENDATION
<u>No apparent issues from cracks, repair/replace joint at 70' located outside of roadway pavement.</u>

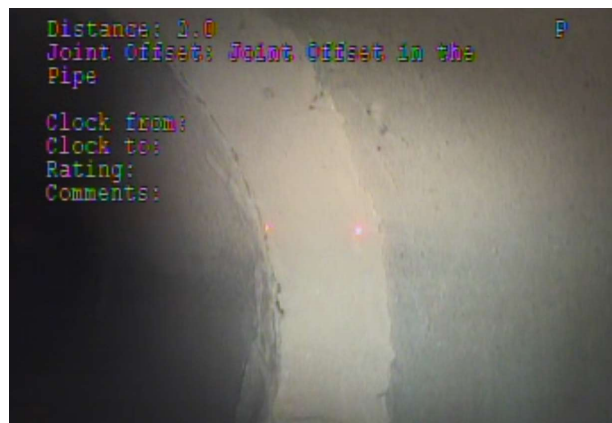
DEFICIENCIES
2' - Joint Offset appears to be grouted

2' - Joint Offset

RECOMMENDATION
Pipe is in good condition. Retain.

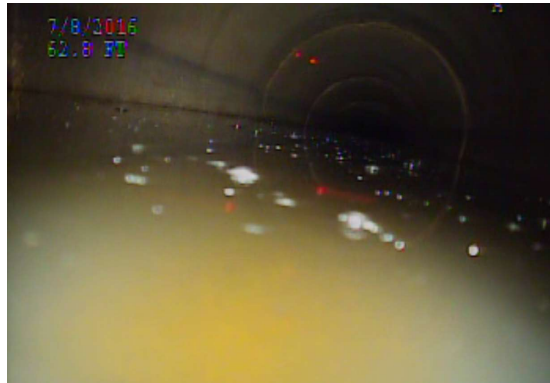
DEFICIENCIES
62' - Water level in pipe

Water in pipe

RECOMMENDATION
Clean outfall and reinspect pipe.

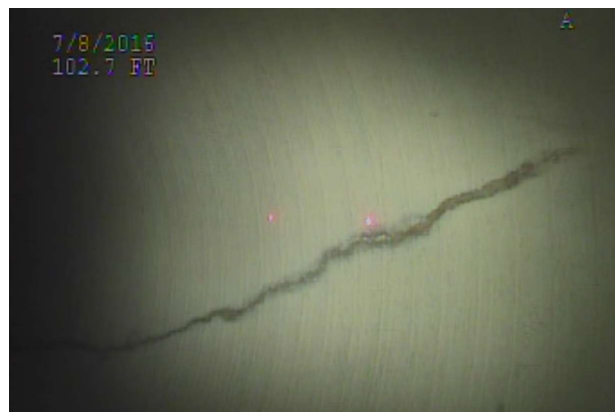
DEFICIENCIES	
<u>Crack > 12" - 27', 103'; Pipe 65B begins at 102.1'</u>	
<u>Joint Offset - 83'; Pipe 65C</u>	
<u>Root in Joint - 83'; Pipe 65C</u>	
<u>Crack in top of pipe 65B for entire length of pipe.</u>

103' - Crack > 12"

RECOMMENDATION	
<u>Joint offset in Pipe 65C is located under pavement and excessive cracking of 65B</u>	
<u>Slip line pipes 65B and 65C.</u>

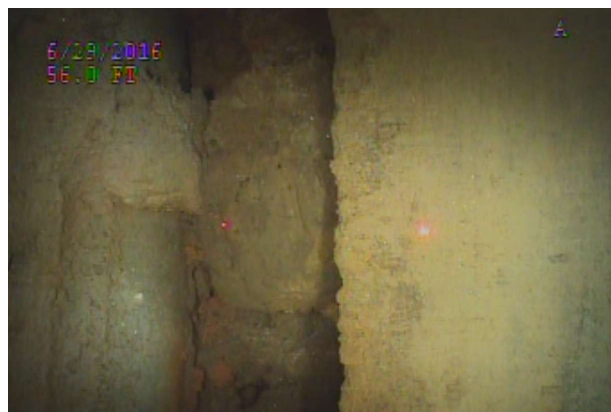
DEFICIENCIES
7.2' - Intruding Sealing Grout;
Cracks > 12" - 31', 43';
56' - Joint Separated > 1"; large amount of sediment in pipe.
60' - Joint Offset

56' - Joint Separated > 1";

RECOMMENDATION
Major joint separation is outside of roadway pavement. Replace from joint separation to end (approx. 16-LF). Remainder of pipe is in good condition.
No apparent issues from cracks.

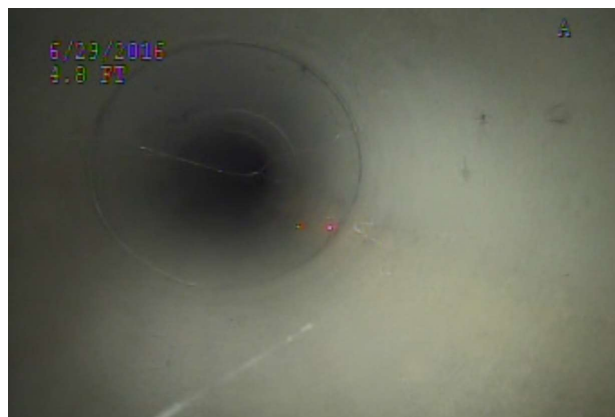
<u>DEFICIENCIES</u>
There were no deficiencies observed during the inspection.

Pipe is in good condition

<u>RECOMMENDATION</u>
Pipe is in good condition. Retain.

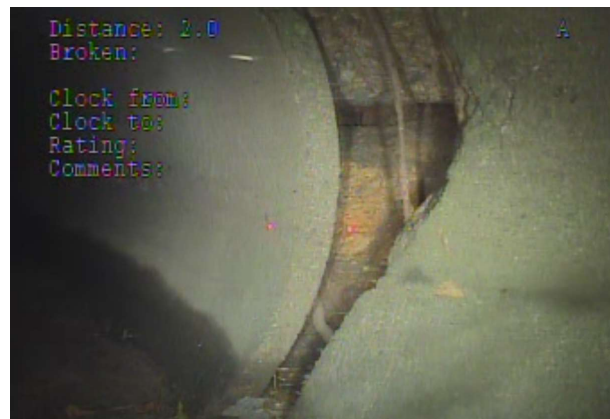
DEFICIENCIES
2' - Broken pipe at joint/connection to drainage box

2' - Broken pipe at joint

RECOMMENDATION
Pipe is in good condition. Repair/grout connection to drainage box.

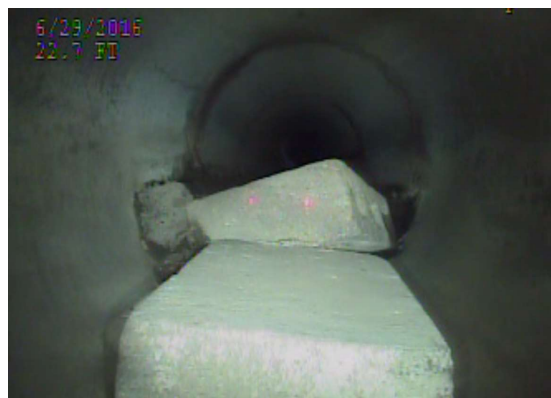
<u>DEFICIENCIES</u>
<u>7' - Intruding Sealing Grout;</u>
<u>Large debris in pipe.</u>

Debris in pipe

<u>RECOMMENDATION</u>
<u>Remove debris. Pipe is in good condition. Retain.</u>

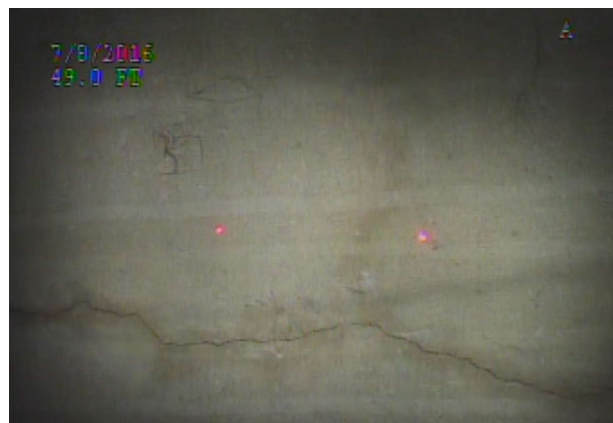
DEFICIENCIES
6' - Crack > 12";
9' - Crack > 12";
49' - Crack > 12"

49' - Crack > 12"

RECOMMENDATION
No apparent issues from cracking. Pipe is in good condition.

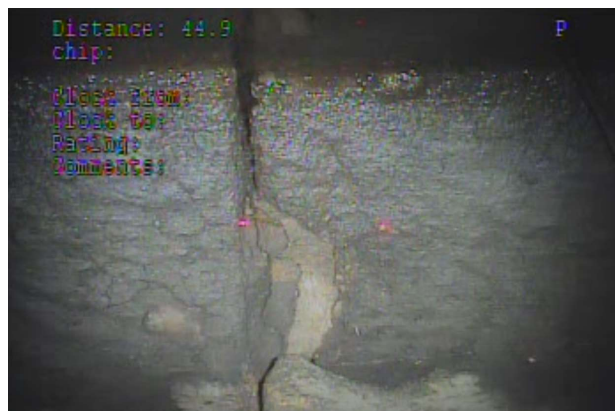
DEFICIENCIES
45' - Chip

45' - Chip

RECOMMENDATION
No apparent issues with chip at 45'. Pipe is in good condition. Retain.

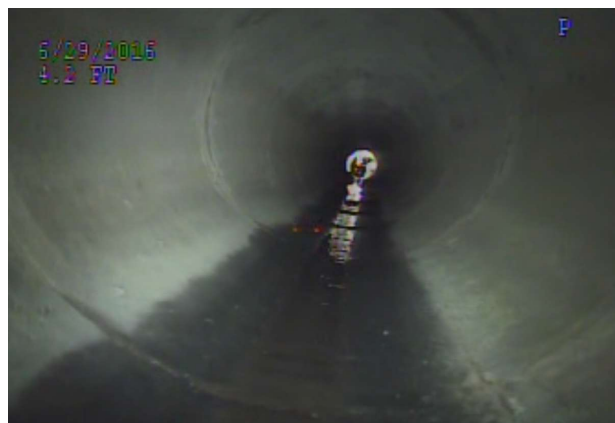
DEFICIENCIES
There were no deficiencies observed during the inspection.

Pipe is in good condition

RECOMMENDATION
Pipe is in good condition.

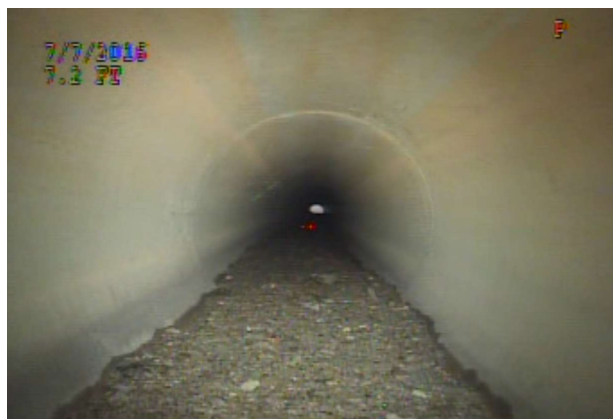
<u>DEFICIENCIES</u>
<u>Major debris accumulation in entire length of pipe.</u>

Debris in pipe

<u>RECOMMENDATION</u>
<u>Clean pipe and retain. Pipe is in good condition.</u>

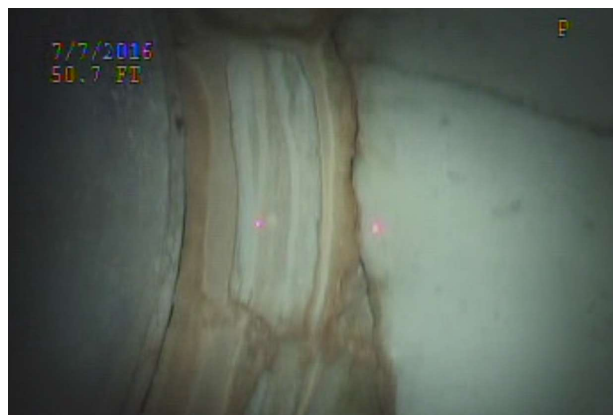
DEFICIENCIES
Debris throughout;
51' - Crack > 12"

51' - Crack > 12"

RECOMMENDATION
Clean and retain. No apparent issues from crack. Some minor infiltration.
Pipe is located outside of I-85 travel lanes.

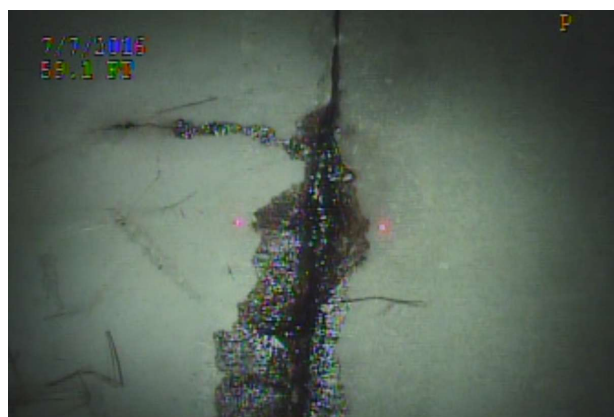
DEFICIENCIES
27' - Joint Offset/Crack < 12"; 49' - Joint Offset;
59' - Infiltration/Crack > 12"; 74' - Broken; 108' - Broken; 115' - Broken/Hole

59' - Infiltration in pipe

RECOMMENDATION
Pipe is located outside of I-85 travel lanes. Replace pipe due to structural issues.

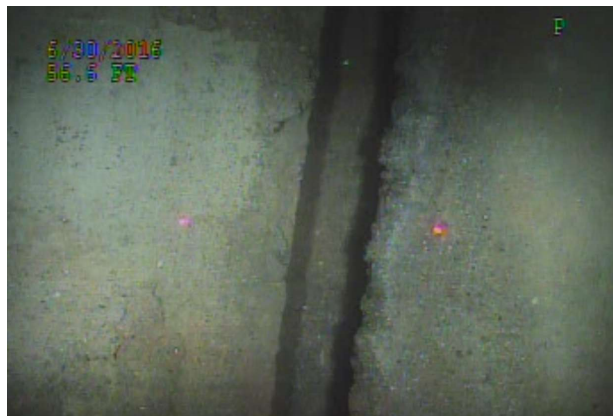
DEFICIENCIES
8' - Joint Offset;
57' - Joint Separated > 1";
69' - Joint Separated > 1"

57' - Joint Separated > 1";

RECOMMENDATION
Major joint separations occur outside of roadway. No apparent issues within roadway. Replace 16' from downstream end. Retain remainder of pipe.

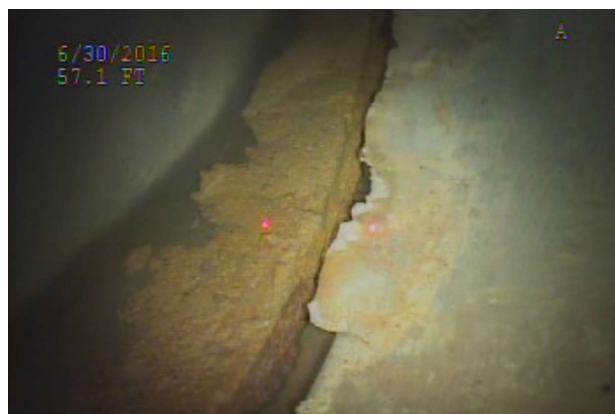
DEFICIENCIES
Joints Offset - 38.5', 47', 57';
Joints Separated > 1" - 38.5', 51'

57' - Joint Offset

RECOMMENDATION
Complete joint separation at 38.5' is under I-85 NB outside lane. Potential for undercutting of pipe. Recommend replacement.

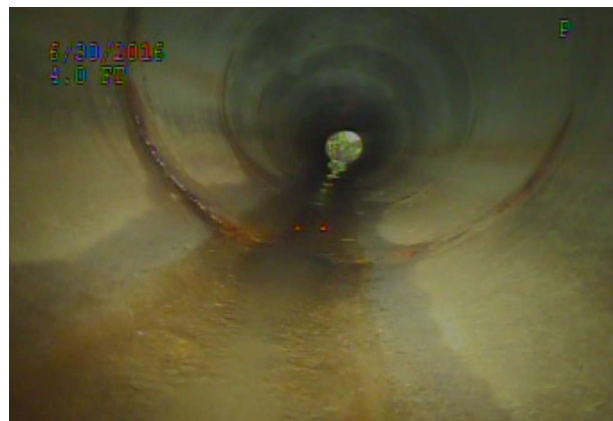
DEFICIENCIES
There were no deficiencies observed during the inspection.

Pipe is in good condition

RECOMMENDATION
Pipe is in good condition. Retain.

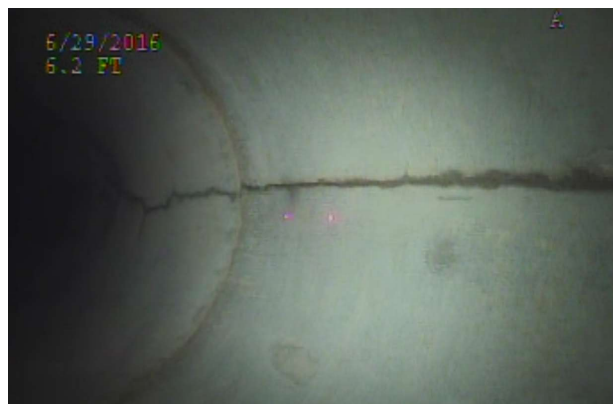
DEFICIENCIES	
6' - Crack > 12";	
24' - Condensation;	
100' - Joint Offset

6' - Crack > 12"

RECOMMENDATION	
Cracking apparent along the top of the pipe under the I-85 SB lanes. Some	
minor infiltration. Replace upstream segment due to joint offset. Slip line pipe.

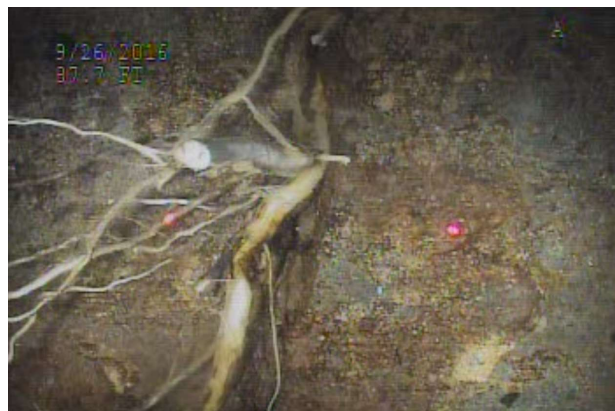
DEFICIENCIES
2.7' - Joint Offset; 9.2' - Joint Offset;
87.7' - Root in Joint

87.7' - Root in Joint

RECOMMENDATION
Clean pipe and outfall. Root intrusion is in last section of pipe. No apparent issues with joint offsets. Retain pipe.

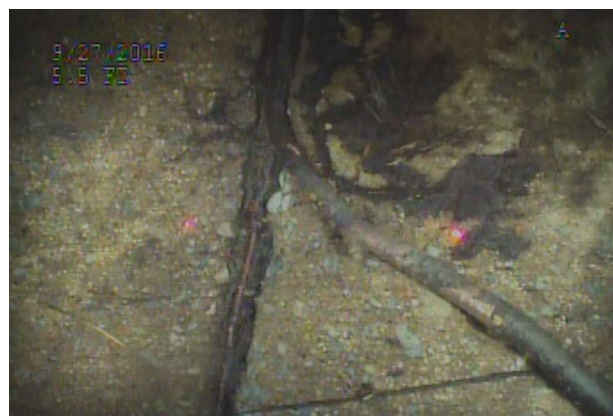
DEFICIENCIES
5.5' - Root in Joint;
9.2' - Joint Separated in Pipe;
21.9' Root in Joint;
25.2' - Joint Offset

5.5' - Root in Joint

RECOMMENDATION
Root intrusion into joints poses a risk to future performance. Remove roots and slip line.

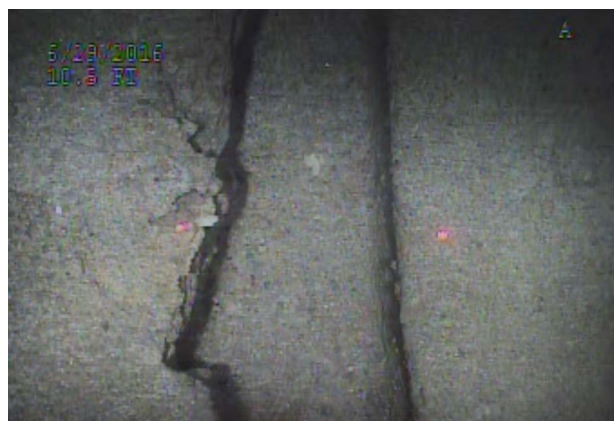
DEFICIENCIES
11' - Joint Offset/Crack > 12"; 15' - Intruding Sealing Grout; 46' - Angular Joint;
52' - Crack > 12"; 63' - Infiltration; 92' - Infiltration; 123' - Intruding Sealing Grout;
140' - Joint Separated > 1"

11' - Joint Offset/Crack > 12"

RECOMMENDATION
Some cracking and infiltration does not appear to affect the performance.
Recommend replacement due to size and structural issues.

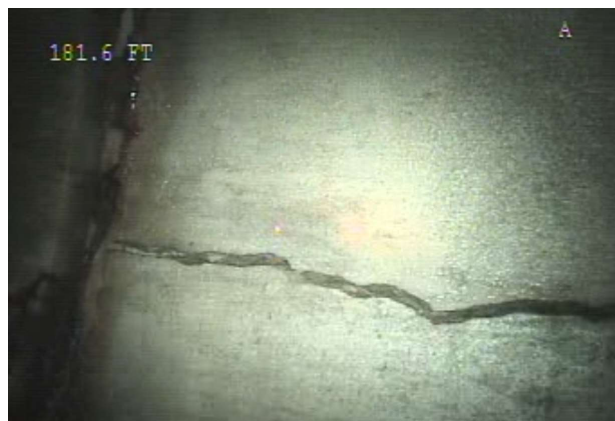
DEFICIENCIES
22' - Crack > 12"/Infiltration; 54' - Crack > 12"/Multidirectional Crack;
54' - Crack > 12"/Multidirectional Crack;
Cracks > 12" - 74', 81', 89', 119', 139', 165', 182', 204';
242' - Pipe collapsed; 243' - pipe collapsed/survey abandoned

182' - Crack > 12"

RECOMMENDATION
Severe cracking along the majority of the length of pipe with infiltration through the cracks. Roots growing through top of pipe. Cracking along bottom of pipe.
Replace pipe.

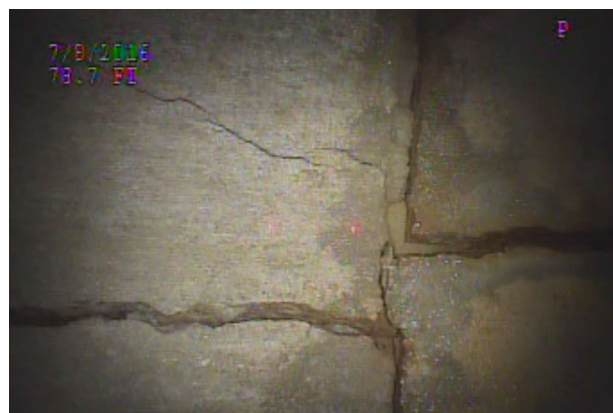
DEFICIENCIES
2' - Root in Joint; Crack > 12" - 21', 78', 174'; 64' - Infiltration;
203' - Joint Separated > 1"; 209' - Joint Separated > 1";

78' - Crack > 12"

RECOMMENDATION
Sediment infiltration due to severe cracking of pipe. Replace pipe.

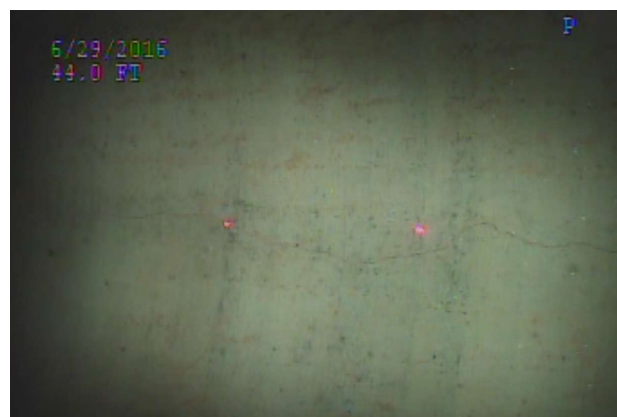
DEFICIENCIES
12' - Intruding Sealing Grout; 44' - Crack > 12";
Angular Joints - 76', 87'
Angular Joints - 76', 87'

44' - Crack > 12"

RECOMMENDATION
Crack at 44' extends the entire length of the pipe segment, located under the right lane of I-85 NB. No apparent infiltration. Remainder of pipe is in good condition. Retain.

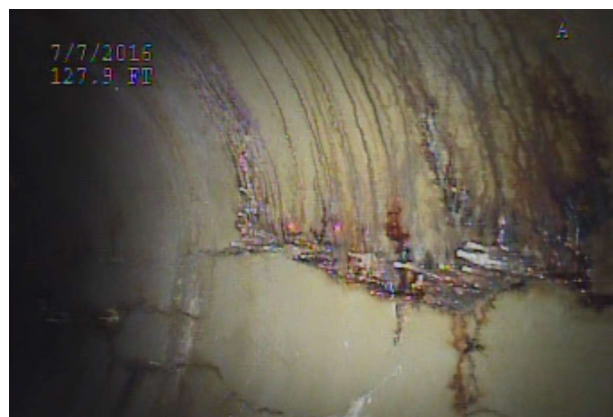
DEFICIENCIES
Cracks > 12" - 13', 22', 42', 86', 148', 208';
22' - Infiltration; 86' - Structural Deformation; 128' - Infiltration;
208' - Infiltration

128' - Crack > 12"

RECOMMENDATION
Sediment infiltration due to severe cracking of pipe. Replace pipe.

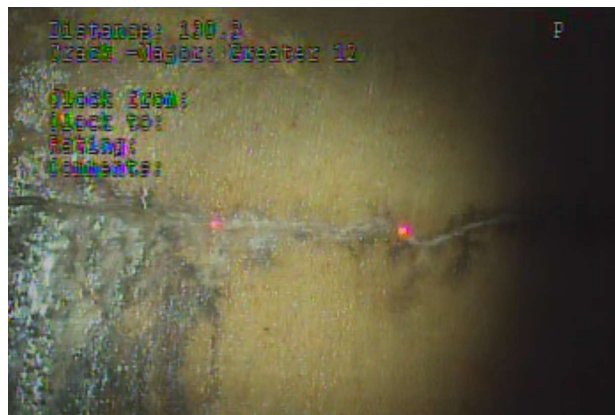
DEFICIENCIES
4' - Joint Separated > 1"; 49' - Chip; 102' - Crack in pipe; 107' - Crack in 12";
115' - Infiltration; 130' - Crack > 12"; 151' - Broken; 156' - Angular Joint;
162' - Joint Separated > 1"; 169.3' - Joint Offset (survey abandoned)

130' - Crack > 12"

RECOMMENDATION
Replace pipe due to excessive infiltration and cracking.

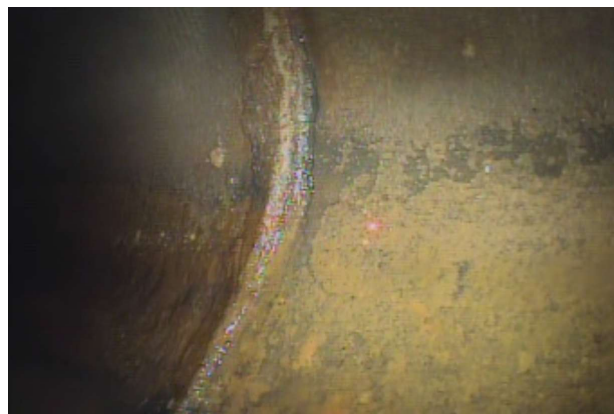
DEFICIENCIES
15' - Intruding Sealing Grout;
57' - Joint Offset

57' - Joint Offset

RECOMMENDATION
Obstruction in pipe from median catch basin. No apparent issues with joint offset. Recommend debris removal and retain.

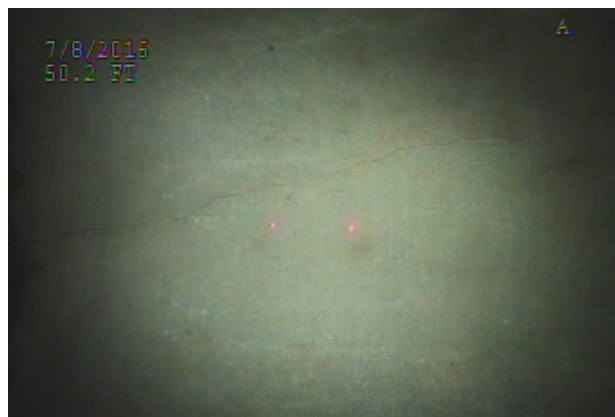
DEFICIENCIES
<u>36' - Crack > 12";</u>
<u>50' - Multidirectional Crack</u>
<u>Cracking occurs under the pavement.</u>

50' - Multidirectional Crack

RECOMMENDATION
<u>The cracking occurs in several locations around the circumference of the pipe.</u>
<u>Recommend replacing pipe under the ramp.</u>

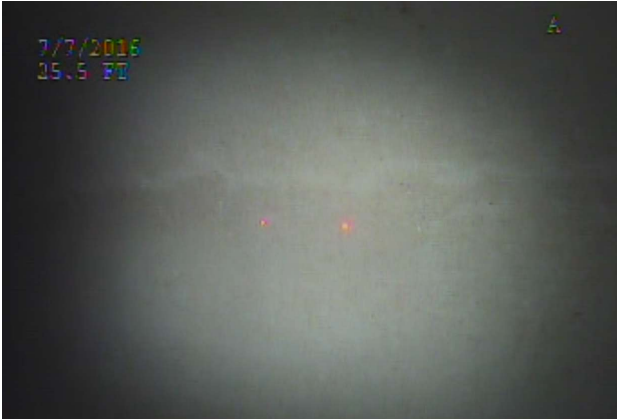
<u>DEFICIENCIES</u>
25.5' - Crack > 12"; 47.5' - Multidirectional Crack; 160'-Joint offset/Gasket exposed. Pipe is full of sediment on downstream end.

25.5' - Crack > 12"

<u>RECOMMENDATION</u>
Sediment infiltration likely from exposed gasket. Clean pipe and repair gasket.
Pipe is in good condition under I-85. Exposed gasket in I-85 NB shoulder.

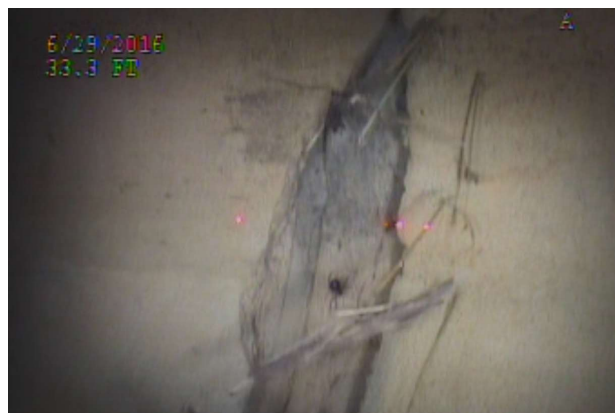
DEFICIENCIES
33' - Chip on top of the pipe;
66' - Intruding Sealing Grout

33' - Chip

RECOMMENDATION
No debris accumulation or apparent issues affecting hydraulics. Retain.

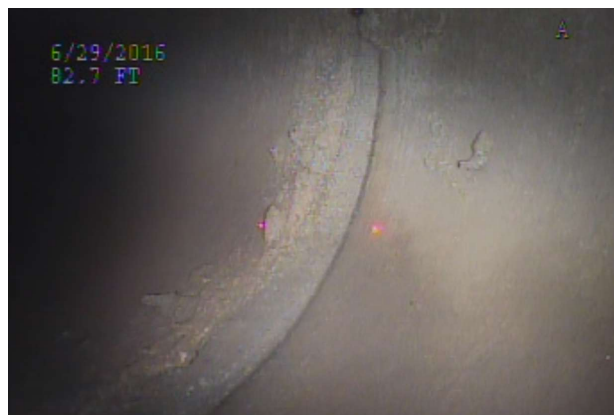
DEFICIENCIES	
65' - Joint Offset;	
83' - Joint Offset;	
139' - Joint Offset

83' - Joint Offset;

RECOMMENDATION	
Video shows multiple joint offsets however pipe appears to function without issues. No evidence of root intrusion or infiltration. Retain.

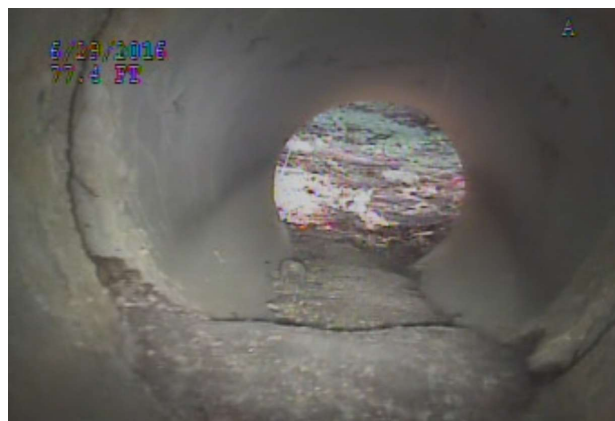
DEFICIENCIES
6.7' - Intruding Sealing Grout;
79' - Joint Offset

79' - Joint Offset

RECOMMENDATION
Recommend replacement of last segment of pipe along I-85 NB shoulder due to joint separation.

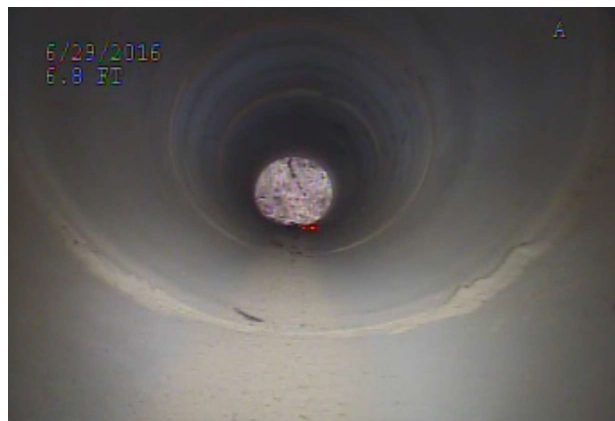
DEFICIENCIES
There were no deficiencies observed during the inspection.

Pipe is in good condition

RECOMMENDATION
Pipe is in good condition. Retain.

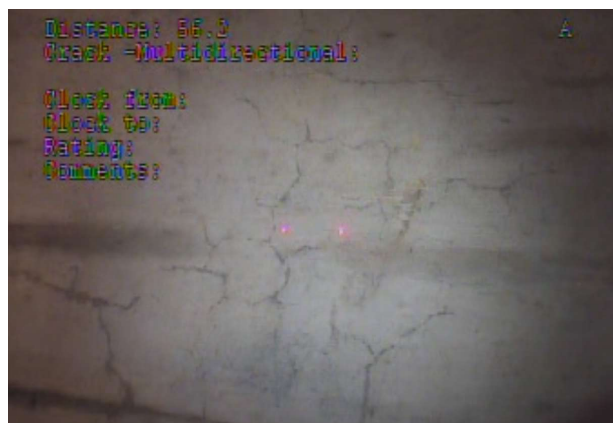
DEFICIENCIES
55' - Joint Separated > 1"/Multidirectional Crack

55' - Multidirectional Crack

RECOMMENDATION
Pipe is good condition for most of its length. Cracking and joint offset occur in last segment in median of I-85. Recommend replacement of last segment of pipe in median and reconnect to median drainage.

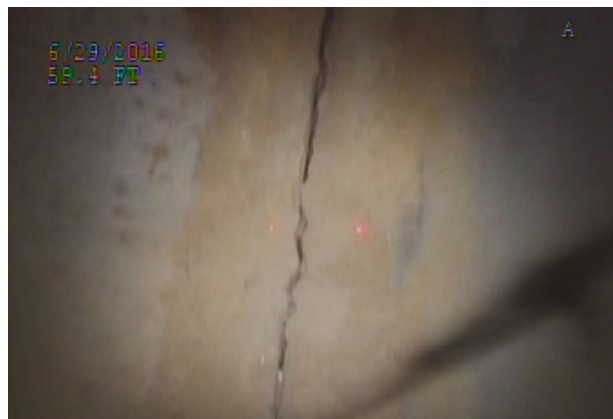
DEFICIENCIES
59' from beginning of inspection - Joint Offset

59' - Joint Offset

RECOMMENDATION
Based on the location of the joint offset and size of the pipe. Recommend retaining pipe and repair joint offset with grout.
