Video Pipe Inspection Report

I-85 Widening Phase III – Cherokee County
From MM 98 to MM 106

Cherokee County, South Carolina
February 24, 2017

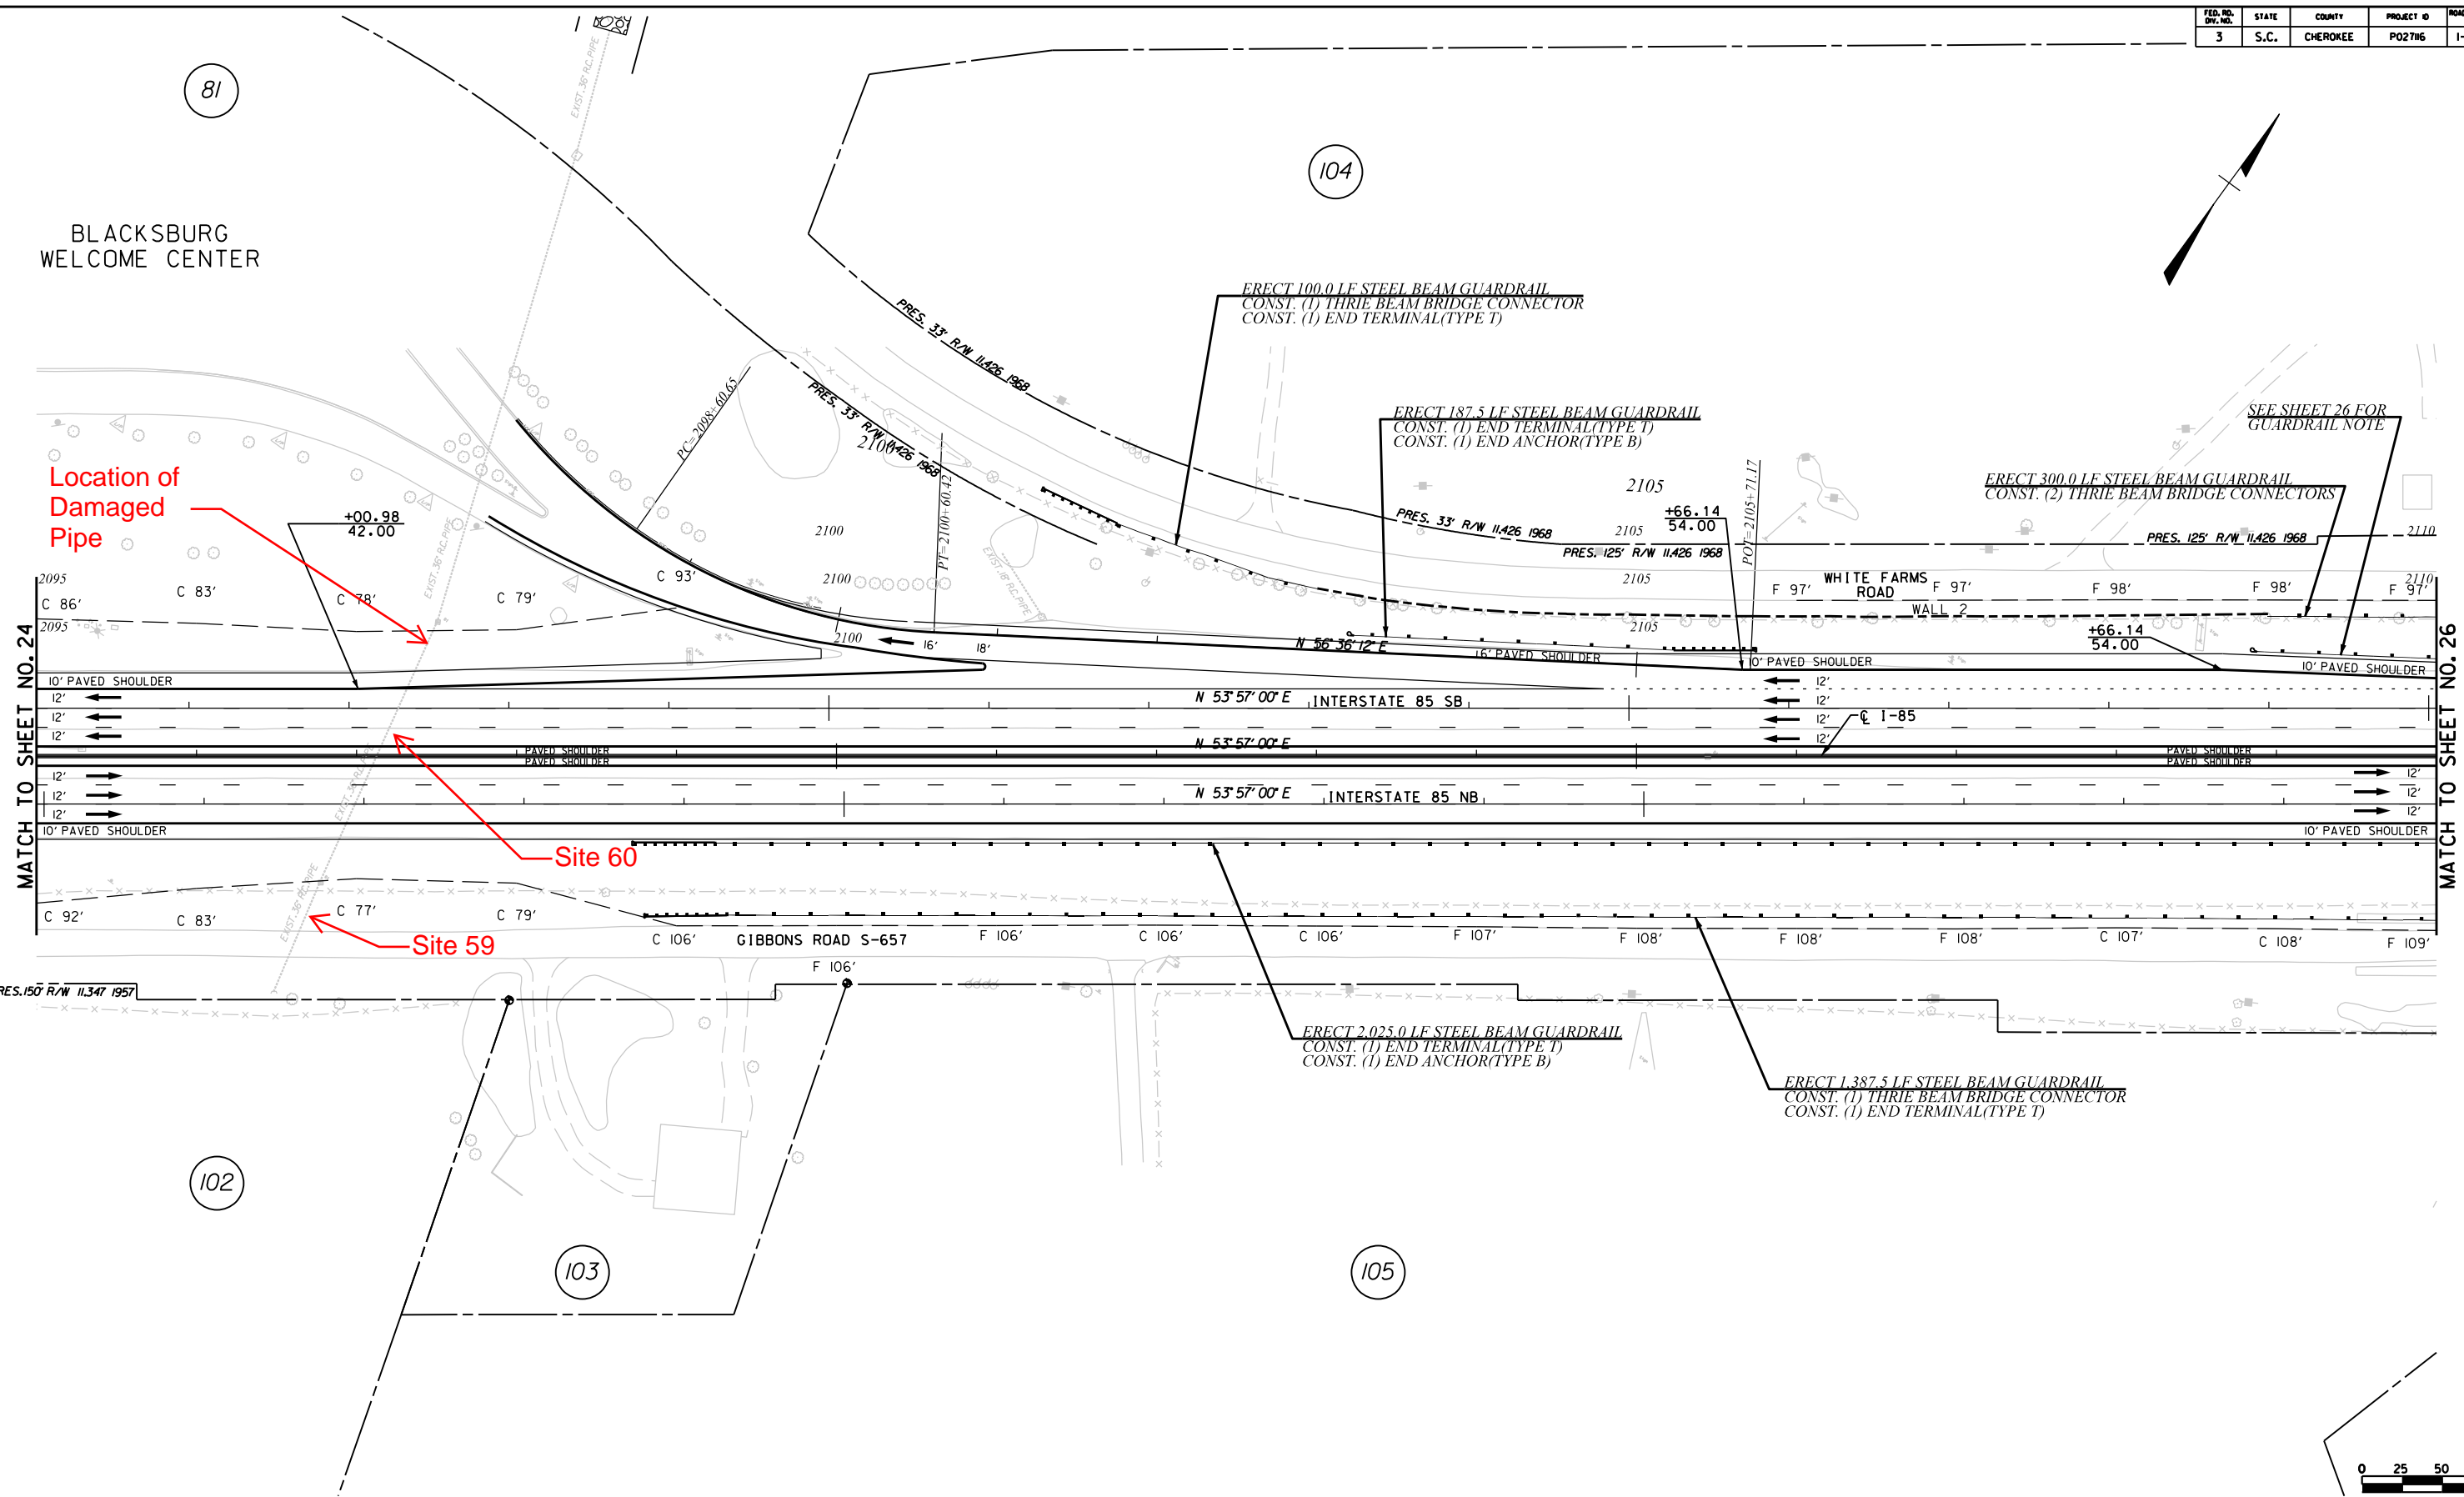
Location of
Damaged
Pipe

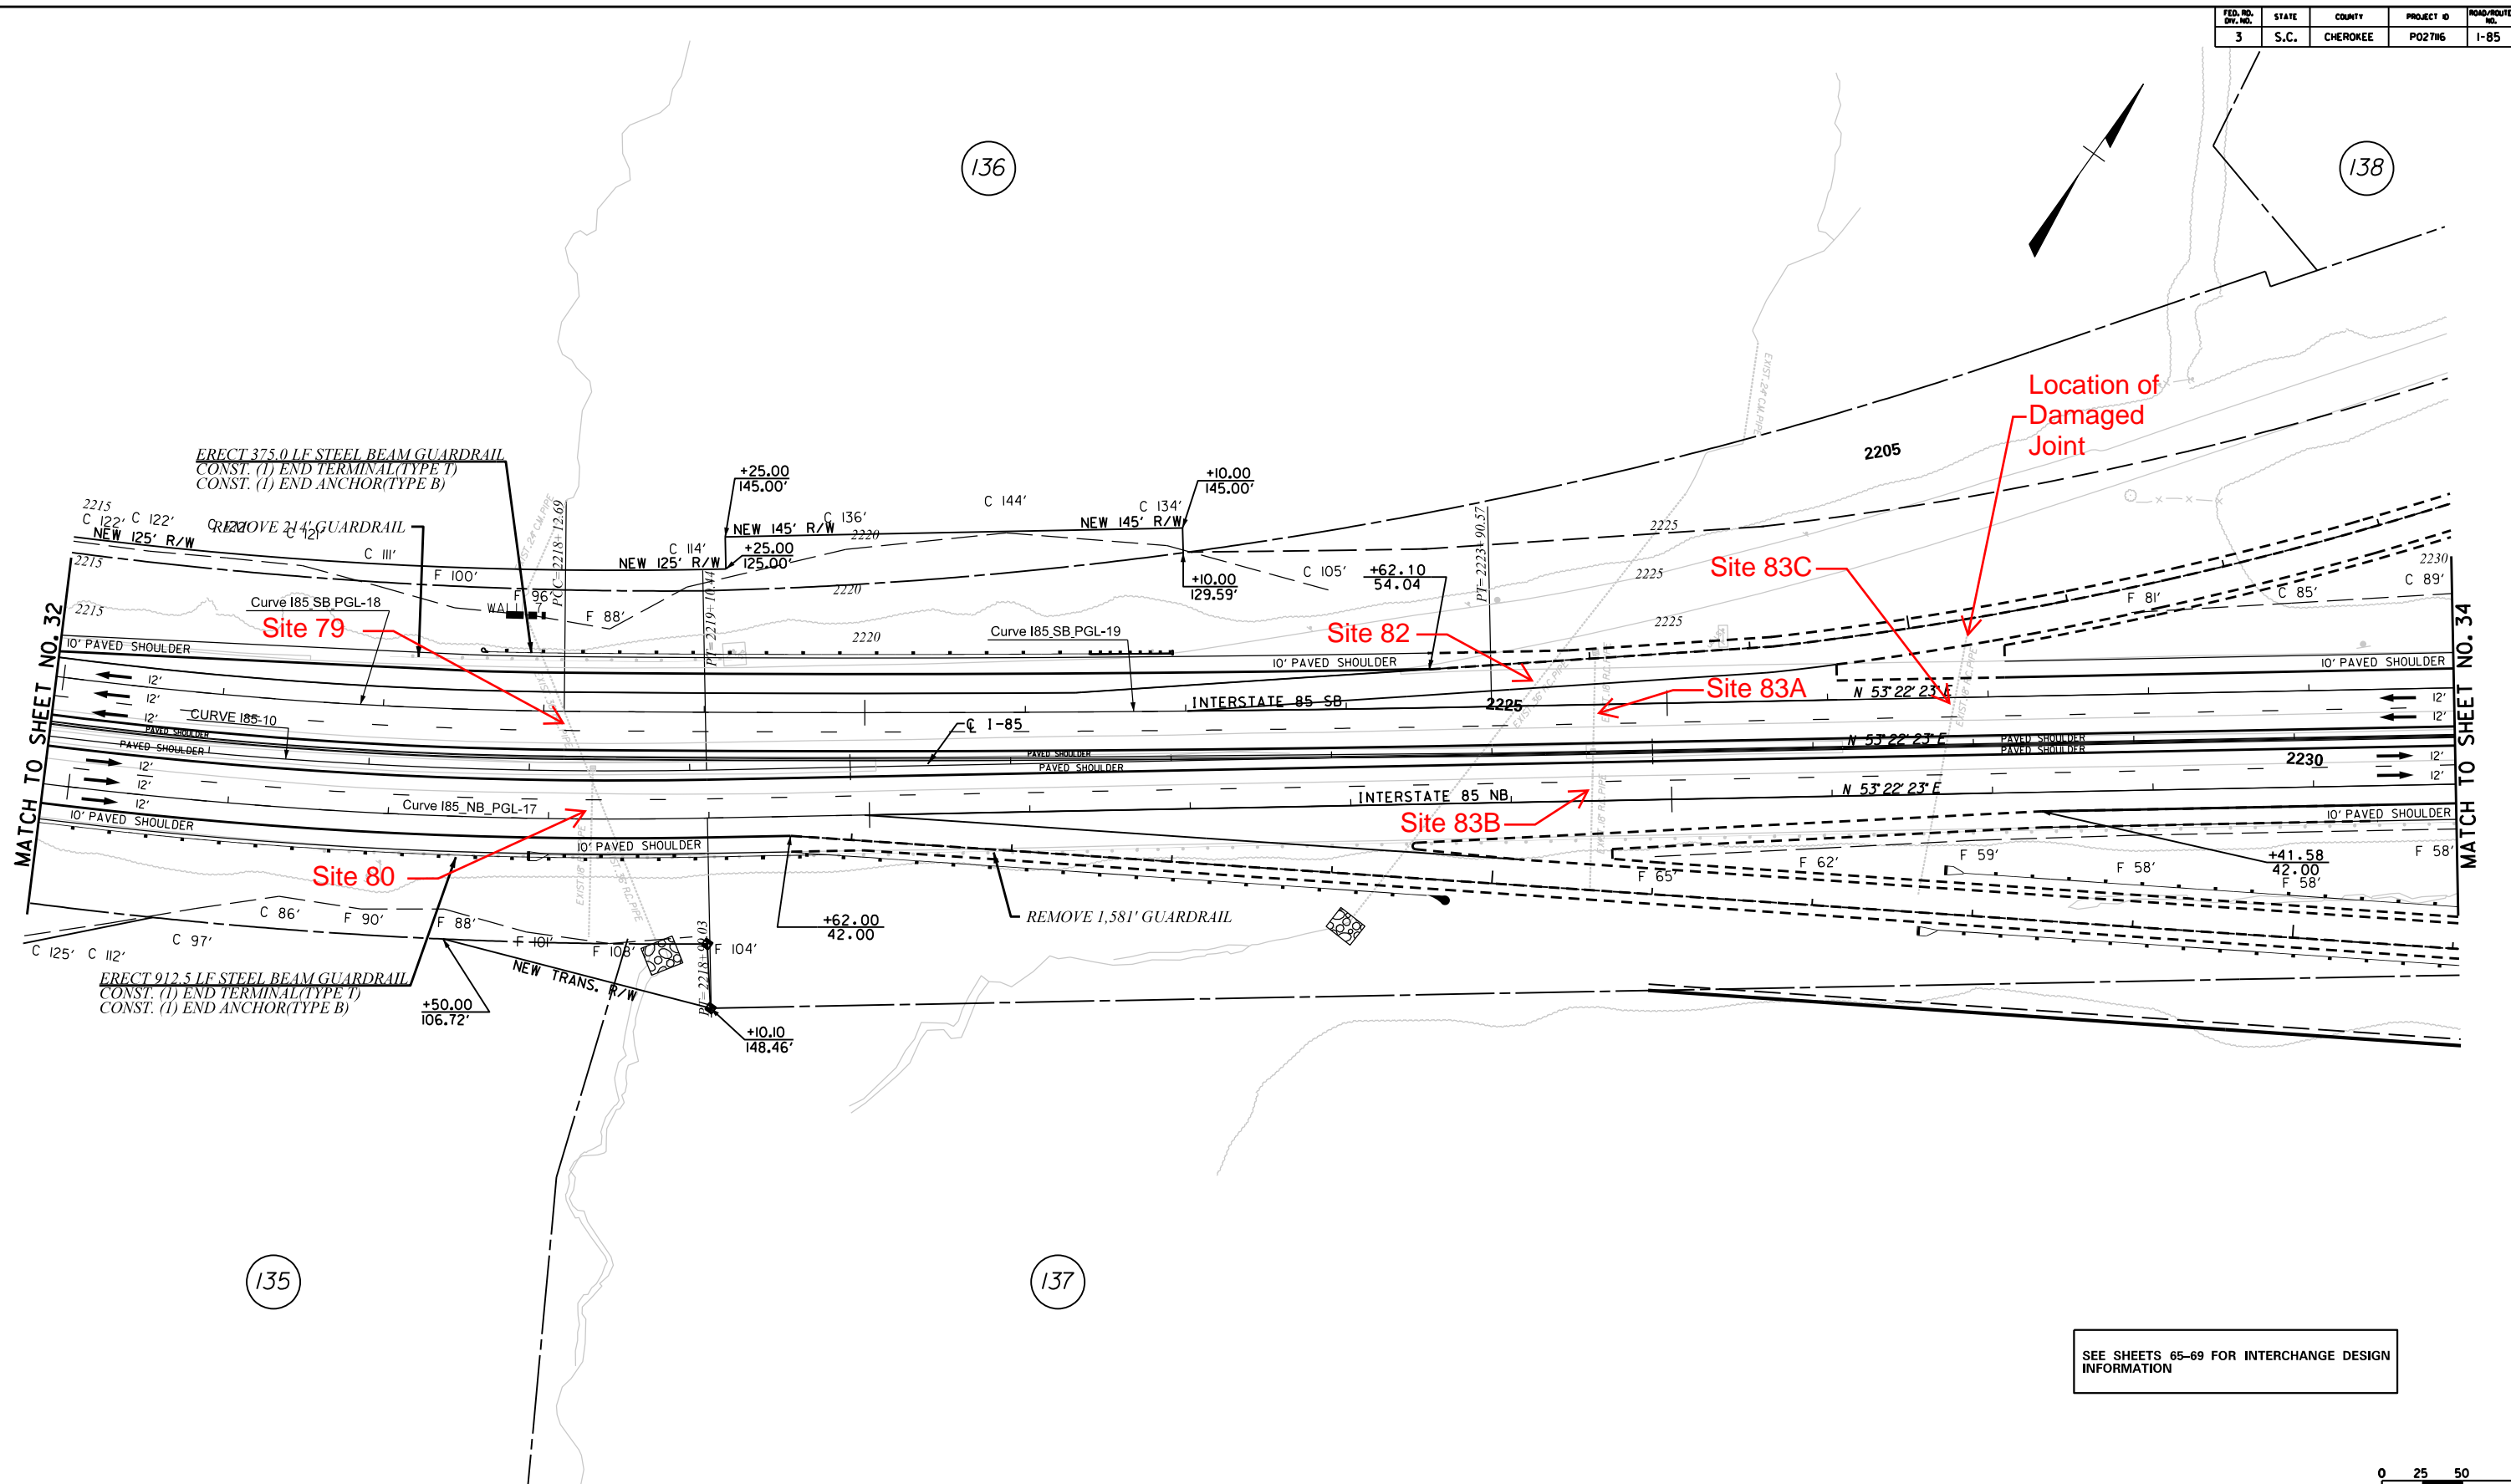
Location of Damaged Joint
