Reference: **Asbestos and Lead-Based Paint Assessment Report
I-526 at Long Point Road – Bridge 08326**
Mount Pleasant, South Carolina
S&ME Project No. 200424A

**Asbestos and Lead-Based Paint Assessment Report
I-526 at S-97 Long Point Road – Bridge 08326
Mount Pleasant, South Carolina
S&ME Project No. 200424A**

Inspection Dates: April 7, 2023 & May 7, 2023

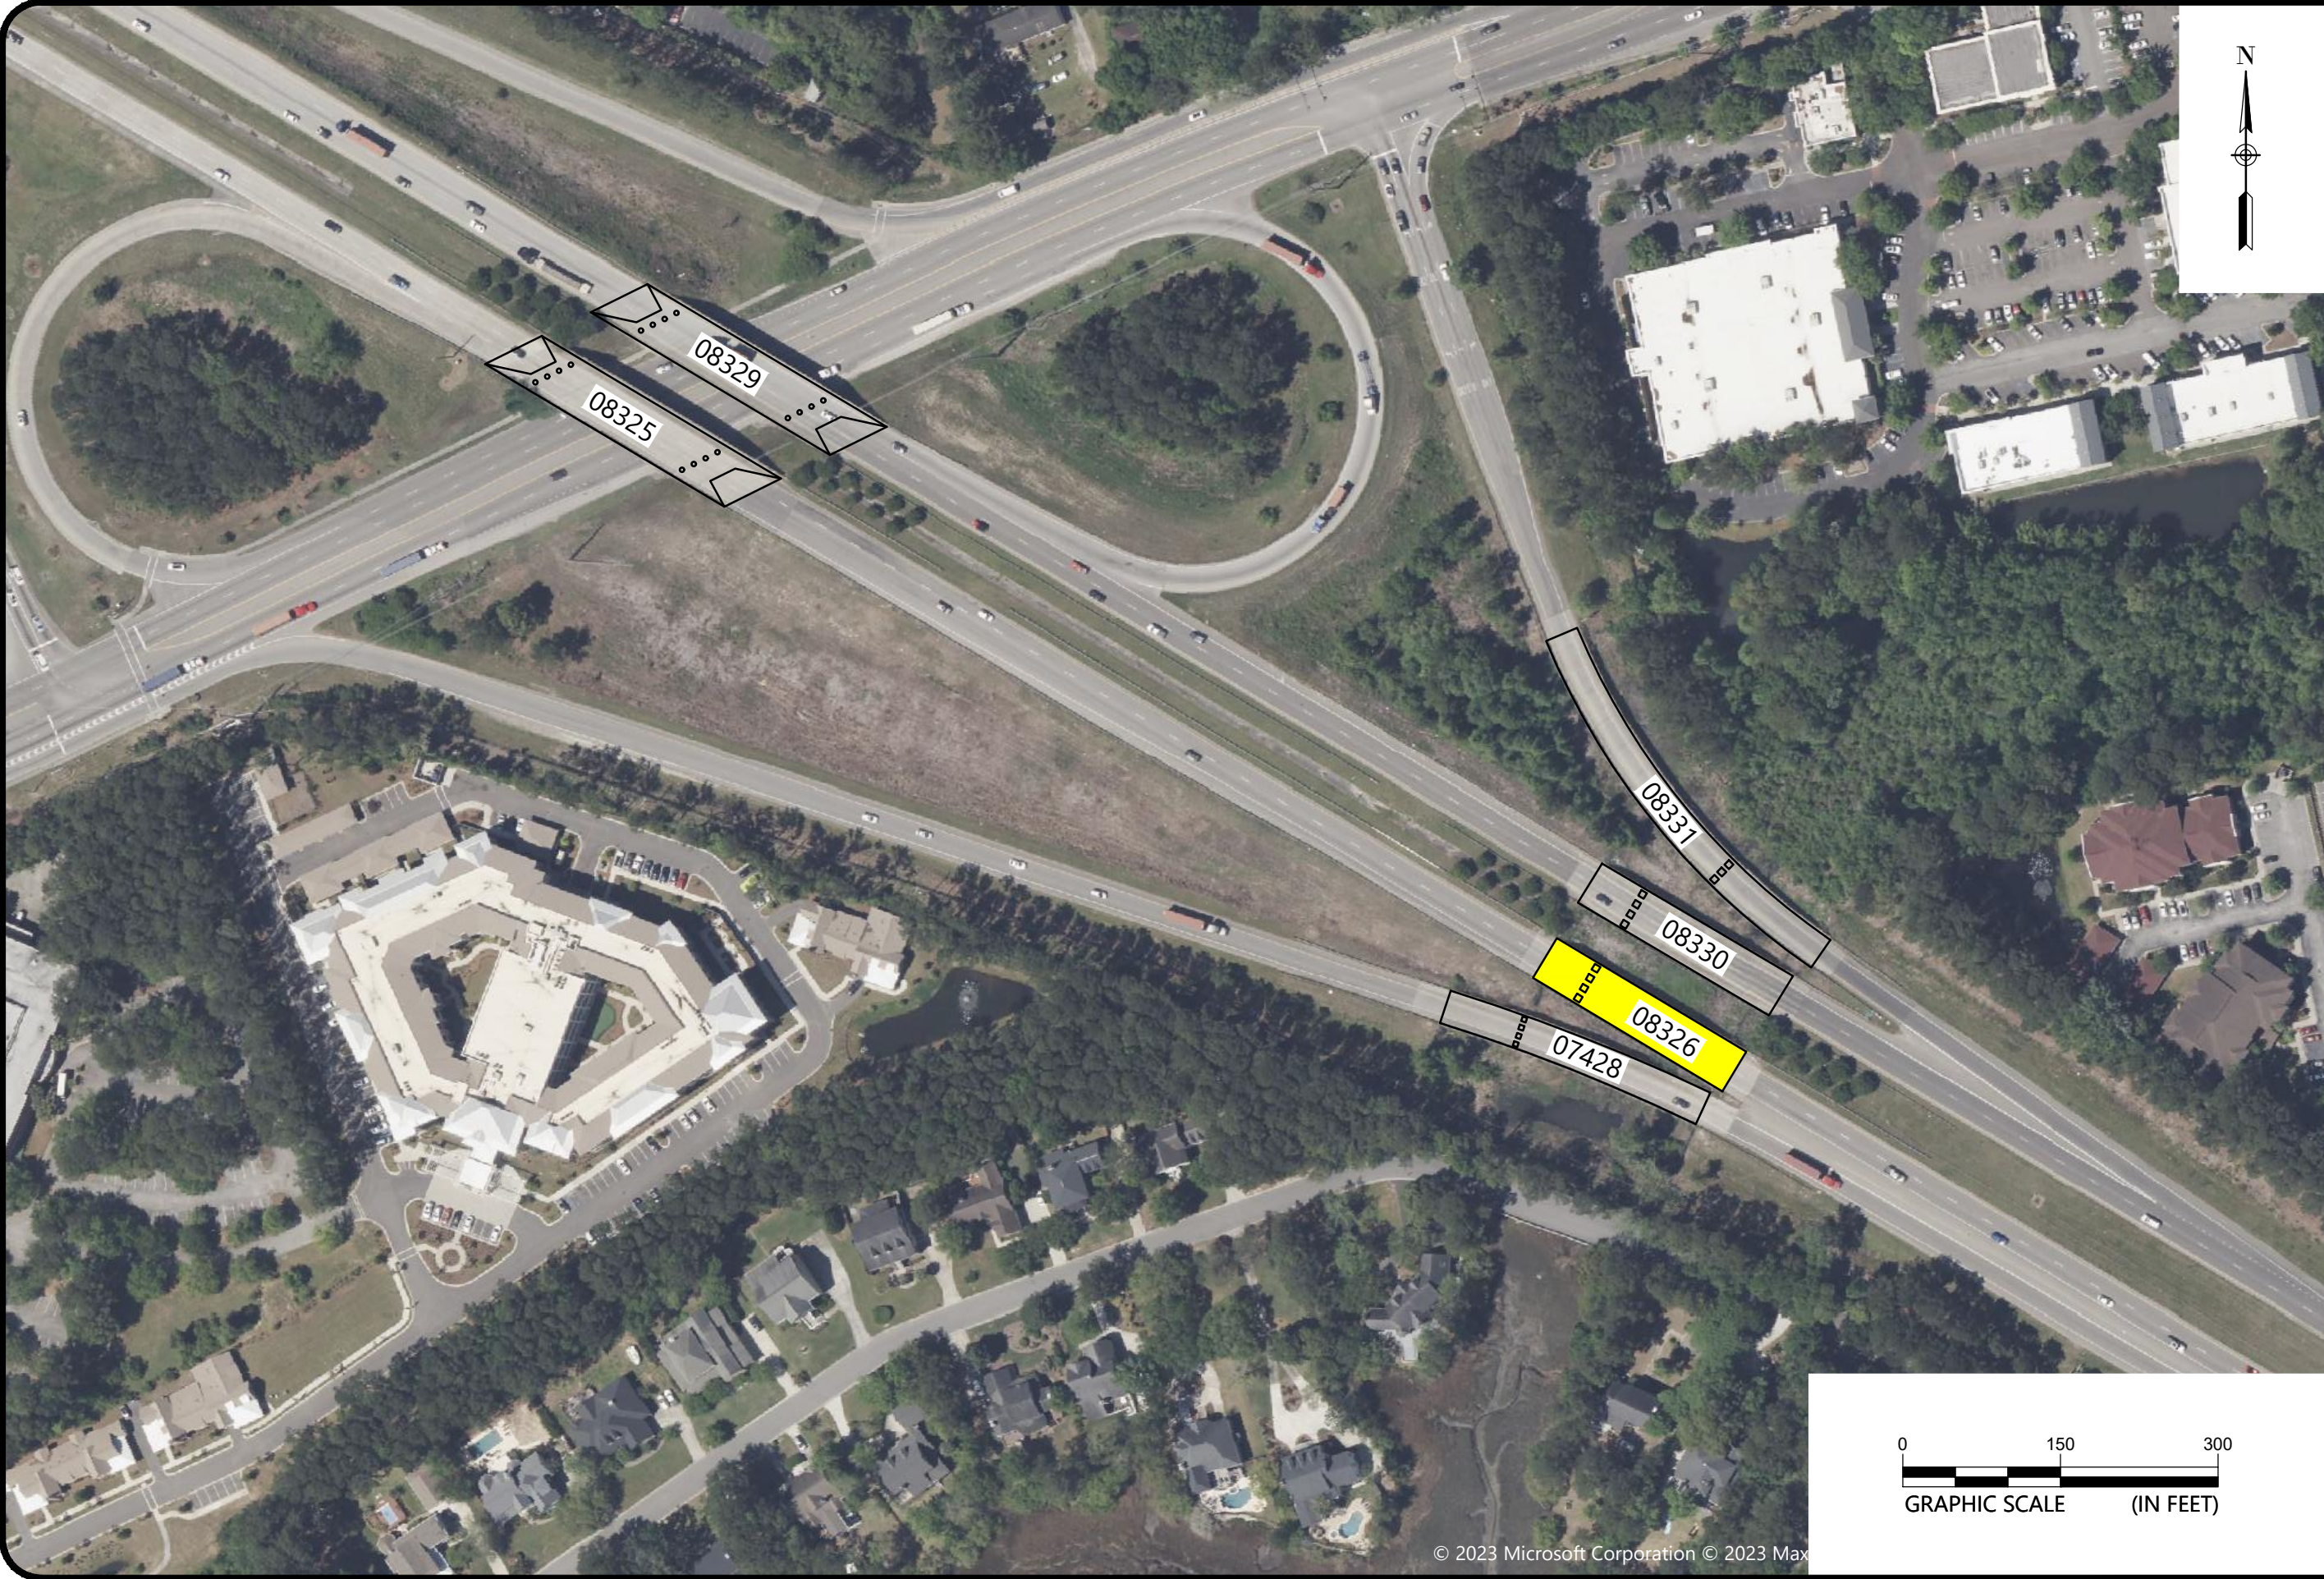
ASBESTOS AND LEAD-BASED PAINT ASSESSMENT	
BRIDGE #08326 1-526 BRIDGES AND RAMPS MOUNT PLEASANT, SOUTH CAROLINA	
SCALE: AS SHOWN	
DATE: 5-25-2023	
PROJECT NUMBER 200424A	
FIGURE NO. 1

Appendix II – Diagram of Bulk Sample Locations
