Reference: **Asbestos and Lead-Based Paint Assessment Report
I-526 at Long Point Road – Bridge 08329**
Mount Pleasant, South Carolina
S&ME Project No. 200424A

**Asbestos and Lead-Based Paint Assessment Report
I-526 at S-97 Long Point Road – Bridge 08329
Mount Pleasant, South Carolina
S&ME Project No. 200424A**

Inspection Dates: April 7, 2023 & May 7, 2023

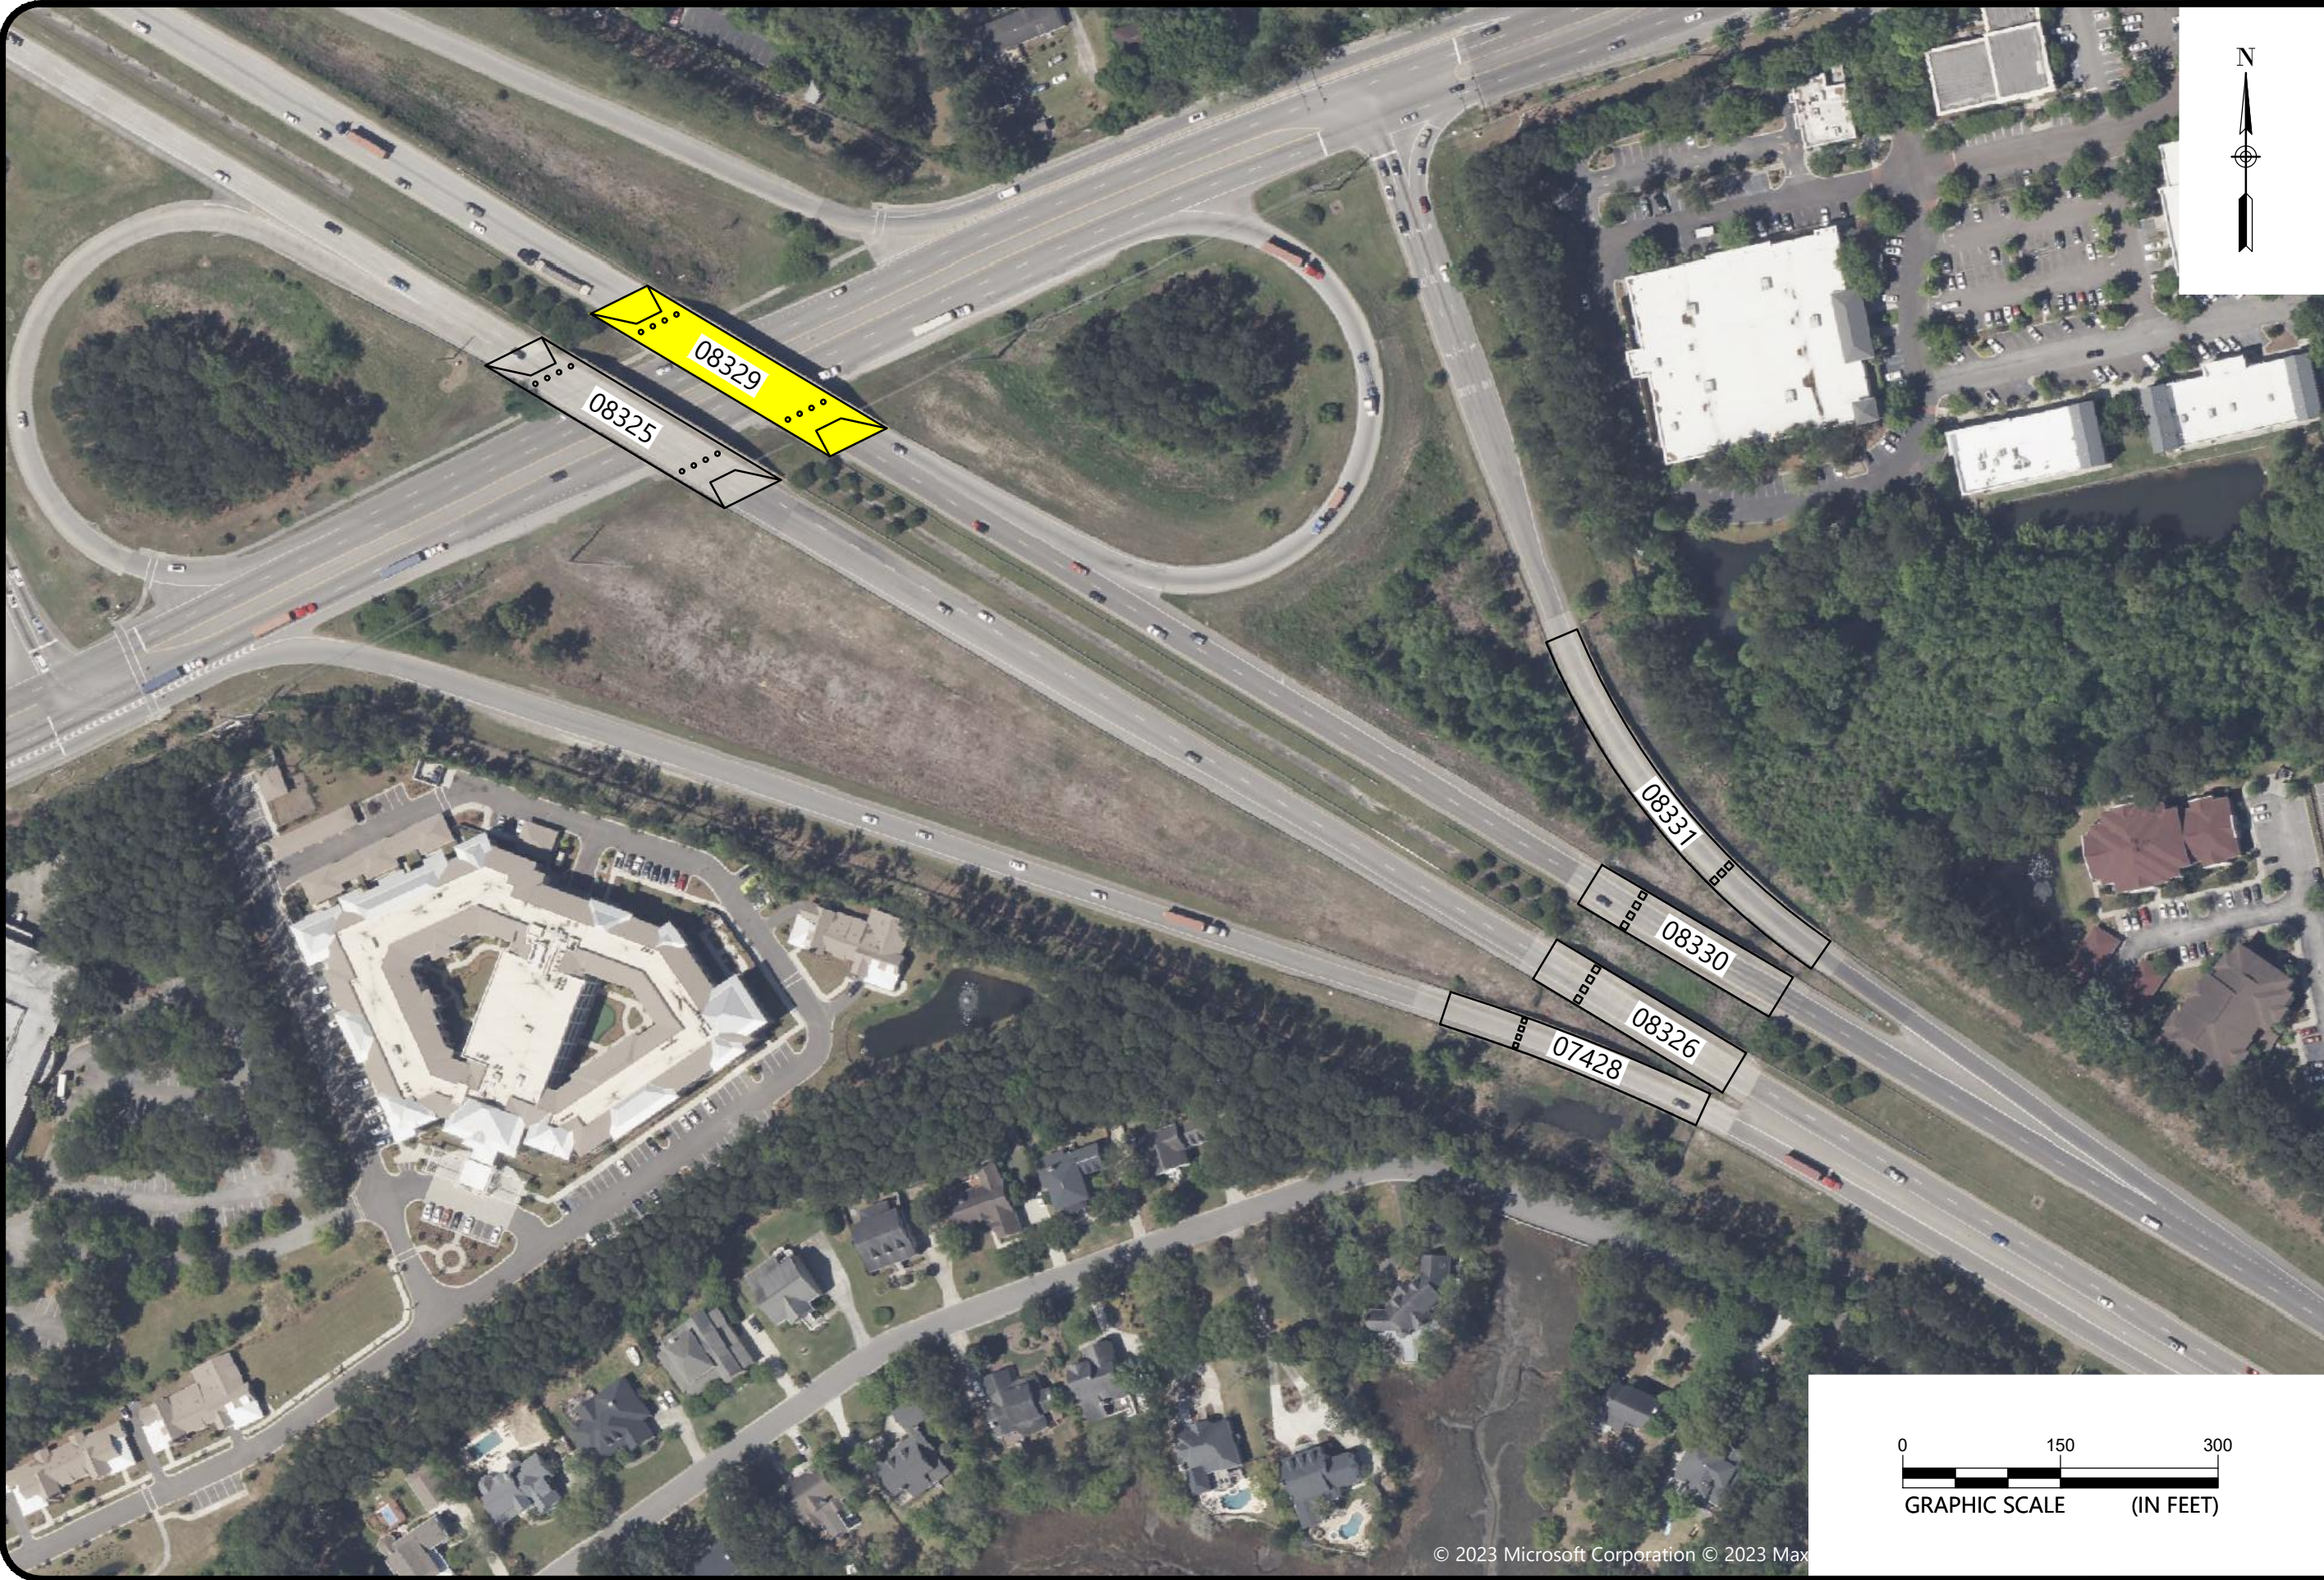
Appendix II – Diagram of Bulk Sample Locations and Confirmed ACMs

Material	HA	Location	Asbestos Type	Percent	Condition	Potential for Disturbance	¹ Approx. Quantity
Caulk/Sealant (black) associated with Bridge Columns at Sidewalk/Footer	CL	Base of Support Columns	Chrysotile	4	G, NF	PSD	72 LF
