BASIS OF DESIGN EXCEPTION

County: Spartanburg & Cherokee Rd./Route: Interstate 85 Const. Pin: P027114

Work Type: Widening and pavement reconstruction

**Prepared for:
South Carolina Department of Transportation**

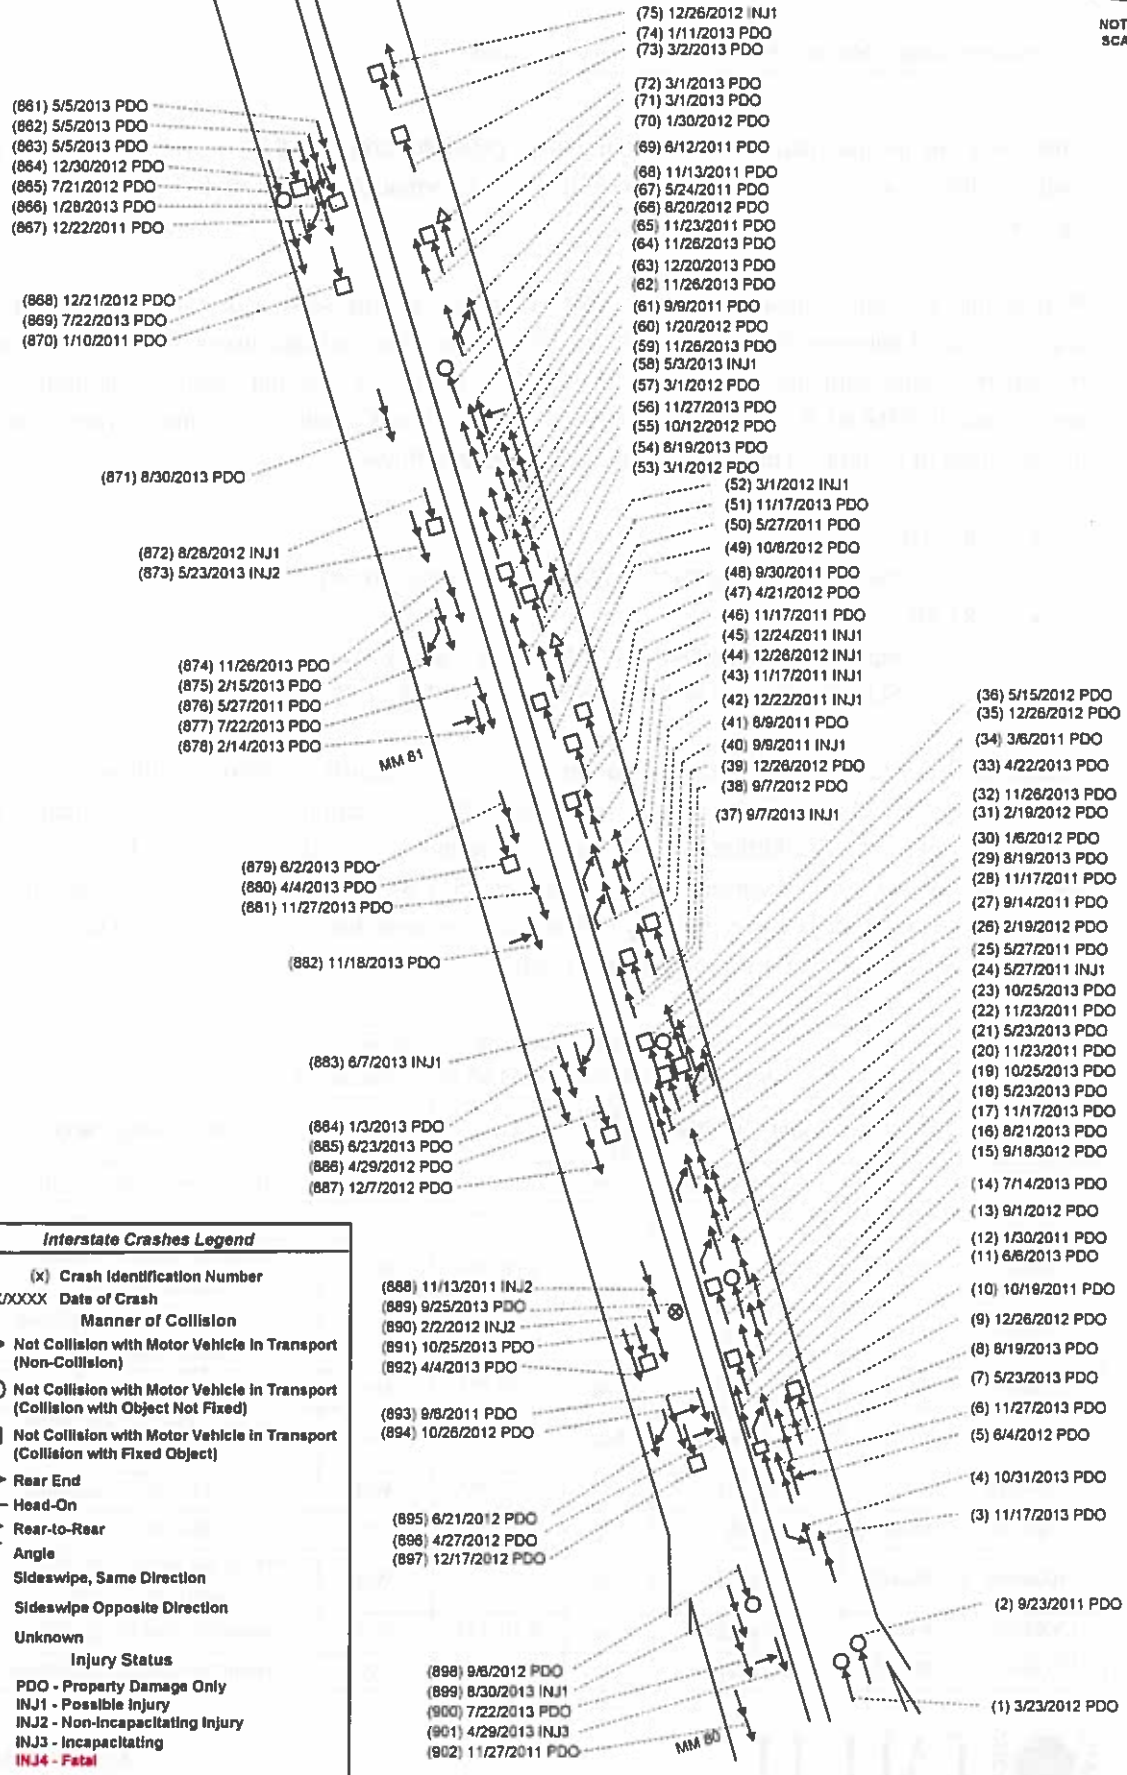
I-85 has two travel lanes in each direction in this segment with vertical curves noted in the vicinity of the following locations: MM 80.4, MM 80.7, and MM 81.0. This segment is approximately 1.5 miles long. The I-85 crash data for this segment are shown Figure 2.

There was one incapacitating accident southbound (MM 80.058) on I-85 that was classified as an angle collision on a dry pavement. No additional information was available as to mitigating factors.

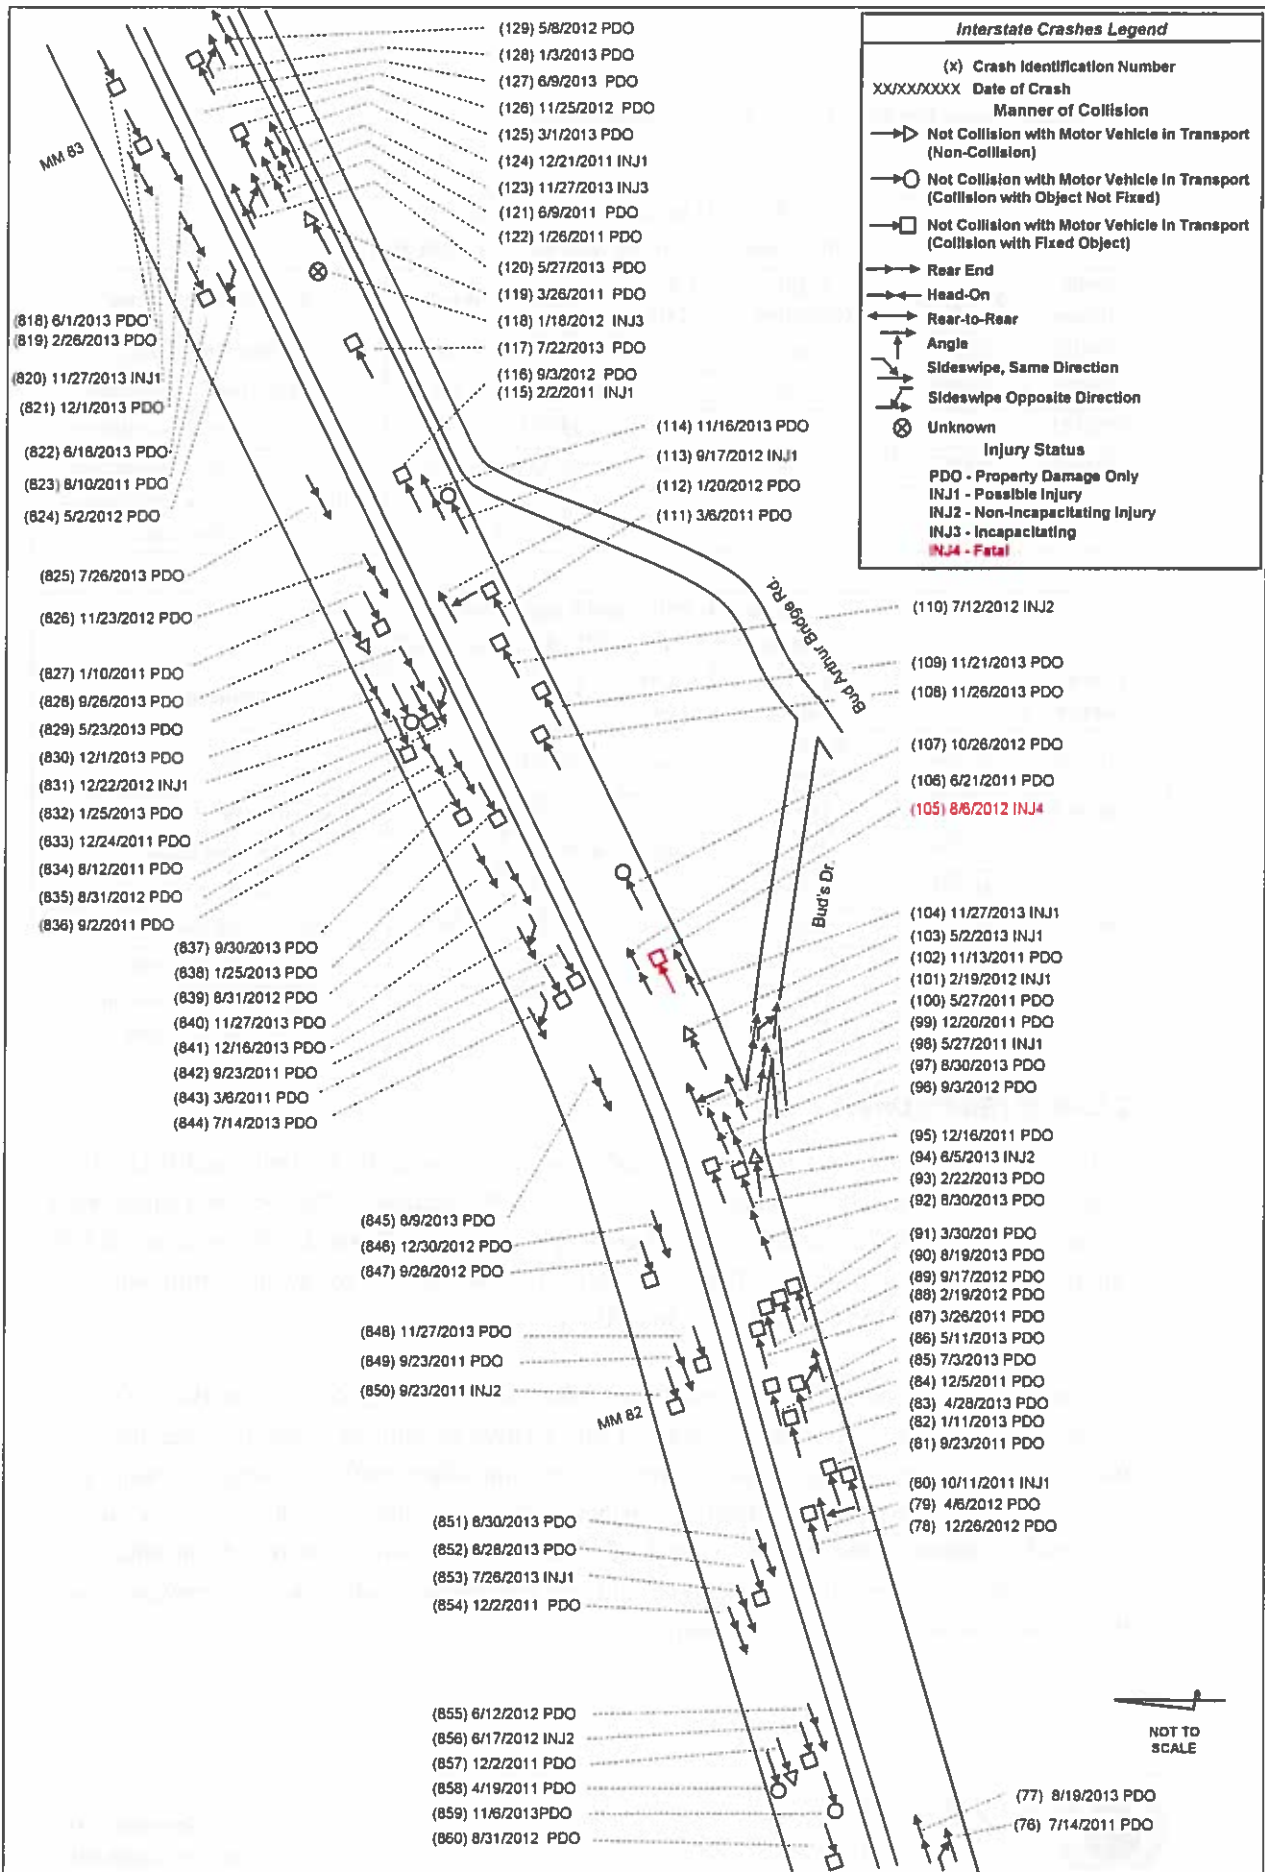
Figure
3

I-85 Exit 82 is a northbound only off-ramp and provides access to Bud's Drive and Bud Arthur Bridge Road approximately 1.2 miles south of the Exit 83 overpass. The I-85 and other study area road crash data for the vicinity of this interchange are shown **Figure 3**. This segment of I-85 is approximately 1.5 miles long. There are vertical curves at the following northbound and southbound locations: MM 82, MM 82.2, and MM 83.

Bud's Drive is a slip road from I-85 northbound to Bud Arthur Bridge Road where Bud's Drive is stop controlled. There were three accidents on Bud's Drive as vehicles exited the interstate (two rear-end and one angle). The unusual ramp design with other traffic crossing the ramp as it merges with Bud's Drive was a likely contributing factor to these accidents. There are 26 northbound accidents in the vicinity of Bud's Drive: 14 were collisions with a fixed object, six were rear end, two were angle collisions, and the remaining crashes were sideswipes, non-collision, or collision with object not fixed.

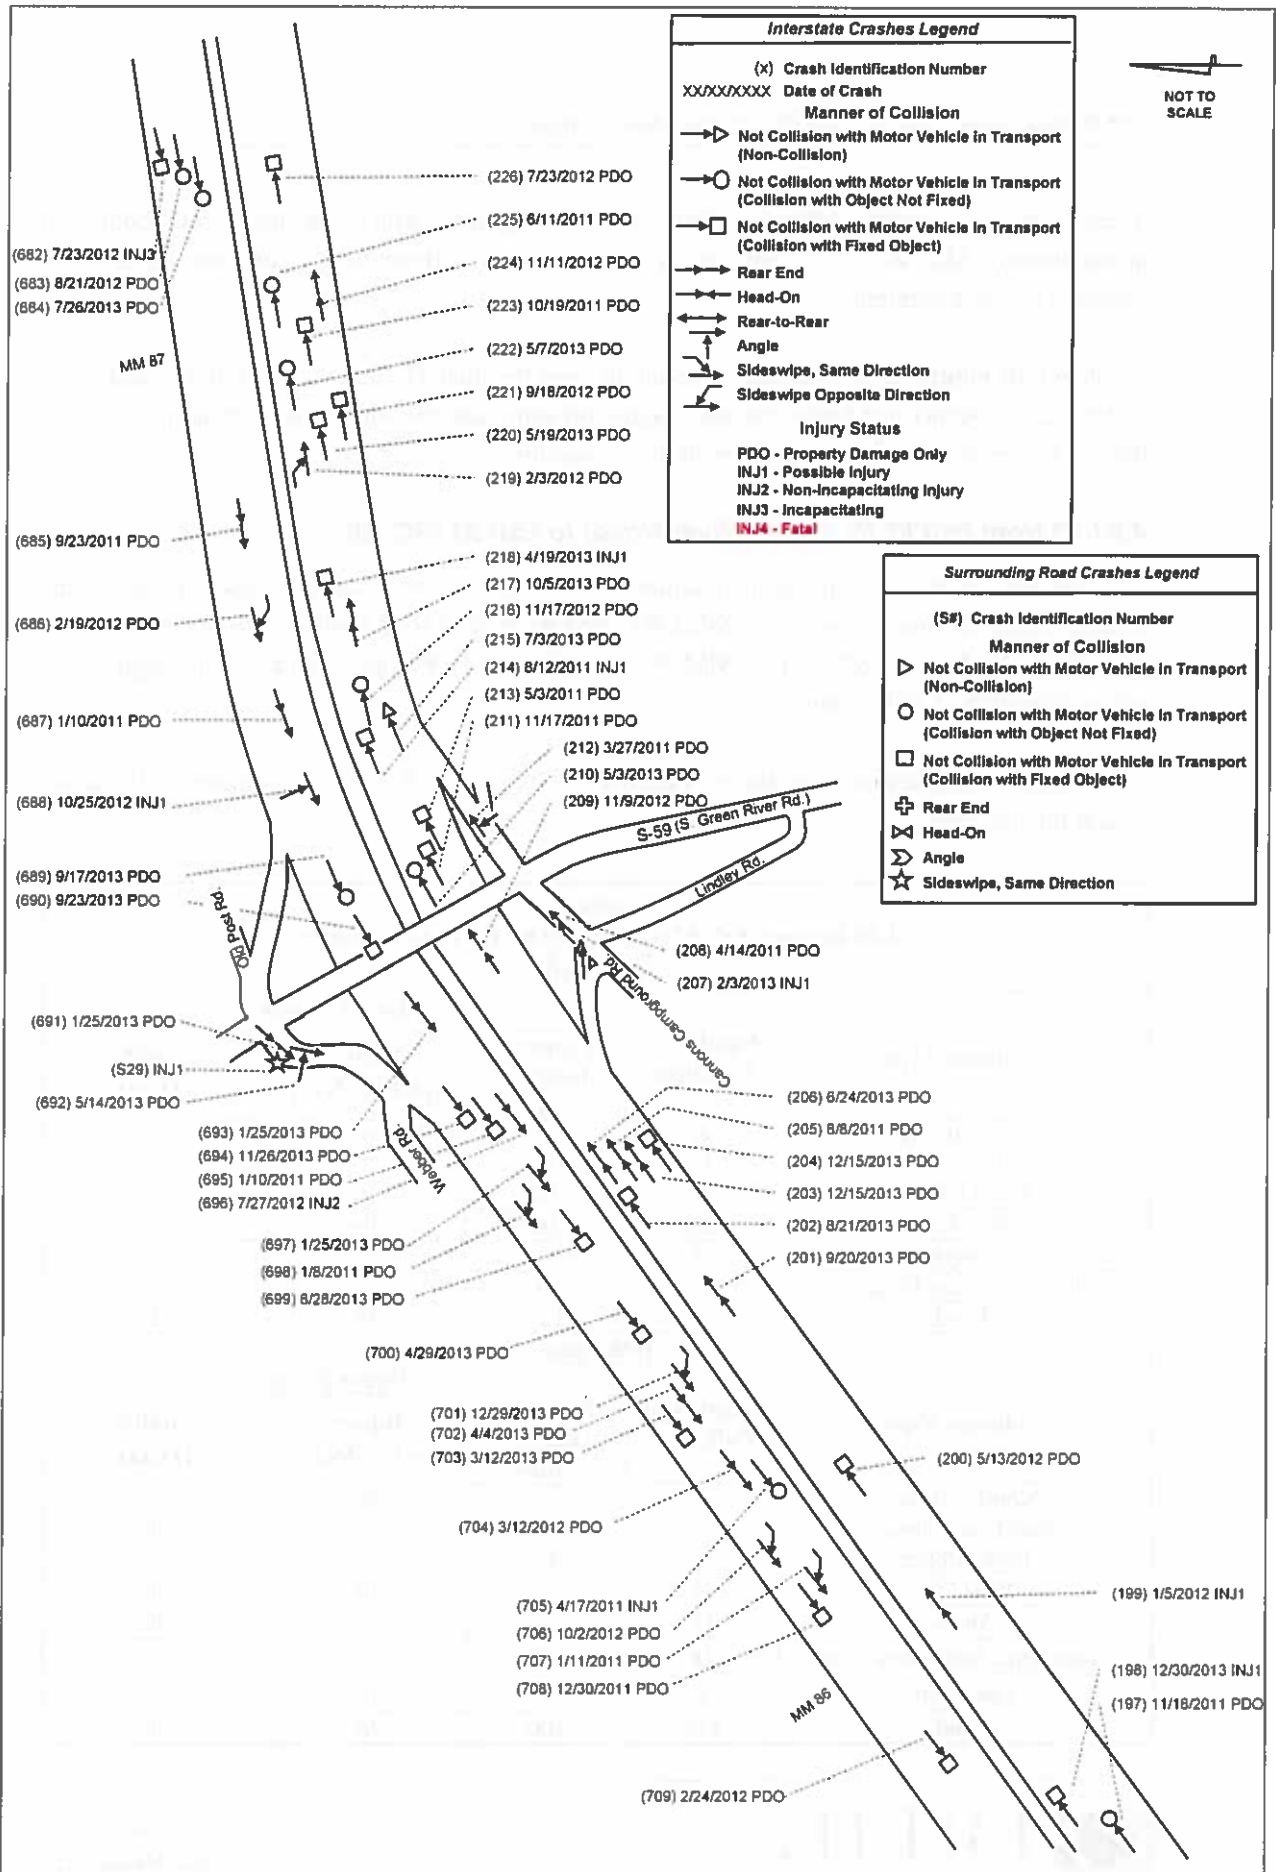
I-85 Exit 87 provides access to S. Green River Road via Cannons Campground and Lindley Road for northbound traffic and via Webber Road and S-665 for southbound traffic. The crash data for this interchange are shown in Figure 6. This segment of I-85 is approximately 1.25 miles long. There are vertical curves at MM 86.1 (northbound and southbound) and MMs 86.4, 86.7, and 87.1 (southbound).

There was one incapacitating accident in this segment which occurred southbound at approximately MM 87.112. This was a collision with a fixed object (median barrier) and occurred on dry pavement.

As shown in **Figure 6**, the number of accidents near the interstate ramps was not atypical. The vertical curve occurs just before the northbound off-ramp and the southbound on-ramp; however, there is no apparent increase in crashes at these locations.

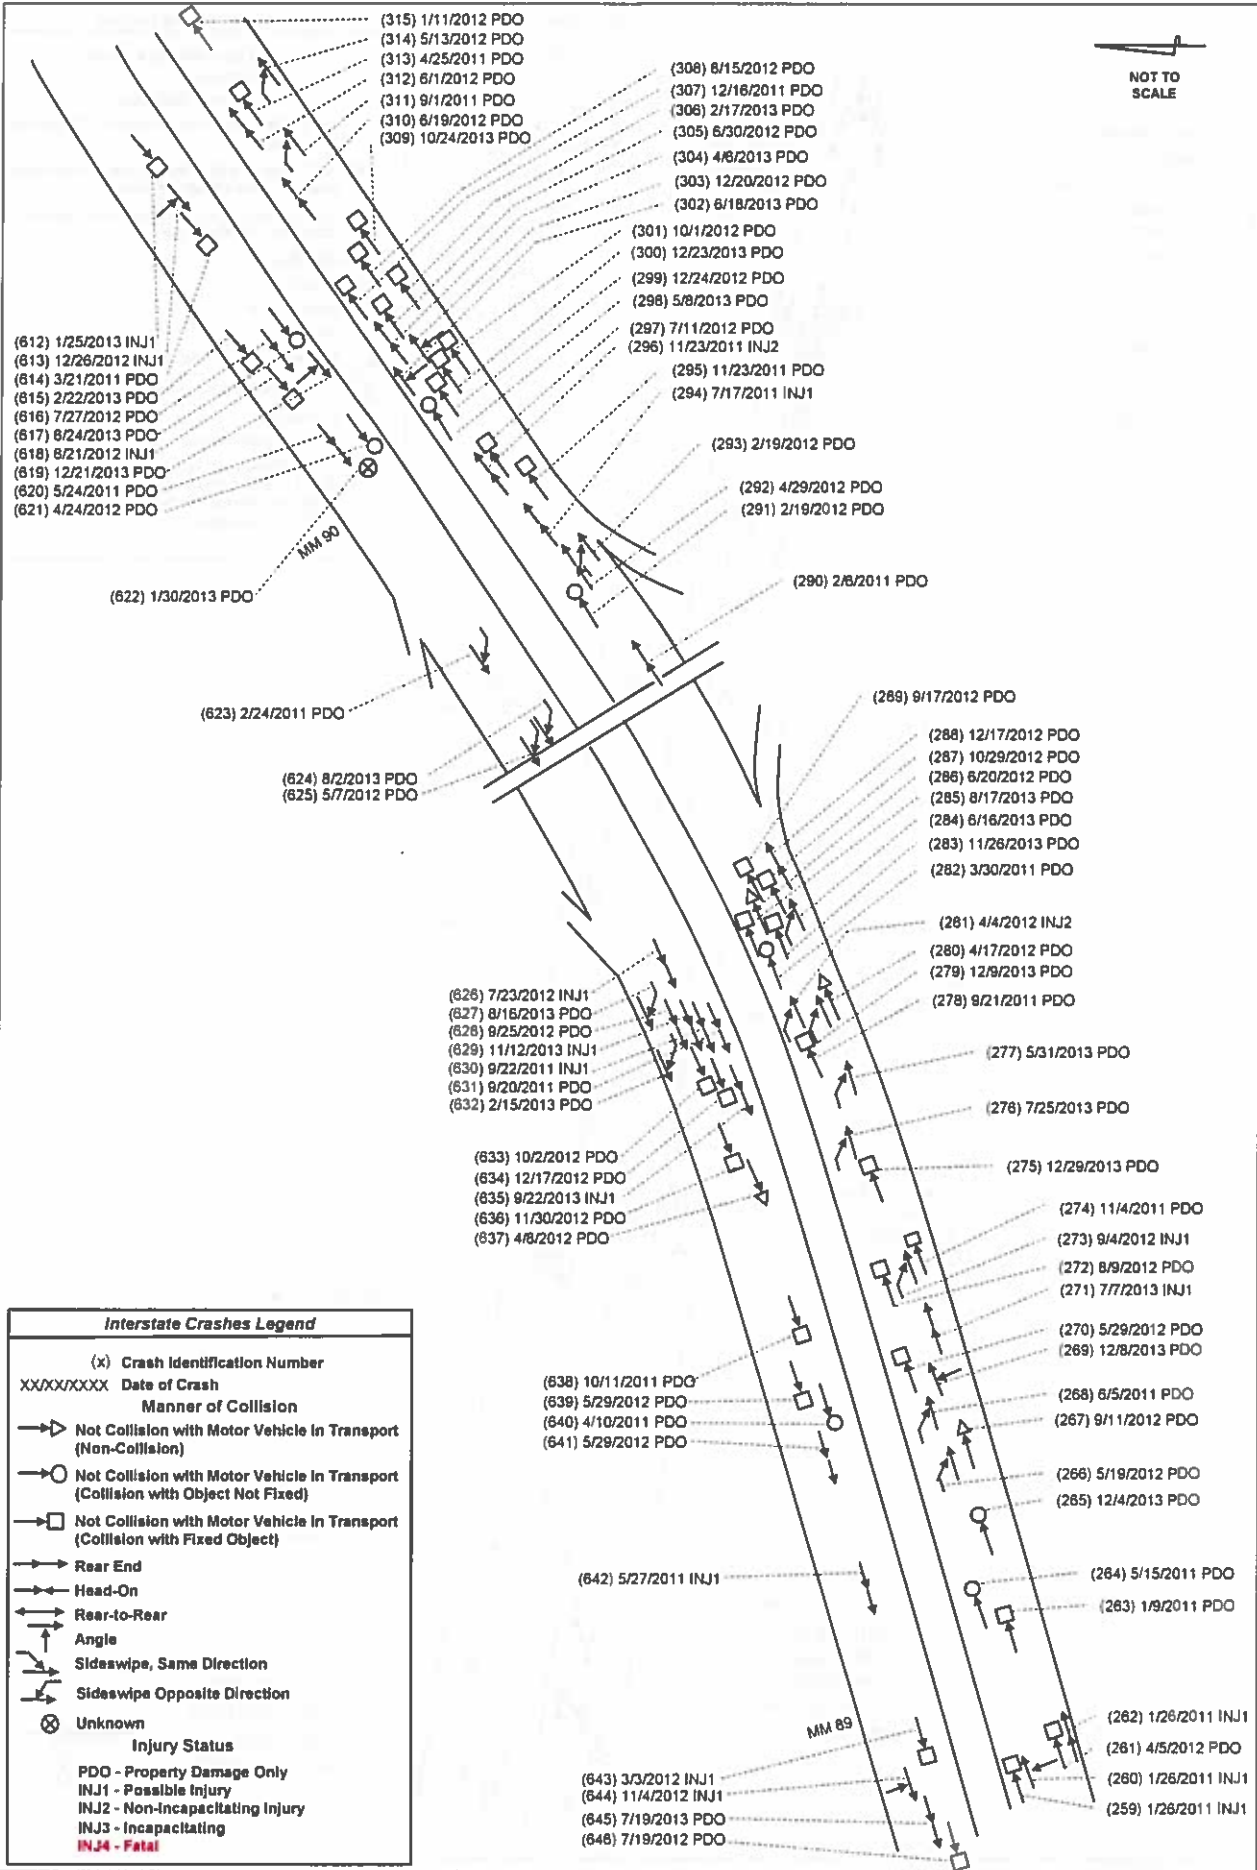
Figure
8

Mainline Between
Exit 87 and Exit 95 - 2

Crash data for this segment are shown **Figures 7 - 10**. **Table 9** shows a summary of the crash data at this location.

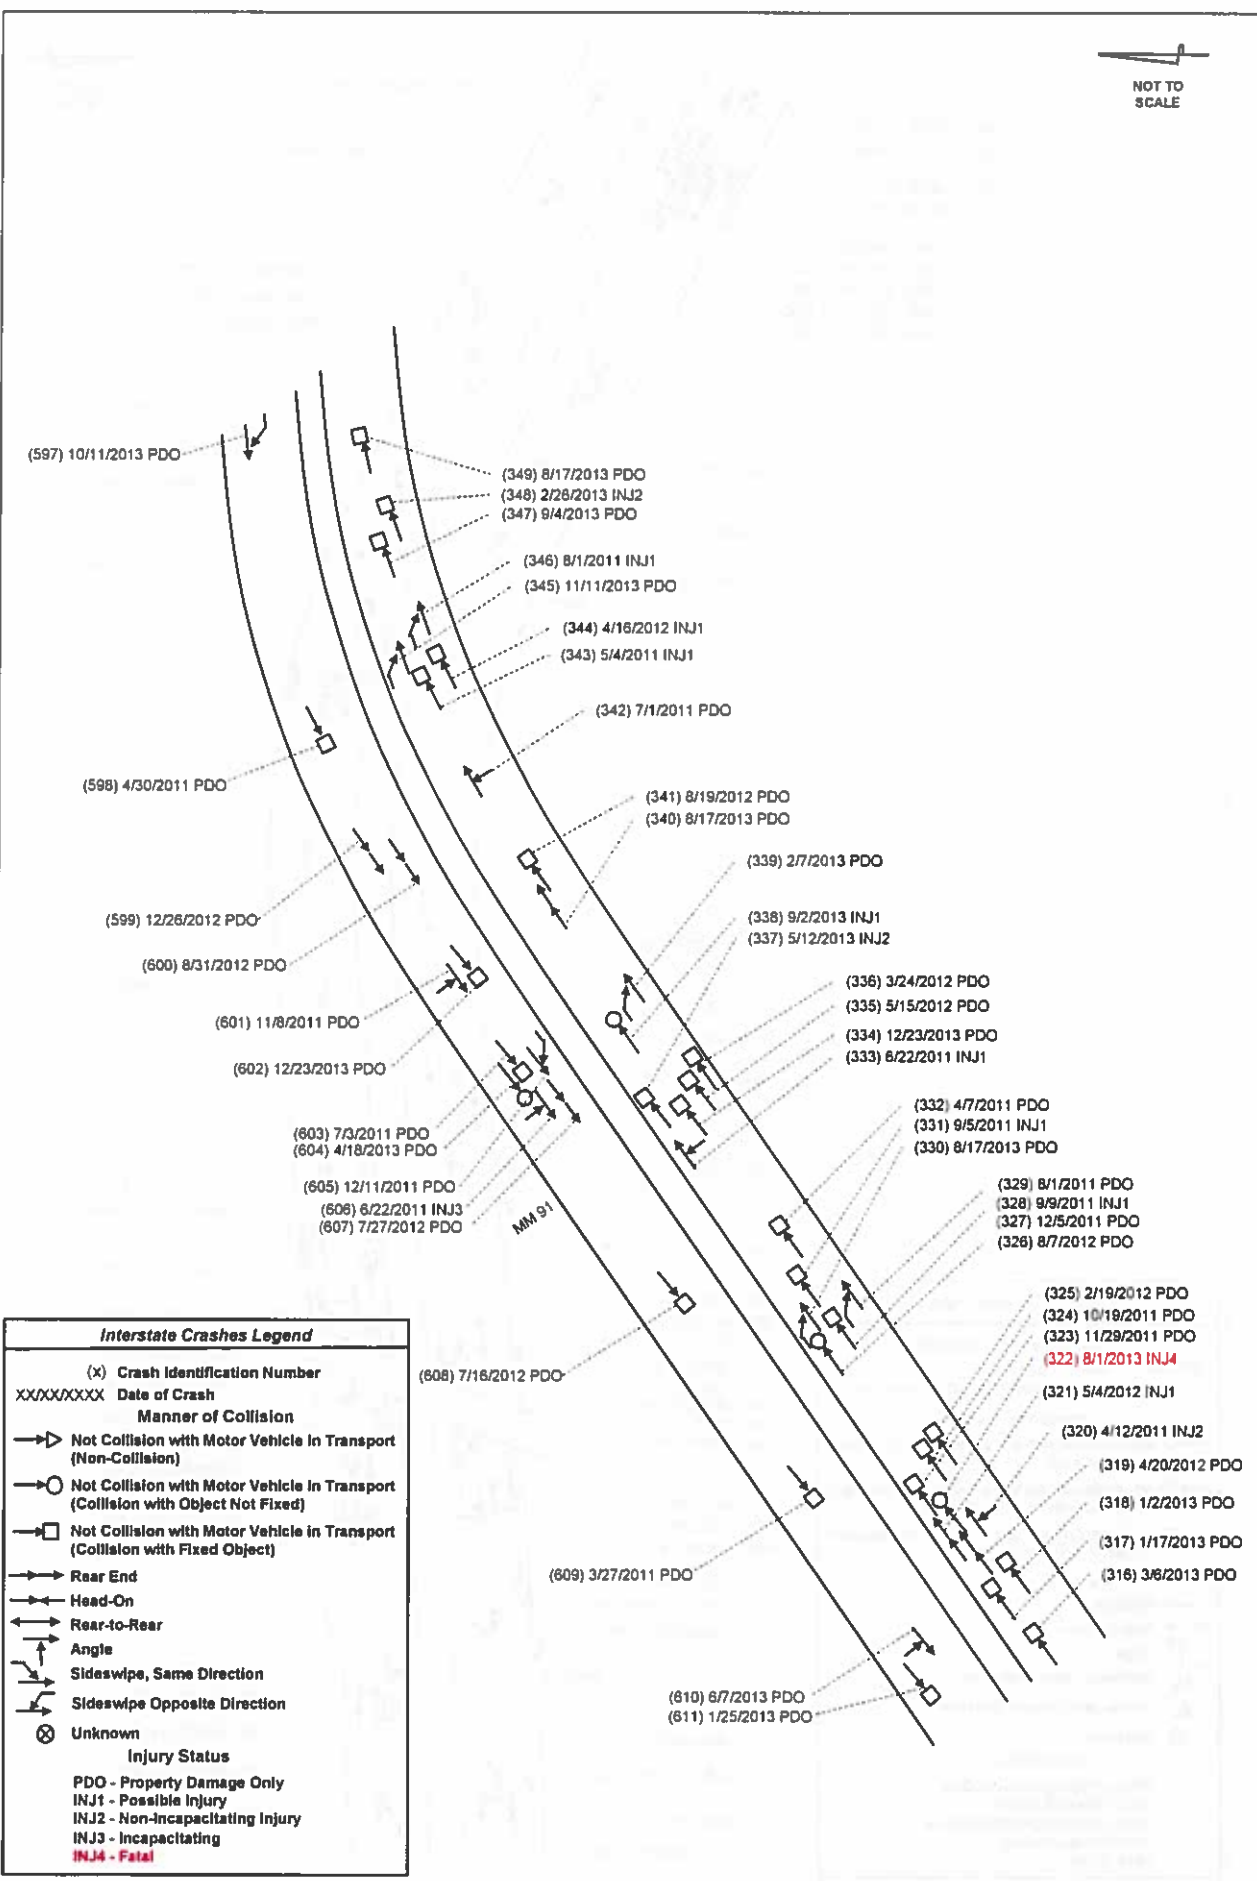
Figure
9

Mainline Between
Exit 87 and Exit 95 - 3

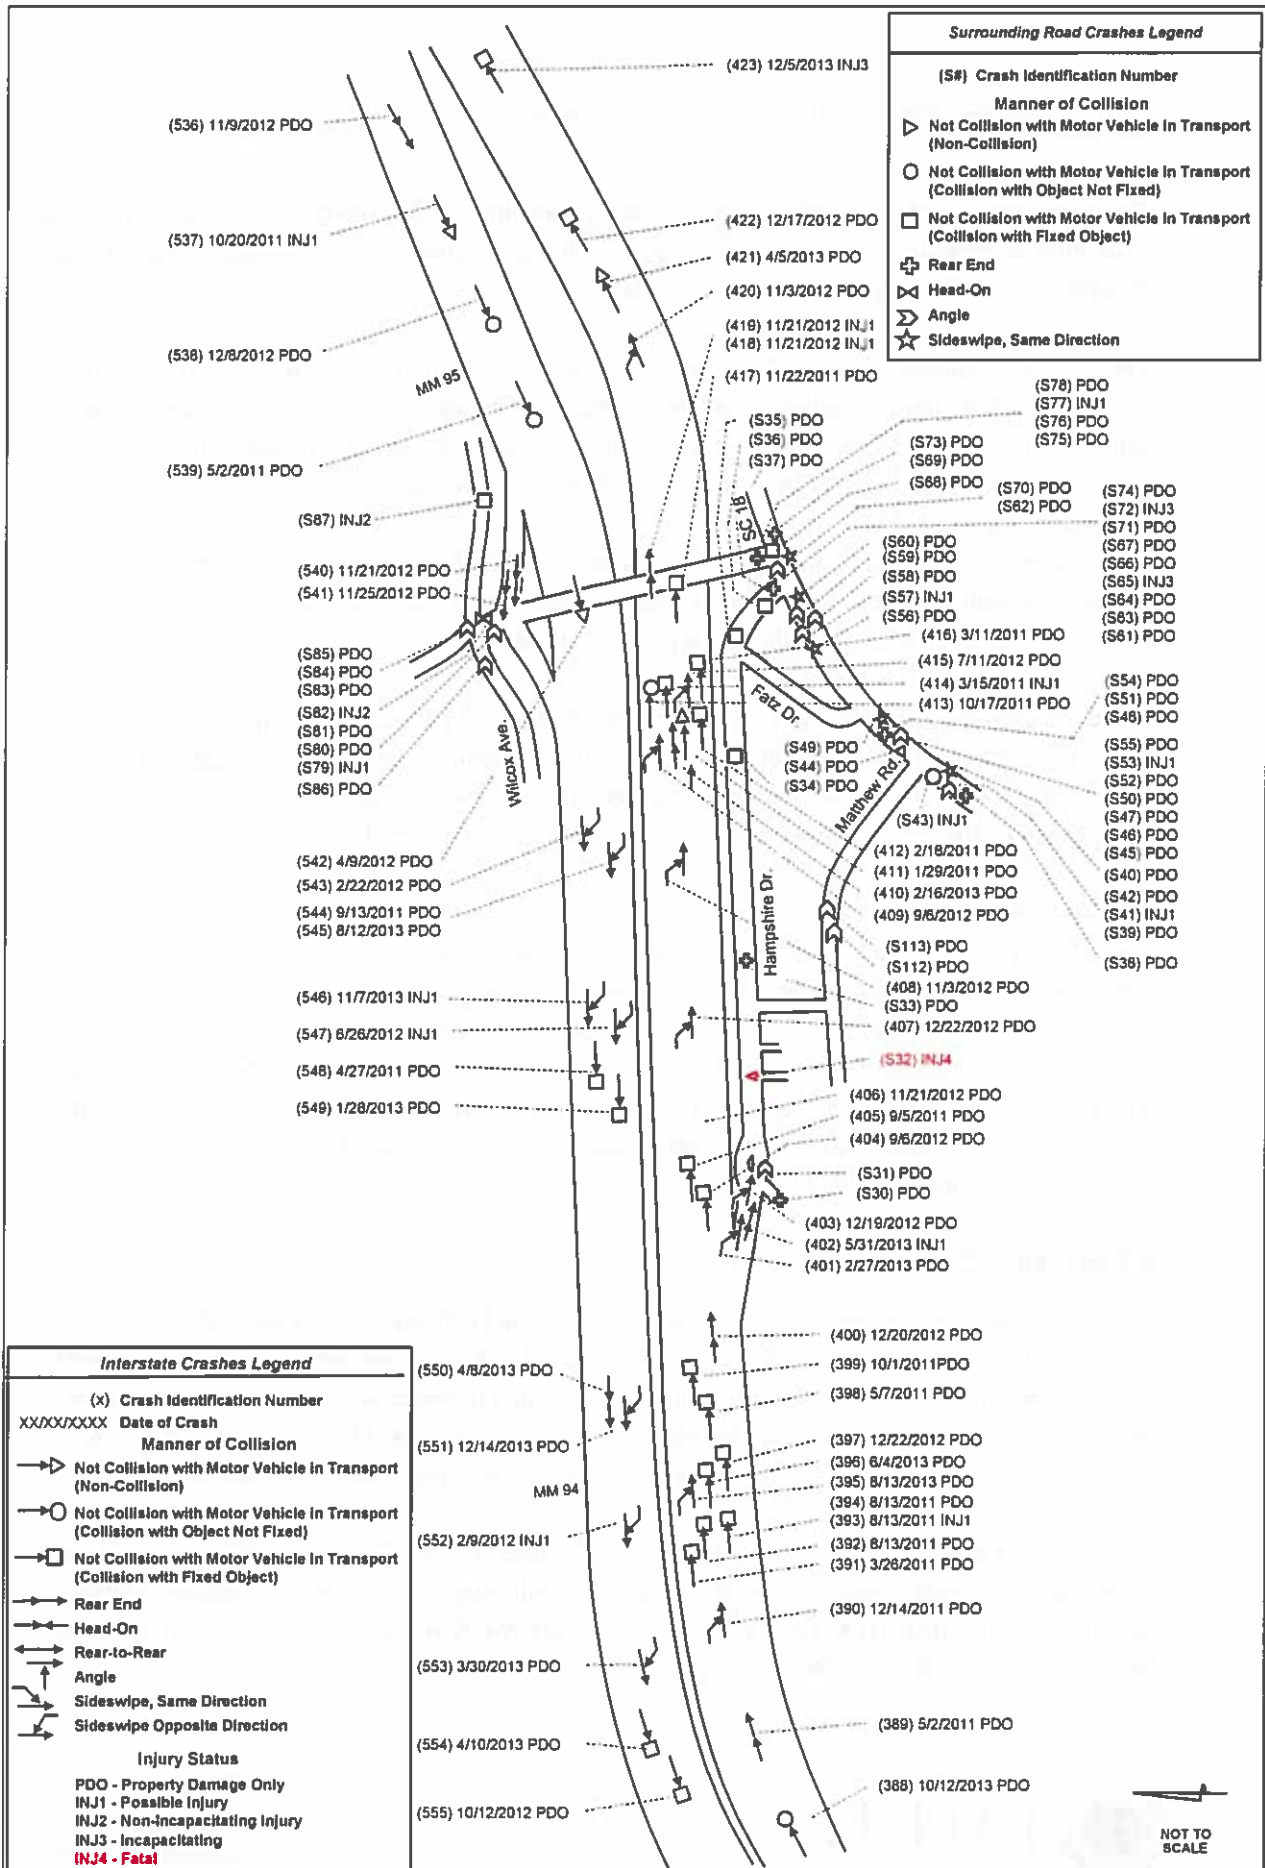
Figure
11

I-85 Exit 95 provides access to SC 18 – Shelby Hwy. via Hampshire Drive and Fatz Drive. The southbound on- and off-ramps connect directly onto SC 18. The northbound off-ramp connects to a bi-directional frontage road (Hampshire Drive) which provides access to SC 18 and adjacent properties. The crash data for this interchange are shown **Figure 11**. This segment of I-85 is approximately 1.75 miles long. There were no vertical curves identified in this section.

As seen in **Figure 11**, there are two areas of concern near Exit 85 northbound. In the approximate 0.2-mile stretch before the northbound exit ramp, there were five vehicle collisions with the median (MMs 93.851, 93.878, 93.946, 93.991, 94.026) and three vehicle collisions with the fence (MMs 93.884, 93.886, 93.927).

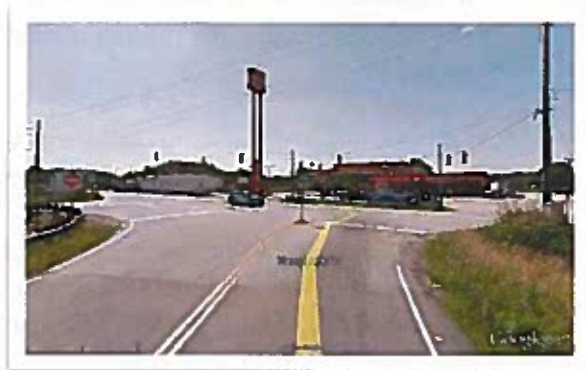
Photo: SC 18 at Hampshire Drive

were angle or sideswipe. Most crashes were classified as property damage only; however, two angle crashes on SC 18 between Hampshire Drive and the S-82 overpass were classified as incapacitating crashes (INJ3). This photo shows the approach to SC 18 from Hampshire Drive. As can be seen, this intersection is a nonstandard four-leg intersection with driveways that form two additional entry points to the intersection. The redesign of the SC 18 corridor including this intersection along with the intersections at Fatz Drive and Matthew Road would improve operations in this area.
