SCDOT BRIDGE INSPECTION FORM

(008) BRIDGE ID: 0720002100200
(005) ROUTE: BEAUFORT US 21
(006) CROSSING: HARBOR RIVER

(009) LOCATION: 12.5 MI SE BEAUFORT
(026) FUNCTIONAL CLASS: 03

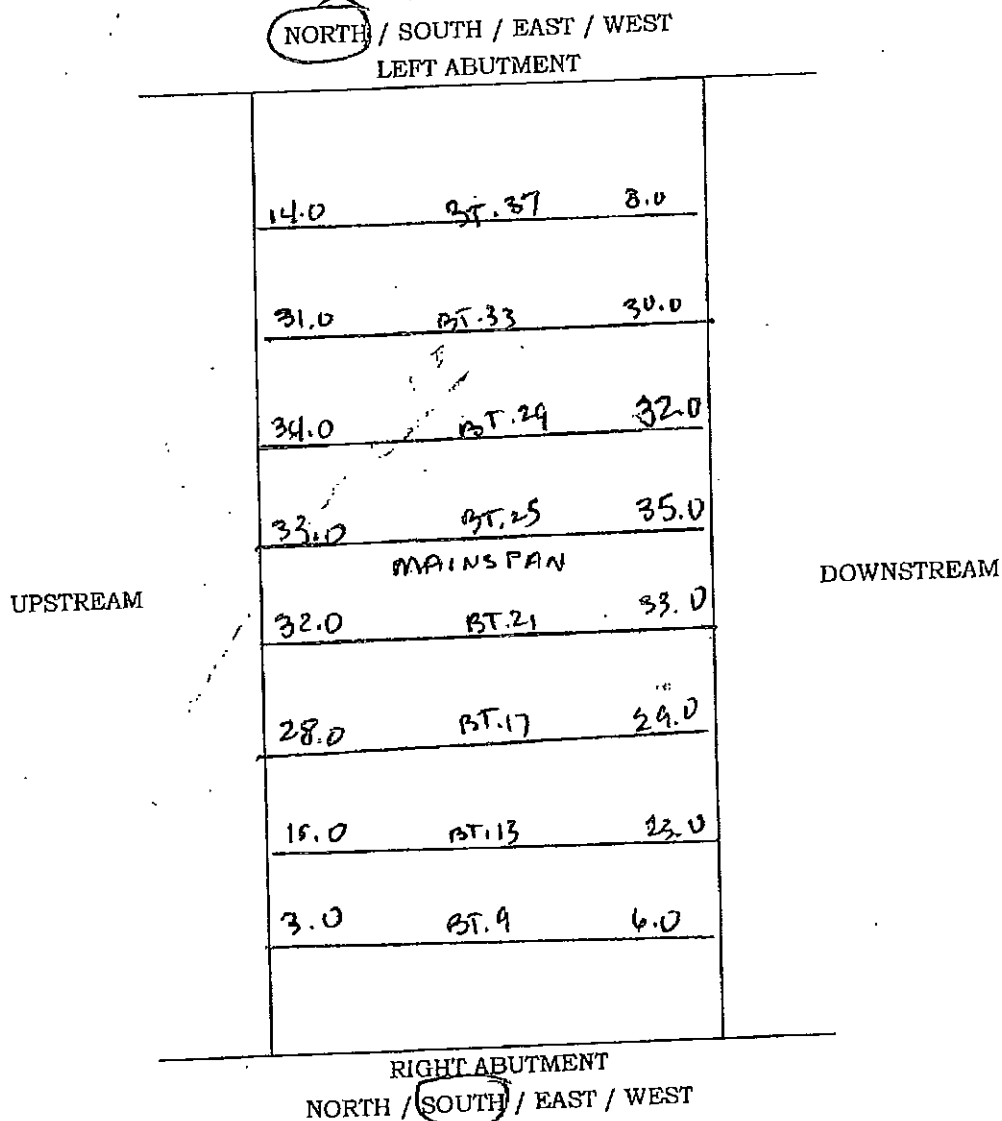
THE OFFICE OF BRIDGE MAINTENANCE		DISTRICT SIX BRIDGE INSPECTION TEAM	
BRIDGE INSPECTION STREAM / GROUND PROFILE		BRIDGE NUMBER: <u>072 0002 100200</u>	
COMMENTS: To TOP of Water(Upstream)=		ROAD NUMBER: <u>US-21</u>	
Taken Midstream @ Bent=		CROSSING: <u>HARBOR RIVER</u>	
_____		TOP OF WATER TO TOP OF PARAPET, CURB, DECK	
<u>WATER PROFILE TAKEN</u>		HORIZONTAL BLOCKAGE (%) _____ TO _____	
<u>W/ BOAT</u>		VERTICAL BLOCKAGE (%) _____

RD, LF
 MEASUREMENT BY

8 NOV-2012
 DATE MEASURED

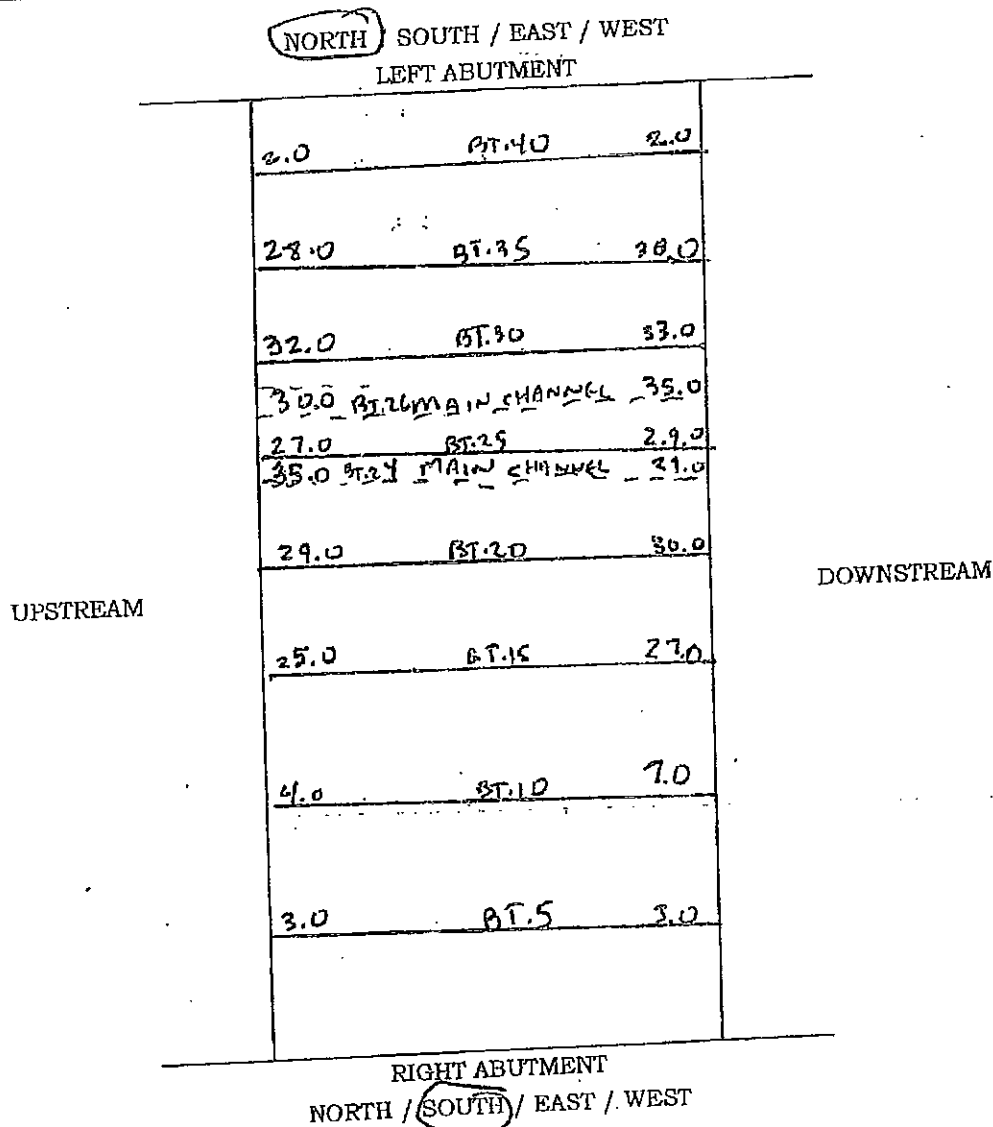
THE OFFICE OF BRIDGE MAINTENANCE		DISTRICT SIX BRIDGE INSPECTION TEAM	
BRIDGE INSPECTION STREAM / GROUND PROFILE		BRIDGE NUMBER: <u>0720002100200</u>	
COMMENTS: To TOP of Water(Upstream)=		ROAD NUMBER: <u>US-21</u>	
Taken Midstream @ Bent=		CROSSING: <u>HABOE RIVER</u>	
<u>WATER PROFILE TAKEN W/ BOAT</u>		TOP OF WATER TO TOP OF PARAPET, CURB, DECK	
		HORIZONTAL BLOCKAGE (%) <u> </u> TO <u> </u>	
		VERTICAL BLOCKAGE (%) <u> </u>

NO, ES, CF, SL
 MEASUREMENT BY

28 OCT-2010
 DATE MEASURED
