APPENDIX T

Timber Bridge Inspection Guidance (TBIG)

Version 2.0, 2024

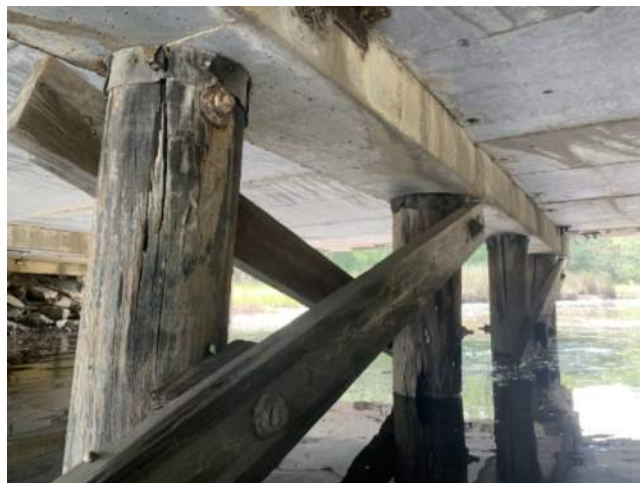
Figure 1.0 Example of a Timber Pile Bridge (Timber Piles under Reinforced Concrete Cap)

Most timber substructures consist of southern yellow pine that has been treated with creosote. Pile end bents may have timber backwalls and wingwalls that retain the embankment material.

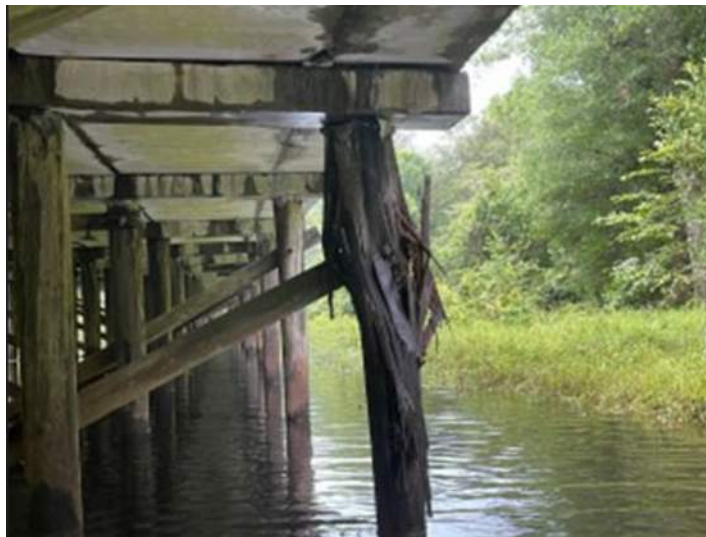
Figure 3.1 Failed timber pile due to internal decay of the pile at a cross-frame through bolt.

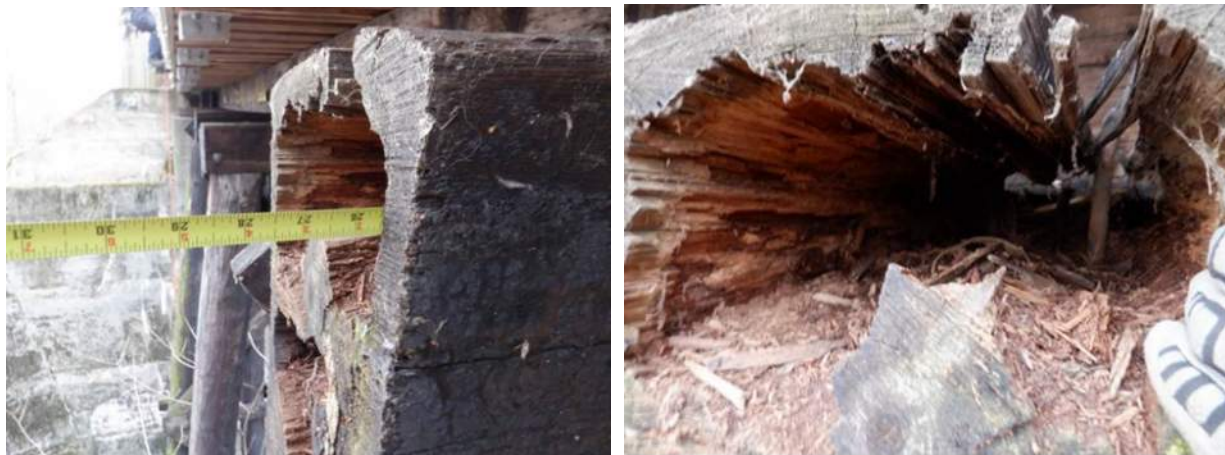
Figure 3.3 Localized collapse of a timber bent cap.

Sunken faces or localized surface depressions can indicate underlying decay. Decay voids or pockets may develop close to the surface of the member, leaving a relatively thin, depressed layer of intact or partially intact wood at the surface. Crushed wood can also be an indicator of decay.

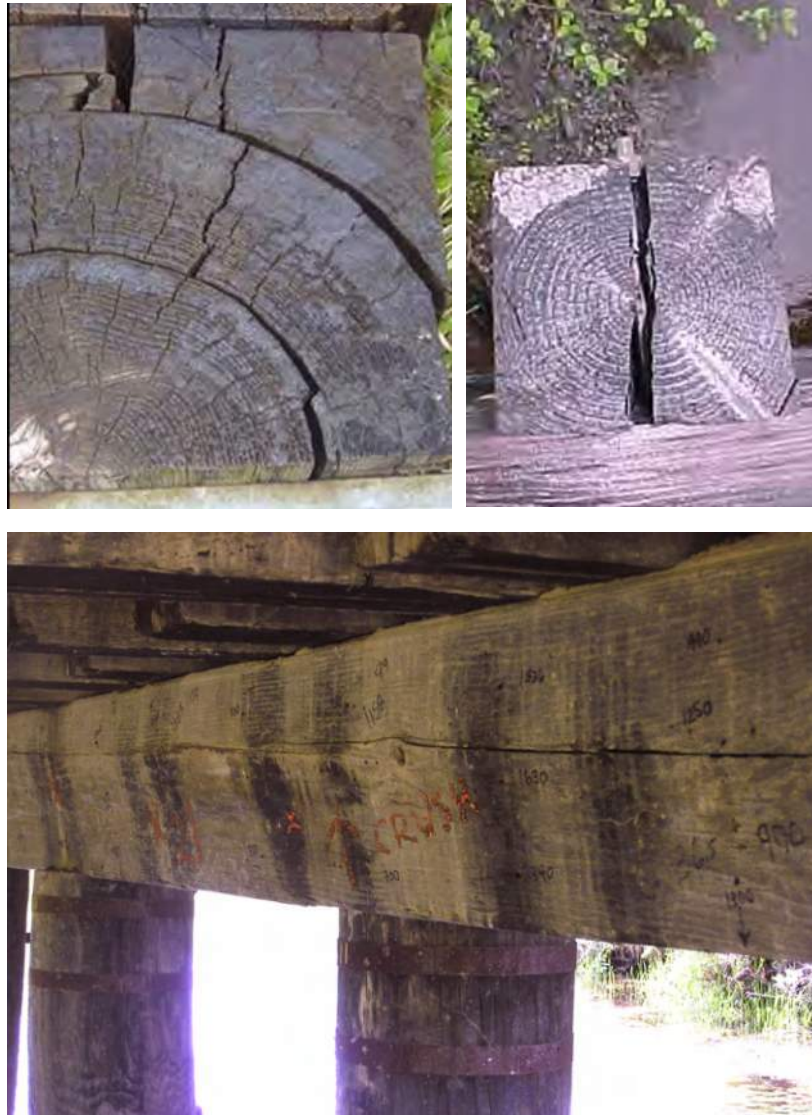
Figure 3.7 Timber members showing various types of deterioration. Top left shows ring shake. Top right shows severe through splits. Bottom picture is of a long horizontal split provides an opportunity for moisture passing through the timber deck to enter the cap, leading to substantial decay.

Timber members are susceptible to drying and weathering, which often result in surface and deep surface checks, ring shake, end checks, and through splits. Checks and splits in members can indicate a weakened member and create an entry for moisture to enter the element. If a check or split develops to a sufficient depth, the inner untreated wood is susceptible to moisture and decay fungi. This will create conditions that can result in severe decay and premature deterioration of a timber bridge element. Severe splits in timber end bent caps often lead to severe decay and should be thoroughly evaluated.

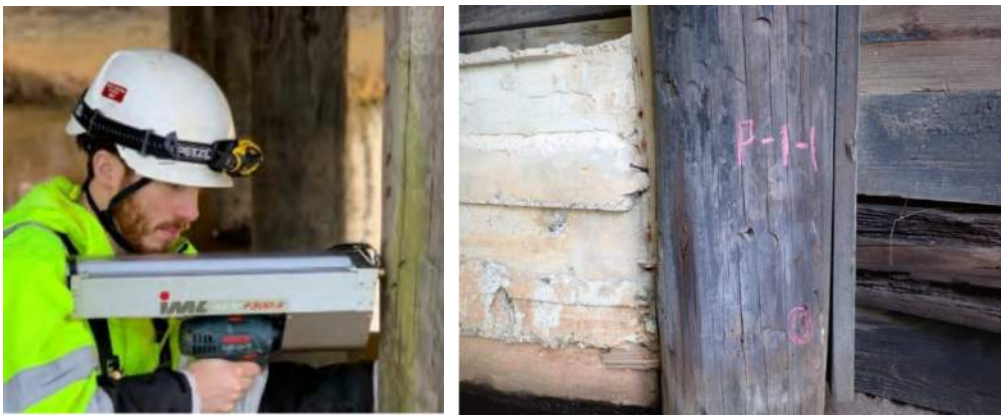
Figure 7.1 In field use of a resistance drill (left photo) and the field marking of a timber pile that has been drilled (right photo).

The resistance drill equipment measures the resistance of wood members to a drill bit that passes through them. This drill bit travels through the member at a defined movement rate and generates information that allows an inspector to determine the exact location and extent of the damaged area. While the unit is usually drilled into a member in a perpendicular direction to the surface, it is also possible to drill into members at an angle.

Resistance drills collect the data electronically or produce a chart or printout showing the relative resistance over its drilling path. Modern tools are also promoting the ability to view the data on a tablet, computer, or phone. Areas of sound wood have varying levels of resistance depending on the density of the species and voids show no resistance. The inspector can determine areas of low, mild, and high levels of decay with this tool, and quantify the level of decay in the cross-section. All holes shall be filled after drilling by injecting a small amount of silicone sealant or marine adhesive into the drill hole. The location of drilling shall be field marked and photographed.

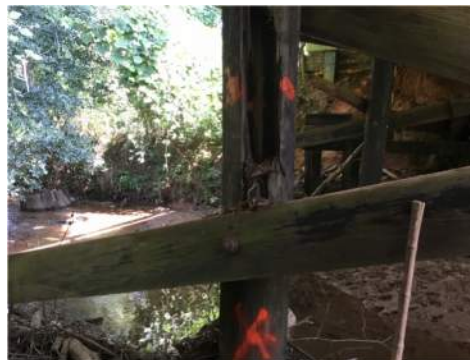
Figure 7.2 Exterior Pile with > 50% Decay, Drilling Not Needed (Critical Finding/A Flag per Figure O.3 in App O)

The BITL shall determine which locations on each timber pile are drilled. The BITL shall also review any drilling previous performed on the bridge. If the pile has previously been drilled and no or minimal defects have been noticed, a different pile should be selected for the current inspection. If decay is noted on the pile, the general area of the decay should be drilled again. *BITLs may be able determine and measure decay on the pile visually or following the sounding the pile and subsequent process of removing decayed timber. If the pile decay has already reached a condition were a Critical Finding or 'A Flag' is required, the pile does not need to be drilled and another pile in that bent should be selected to satisfy the requirement of the IDTL.*

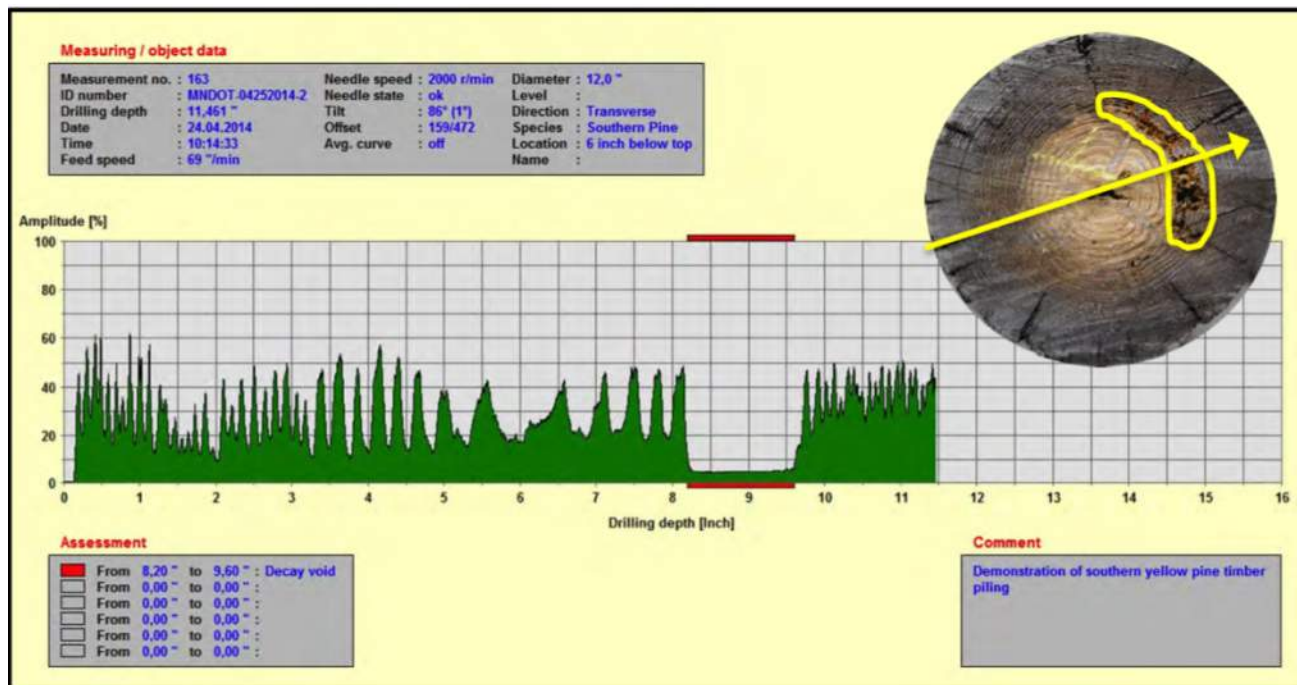
$$\text{Percent Decay} = \frac{\text{Length of Measured Decay}}{\text{Diameter of Decayed Pile}} \times 100\% = \frac{2 \text{ inches}}{12 \text{ inches}} \times 100\% = 17\%$$

Figure 8.2.1 Electronic view of a southern yellow pine timber piling showing a decay pocket between 8 and 10 inches of the drilling profile.

$$\text{Percent Decay} = \frac{\text{Length of Measured Decay}}{\text{Diameter of Decayed Pile}} \times 100\%$$

Bridge inspectors are to consider both moderate and severe decay (per Table 7.3) as decay when determining the percent decay. *Bridge inspectors should attempt to determine the minimum timber cross section area remaining as it will control condition coding and load rating. See Section 7.2 of this appendix for a discussion on visually observable decay or observable decay following sounding. Measured area of decay can be used to determine the percent decay in lieu of drilling, if determined appropriate by the BITL.* Load rating engineers (per the LRGD) may consider moderate (or partial) decay by engineering judgement to more accurately determine the remaining pile capacity when performing a load rating on a timber member.
