Geotechnical Subsurface Exploration and Laboratory Testing Data Report

2016-1A Emergency Bridge Replacement Package

S-461 (North Old Georgetown Road) Bridge over Tributary to Lynches River

F&R Project No. 65U-0177

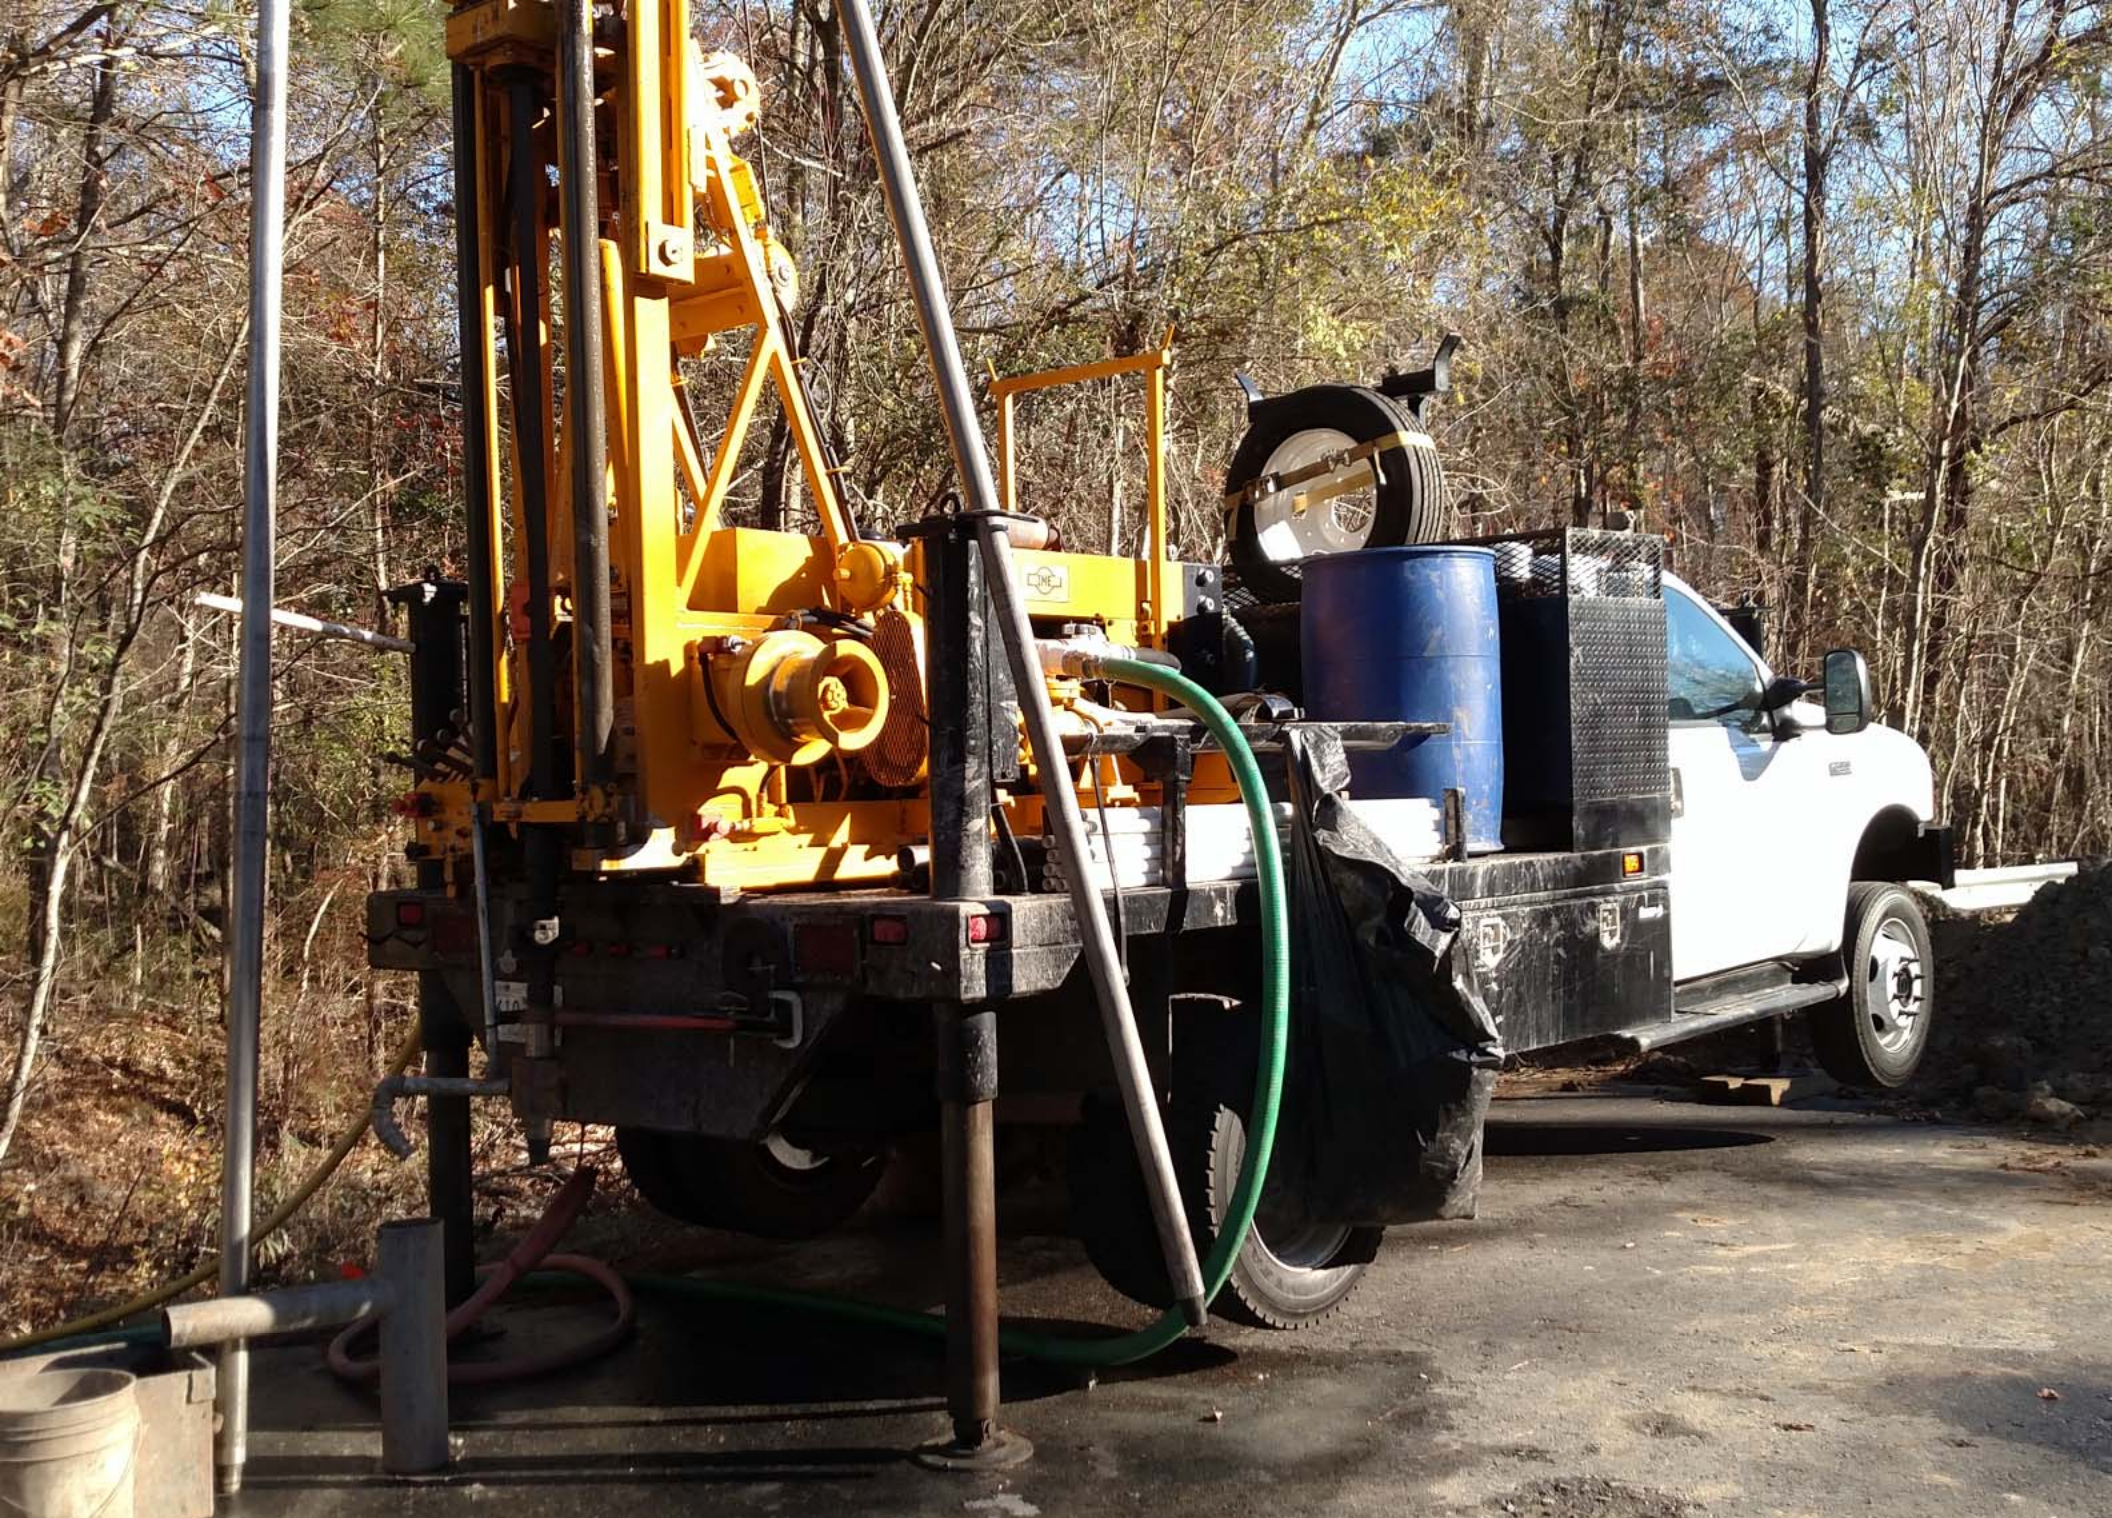
Figure No. 3: Photograph of Soil Test Boring STB-301 Being Drilled

The subsurface exploration program included two Standard Penetration Test (SPT) borings, each located as close as possible to opposite ends of the existing bridge. The borings are designated as Soil Test Borings STB-301 and STB-302. The SPT tests were performed almost continuously from the existing ground surface to a depth of 10 feet and at approximate 5-foot intervals thereafter until prior termination at a depth of approximately 86.5 feet below the existing ground surface. Approximate boring locations are identified on Figure No. 2 - Location Plan included in Appendix I of this report. Photographic documentation of the drill rig in operation at the locations of STB-301 and STB-302 are also included in Appendix I and presented as Figure No. 3 and 4, respectively.

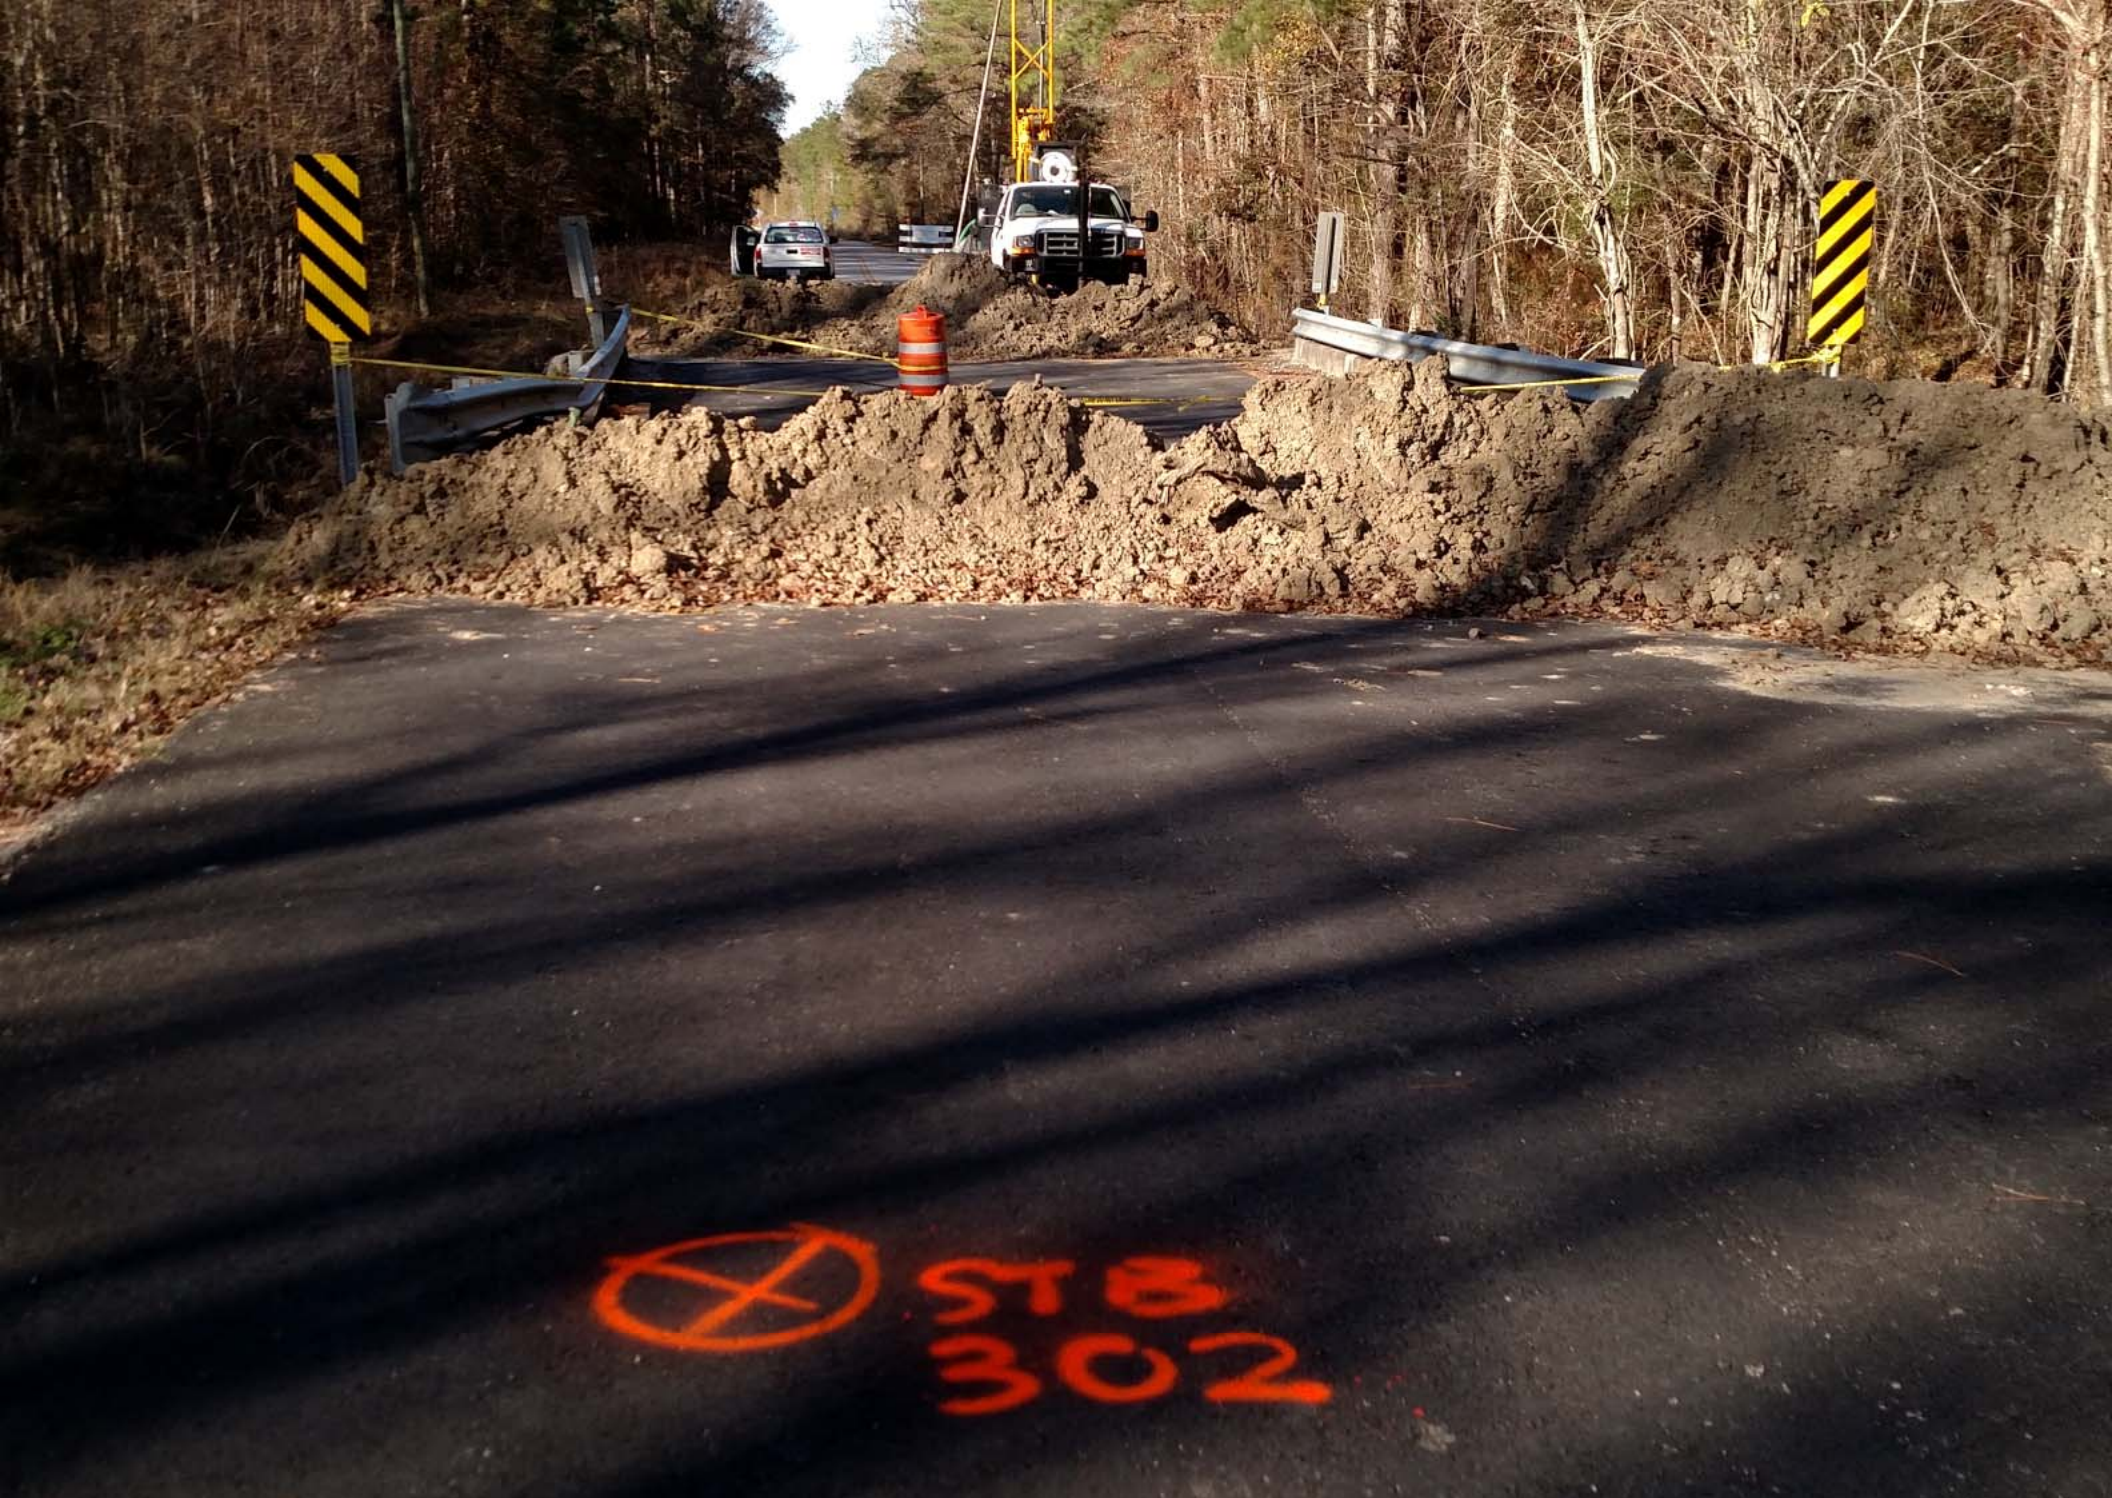
Figure No. 4: Photograph of Soil Test Boring STB-302

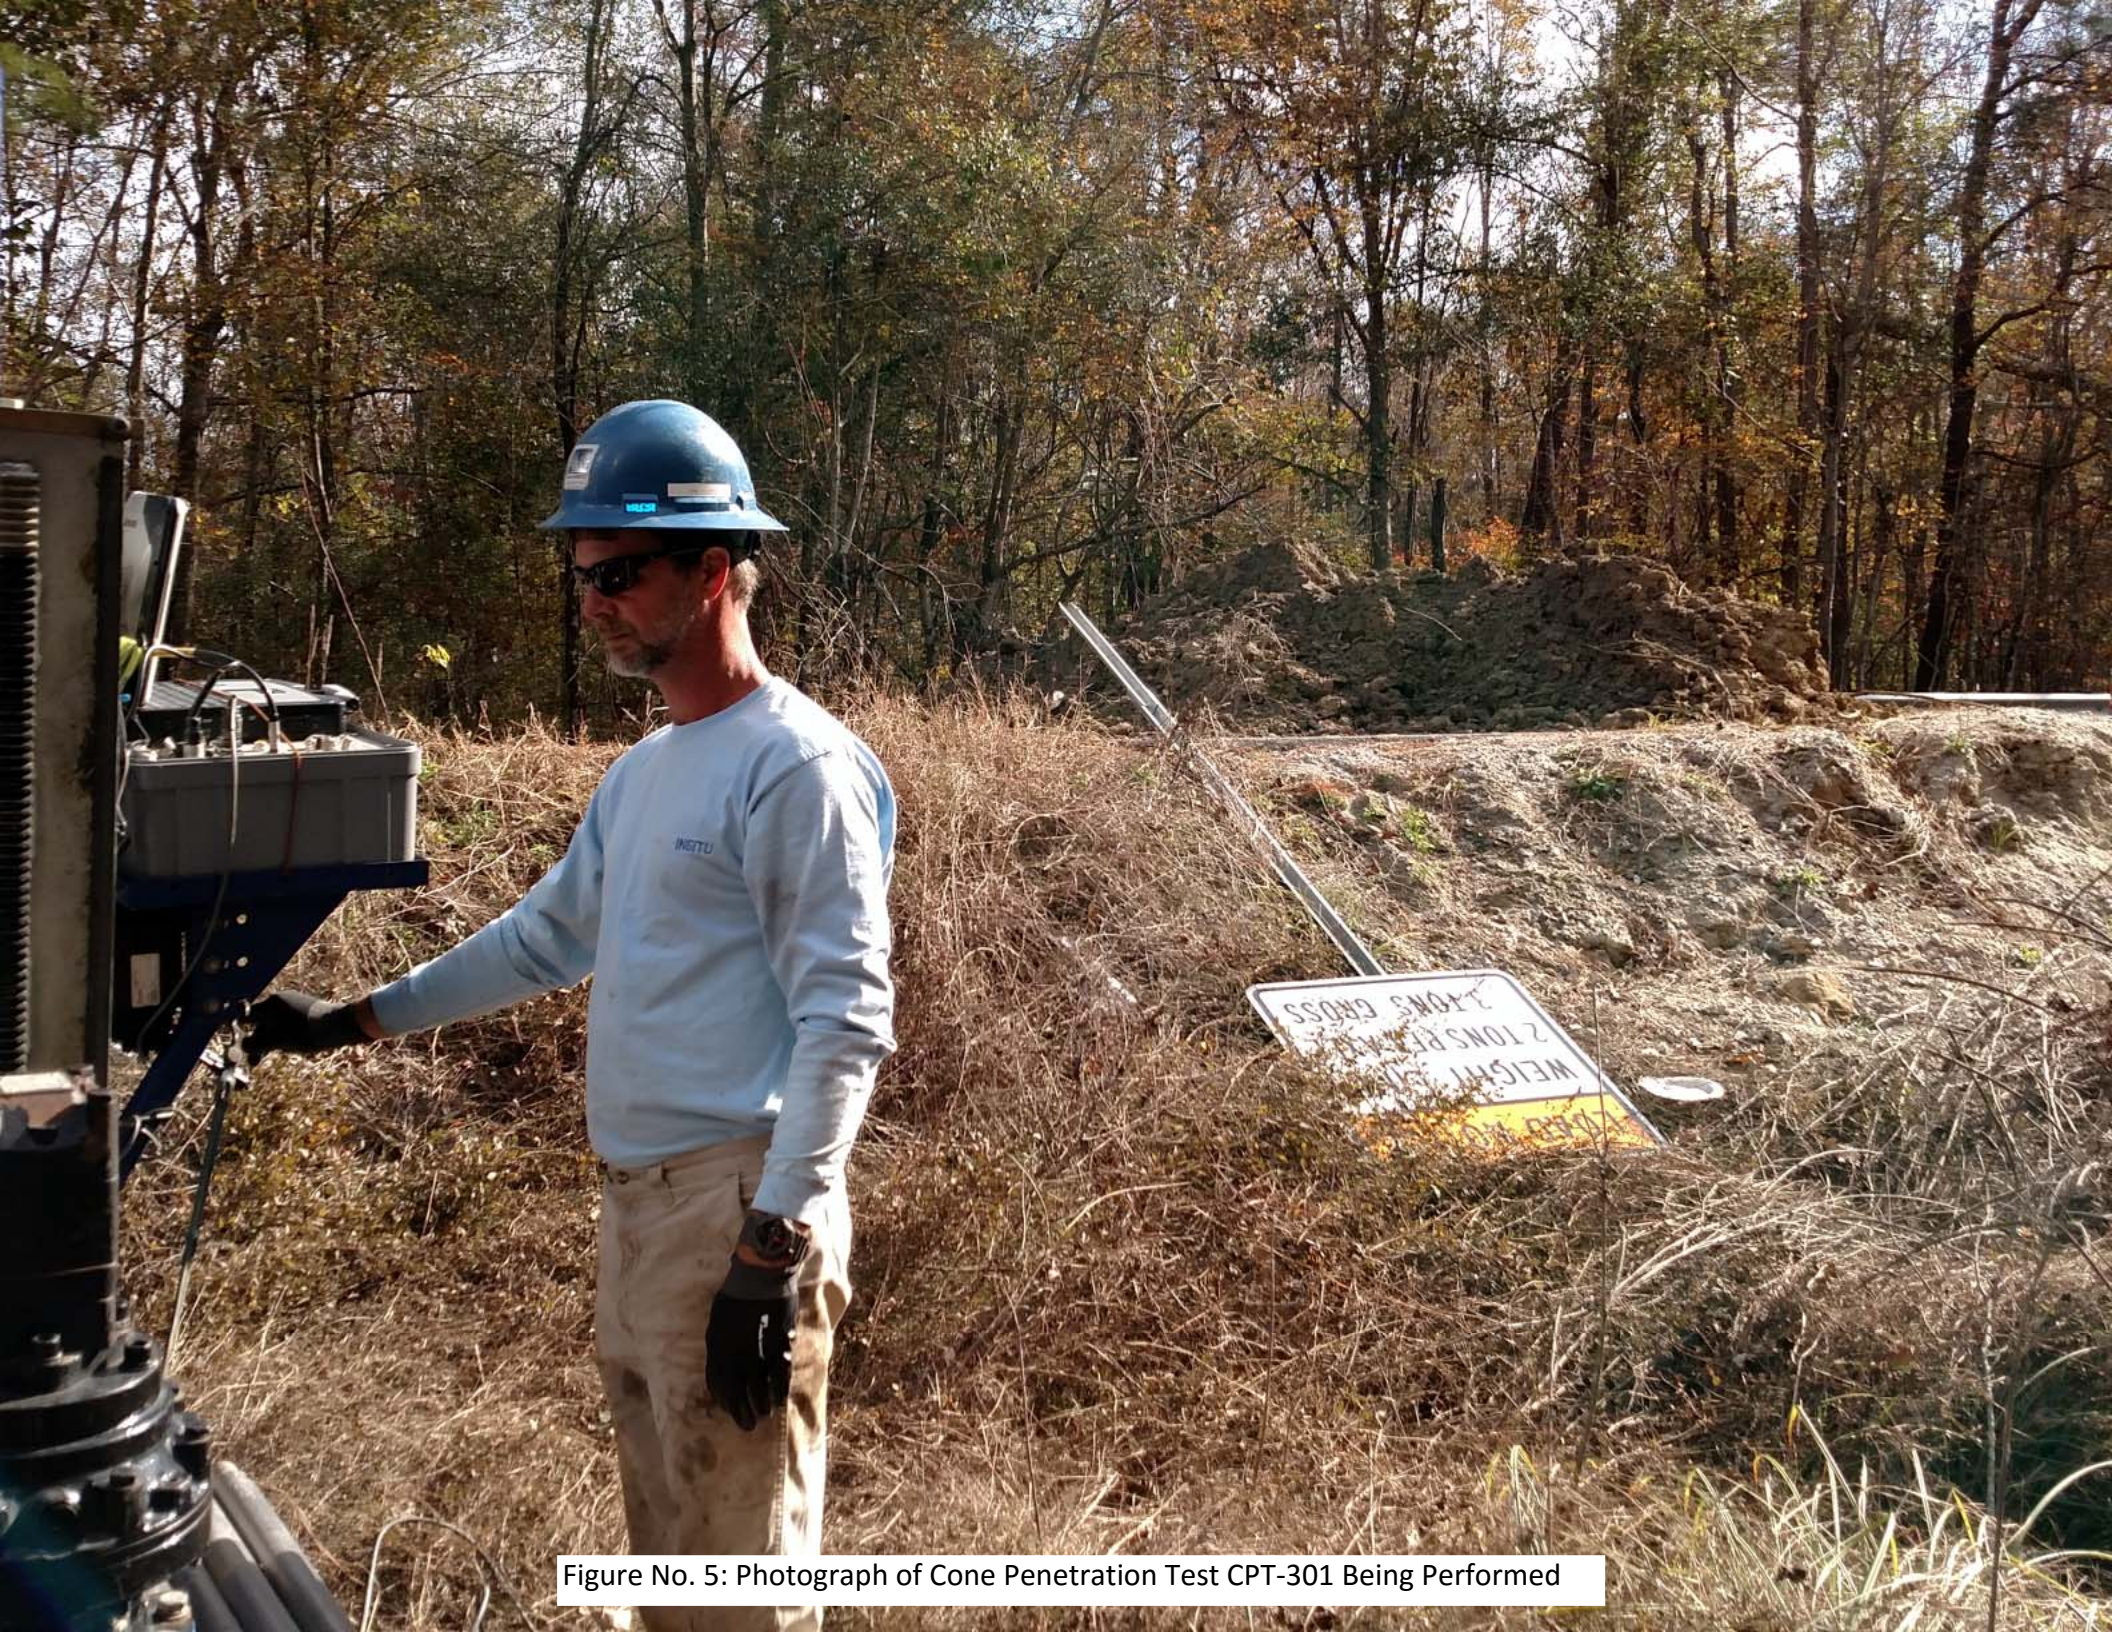
Figure No. 5: Photograph of Cone Penetration Test CPT-301 Being Performed

The equipment used for the exploration includes an electronic 15 cm² Vertek seismic cone, hydraulically advanced into the soil using a Vertek S4 Scorpien CPT rig capable of 20 tons of thrust. The collected raw data was processed by Palmetto Insitu, LLC using Bentley's gINT V8i SS2 software (version 08.30.04.206) and Dataforensics, RapidCPT software (version 4.2.2.0). The legend used for the SBT correlations is based on Robertson and Campanella: 1990 and is included with the CPT results provided in Appendix III. An electronic file (in .CSV file format) containing the CPT results will be provided via email along with this report. Photographic documentation of the CPT rig in operation at the location of CPT-301 and CPT-302 is included in Appendix 1 and presented as Figure No. 5 and 6, respectively.

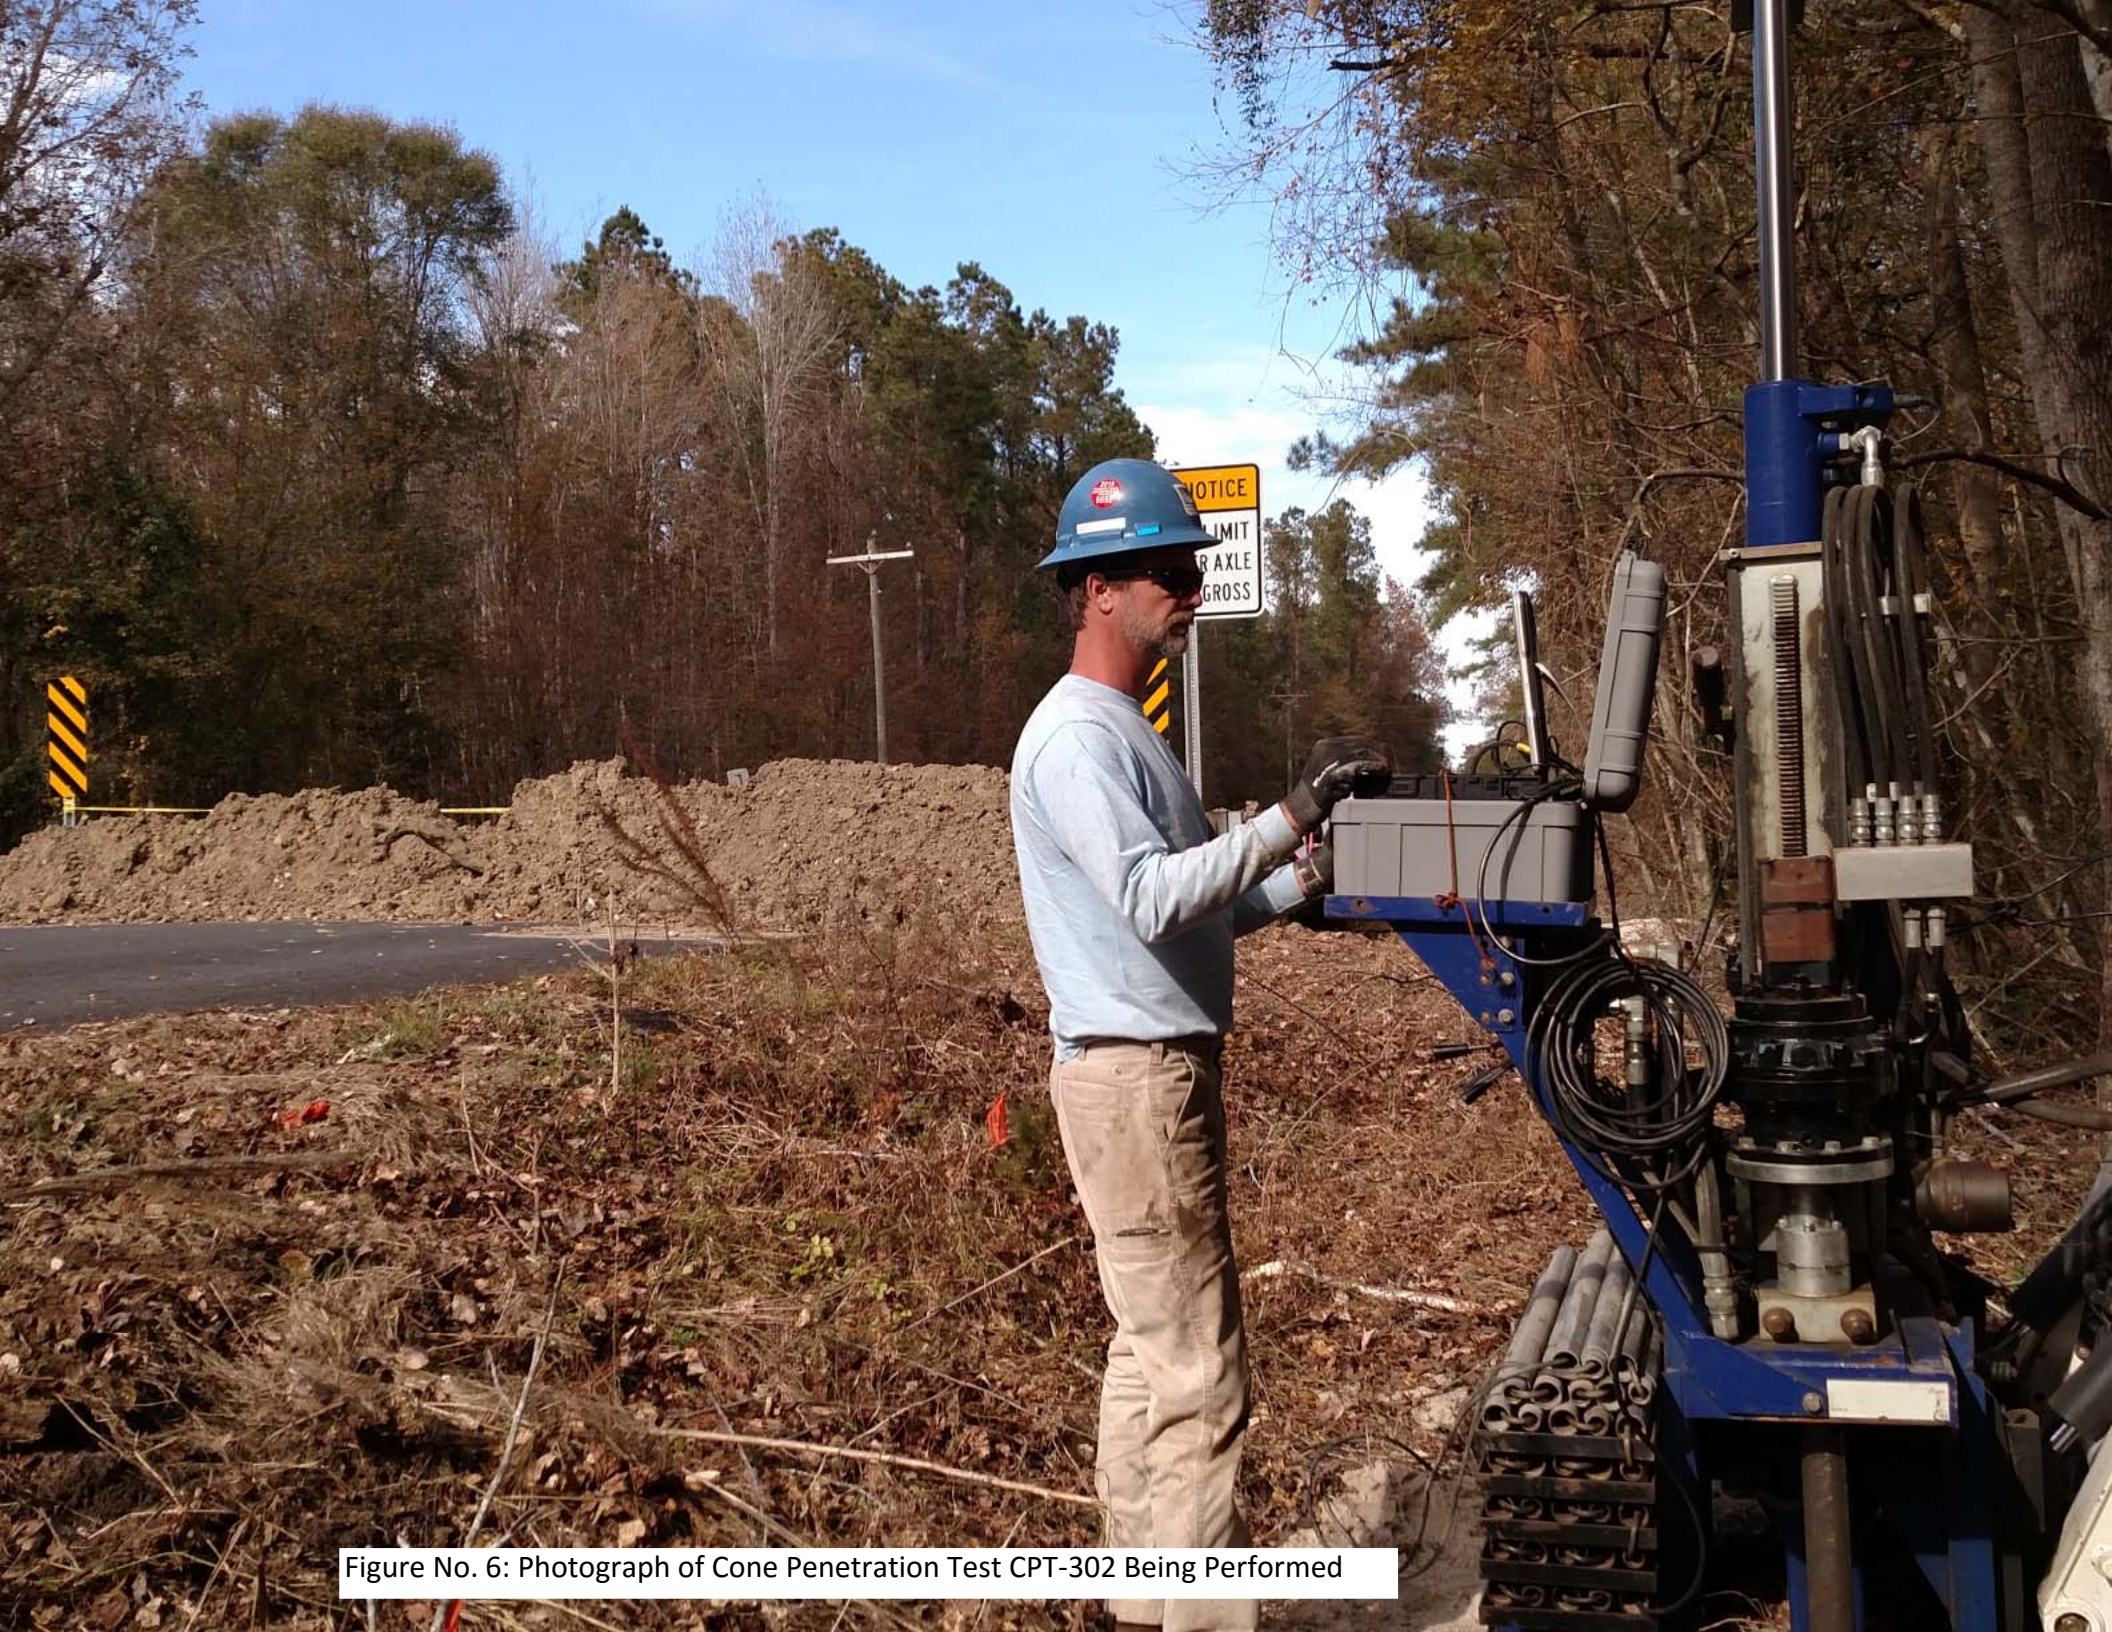
Figure No. 6: Photograph of Cone Penetration Test CPT-302 Being Performed

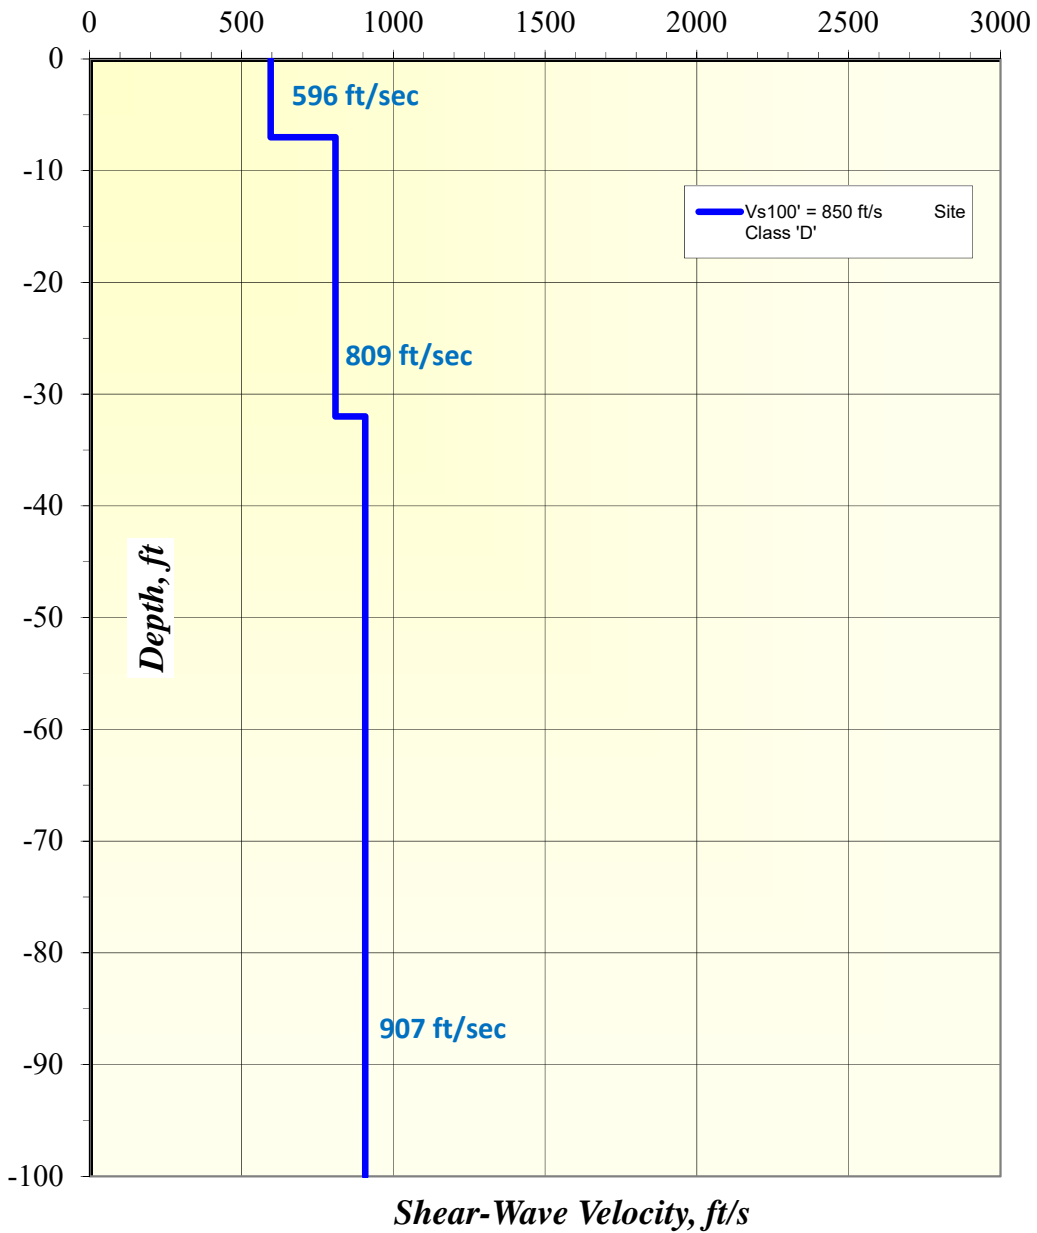
Vs Model

Refraction Microtremor (REMI) Results

A Refraction Microtremor (ReMi) survey was performed at one location (array) longitudinal to the road and just to the north side of the bridge. The ReMi survey was conducted to provide estimated measurements of the soil shear wave velocity in the upper 100 feet. The dispersive characteristic of Rayleigh waves when traveling through a layered medium is measured from the surface, which makes the method nondestructive and nonintrusive. A seismic source (ambient "noise") is applied at the ground surface where vertical transducers record the propagation of

surface waves. By analyzing the phase information for each frequency contained in the wave train, the Rayleigh and shear wave velocity can be determined. The data was processed using SeisOpt® ReMi™ software to reveal a one-dimensional average shear-wave (S-wave) velocity structure for the array. The survey was performed to provide the average shear wave velocity to a depth of 100 feet used to determine the seismic Site Classification in accordance with Chapter 16 of the 2015 International Building Code (IBC). The result of the geophysical test is included in Appendix IV of this report.
