**FOURTH FIVE-YEAR REVIEW REPORT  
SANGAMO WESTON/TWELVEMILE CREEK/LAKE HARTWELL PCB  
CONTAMINATION SUPERFUND SITE  
PICKENS COUNTY, SOUTH CAROLINA**

**U.S. Environmental Protection Agency  
Region 4 Superfund Division  
61 Forsyth Street, SW  
Atlanta, Georgia 30303**

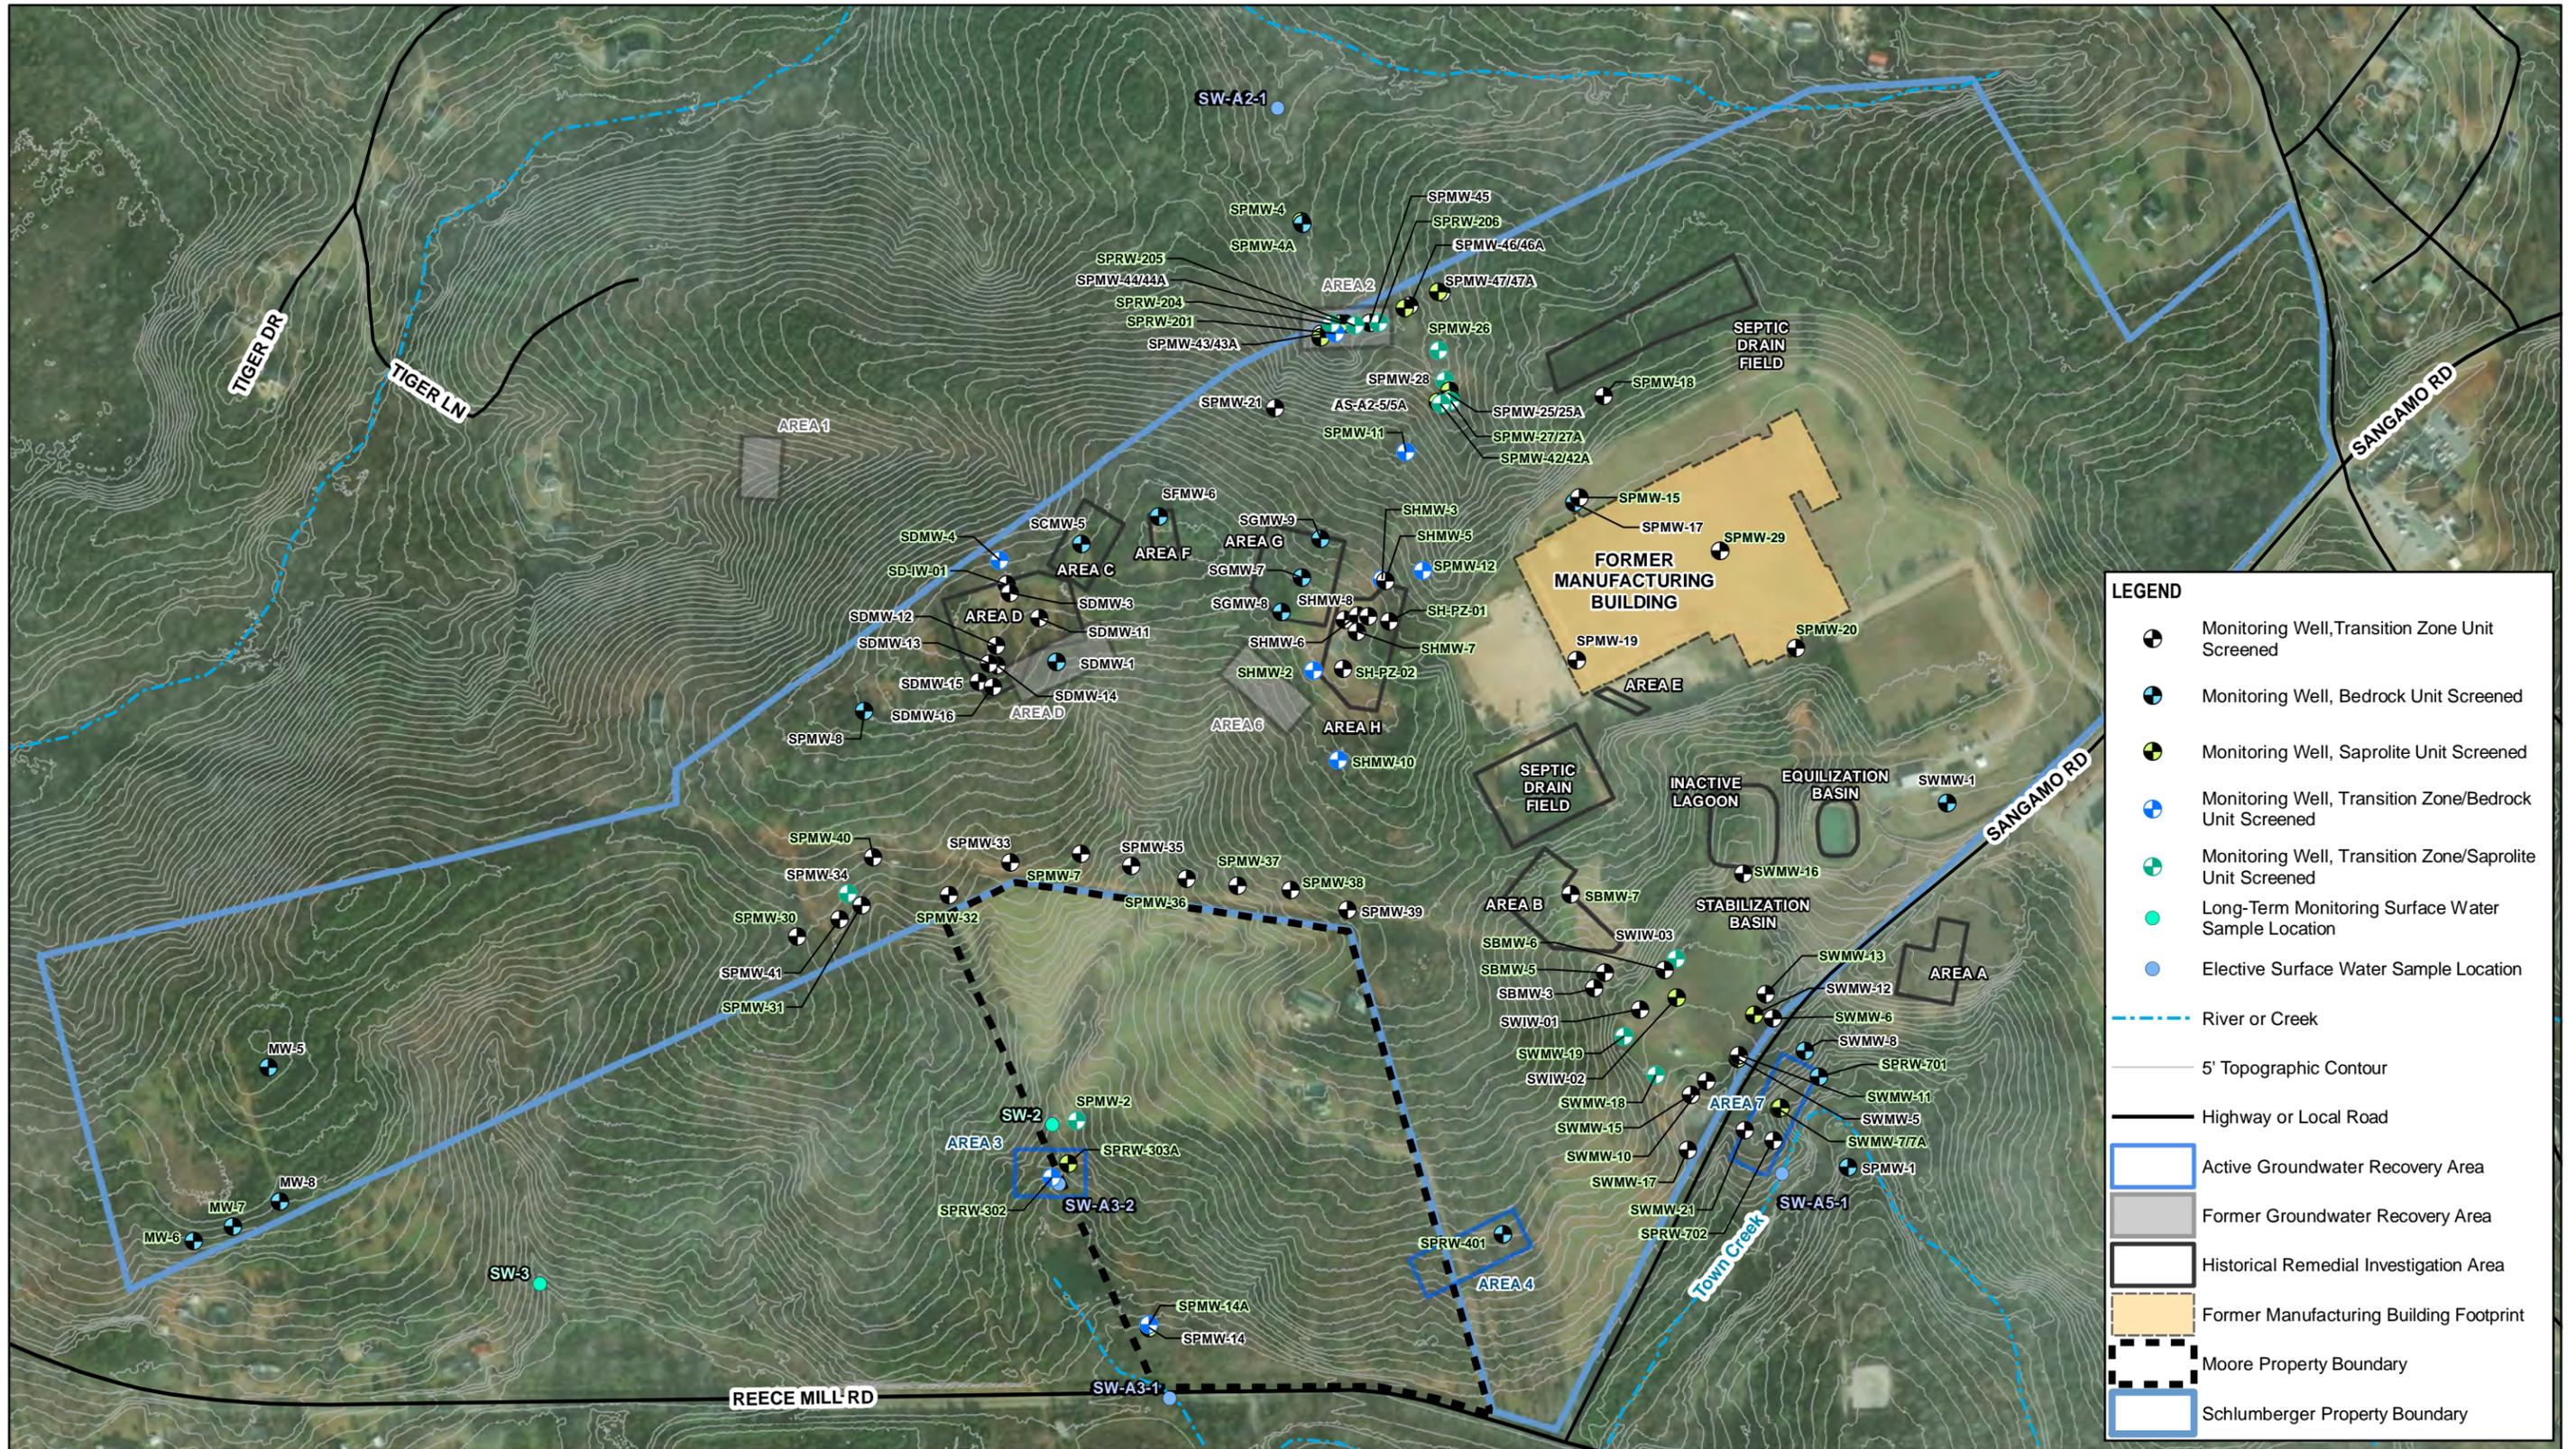
**Figure 2**  
**Plant Site Map, March 2018**  
*Fourth Five-Year Review Report*  
*Sangamo Weston Site, Pickens, South Carolina*

- Monitoring Well, Transition Zone Unit Screened
- Monitoring Well, Bedrock Unit Screened
- Monitoring Well, Saprolite Unit Screened
- Monitoring Well, Transition Zone/Bedrock Unit Screened
- Monitoring Well, Transition Zone/Saprolite Unit Screened
- Long-Term Monitoring Surface Water Sample Location
- Elective Surface Water Sample Location
- River or Creek
- 5' Topographic Contour
- Highway or Local Road
- Active Groundwater Recovery Area
- Former Groundwater Recovery Area
- Historical Remedial Investigation Area
- Former Manufacturing Building Footprint
- Moore Property Boundary
- Schlumberger Property Boundary

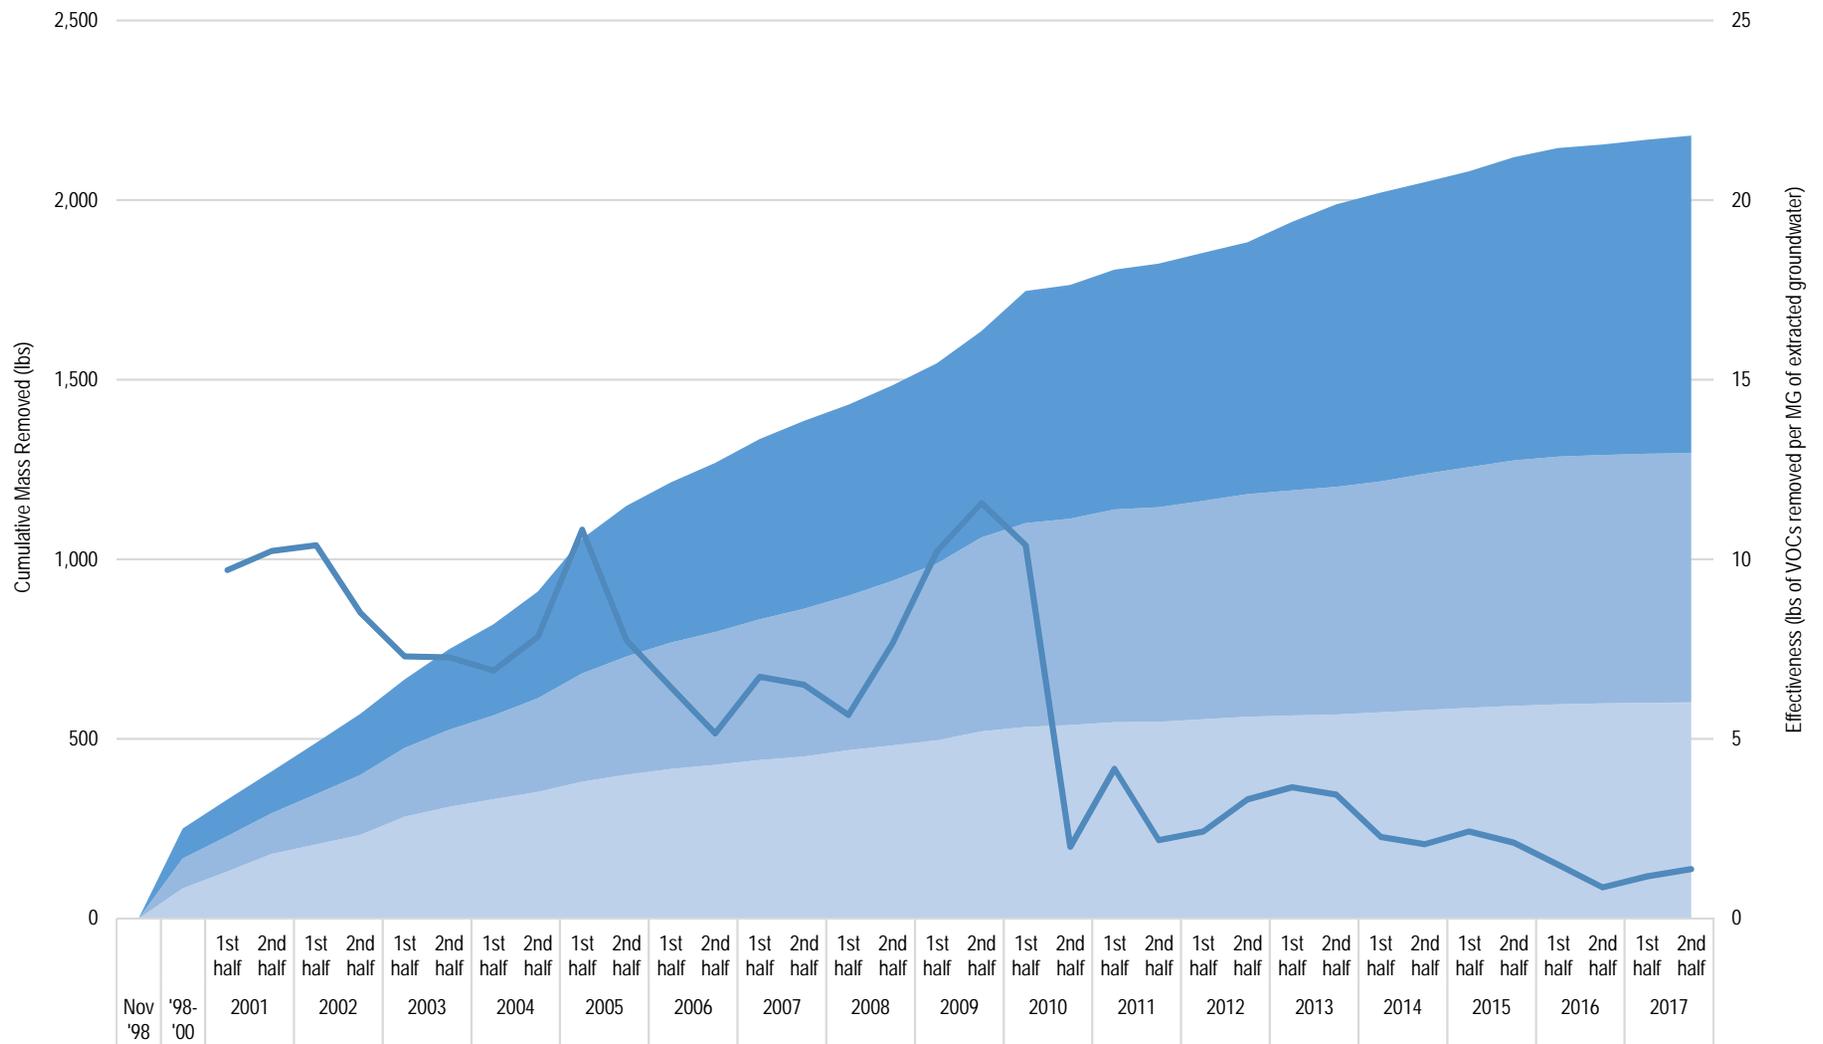
**FIGURE 5**  
**GWTS Cumulative Mass Removal - VOCs**  
*Fourth Five-Year Review Report*  
*Sangamo Weston Site, Pickens, South Carolina*

1,2-DCE = dichloroethene (total of cis-1,2-DCE + trans-1,2-DCE)  
 GWTS = groundwater treatment system  
 lbs = pounds  
 MG = million gallons  
 PCE = tetrachloroethene  
 TCE = trichloroethene  
 VOC = volatile organic compound

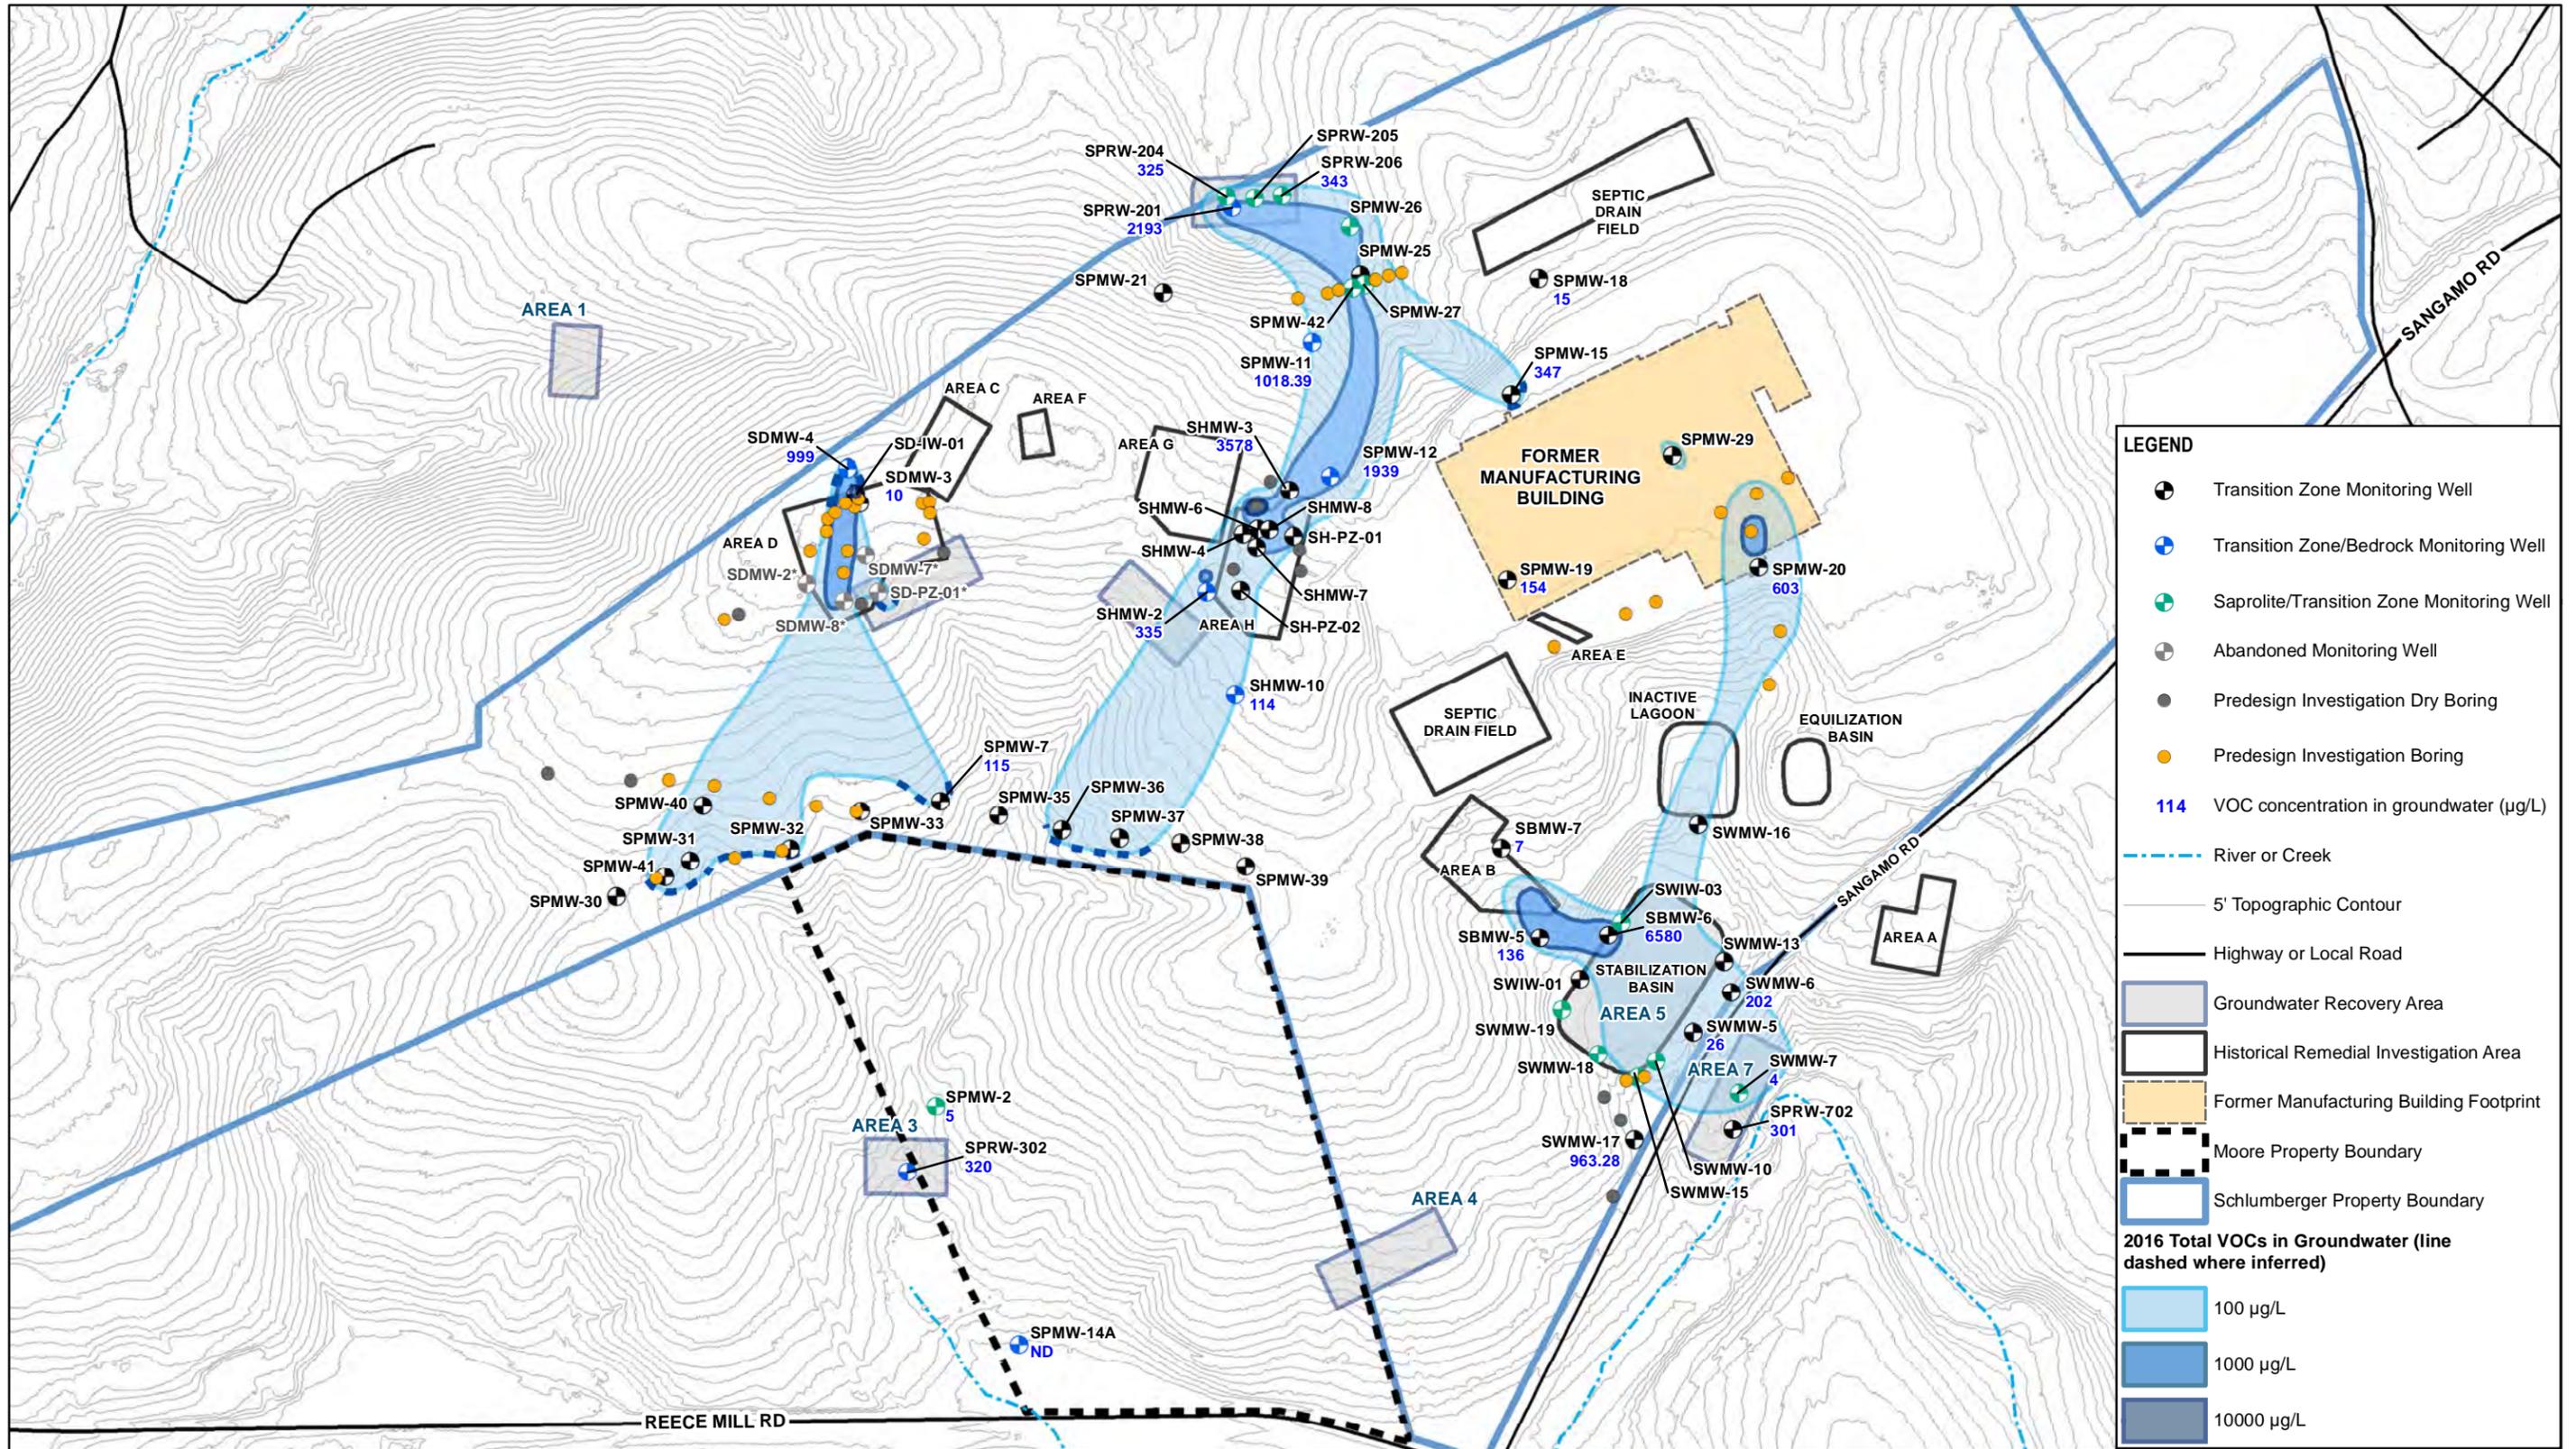
**Figure 7**  
**Plant Site VOC Plume Extents, 2016**  
*Fourth Five-Year Review Report*  
*Sangamo Weston Site, Pickens, South Carolina*

1. Wells screened exclusively in bedrock were excluded from the VOC plume contours.
2. \* Well abandoned in 2016
3. VOC plume developed using data from the 2016 Long Term Monitoring sampling and the 2016 Predesign Investigation.

In the Third FYR Report (EPA 2015), a recommendation was made for the Plant Site to evaluate and implement more sustainable remedial alternatives to reduce the dependence on the current pump and treat remedy, while continuing to protect surface waters and receptors. In 2015 and 2016, Additional Environmental Investigation (AEI) and Predesign Investigation were conducted to identify residual source zones that are sustaining VOC and PCB groundwater plumes and groundwater migration pathways from source zones (for example, Area D, Area H, and the Former Manufacturing Building [FMB] area) to discharge areas (for example, Areas 2, 3, and 5). Data gathered during these investigations served to refine the conceptual site model which was presented in the 2016 Annual Report and evaluate alternative treatment systems for the Plant Site that could be a viable replacement for the existing pump and treat system (CH2M 2016a). The total VOC and PCB plume extents as defined by the AEI and Predesign investigations completed in 2015 and 2016 are shown on **Figure 7** and **Figure 8**, respectively.

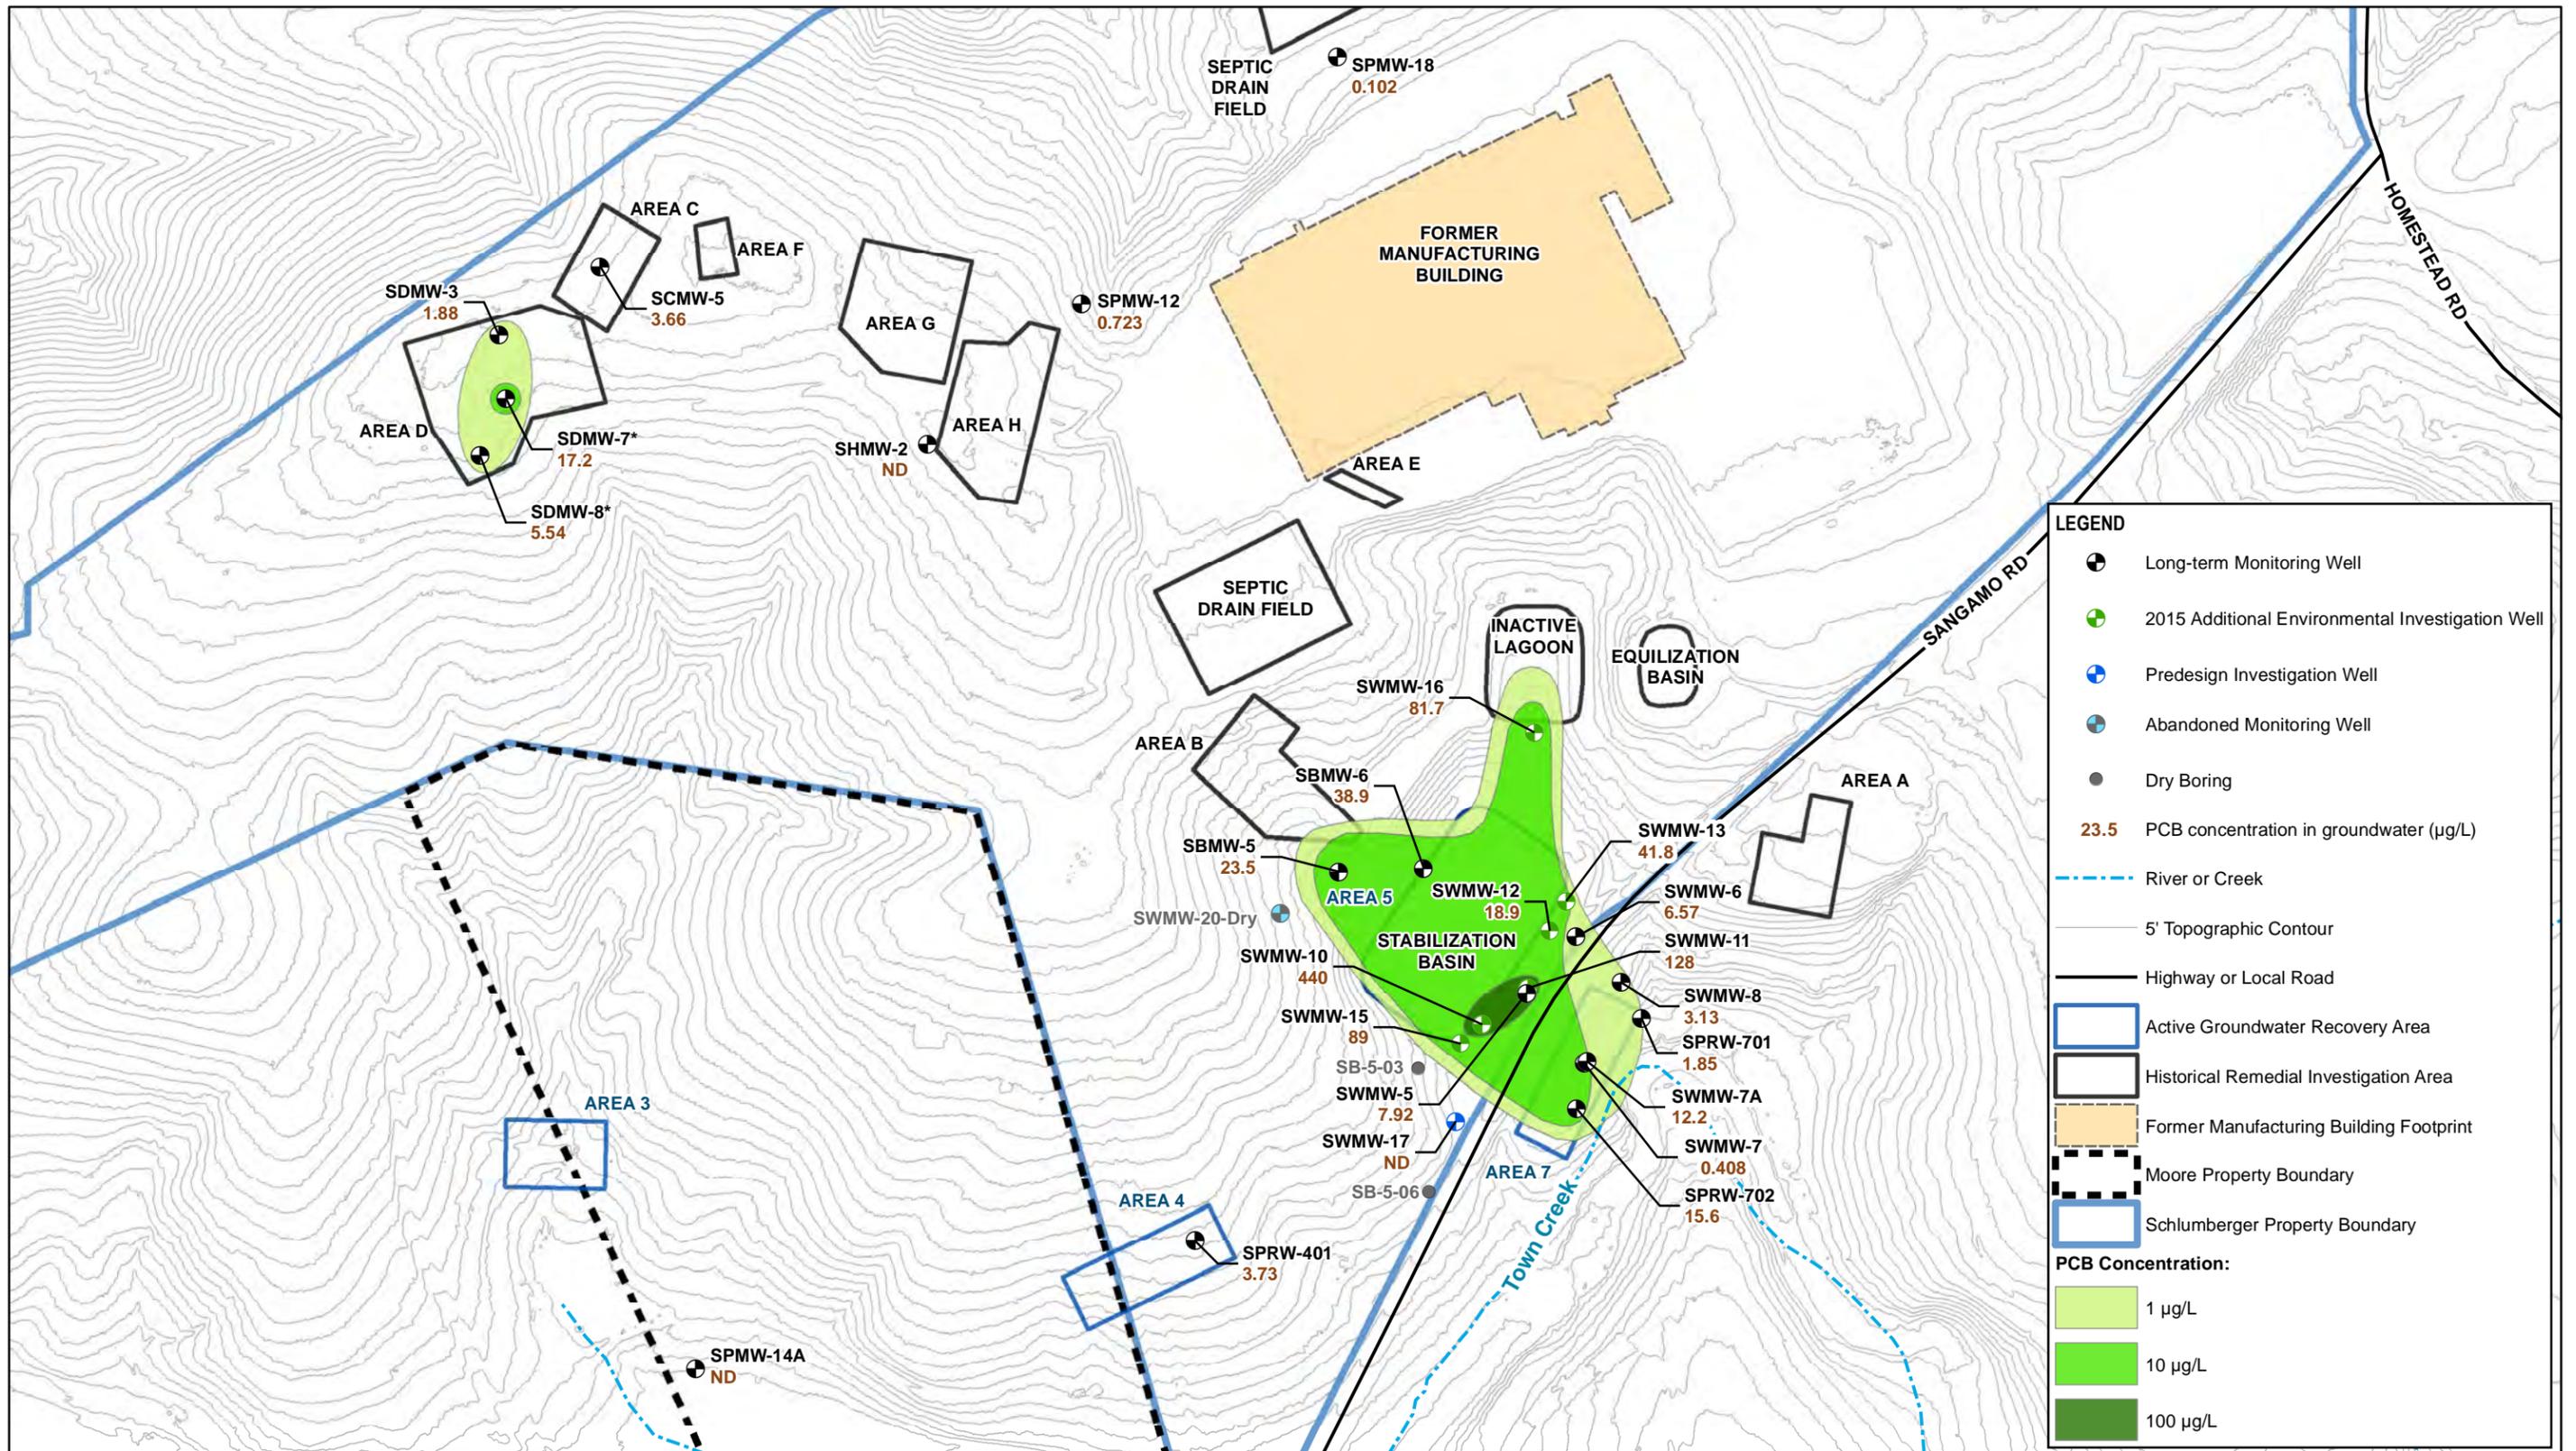
**Figure 8**  
**Plant Site PCB Plume Extent, 2016**  
 Fourth Five-Year Review Report  
 Sangamo Weston Site, Pickens, South Carolina

**Notes:**  
 1. \* Well abandoned in 2016 before excavation

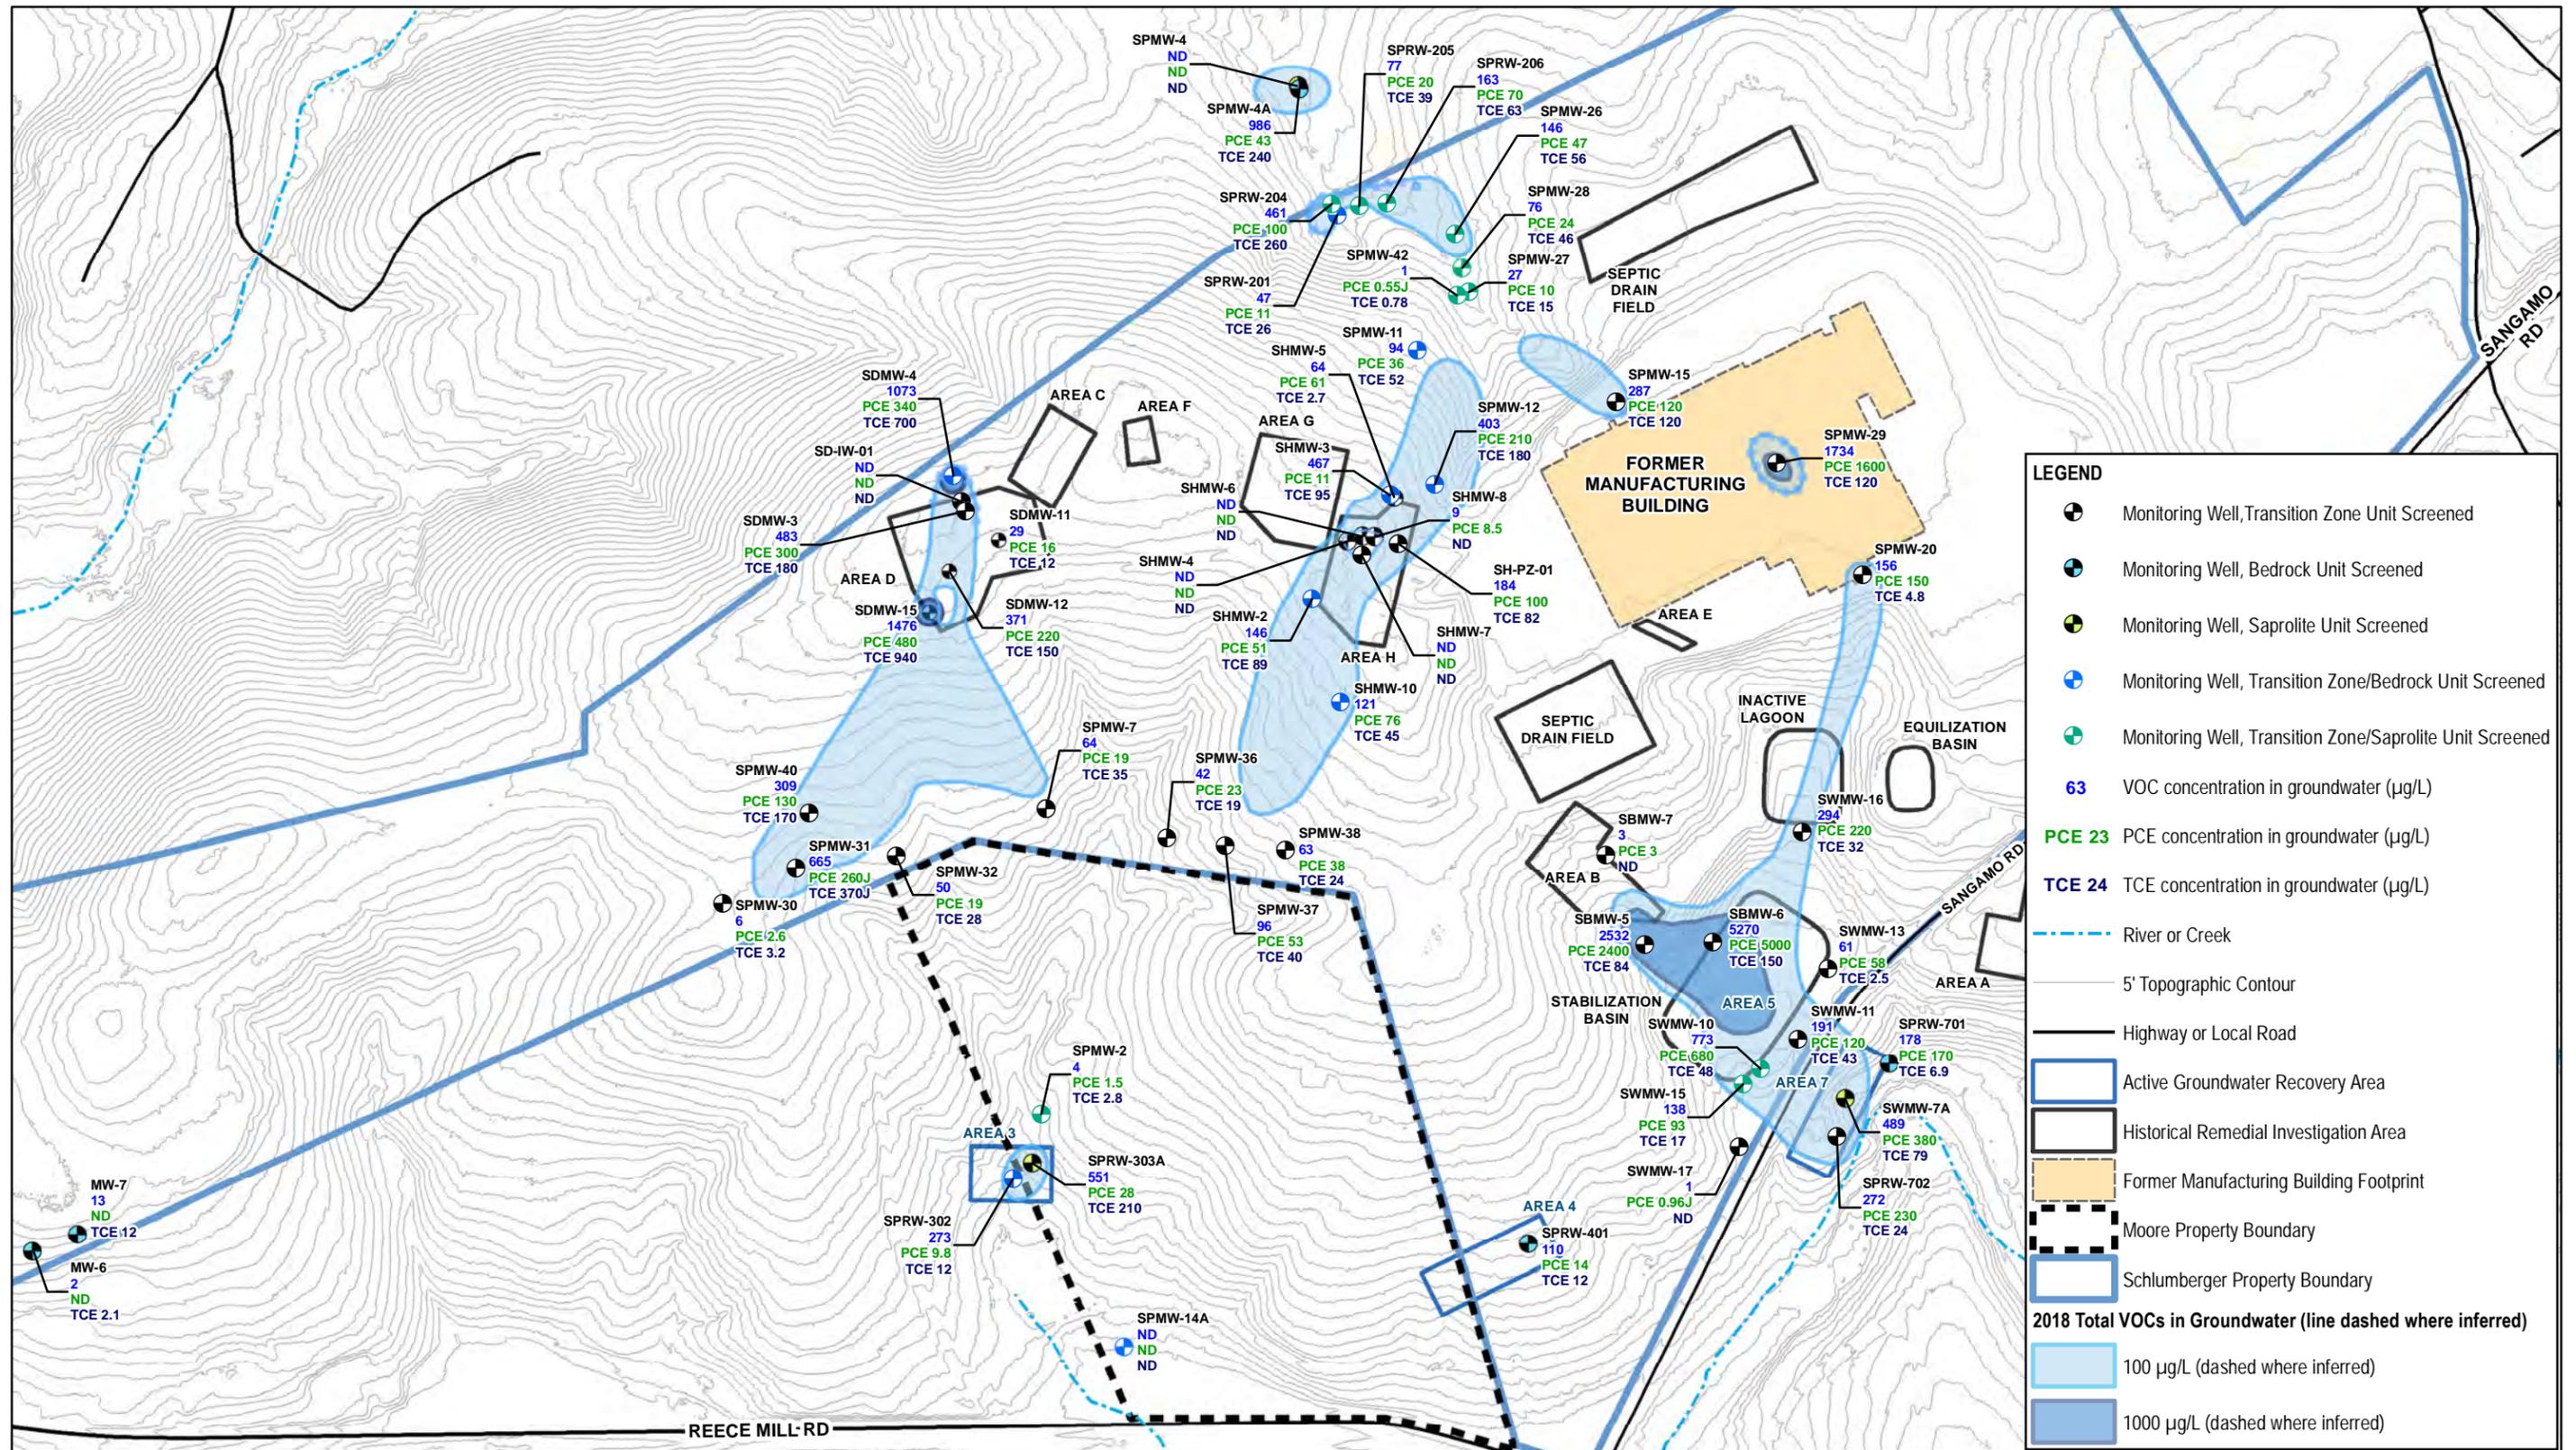
**Figure 9**  
**Plant Site VOC Plume Extents, March 2018**  
*Fourth Five-Year Review Report*  
*Sangamo Weston Site, Pickens, South Carolina*

- VOC plume developed using data from the 2018 LTM biennial and the March 2018 UIC groundwater sampling events. Please refer to figures in section 4 through section 6 for more detail about the March 2018 sampling events.
- Wells screened exclusively in bedrock were excluded from the VOC plume contours.

Overall, the extent and the magnitude of VOC contamination have been significantly reduced compared to those noted in March 2014. Two plumes with total VOC concentrations greater than 1,000 µg/L (with a combined approximate area of 1.5 acres) that were previously observed in Area 2 and Area H in March 2014 were no longer present in March 2018. Changes in the VOC plume extents are a result of the continued groundwater pump and treat as well as several contaminated soil excavations (Areas B, D and H) and recent ISCO and AS pilot studies. Concentration trend graphs of PCE, TCE, and DCE isomers for wells with three or more data points are provided in the 2018 Annual Report (CH2M 2018a). The extent of PCB contamination at Area D is smaller than that noted in March 2016, while the extent of PCB contamination at other areas remains stable.

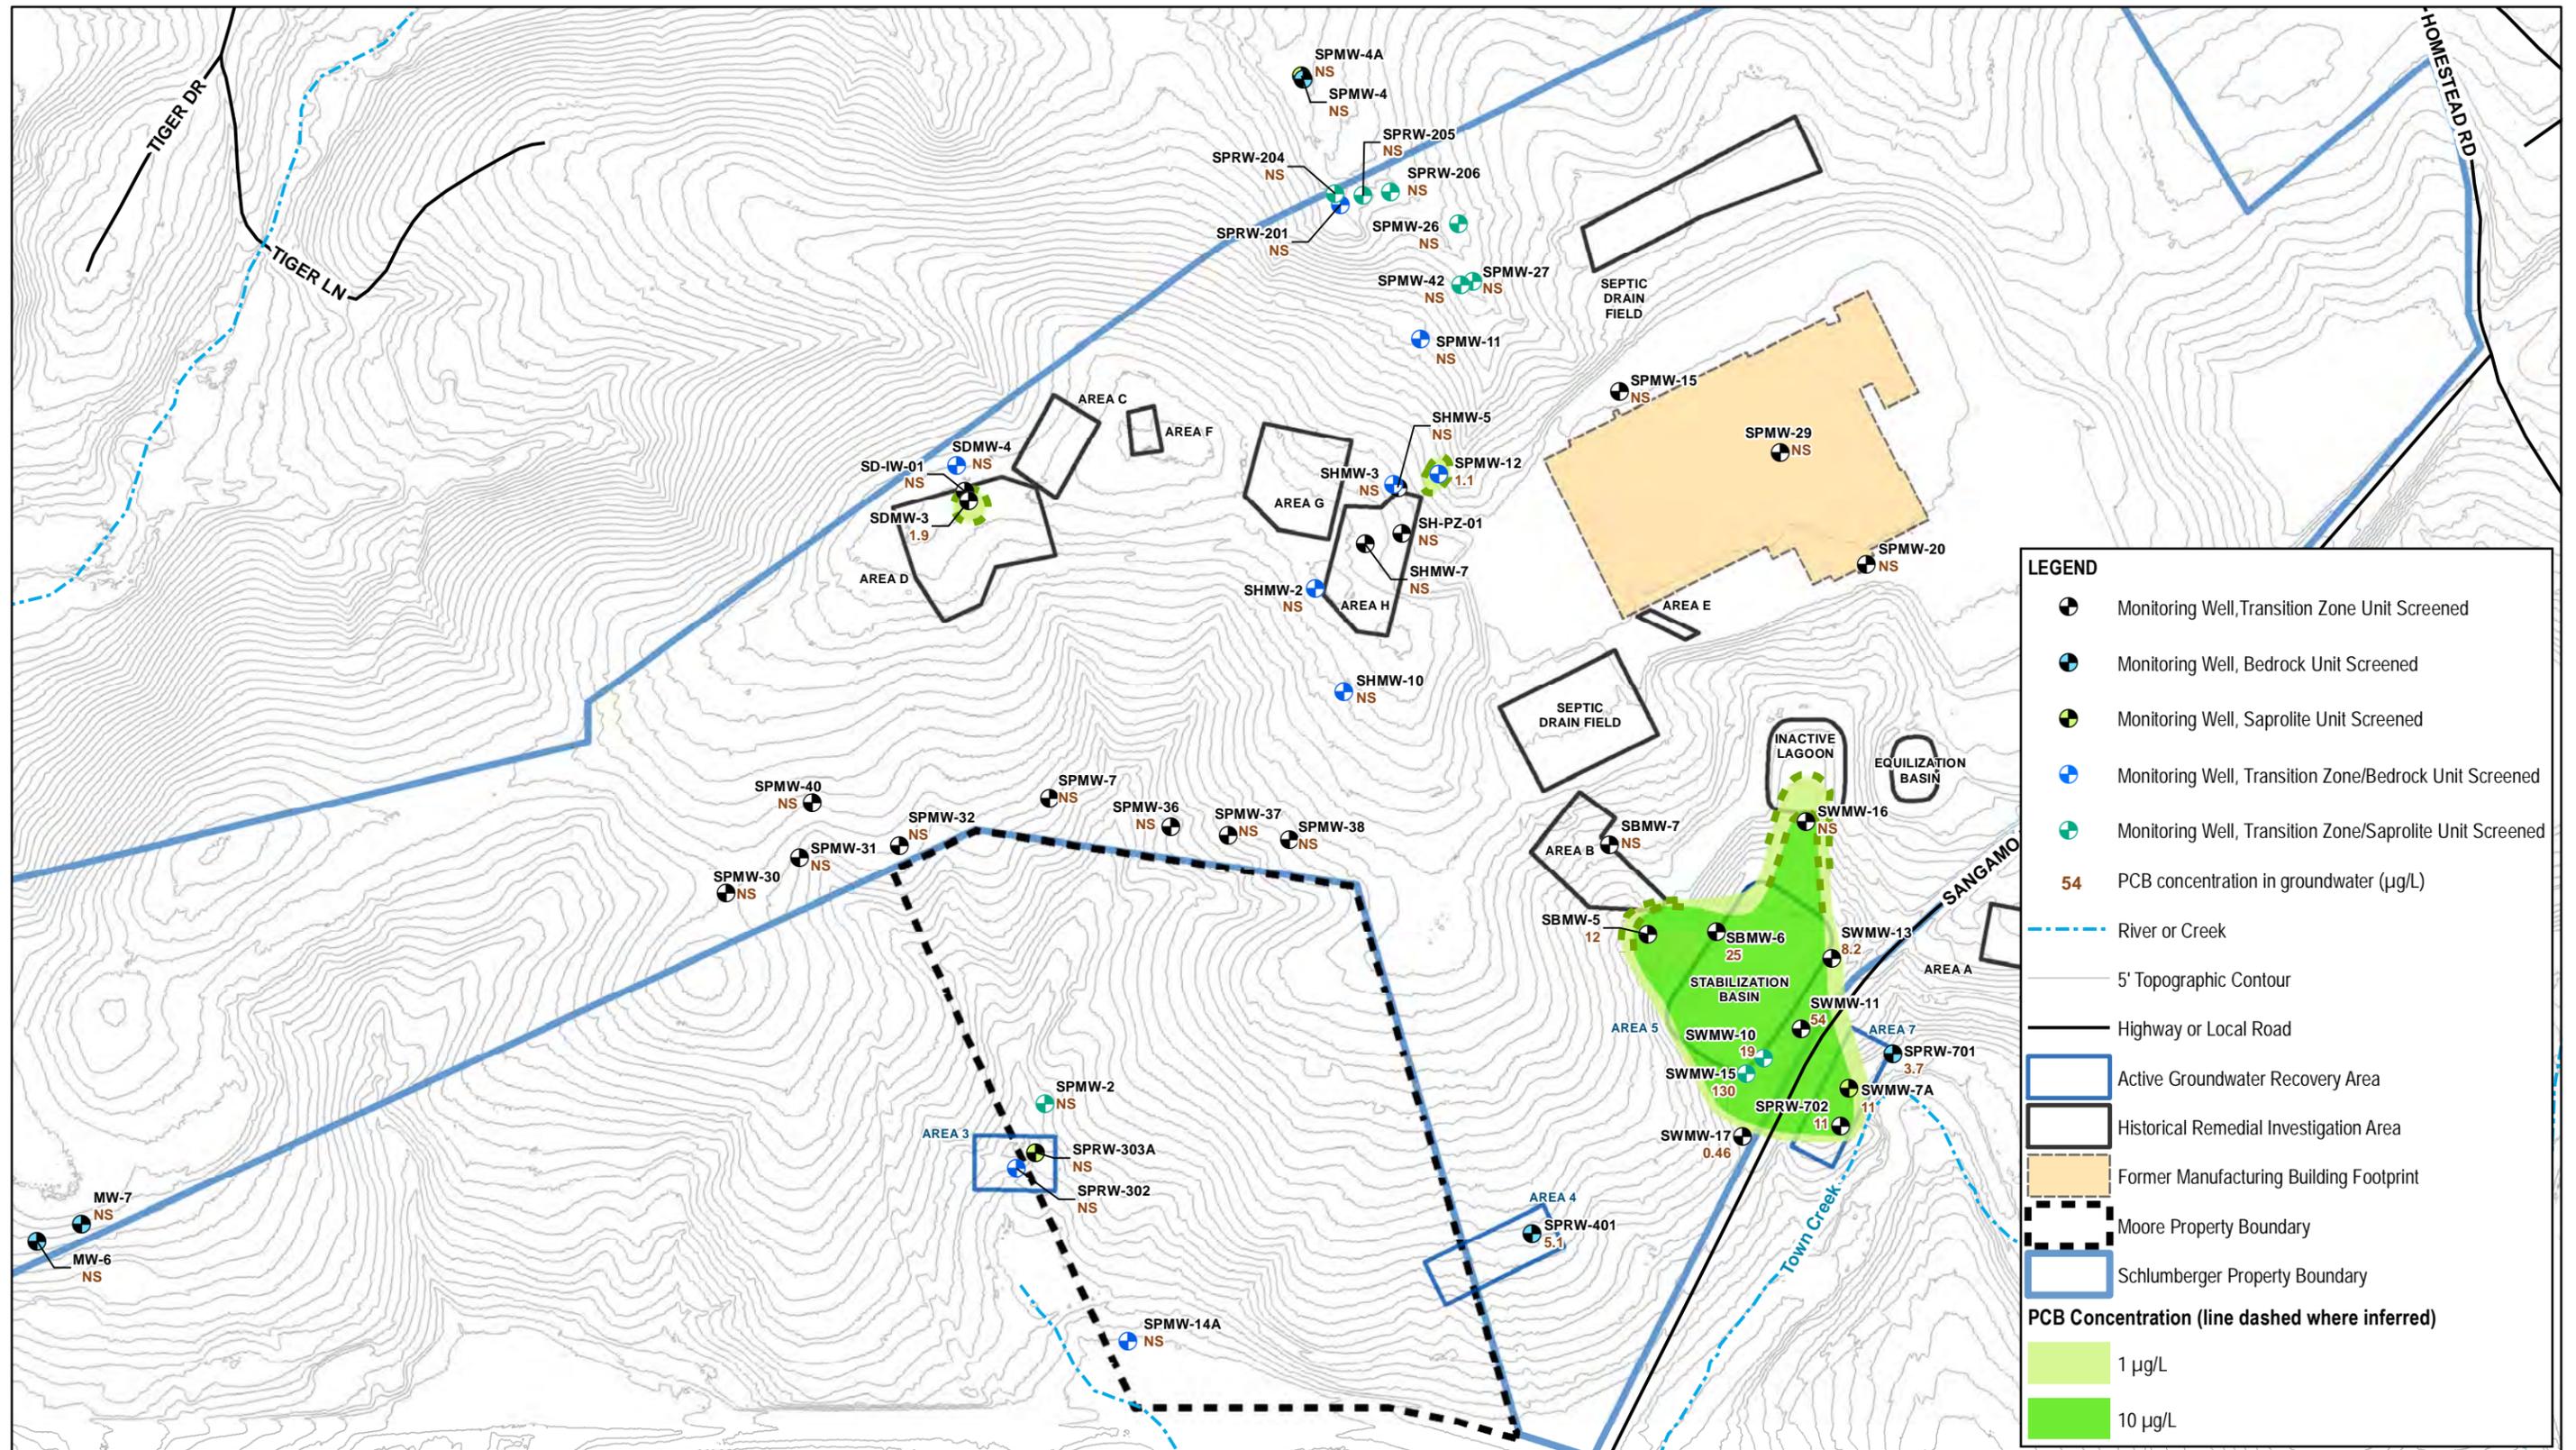
**Figure 10**  
**Plant Site PCB Plume Extent, March 2018**  
*Fourth Five-Year Review Report*  
*Sangamo Weston Site, Pickens, South Carolina*

**Notes:**  
 1. PCB plume developed using data from the 2018 LTM biennial groundwater sampling event.  
 2. Wells screened exclusively in bedrock were excluded from the PCB plume contours.
