**FOURTH FIVE-YEAR REVIEW REPORT  
SANGAMO WESTON/TWELVEMILE CREEK/LAKE HARTWELL PCB  
CONTAMINATION SUPERFUND SITE  
PICKENS COUNTY, SOUTH CAROLINA**

**U.S. Environmental Protection Agency  
Region 4 Superfund Division  
61 Forsyth Street, SW  
Atlanta, Georgia 30303**

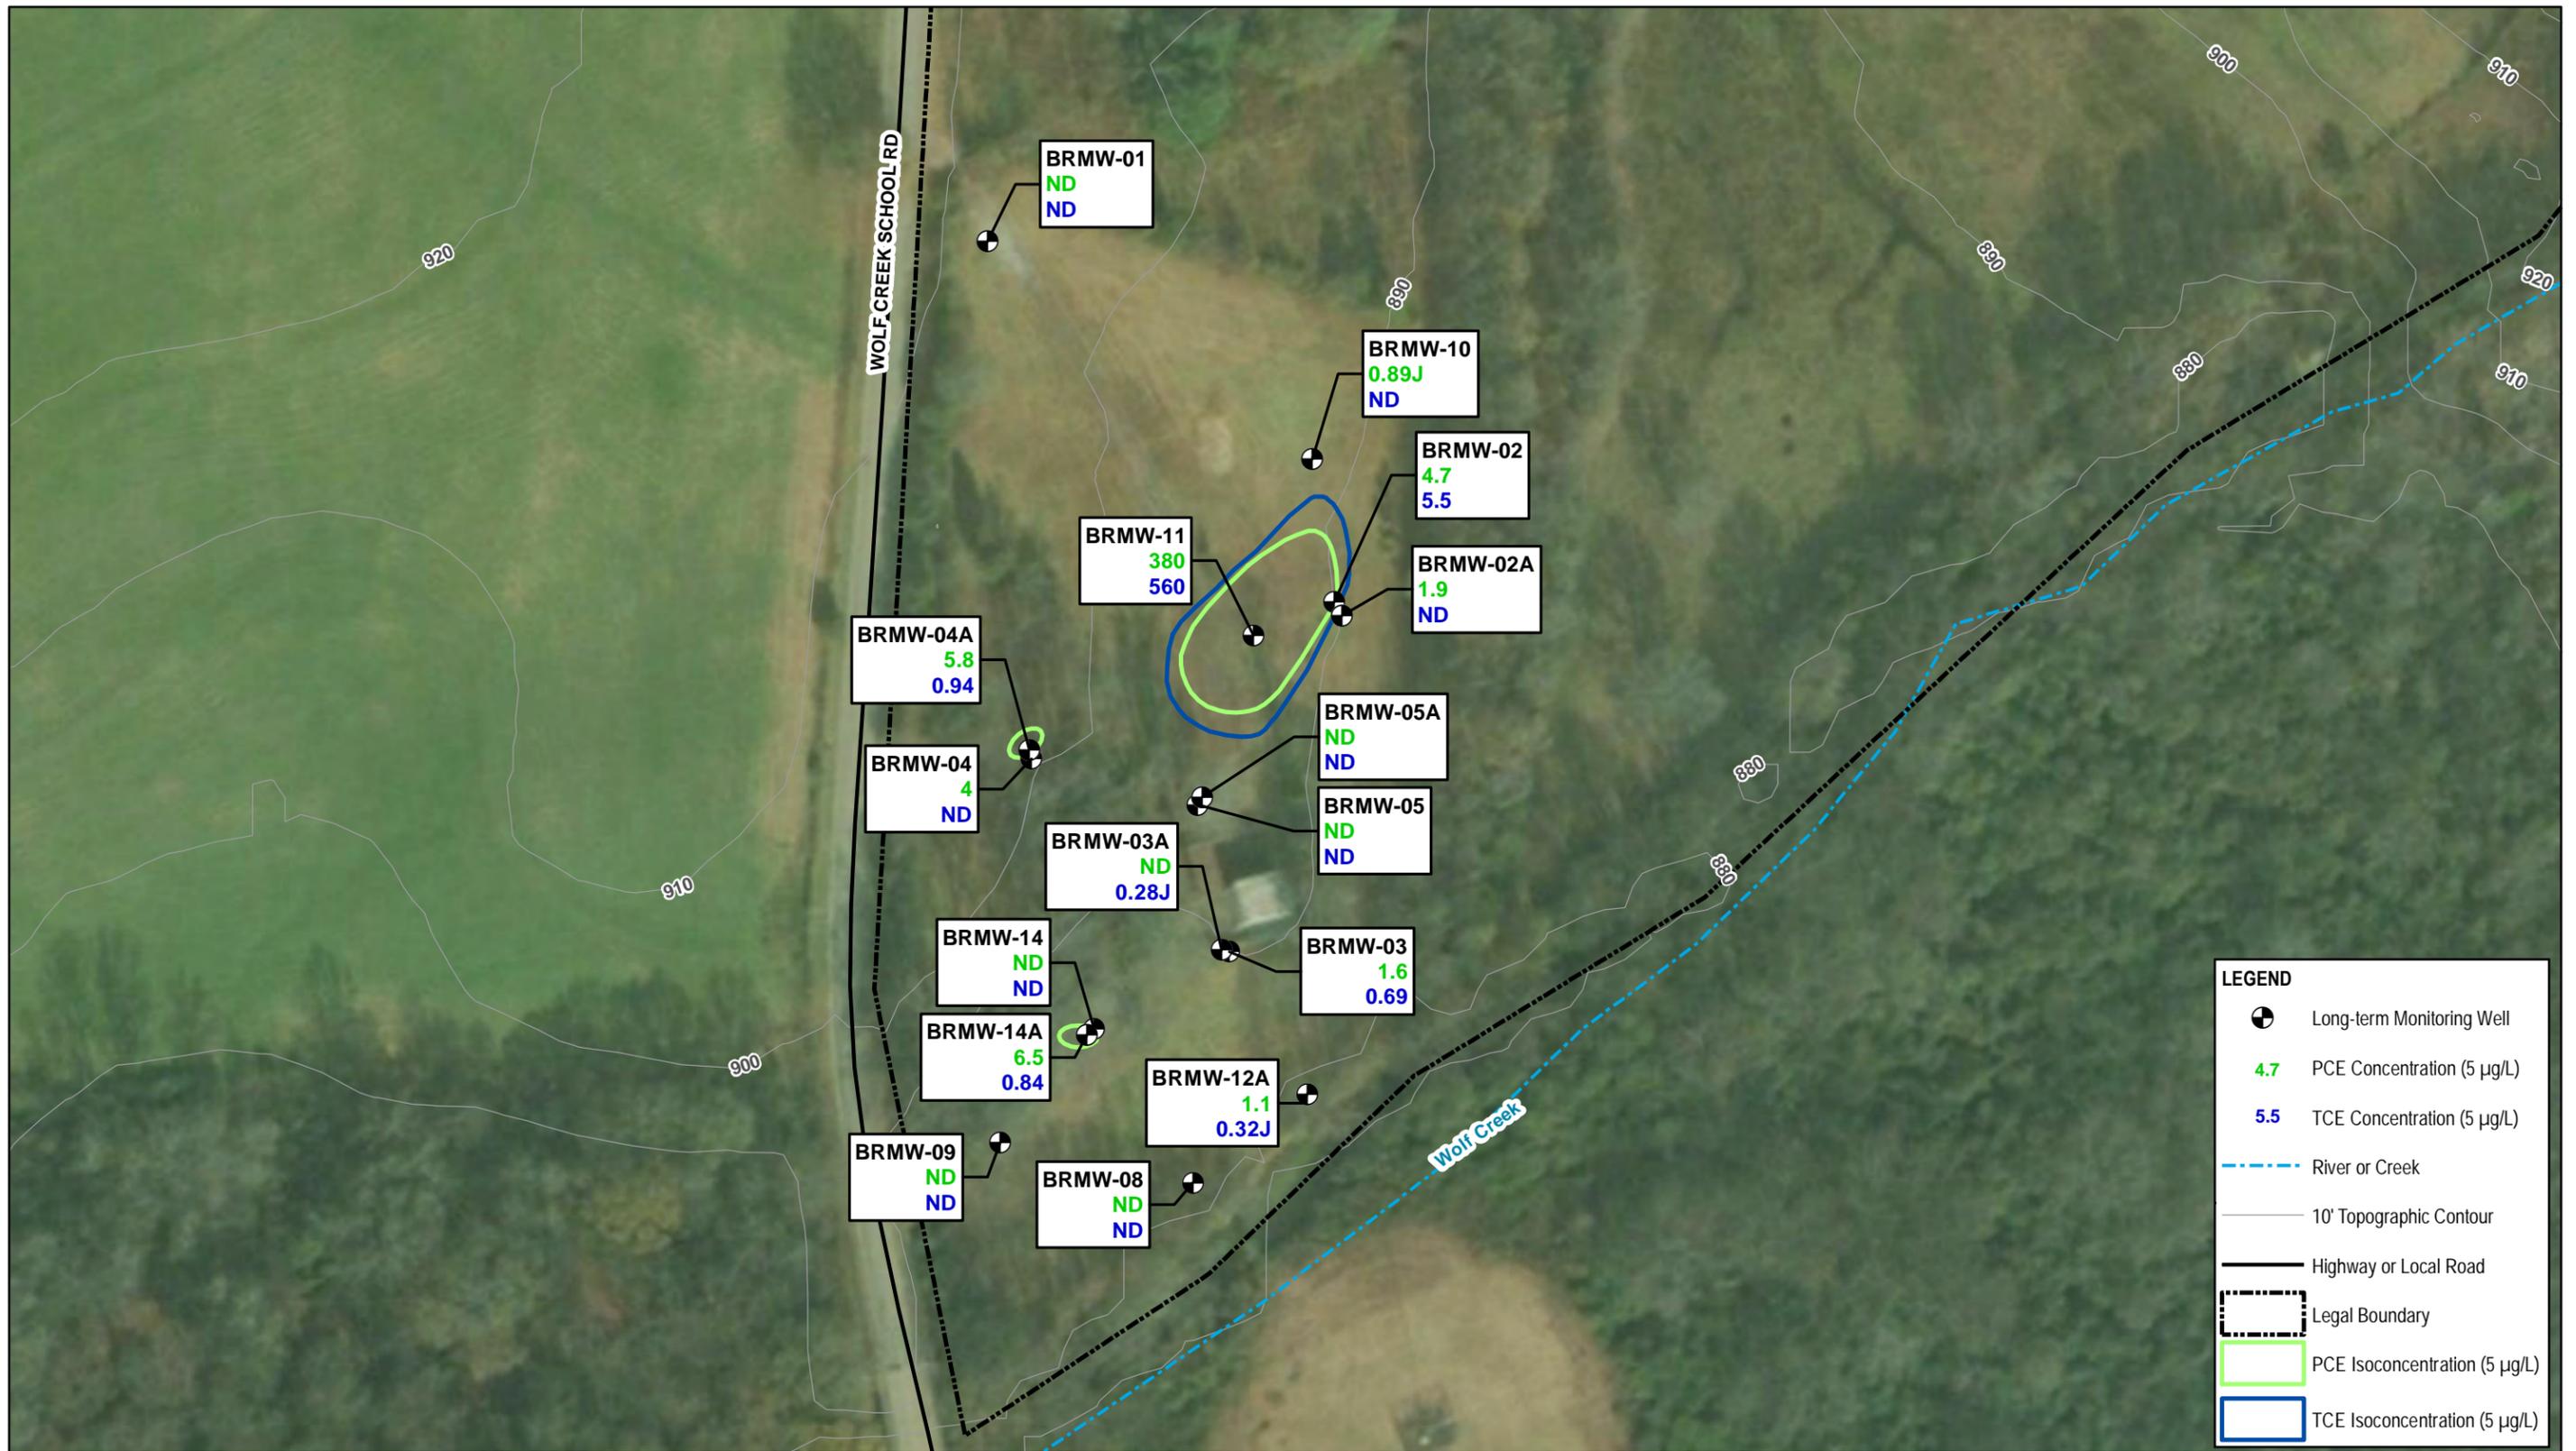
**Figure 11**  
Breazeale Site PCE and TCE Concentrations in Groundwater, March 2018  
*Fourth Five-Year Review Report*  
*Sangamo Weston Site, Pickens, South Carolina*

**Notes:**  
PCE and TCE plumes developed using data from the 2018 LTM biennial groundwater sampling event.  
**Acronyms:**  
J = estimated concentration  
µg/L = micrograms per liter  
ND = not detected  
PCE = tetrachloroethene  
TCE = trichloroethene

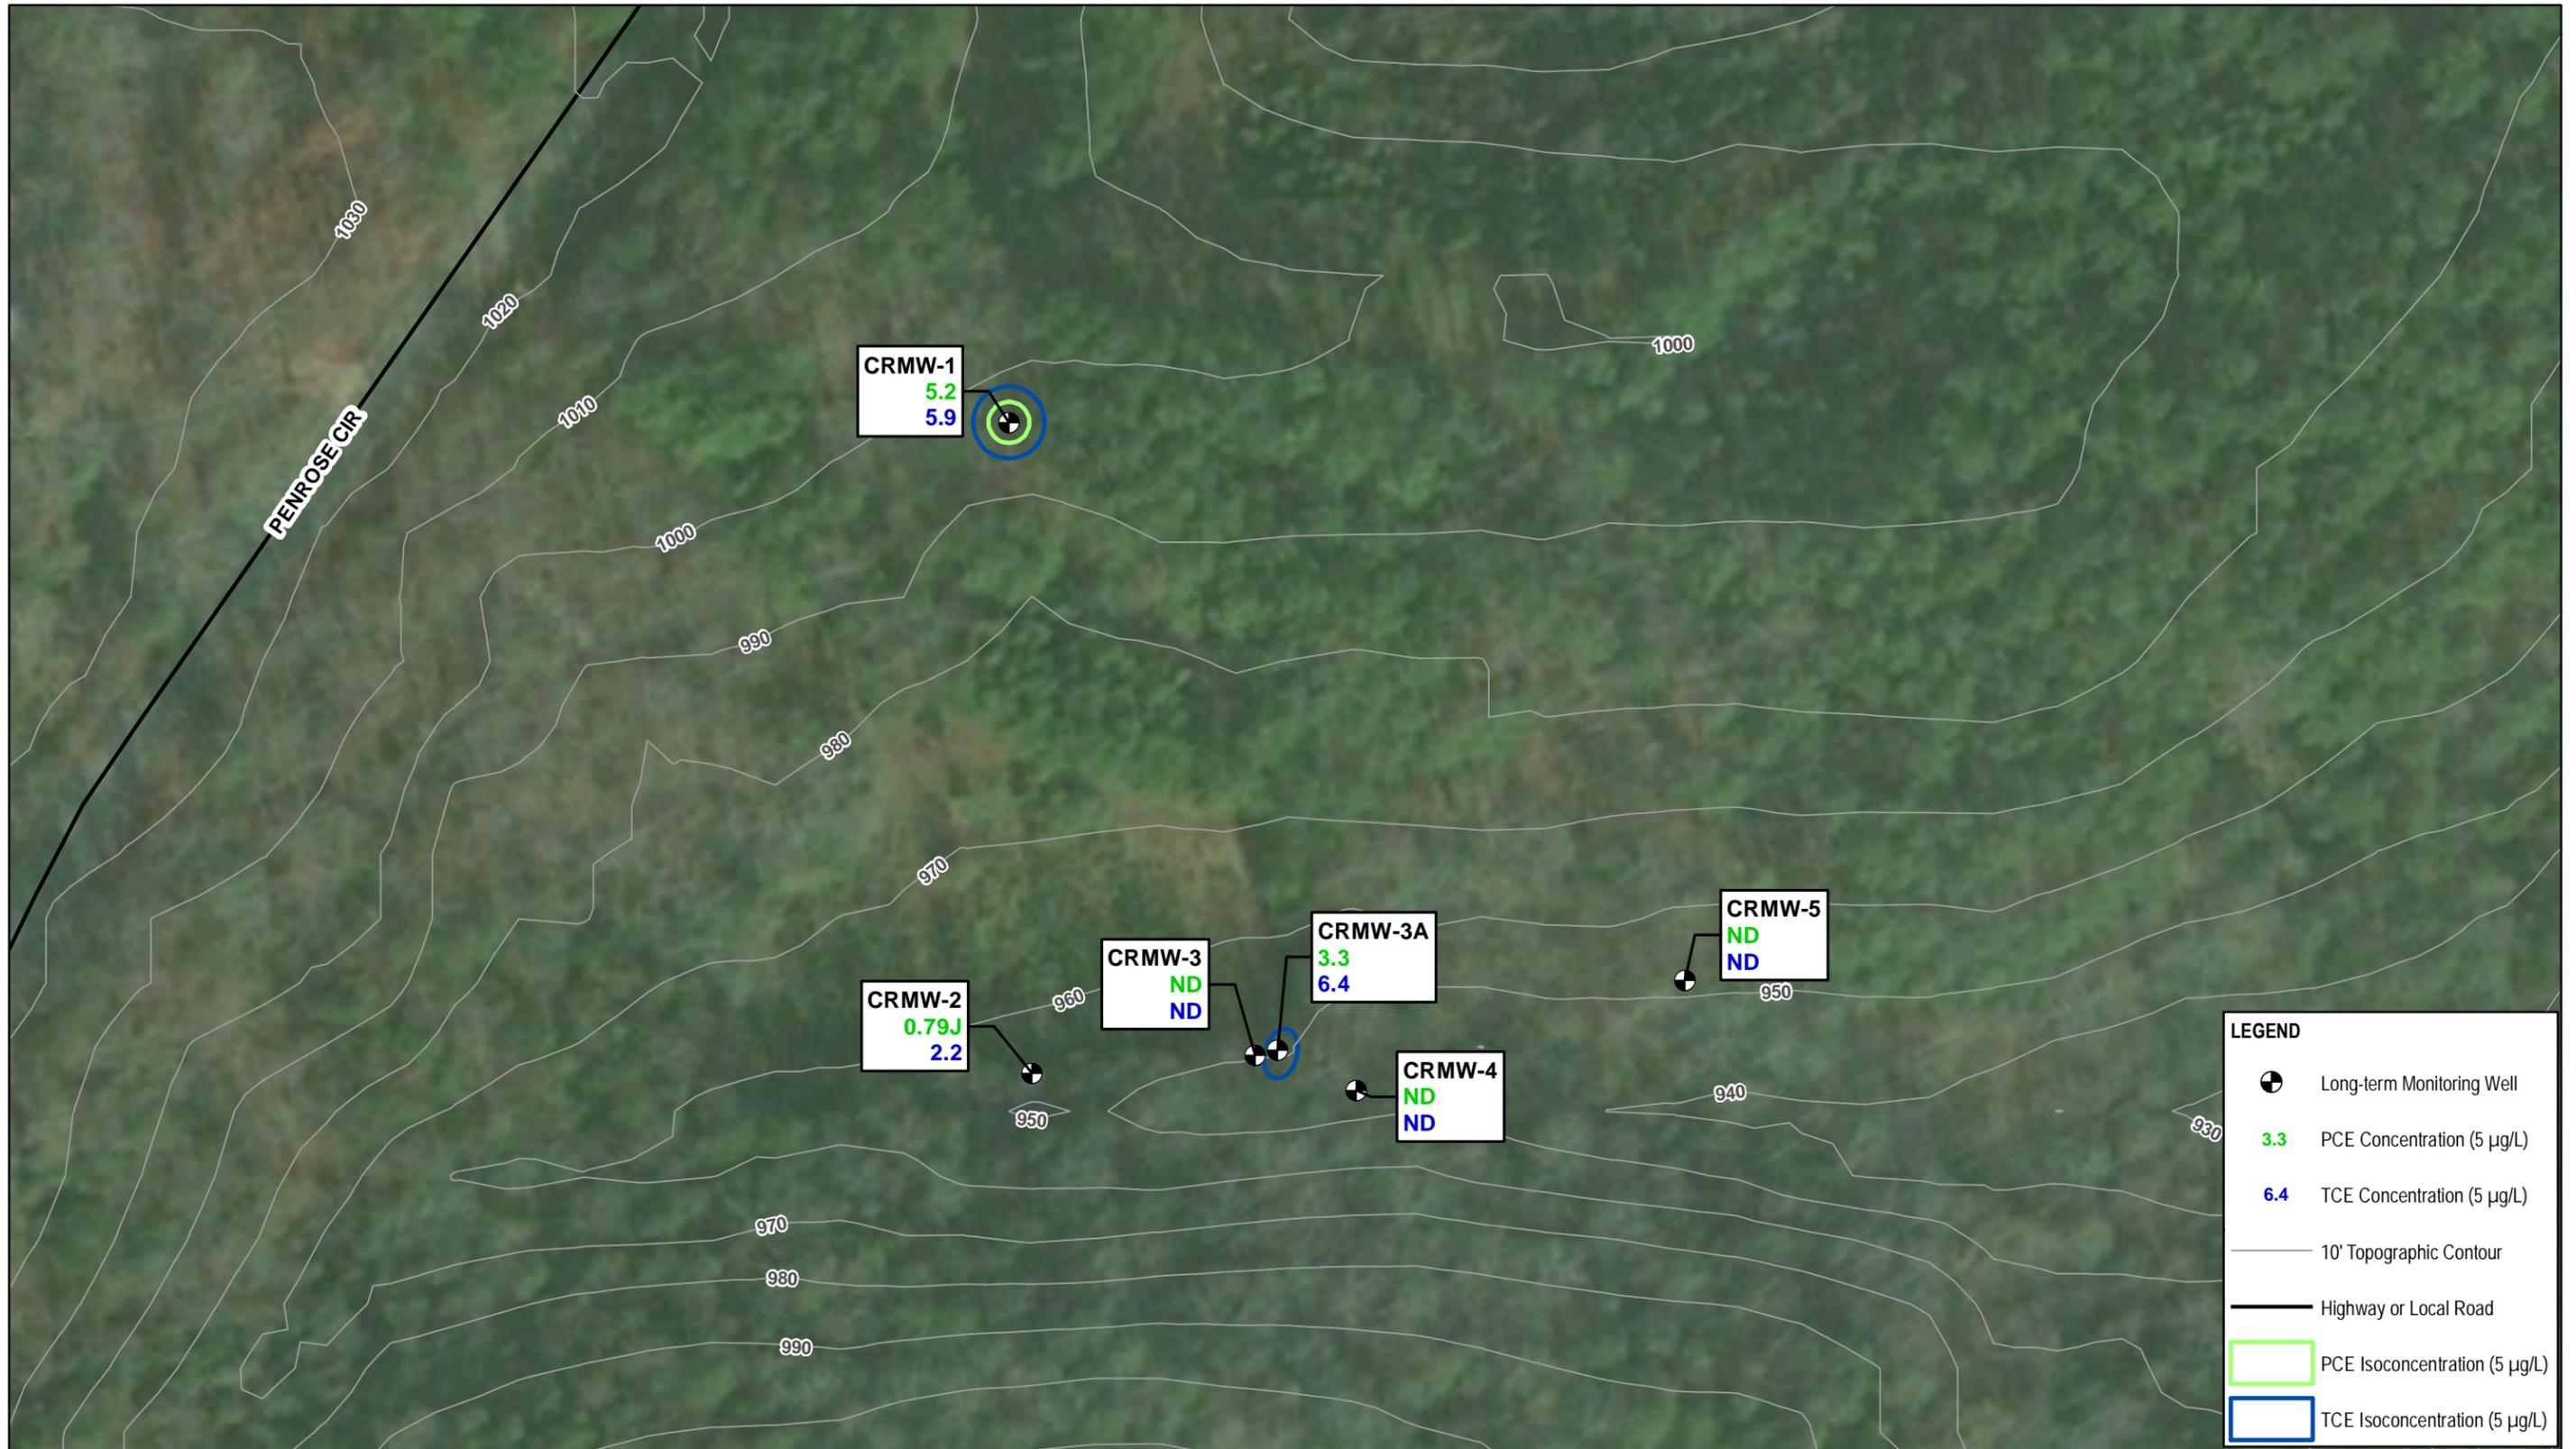
**Figure 12**  
**Cross Roads Site PCE and TCE Concentrations in Groundwater, March 2018**  
*Fourth Five-Year Review Report*  
*Sangamo Weston Site, Pickens, South Carolina*

**Notes:**  
PCE and TCE plumes developed using data from the 2018 LTM biennial groundwater sampling event.

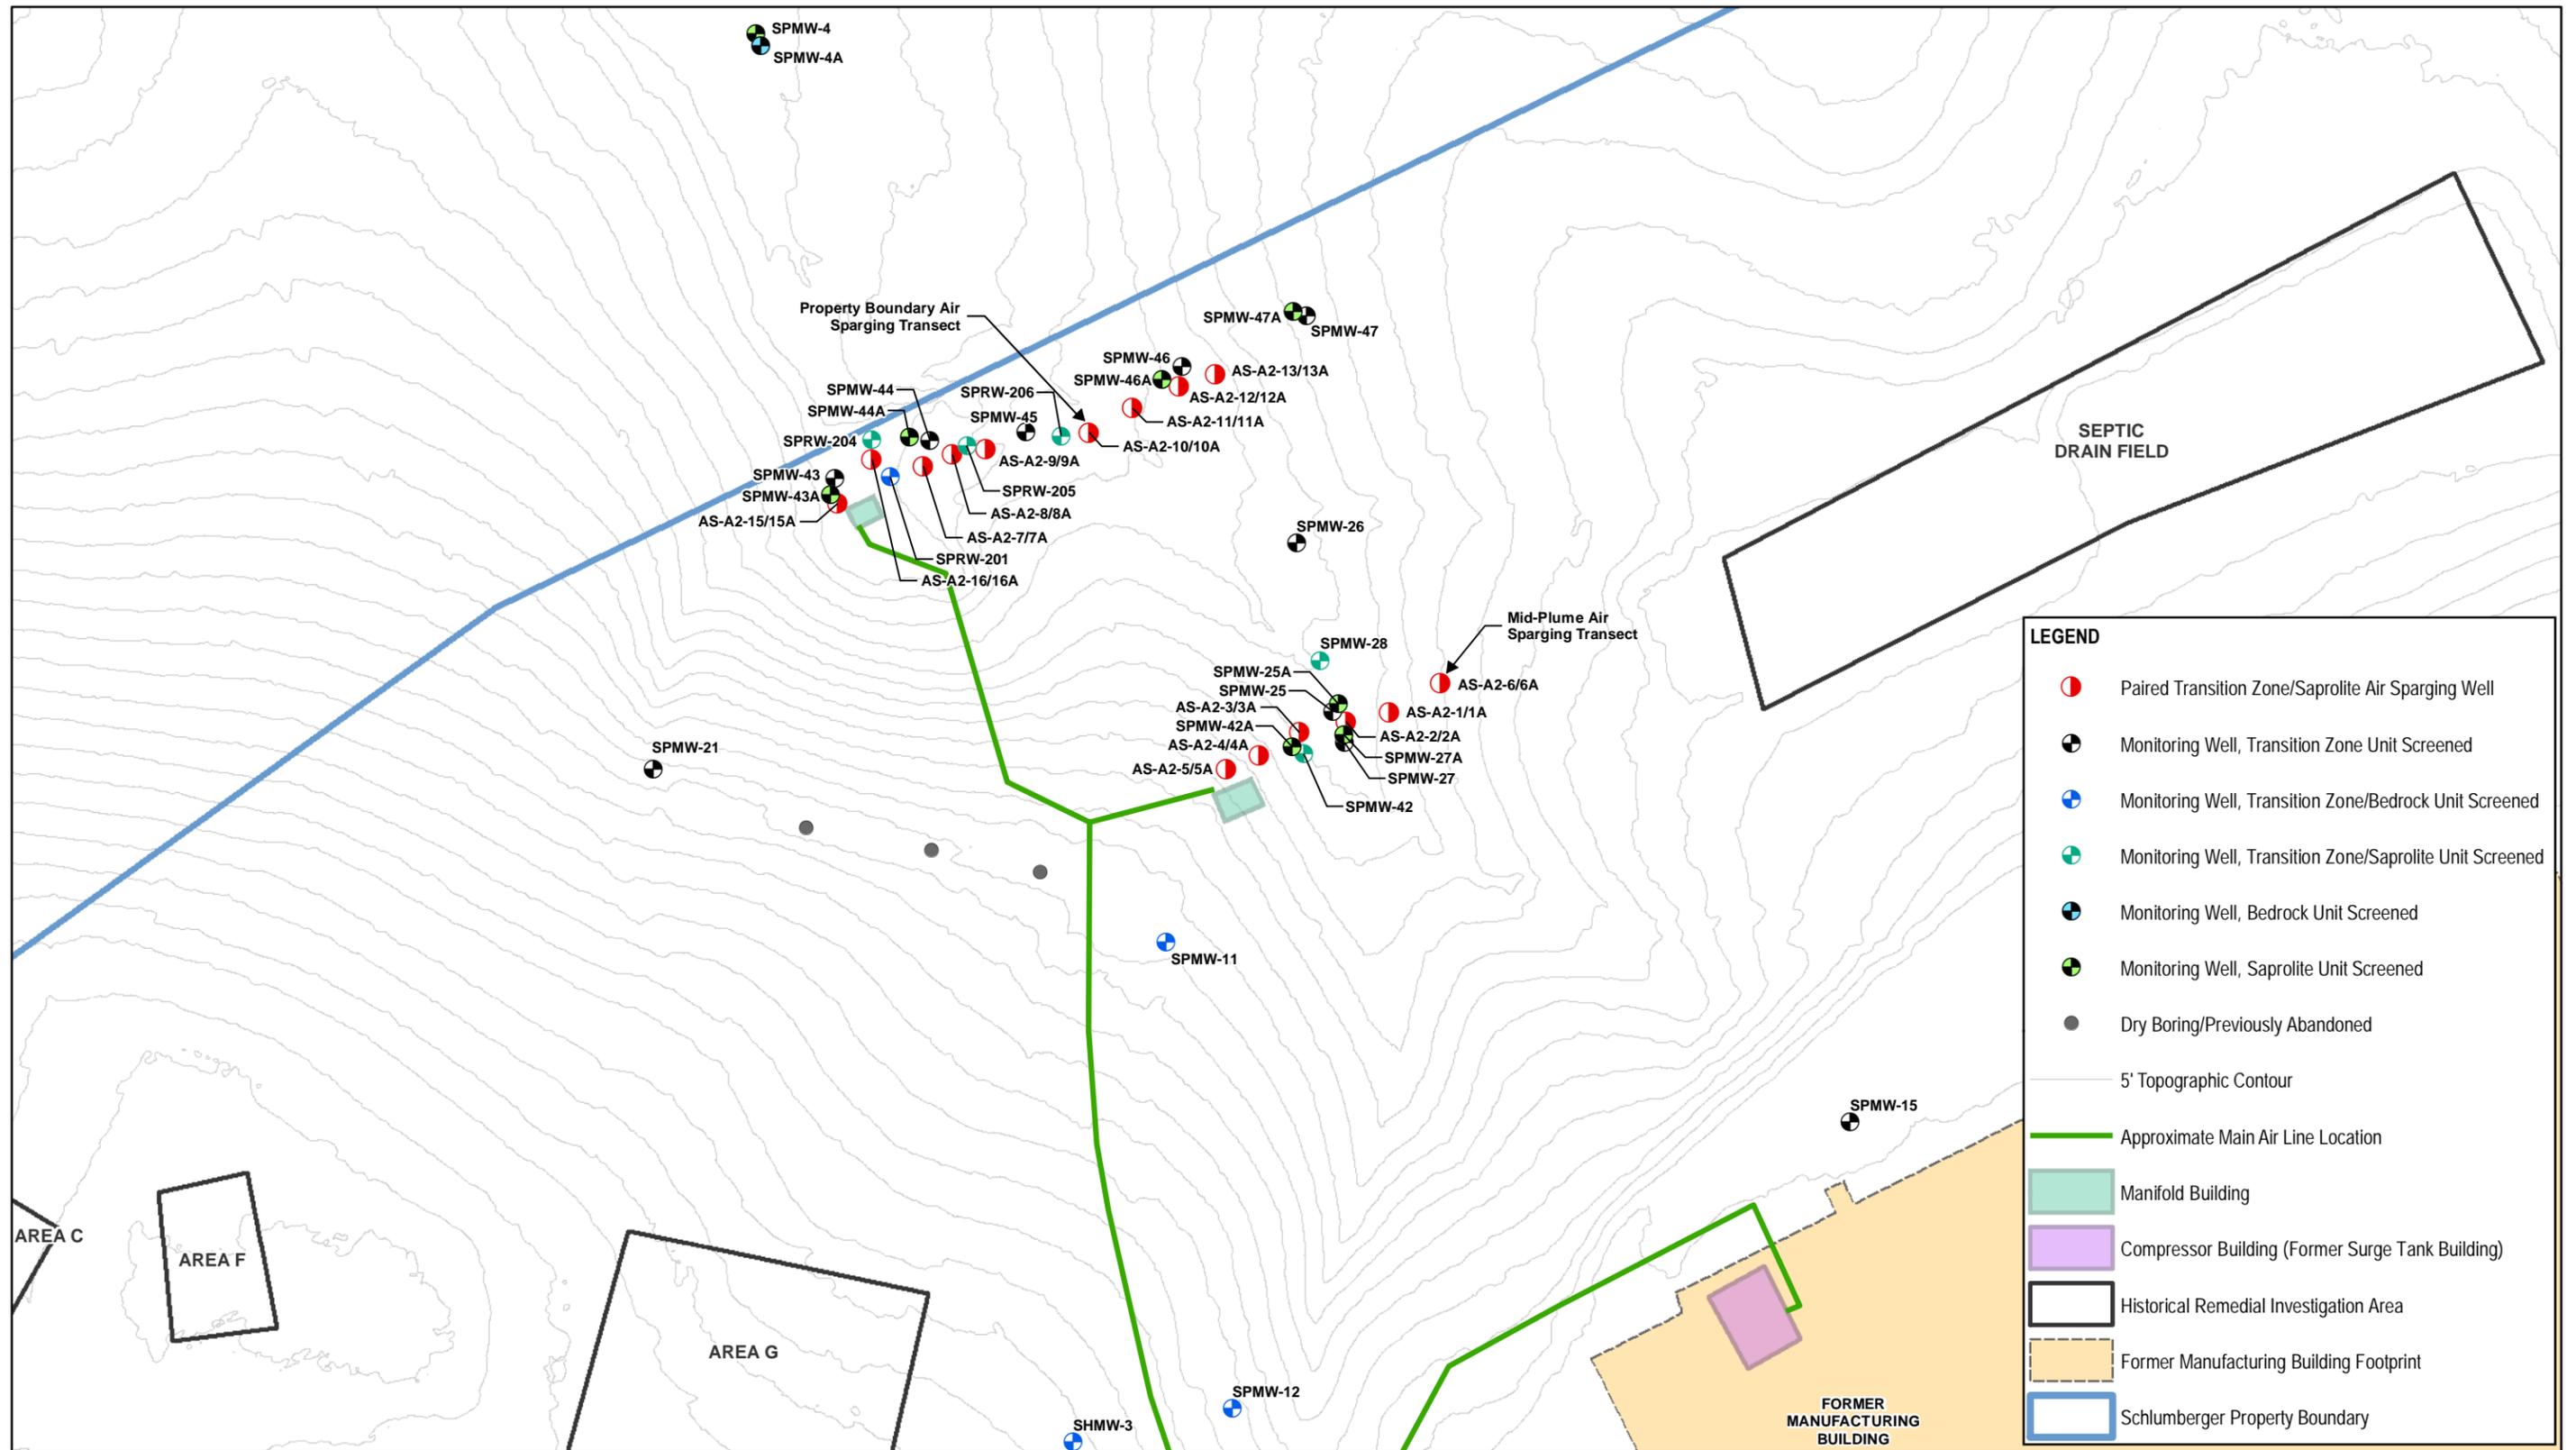
**Figure 15**  
**Area 2 Air Sparging Pilot Study Layout**  
 Fourth Five-Year Review Report  
 Sangamo Weston Site, Pickens, South Carolina

**Notes:**  
 AS wells AS-A2-1, 2, 3, 4, 2A, and 3A were installed as part of the Area 2 Phase I Air Sparging Pilot Study  
 Individual air lines are run to each AS well from the manifold building

- **Area 2.** In 2016, Phase I of a pilot study was completed to evaluate if AS could effectively reduce VOC concentrations in groundwater and ultimately replace the existing groundwater extraction system in this area. Four transition-zone AS wells and two saprolite AS wells were installed in October 2016 as the mid-plume transect, which is approximately 300 feet hydrologically upgradient from the property boundary. The Phase I AS system began operation in November 2016. An additional 14 transition-zone AS wells and 16 saprolite AS wells were installed between August and December 2017 as part of Phase II of the pilot study. The objective was to expand the Phase I AS system to span the plume and evaluate AS effectiveness along the property boundary where the groundwater table was closer to the ground surface. After the expansion, the property boundary transect consists of nine paired AS wells and the mid-plume transect consists of six paired AS wells. Three AS locations along the property boundary began operation in November 2017, and the complete Phase II AS system has been operating since March 2018. Since pilot start up, the system appears to be significantly reducing VOC concentrations in groundwater.

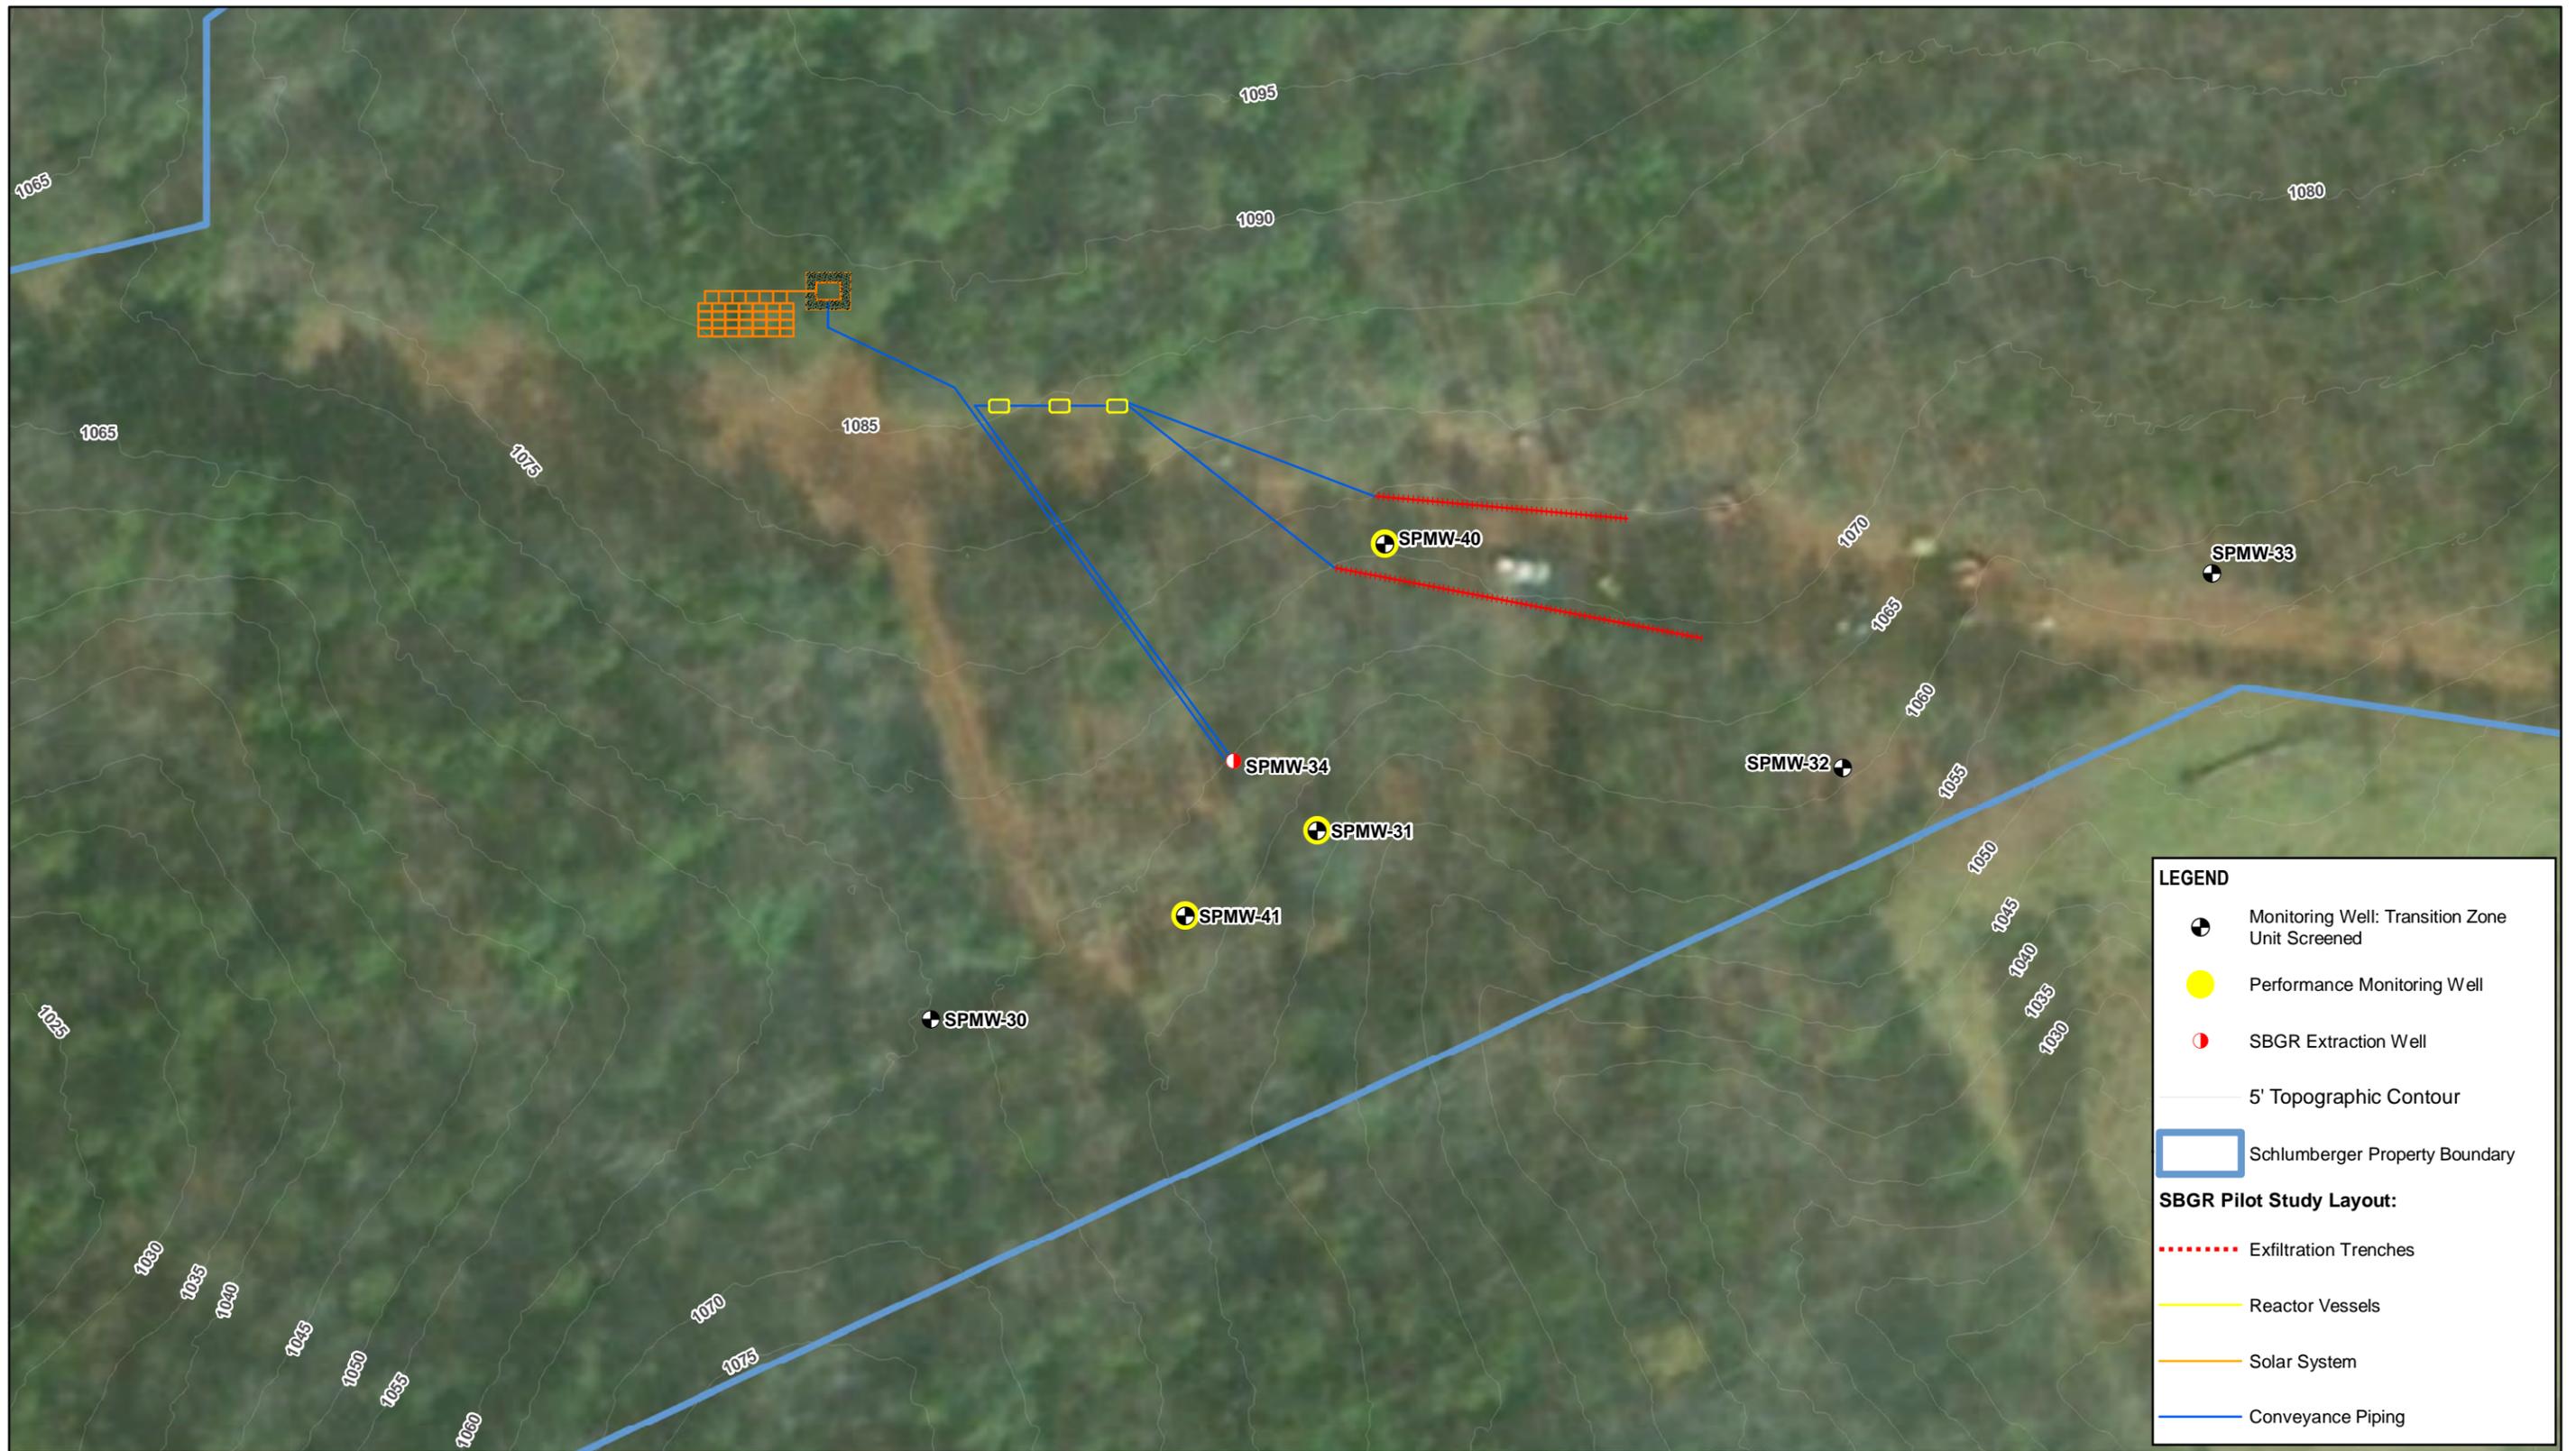
**Figure 16**  
**Area 3 SBGR Pilot Study Layout**  
*Fourth Five-Year Review Report*  
*Sangamo Weston Site, Pickens, South Carolina*

**Notes:**  
 SBGR = Subgrade biogeochemical reactor

- **Area 3.** In June 2018, a pilot study was initiated to evaluate the feasibility of replacing the existing groundwater recovery system with a subgrade biogeochemical reactor (SBGR) (CH2M 2018c). The SBGR technology promotes abiotic degradation of VOCs using zero-valent iron, which can completely break down PCE and TCE based on bench-scale testing results. The SBGR was installed in June 2018 and went through optimization testing until September 2018 when the pilot study began (CH2M 2018c). Since pilot study start up, the system has continued to reduce VOC concentration in groundwater, the SBGR is functioning as intended in parallel with upgradient source treatment at Areas D and H, and the solar system that powers the SBGR is operating as designed (CH2M 2019).

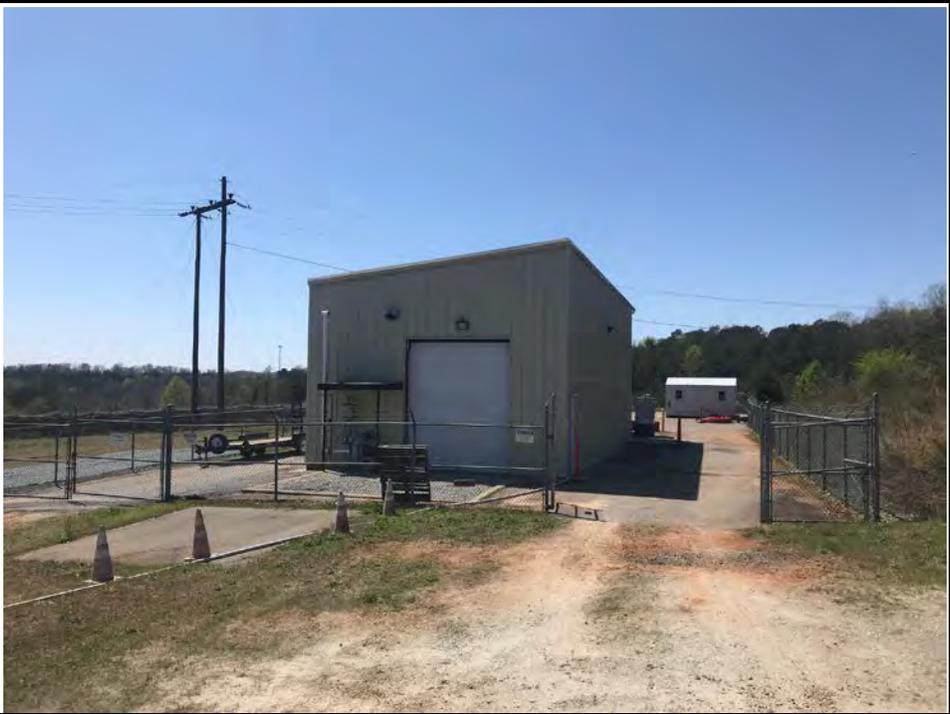
<b>Photo No.</b> 1	<b>Date</b> 9-20-2018

<b>Description</b> <i>Plant Site</i> Wastewater Treatment Plant (WWTP) Building

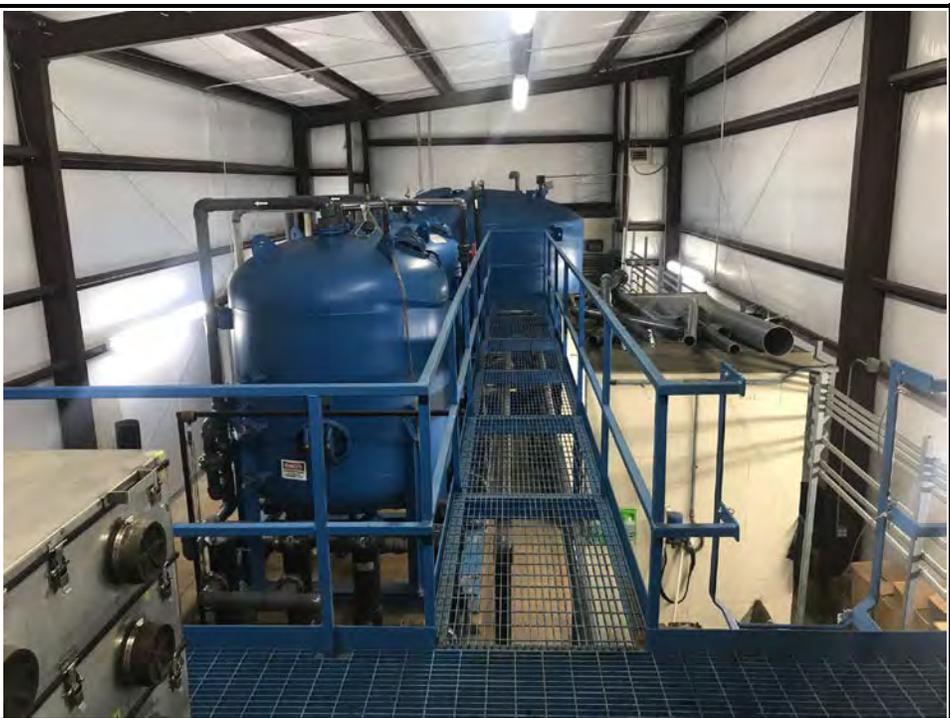
<b>Photo No.</b> 2	<b>Date</b> 9-20-2018

<b>Description</b> <i>Plant Site</i> WWTP Interior

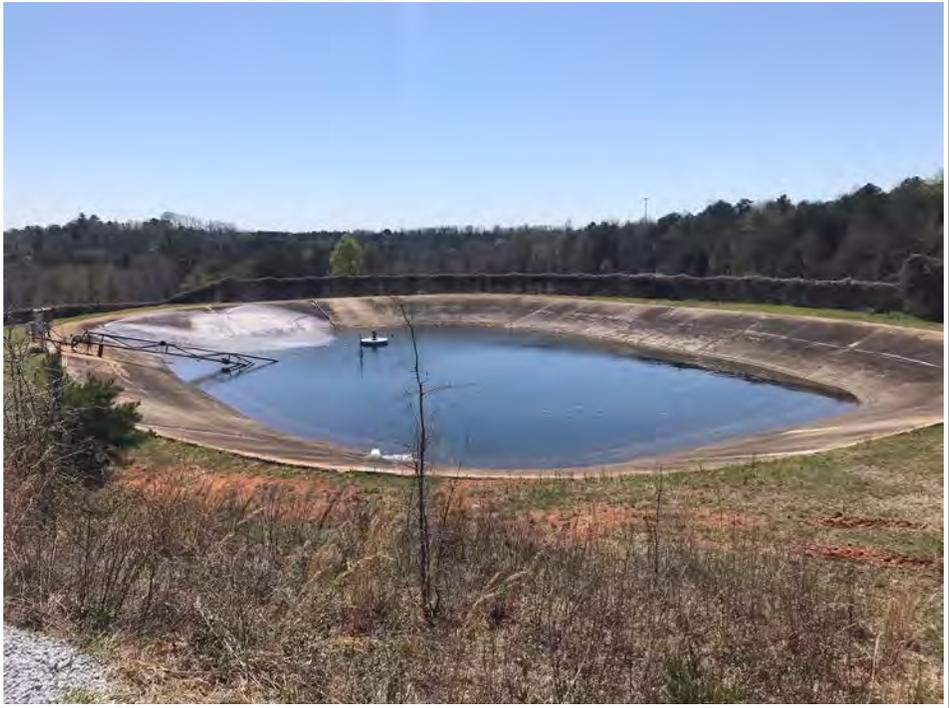
<b>Photo No.</b> 3	<b>Date</b> 9-20-2018

<b>Description</b> <i>Plant Site</i> WWTP Equalization Basin and Aeration System

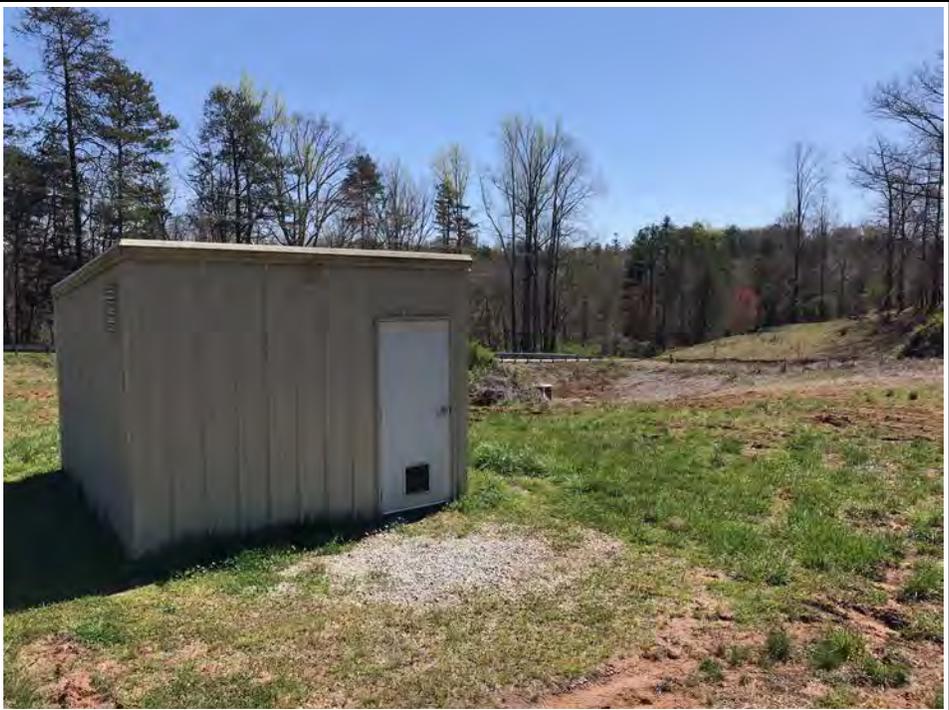
<b>Photo No.</b> 4	<b>Date</b> 9-20-2018

<b>Description</b> <i>Plant Site</i> Area 5 Pumphouse and Sump

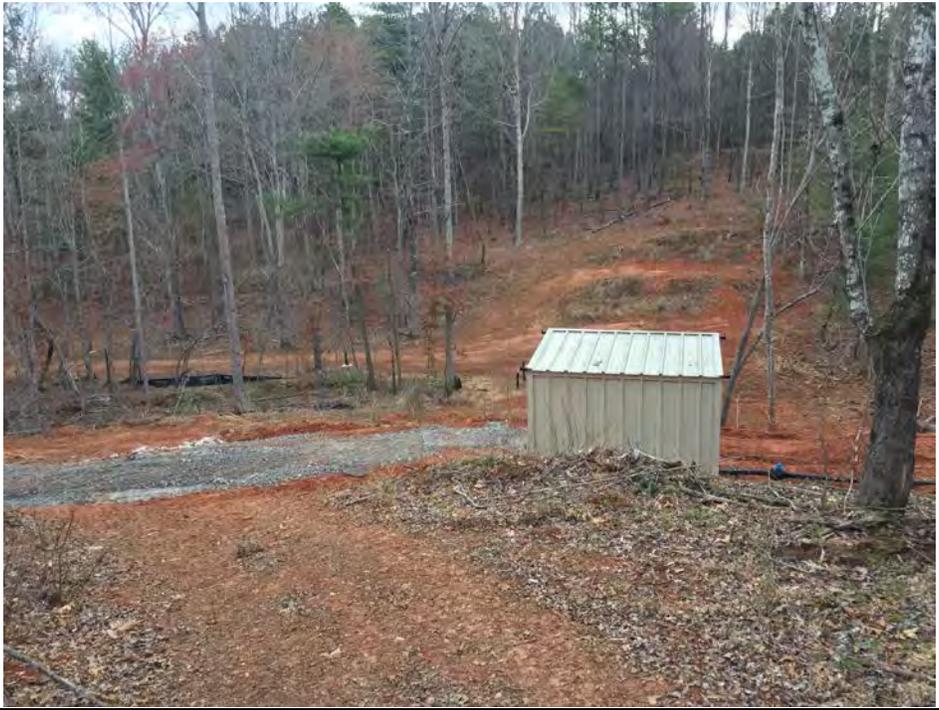
<b>Client Name:</b> Schlumberger Technology Corporation		<b>Site Location:</b> OU1
<b>Photo No.</b> 5	<b>Date</b> 9-20-2018

<b>Description</b> <i>Plant Site</i> Area 2 – Mid-plume Air Sparge System

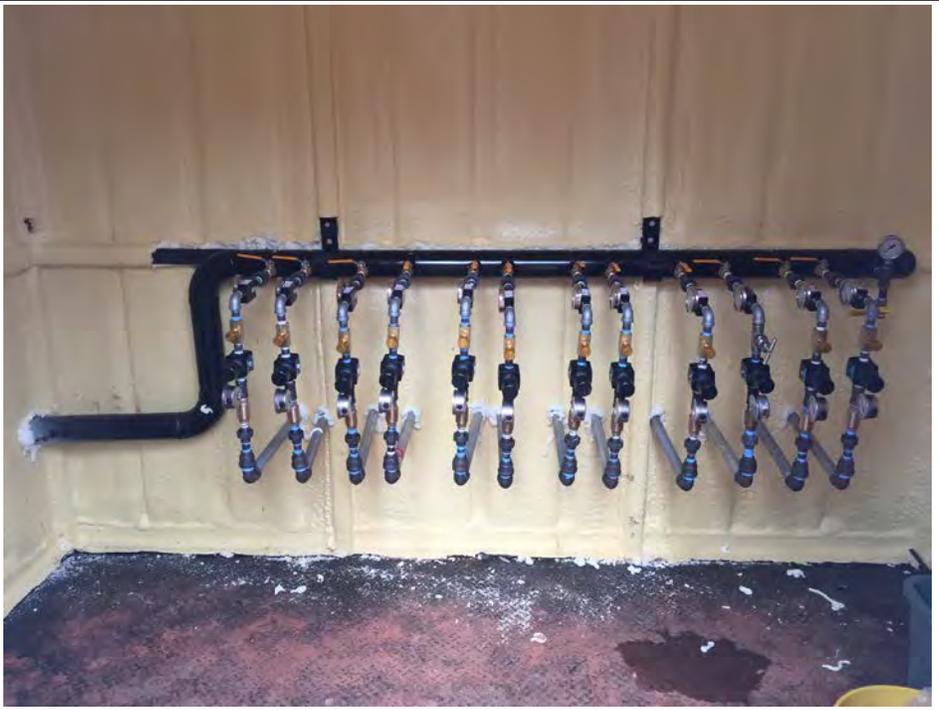
<b>Photo No.</b> 6	<b>Date</b> 9-20-2018

<b>Description</b> <i>Plant Site</i> Area 2 – Mid-plume Air Sparge System Manifold

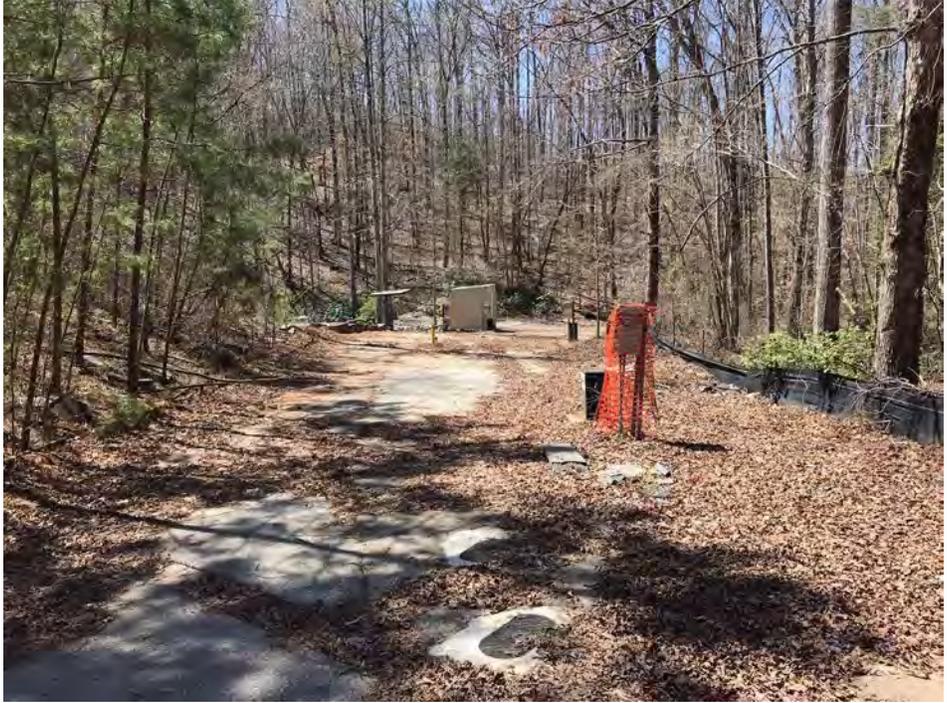
<b>Client Name:</b> Schlumberger Technology Corporation		<b>Site Location:</b> OU1
<b>Photo No.</b> 7	<b>Date</b> 9-20-2018

<b>Description</b> <i>Plant Site</i> Area 2 - Property boundary Air Sparge System

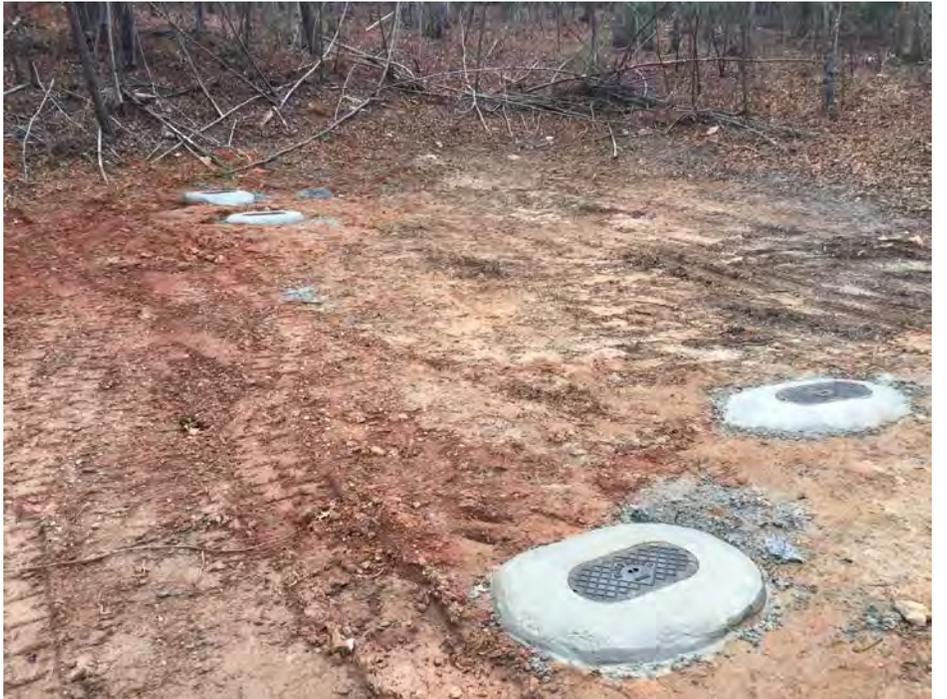
<b>Photo No.</b> 8	<b>Date</b> 9-20-2018

<b>Description</b> <i>Plant Site</i> Area 2 – Air Sparge Well Surface Completions

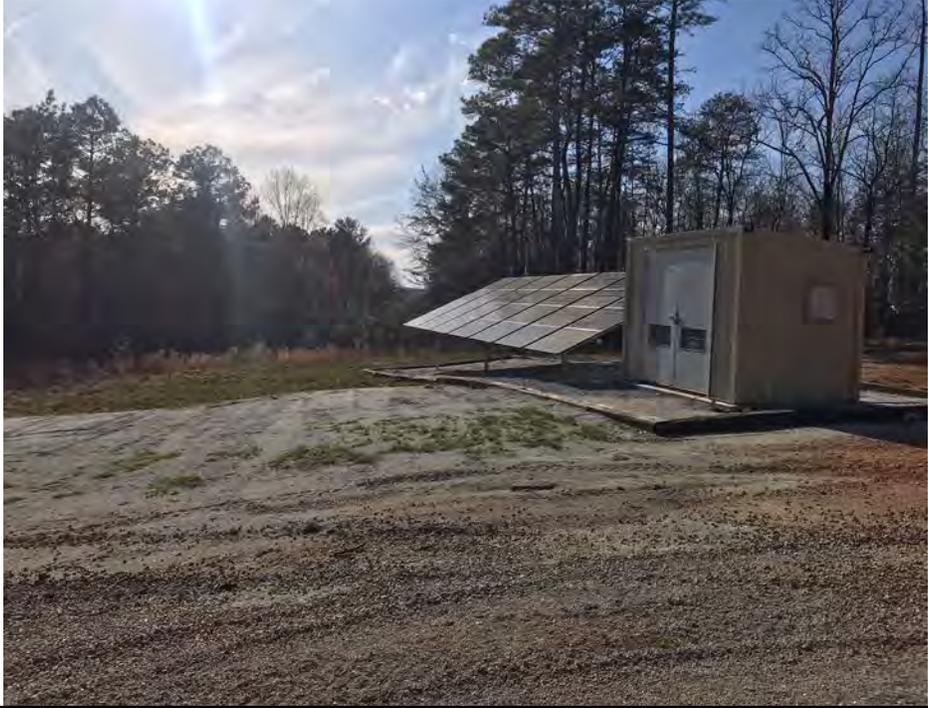
<b>Client Name:</b> Schlumberger Technology Corporation		<b>Site Location:</b> OU1
<b>Photo No.</b> 9	<b>Date</b> 9-20-2018

<b>Description</b> <i>Plant Site</i> Area 3 – Solar Array for Subgrade Biogeochemical Reactor (SBGR) System

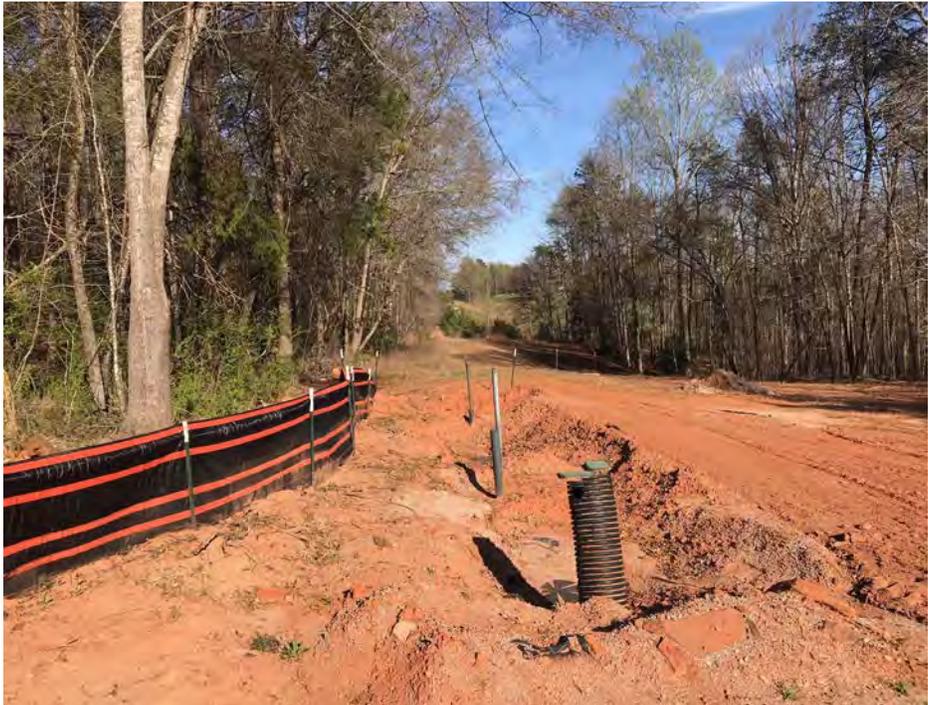
<b>Photo No.</b> 10	<b>Date</b> 9-20-2018

<b>Description</b> <i>Plant Site</i> Area 3 – SBGR Reactor Vessel Inspection Ports
