**FOURTH FIVE-YEAR REVIEW REPORT  
SANGAMO WESTON/TWELVEMILE CREEK/LAKE HARTWELL PCB  
CONTAMINATION SUPERFUND SITE  
PICKENS COUNTY, SOUTH CAROLINA**

**U.S. Environmental Protection Agency  
Region 4 Superfund Division  
61 Forsyth Street, SW  
Atlanta, Georgia 30303**

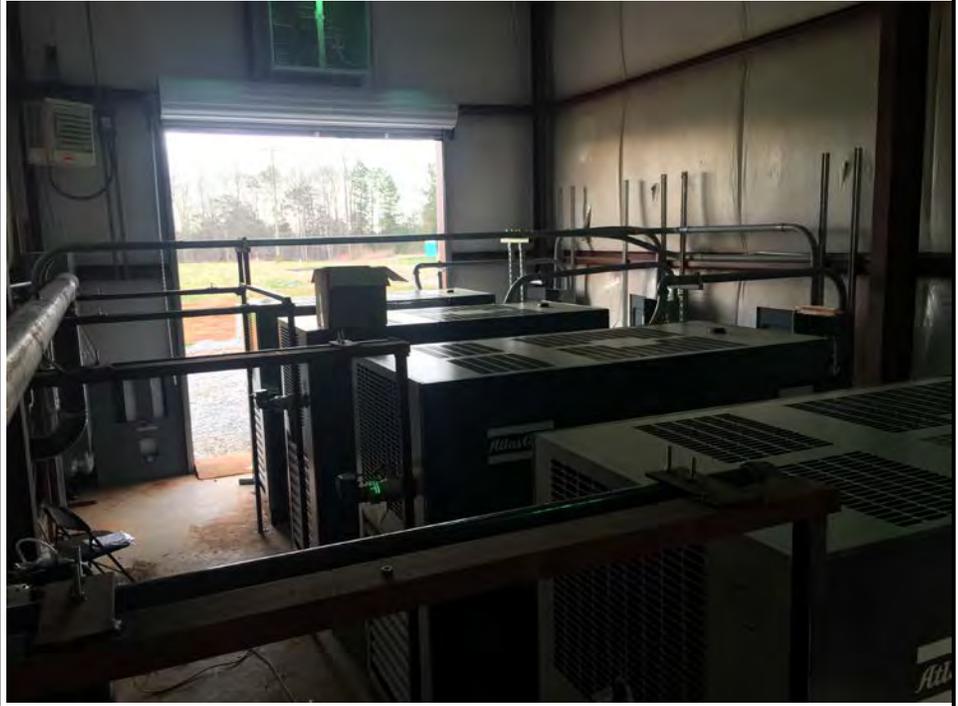
<b>Photo No.</b>	<b>Date</b>
11	9-20-2018

**Description**  
*Plant Site*  
 Area 2 – Compressor Building  
 (Former Surge Tank Building)

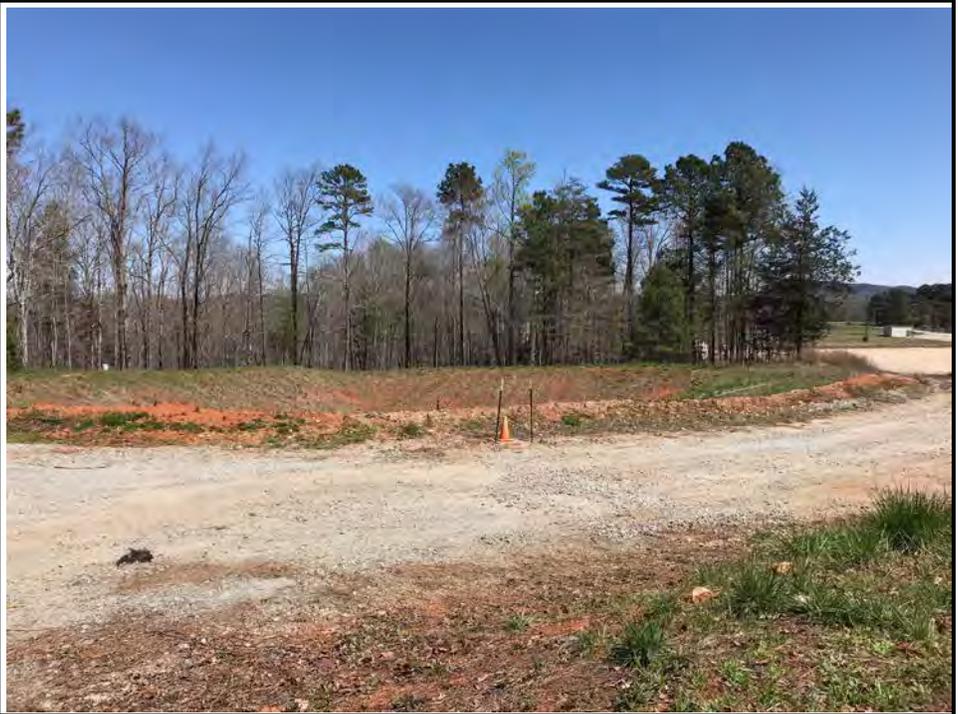
<b>Photo No.</b>	<b>Date</b>
12	9-20-2018

**Description**  
*Plant Site*  
 Area H – Current  
 Condition

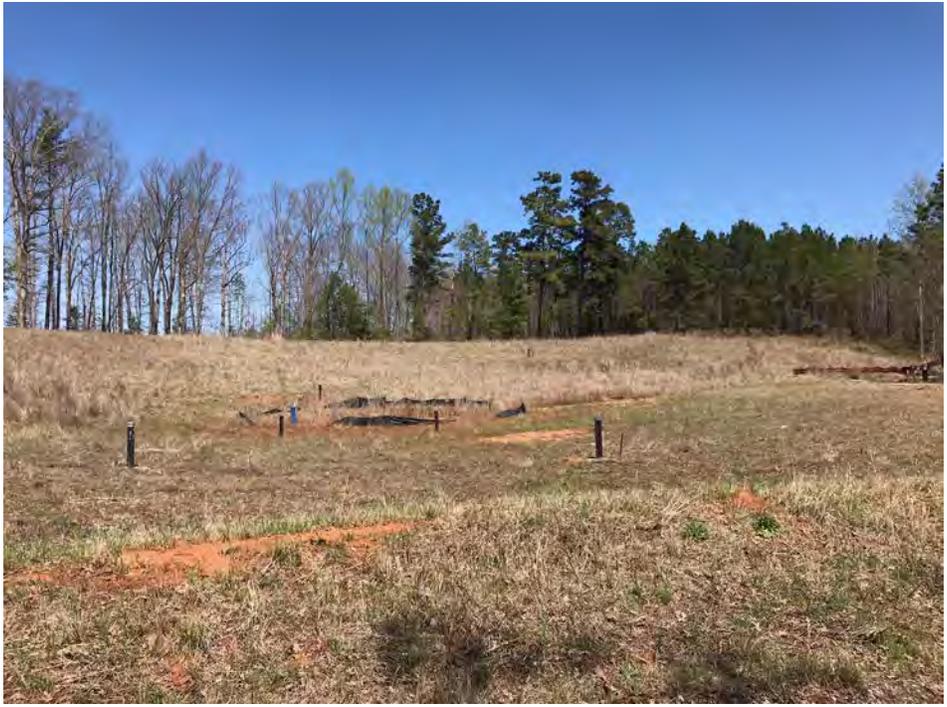
<b>Client Name:</b> Schlumberger Technology Corporation		<b>Site Location:</b> OU1
<b>Photo No.</b> 13	<b>Date</b> 9-20-2018

<b>Description</b> <i>Plant Site</i> Area D – Post Excavation, Looking North

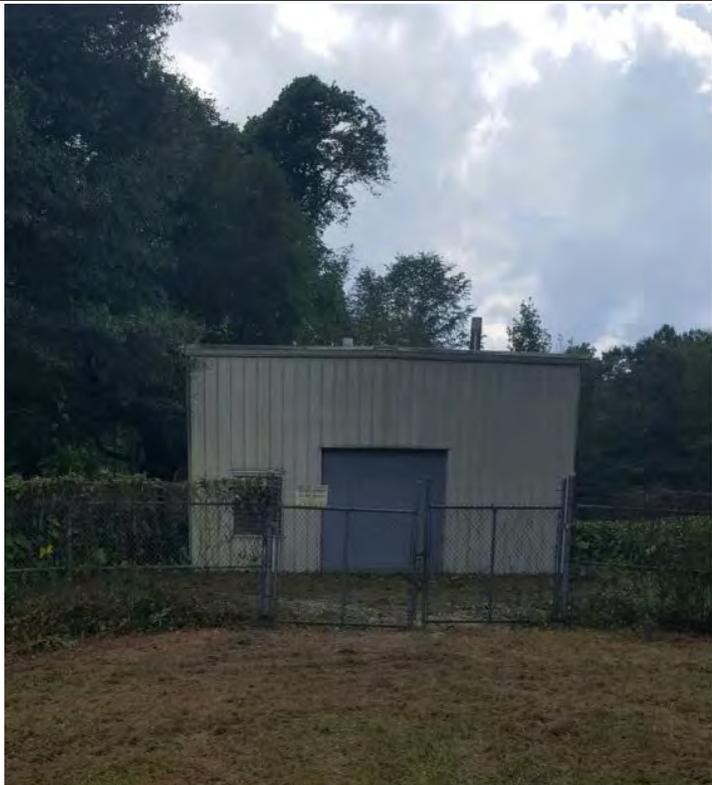
<b>Photo No.</b> 14	<b>Date</b> 9-20-2018

<b>Description</b> <i>Breazeale Site</i> Exterior of Decommissioned WWTP Building

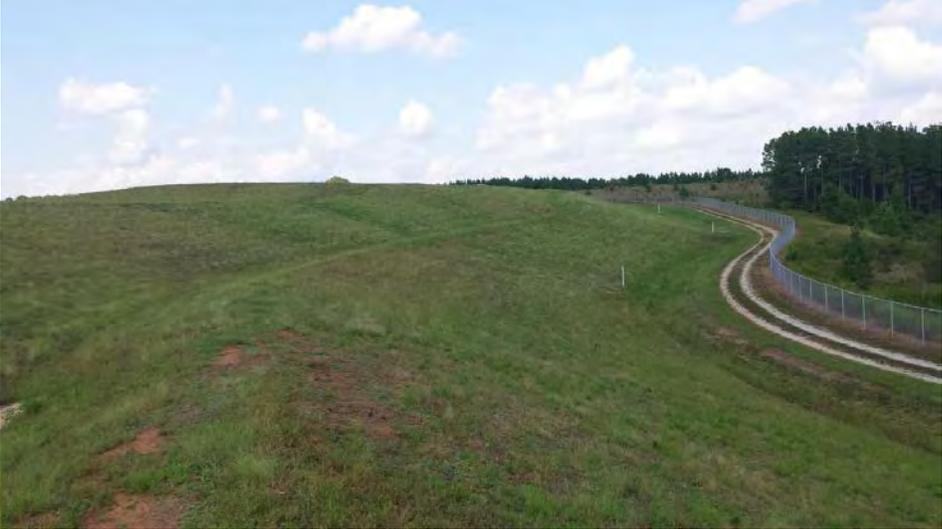
<b>Client Name:</b> Schlumberger Technology Corporation		<b>Site Location:</b> Operable Unit Two (OU2)
<b>Photo No.</b> 1	<b>Date</b> 9-20-2018

<b>Description</b> <i>Twelve Mile Creek (OU2) Sediment Management Unit (SMU)</i> View of east side of the SMU looking north		
<b>Photo No.</b> 2	<b>Date</b> 9-20-2018

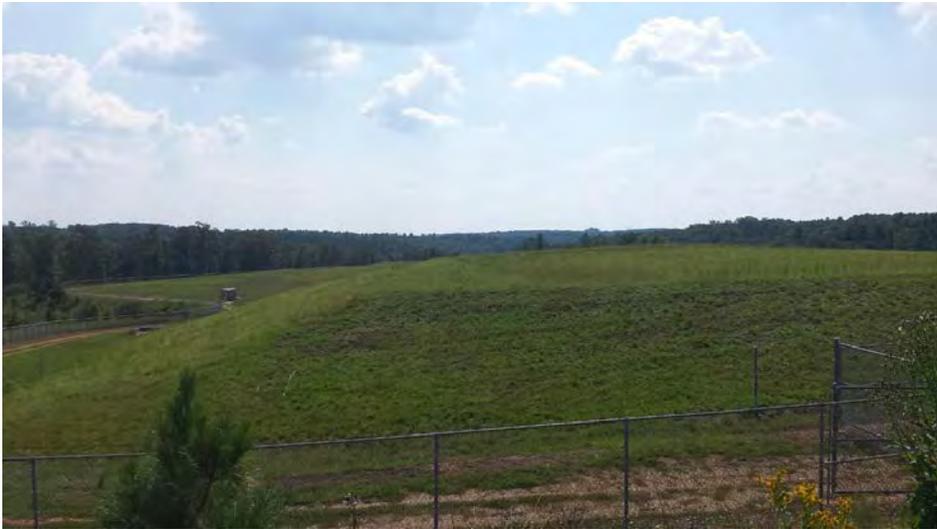
<b>Description</b> <i>Twelve Mile Creek (OU2) SMU</i> View of the upper section of the SMU looking southwest

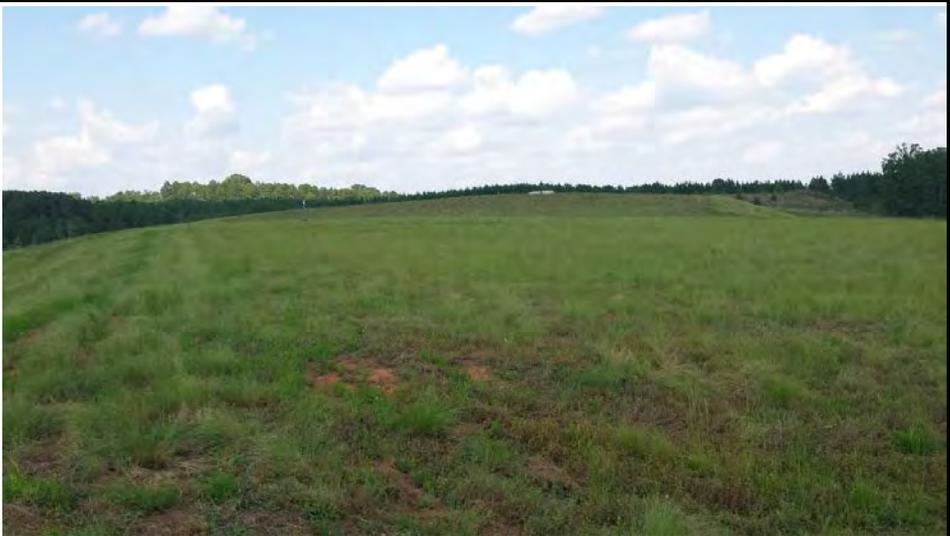
<b>Client Name:</b> Schlumberger Technology Corporation		<b>Site Location:</b> OU2
<b>Photo No.</b> 3	<b>Date</b> 9-20-2018

<b>Description</b> <i>Twelve Mile Creek (OU2) SMU</i> View of the SMU looking north

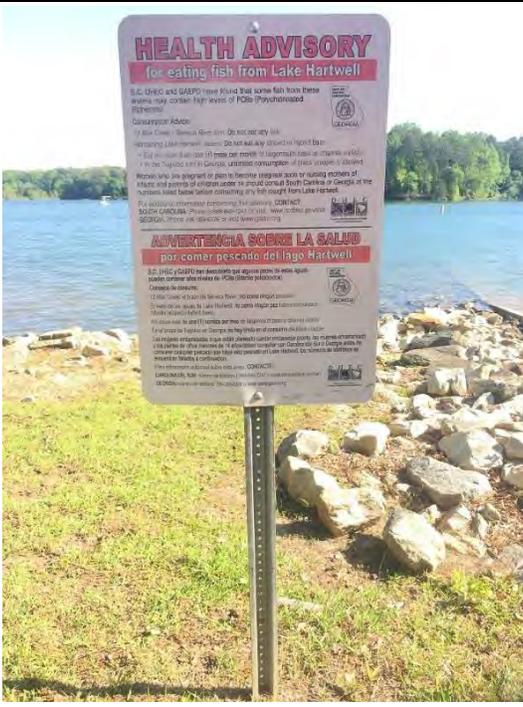
<b>Photo No.</b> 4	<b>Date</b> 9-20-2018

<b>Description</b> <i>Twelve Mile Recreational Area Boat Launch/Ramp, Lake Hartwell (OU2)</i> Posted health advisory sign for fish consumption

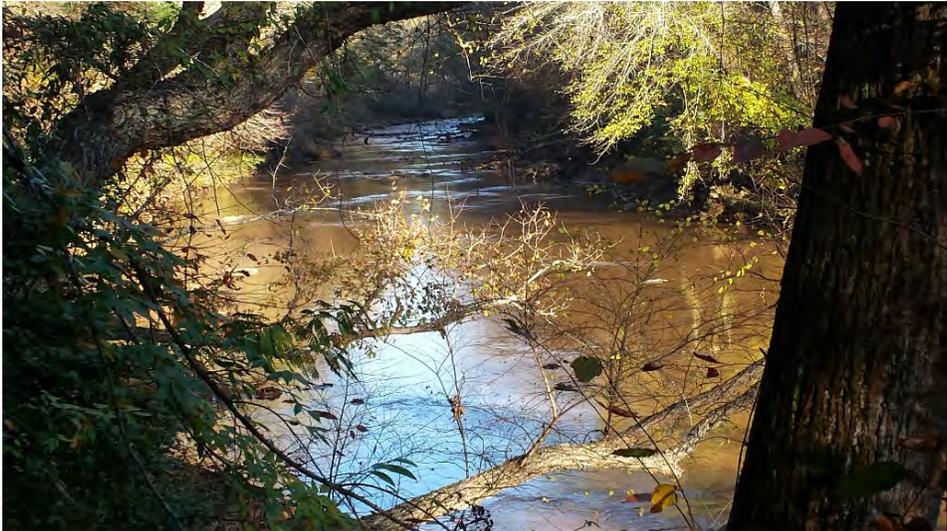
<b>Client Name:</b> Schlumberger Technology Corporation		<b>Site Location:</b> OU2
<b>Photo No.</b> 5	<b>Date</b> 9-20-2018

<b>Description</b> <i>Twelve Mile Creek (OU2)</i> From the Whitfield's property looking upstream across Twelve Mile Creek

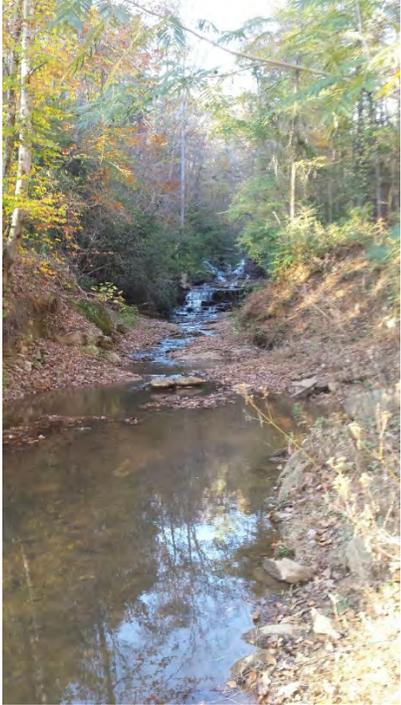
<b>Photo No.</b> 6	<b>Date</b> 9-20-2018

<b>Description</b> <i>Twelve Mile Creek (OU2)</i> Camp Creek – Side wall revegetation (1)

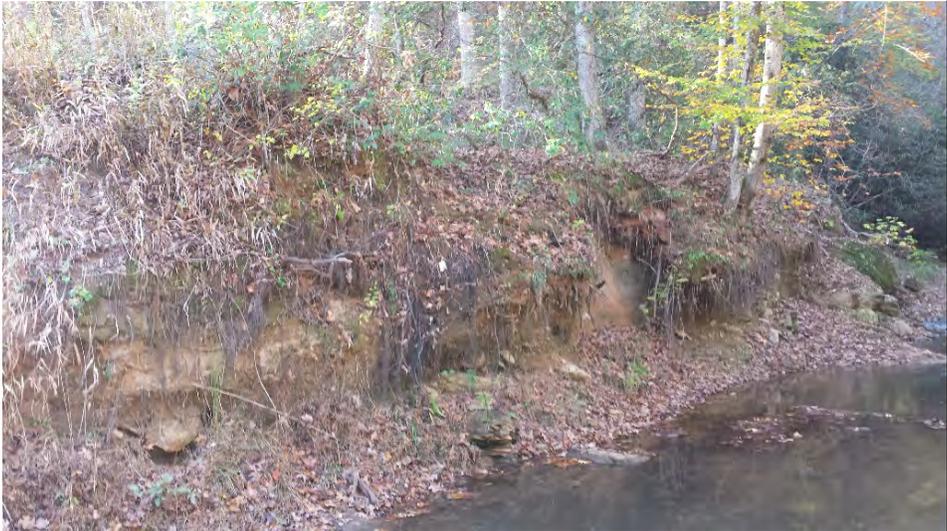
<b>Photo No.</b> 7	<b>Date</b> 9-20-2018

<b>Description</b> <i>Twelve Mile Creek (OU2)</i> Camp Creek – Side wall revegetation (2)

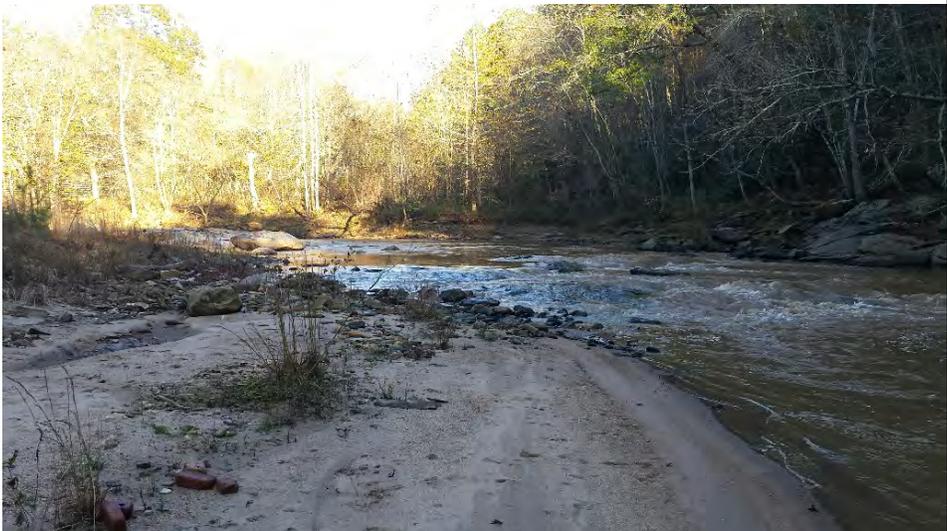
<b>Photo No.</b> 8	<b>Date</b> 9-20-2018

<b>Description</b> <i>Twelve Mile Creek (OU2)</i> Balls Beach – From Ball’s Beach looking upstream

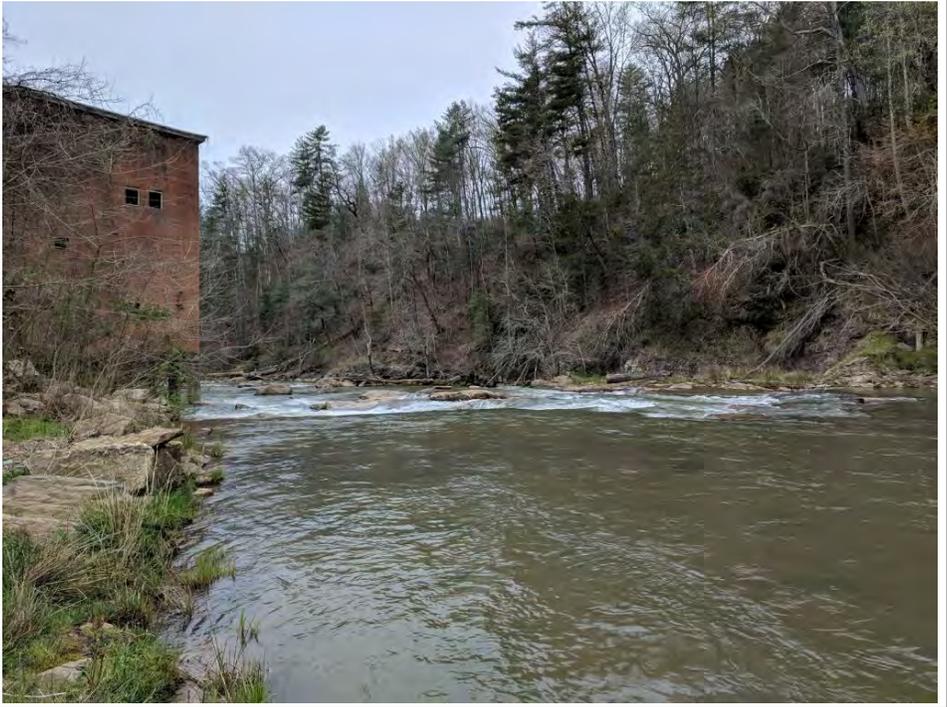
<b>Client Name:</b> Schlumberger Technology Corporation		<b>Site Location:</b> OU2
<b>Photo No.</b> 10	<b>Date</b> 9-20-2018

<b>Description</b> Historic location of Woodside I Dam

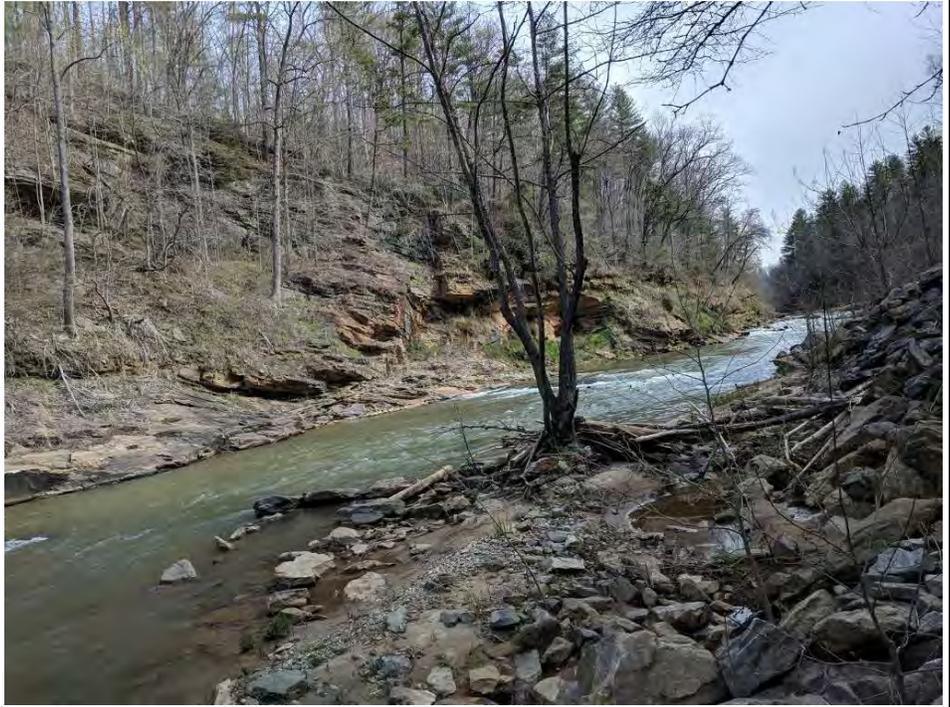
<b>Client Name:</b> Schlumberger Technology Corporation		<b>Site Location:</b> OU2
<b>Photo No.</b> 11	<b>Date</b> 9-20-2018

<b>Description</b> Historic location of Woodside II Dam
