GEOTECHNICAL BASE LINE REPORT

Route S-41-78 Replacement Bridge over Persimmon Creek
Saluda County, South Carolina

SCDOT Project ID: P038308
F&ME Project #: G6100.05.16

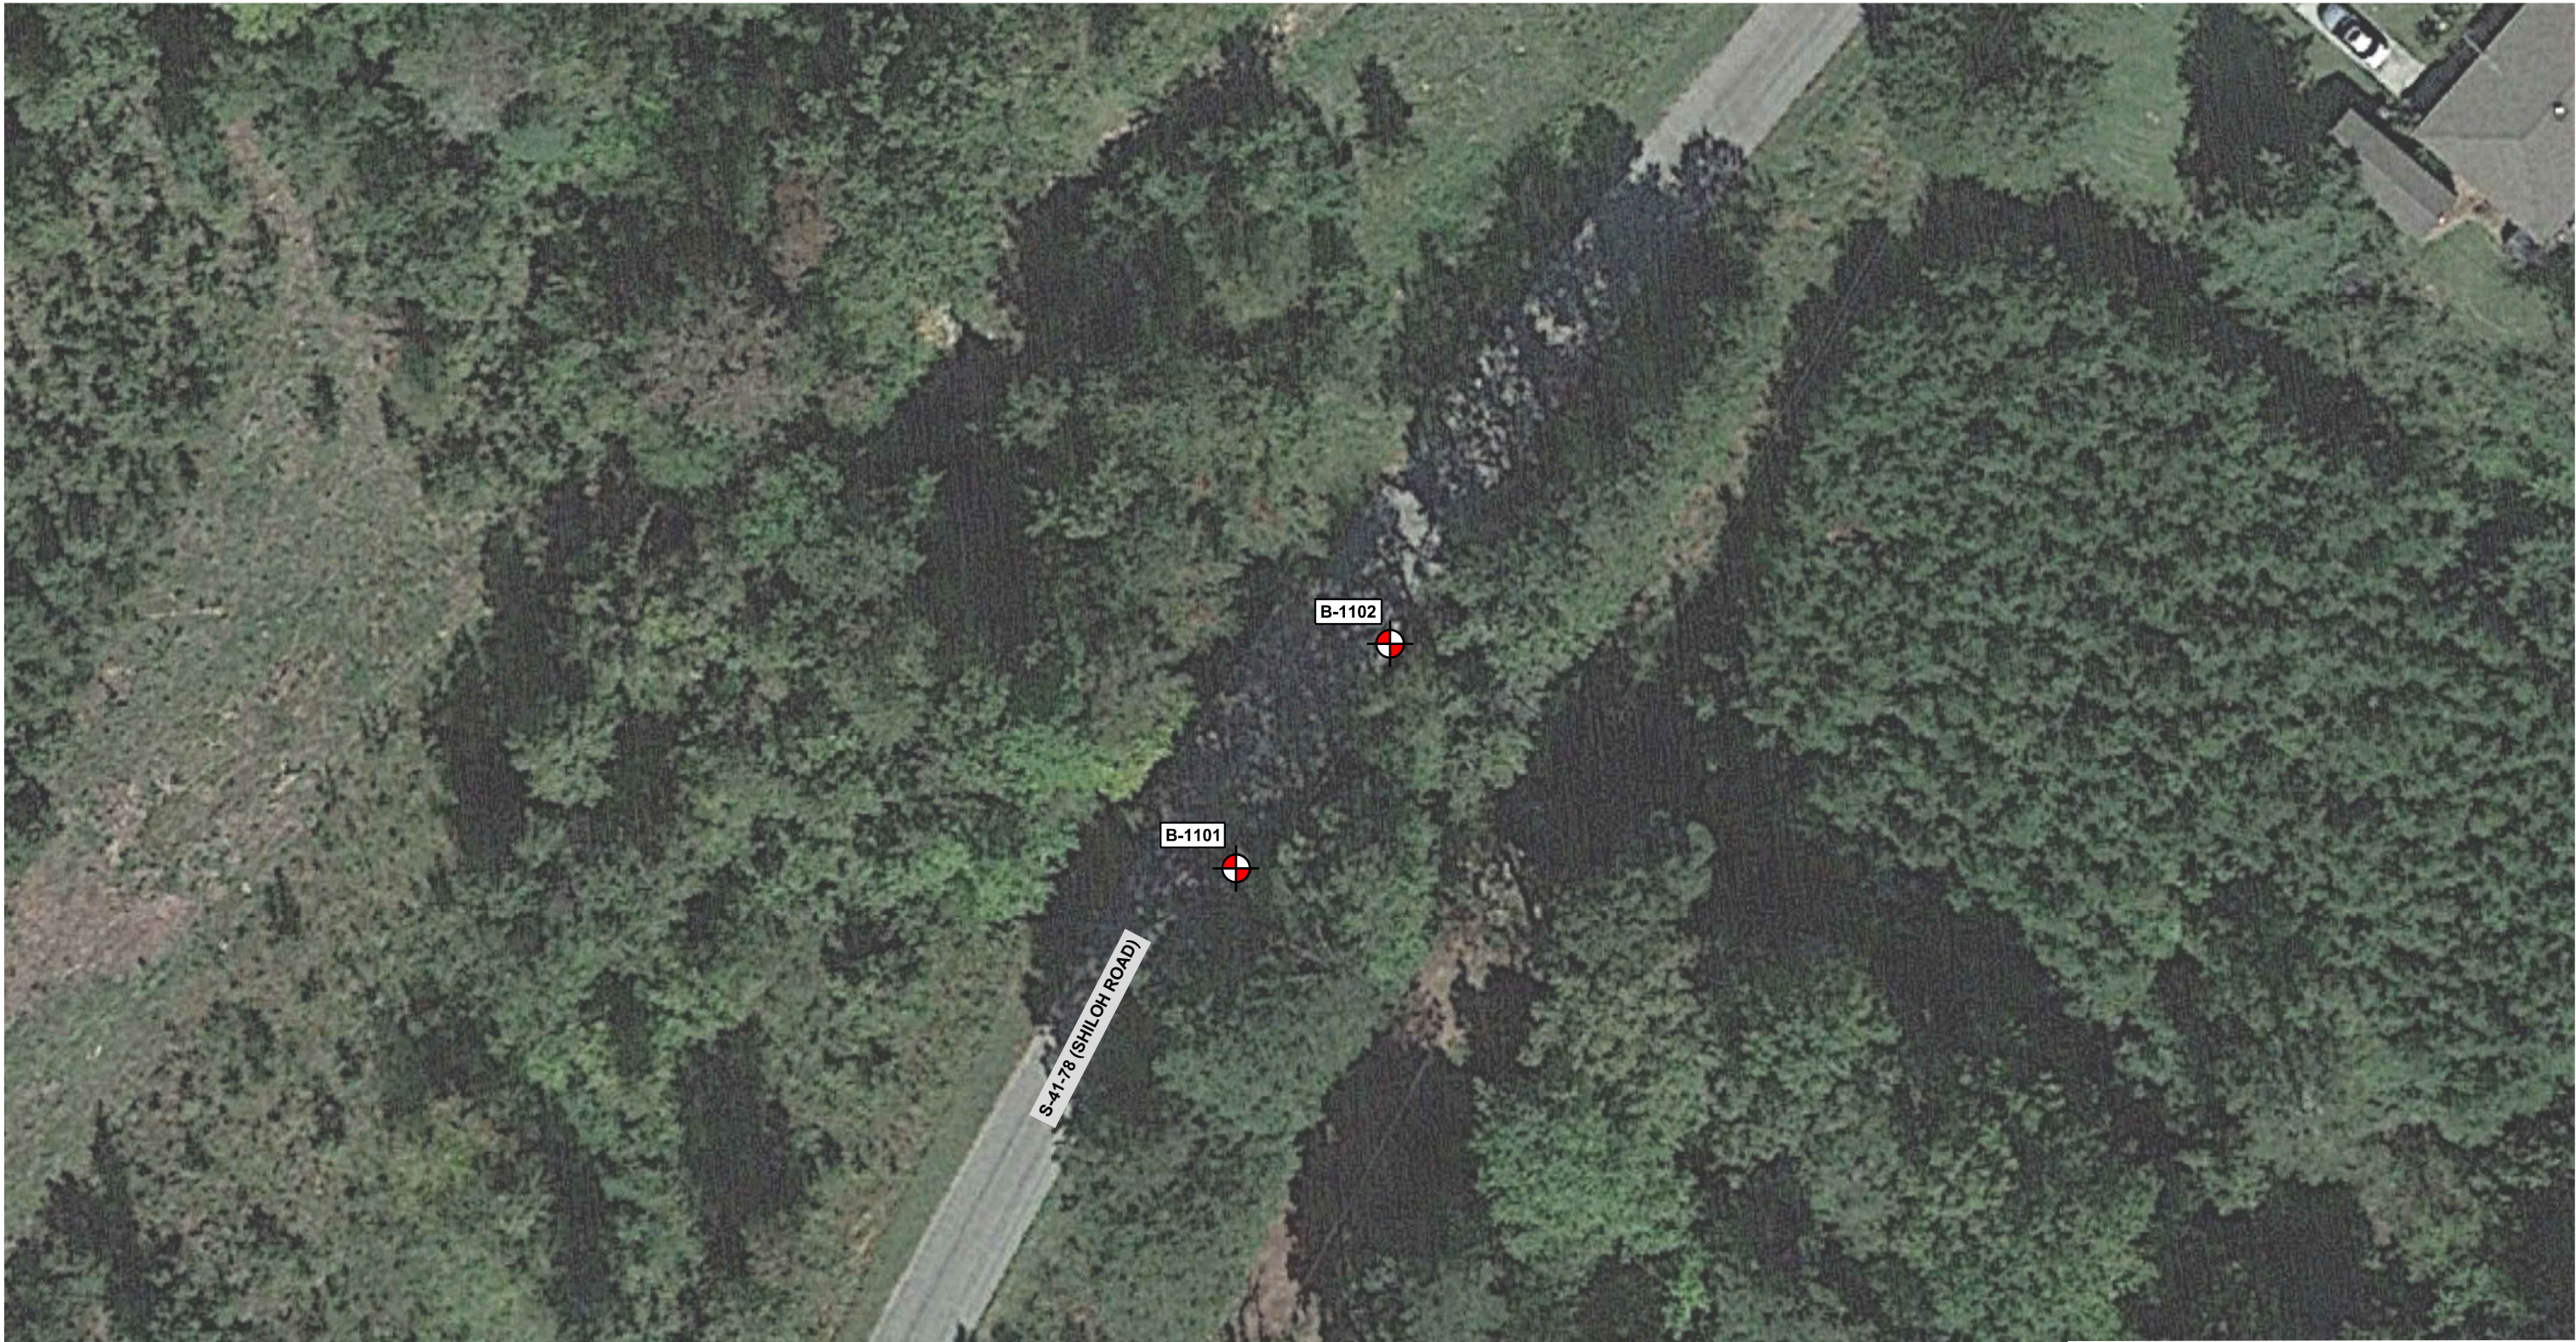
FIGURE 2

SOIL TEST BORING LOCATION

BORING LOCATION PLAN

On June 26 and 27, 2019, F&ME performed two (2) soil test borings (STB's). The test boring locations were performed in proximity to the existing bridge end bent locations. The intent of the subsurface investigation was to provide a broad indication of the subsurface conditions at the site.

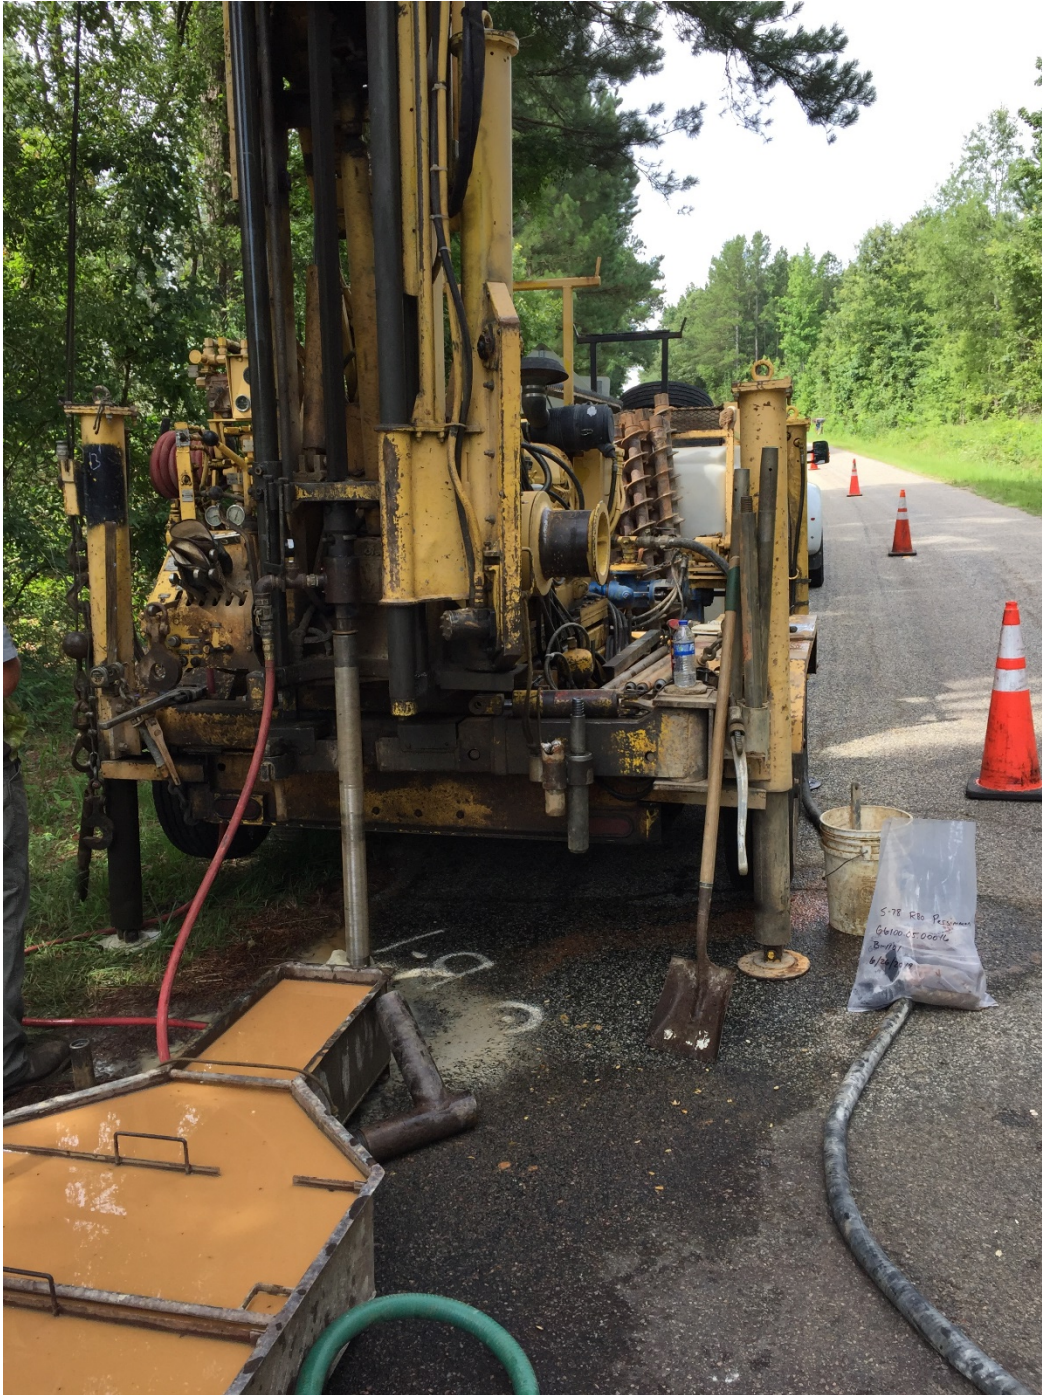
B-1101

Drill Rig Setup Photographs

The STB's were advanced using a CME 45B trailer mounted drill rig with an automatic standard penetration test (SPT) hammer system. Rotary wash drilling techniques were used during drilling to maintain a stable borehole. Standard split-spoon sampling was performed continuously over the first ten (10) feet of the boring depth and at five (5) foot intervals thereafter. Soil test borings were advanced to a drilling refusal condition and subsequently advanced into rock using NQ rock coring techniques. Details of each STB are included on the individual Soil Test Boring Logs in Section 4 in the Appendix of this report.

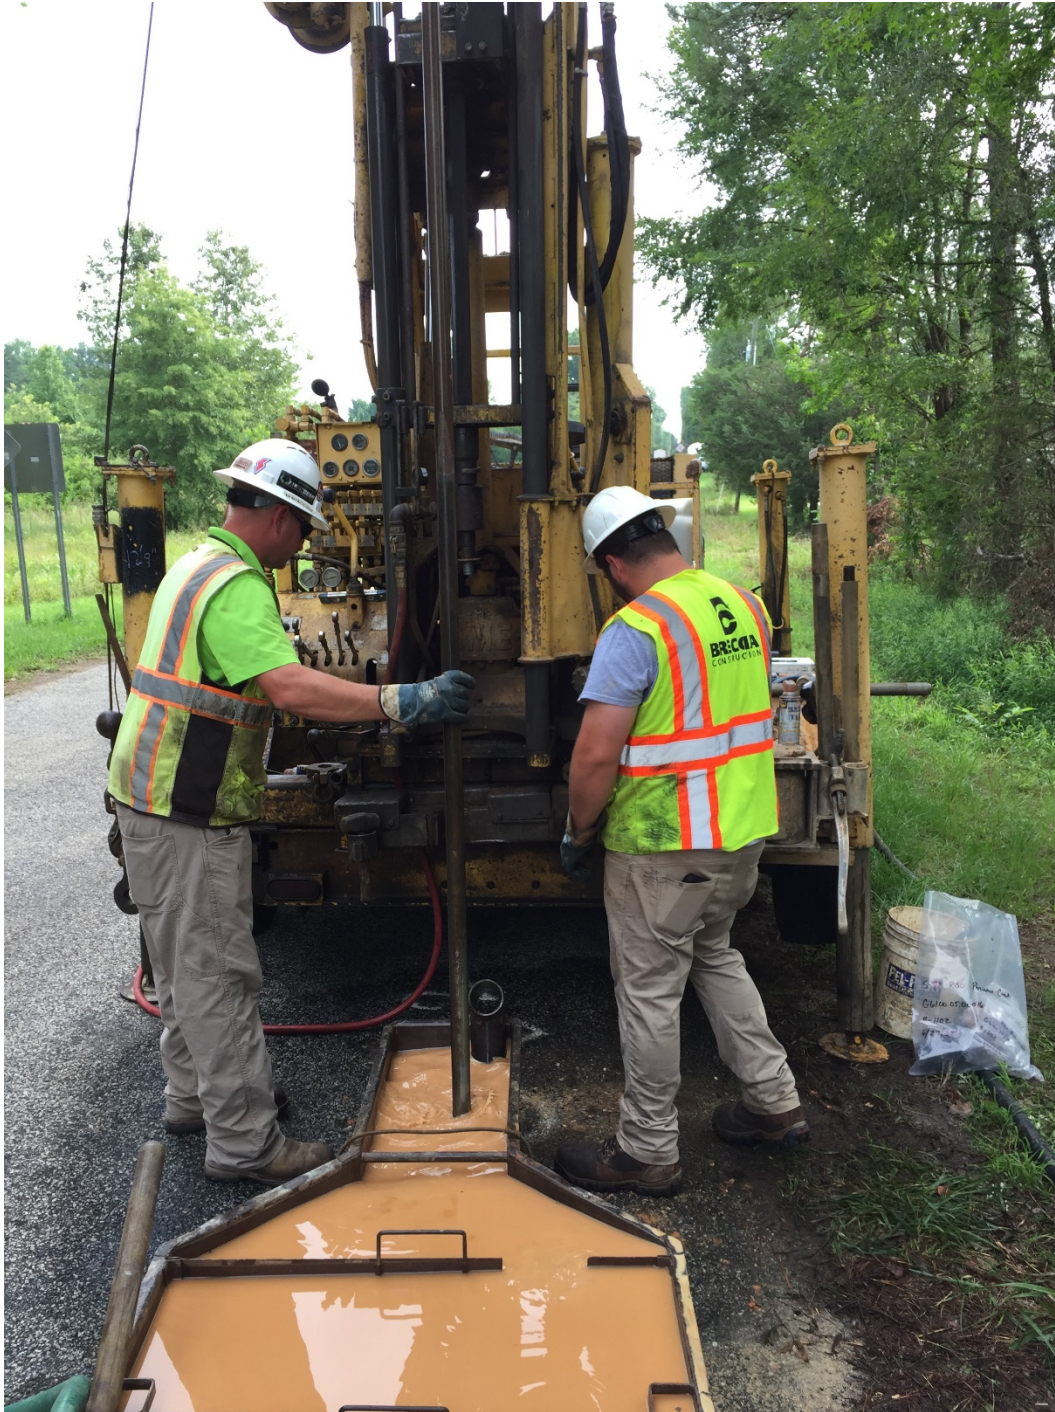
B-1102

Drill Rig Setup Photographs

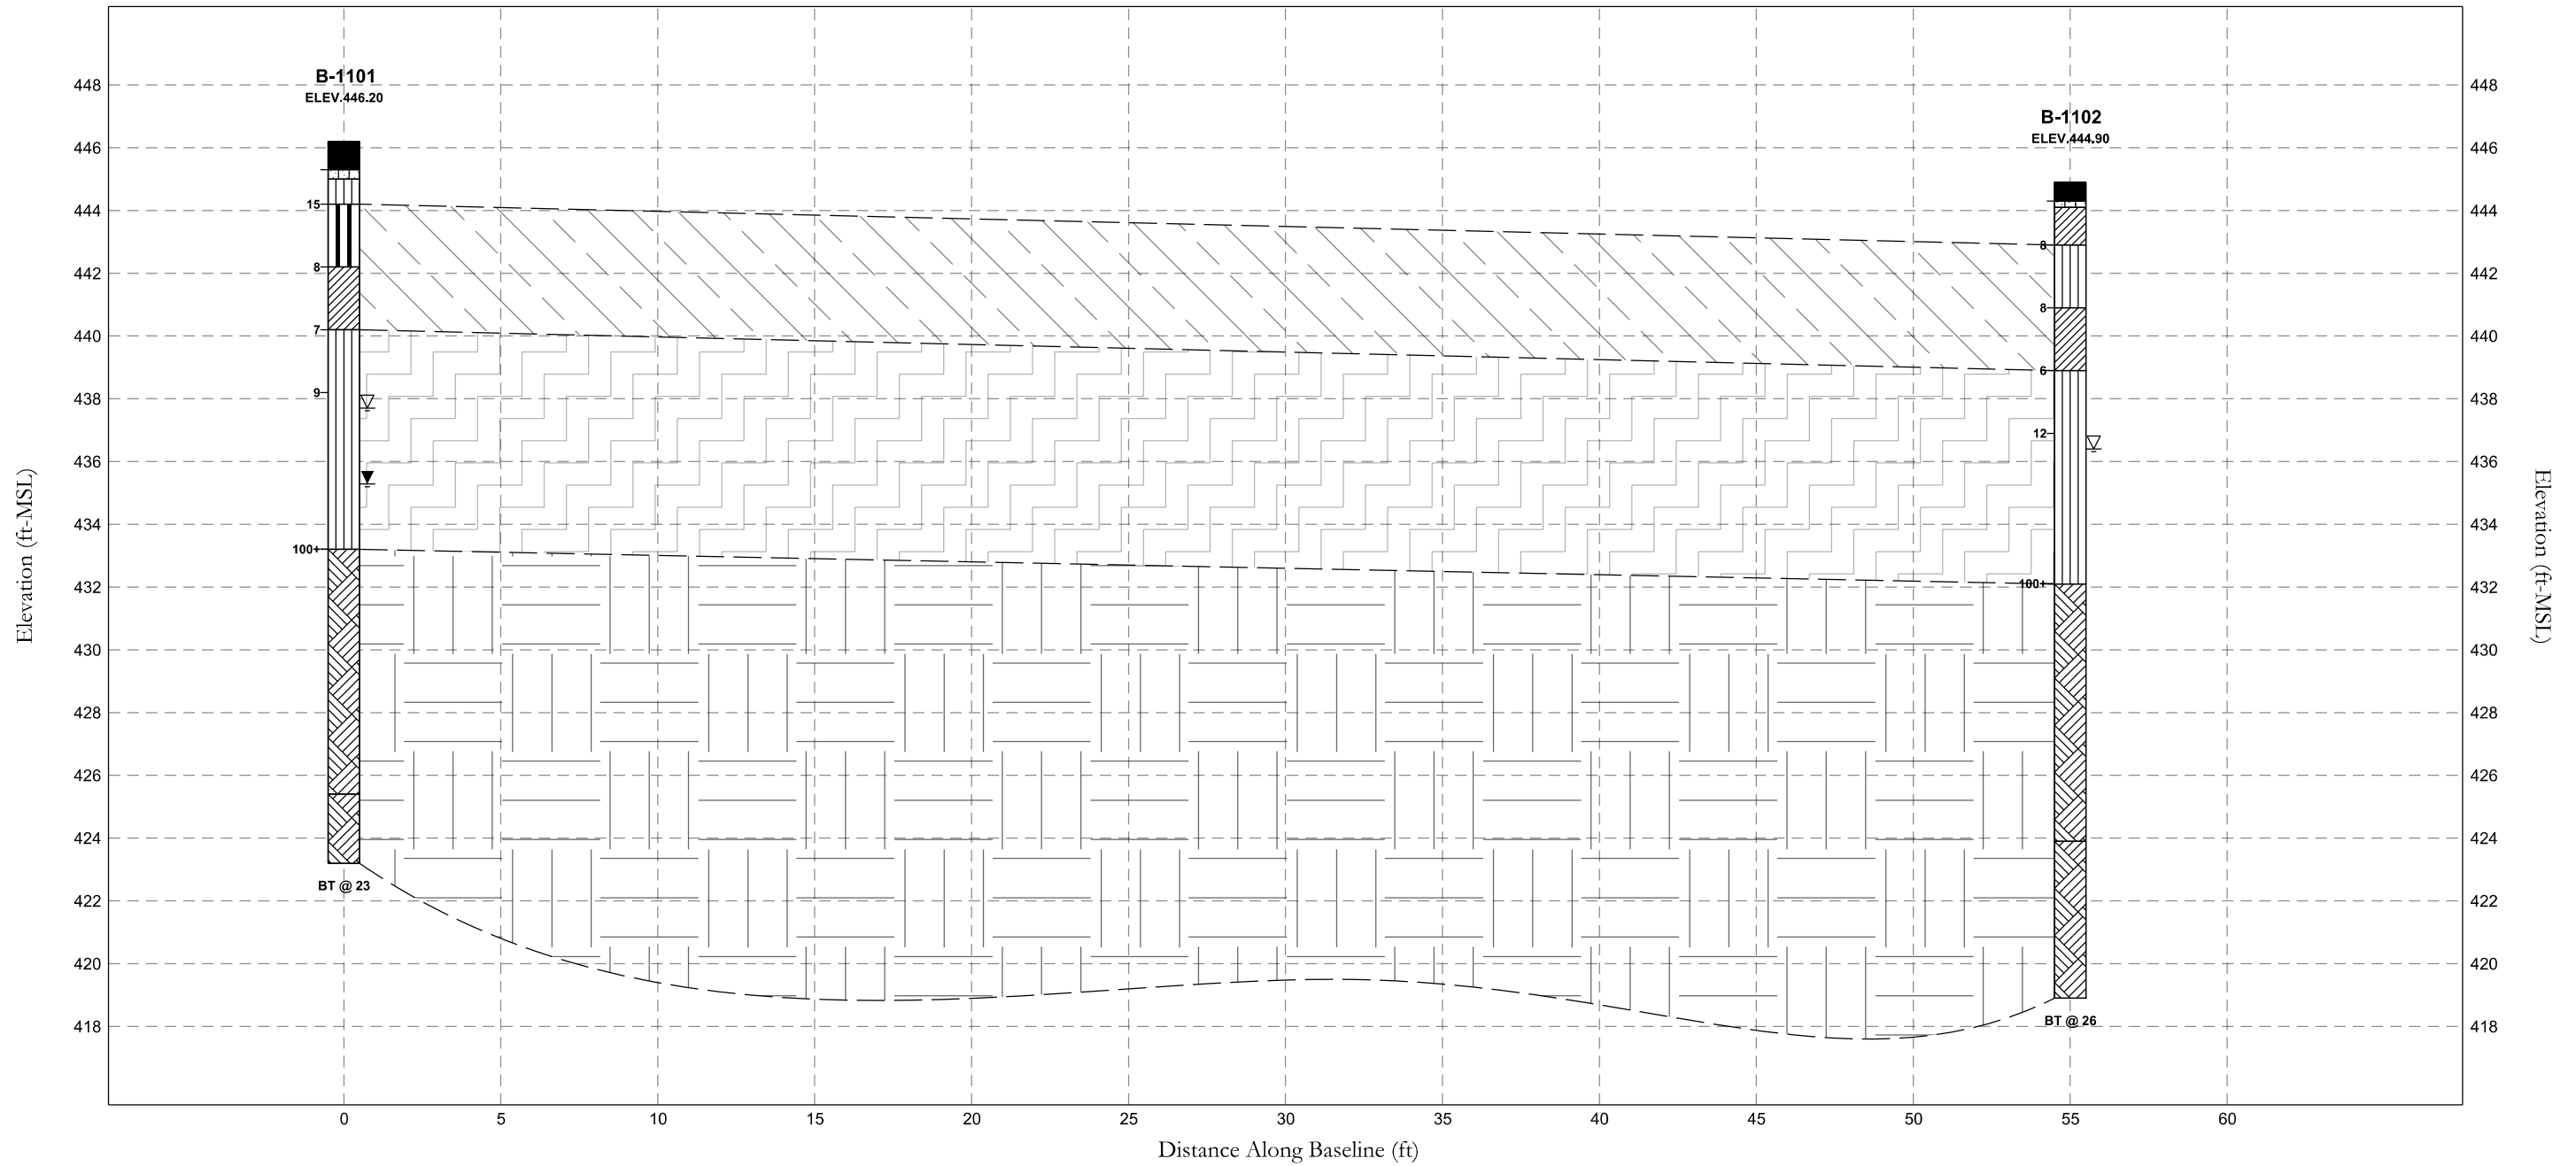
GENERALIZED SUBSURFACE PROFILE

ALLUVIUM

RESIDUUM

BEDROCK

The generalized subsurface profile is provided for illustrative purposes. The intent of this drawing is to provide the reader with very general information on soil stratigraphy at the bridge site. Variations in the indicated subsurface conditions will become evident once additional borings are performed.

SOIL AND ROCK STRATIGRAPHY					
Strata	Elevation of Top Layer (ft-MSL)	Depth to Top of Layer (ft.)	USCS Soil Type	Avg. SPT N Value (bpf)	Comments
Fill	445	0	SM, ML	N/A	-
Alluvium	443	2	MH, ML, CL	10	-
Residuum	439	6	ML	8	-
Bed Rock	432	13	N/A	N/A	Quartzite/Meta-Tuff

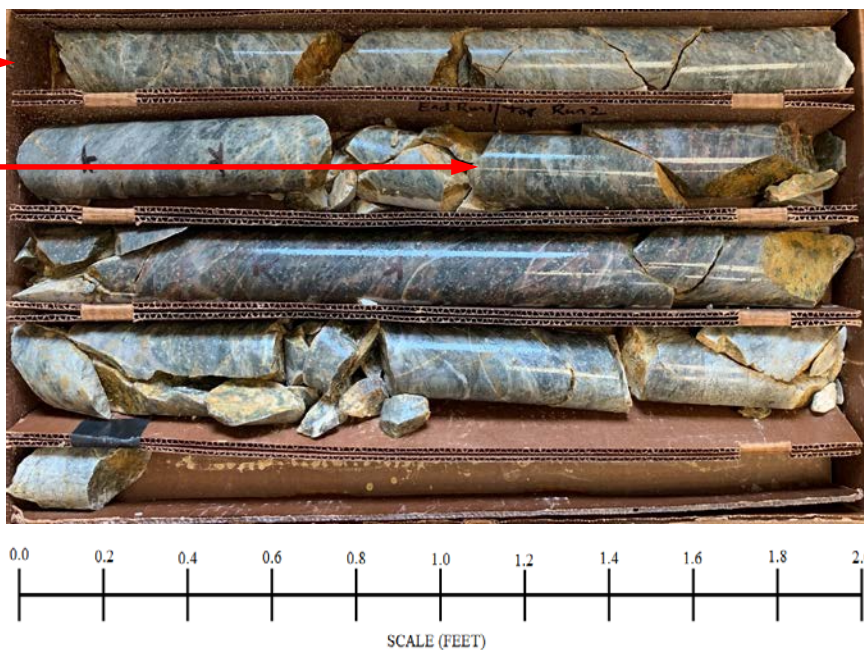
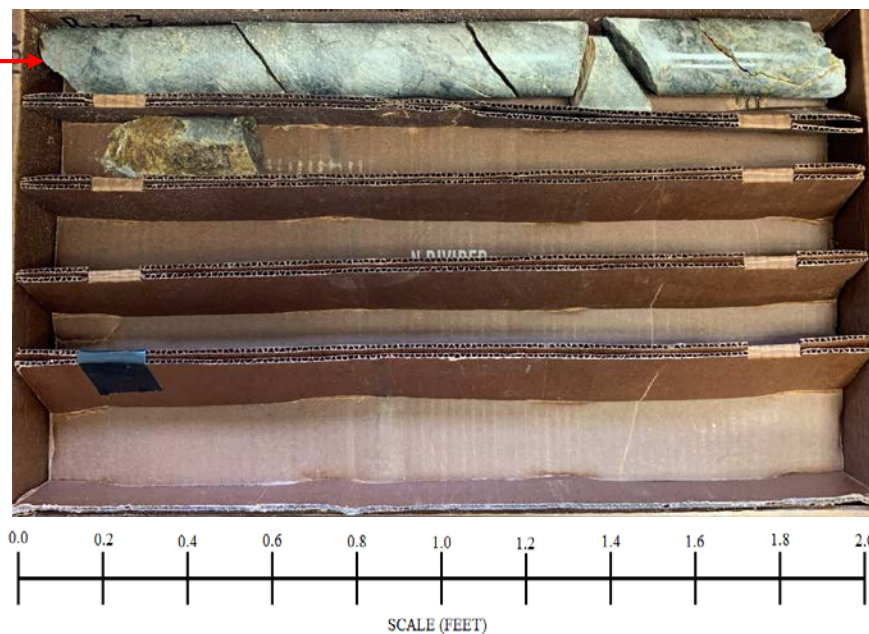
S-41-78 RBO Persimmon Creek
Boring B-1101

Begin Run 1
13.0 feet

Begin Run 2
15.8 feet

Begin Run 3
20.8 feet

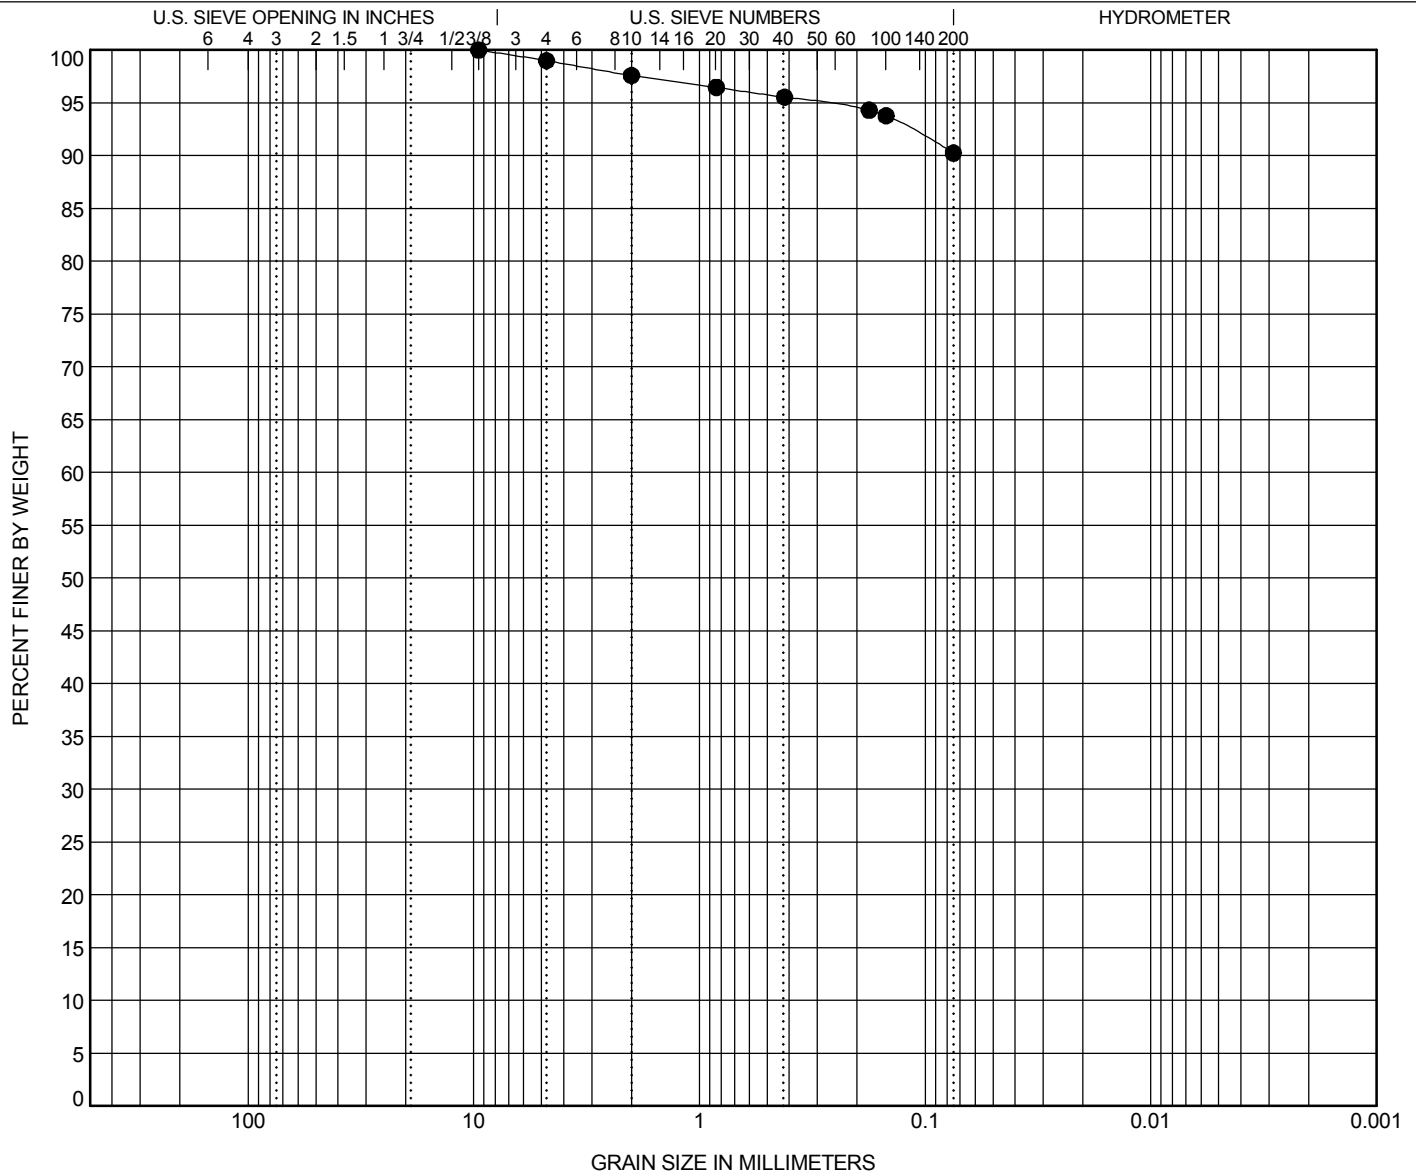
BOREHOLE	DEPTH	Classification					LL	PL	PI	Cc	Cu
● B-1101	6.0	Lean CLAY (CL/A-7-6(17))					41	23	18		
BOREHOLE	DEPTH	D100	D95	D50	D10	%Gravel	%Sand	%Silt		%Clay	
● B-1101	6.0	9.51	0.286			1.0	8.7	90.3

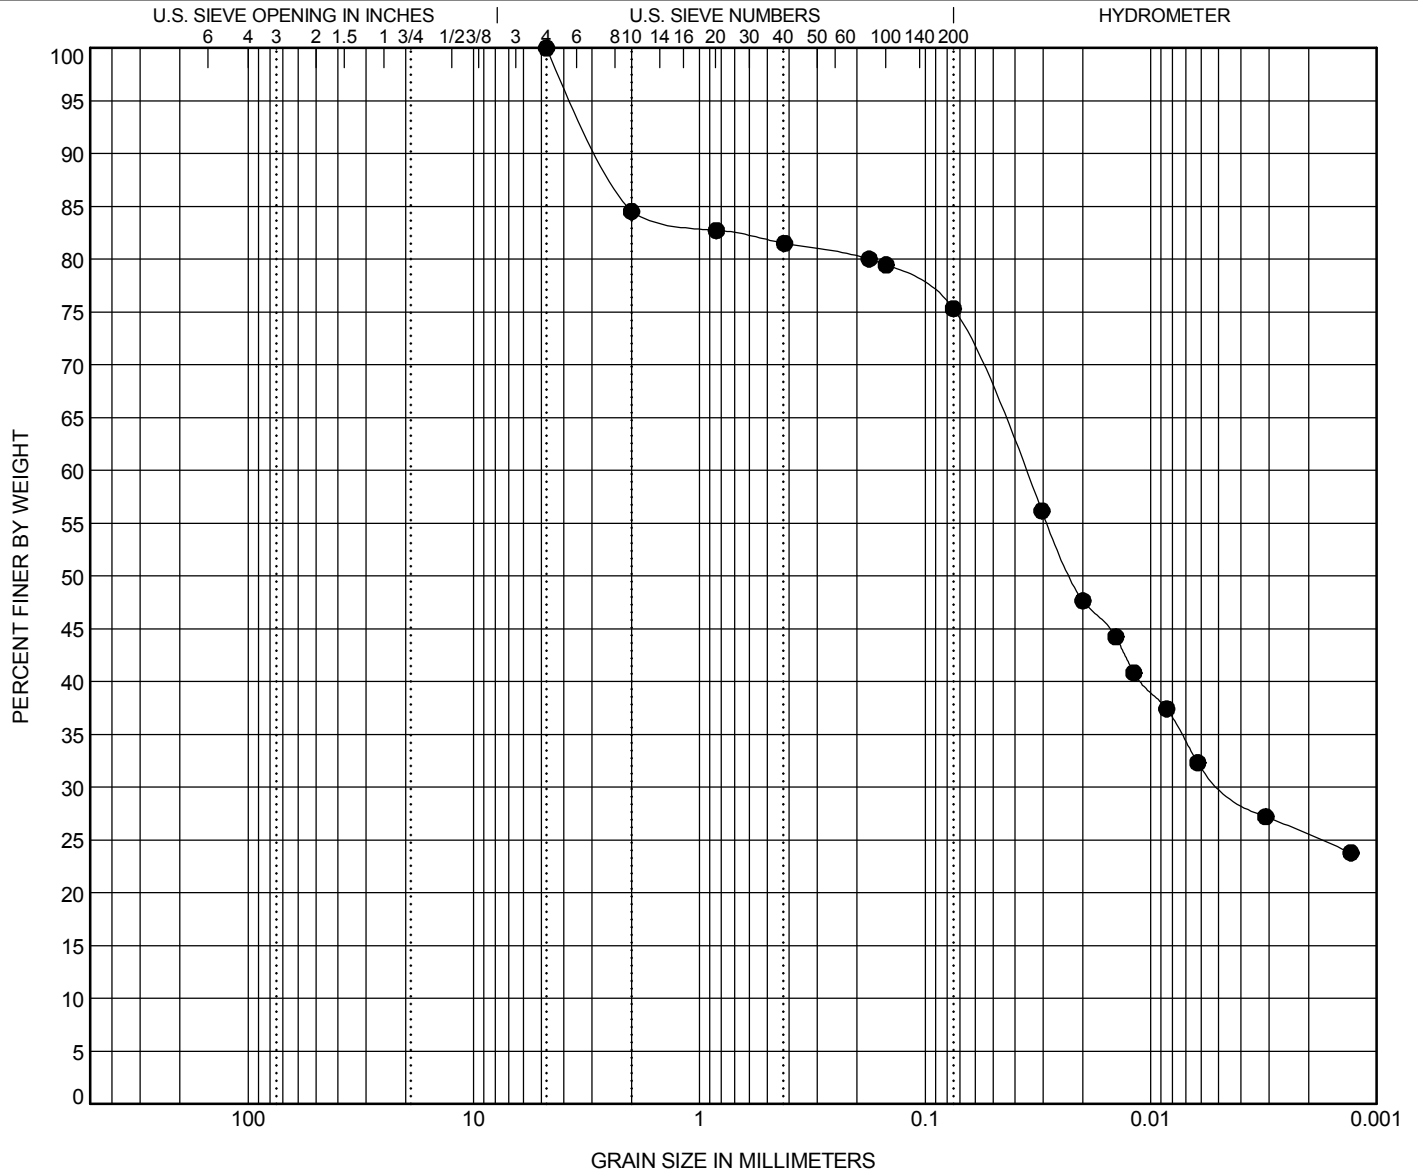
BOREHOLE	DEPTH	Classification					LL	PL	PI	Cc	Cu
● B-1101	8.0	SILT (ML) with Sand									
BOREHOLE	DEPTH	D100	D95	D50	D10	%Gravel	%Sand	%Silt	%Clay		
● B-1101	8.0	4.76	3.597	0.022		0.0	24.6	44.6	30.7

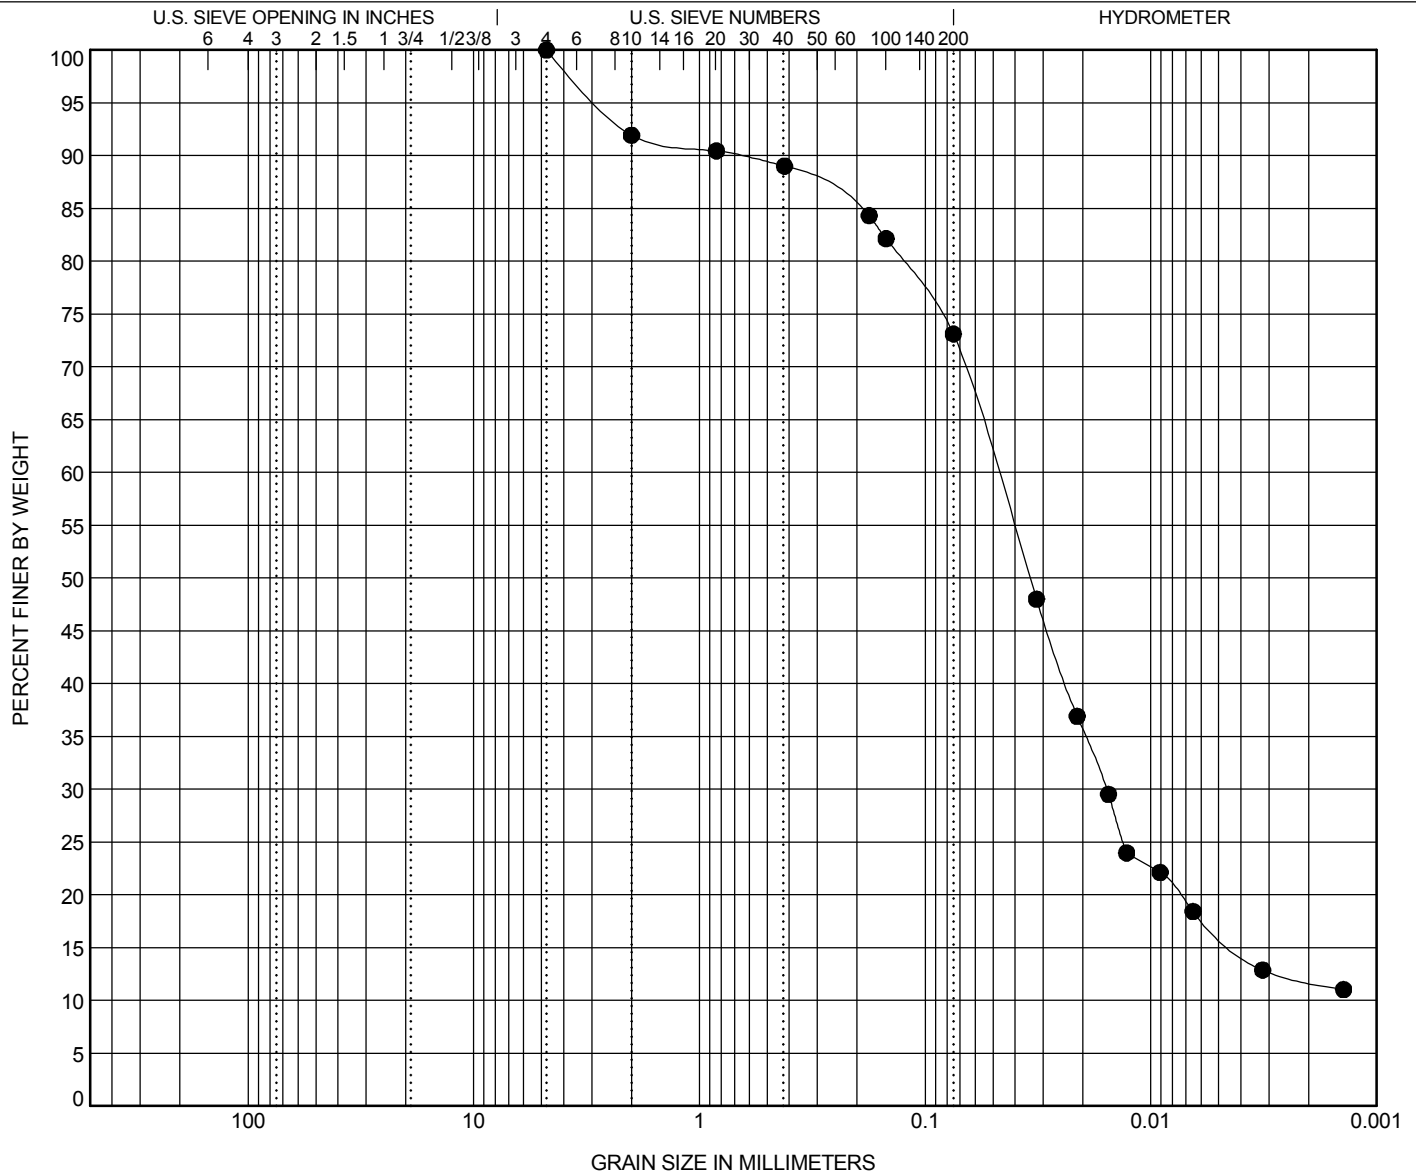
BOREHOLE	DEPTH	Classification					LL	PL	PI	Cc	Cu
● B-1101	10.0	SILT (ML) with Sand									
BOREHOLE	DEPTH	D100	D95	D50	D10	%Gravel	%Sand	%Silt	%Clay		
● B-1101	10.0	4.76	2.78	0.034		0.0	26.9	56.7	16.4

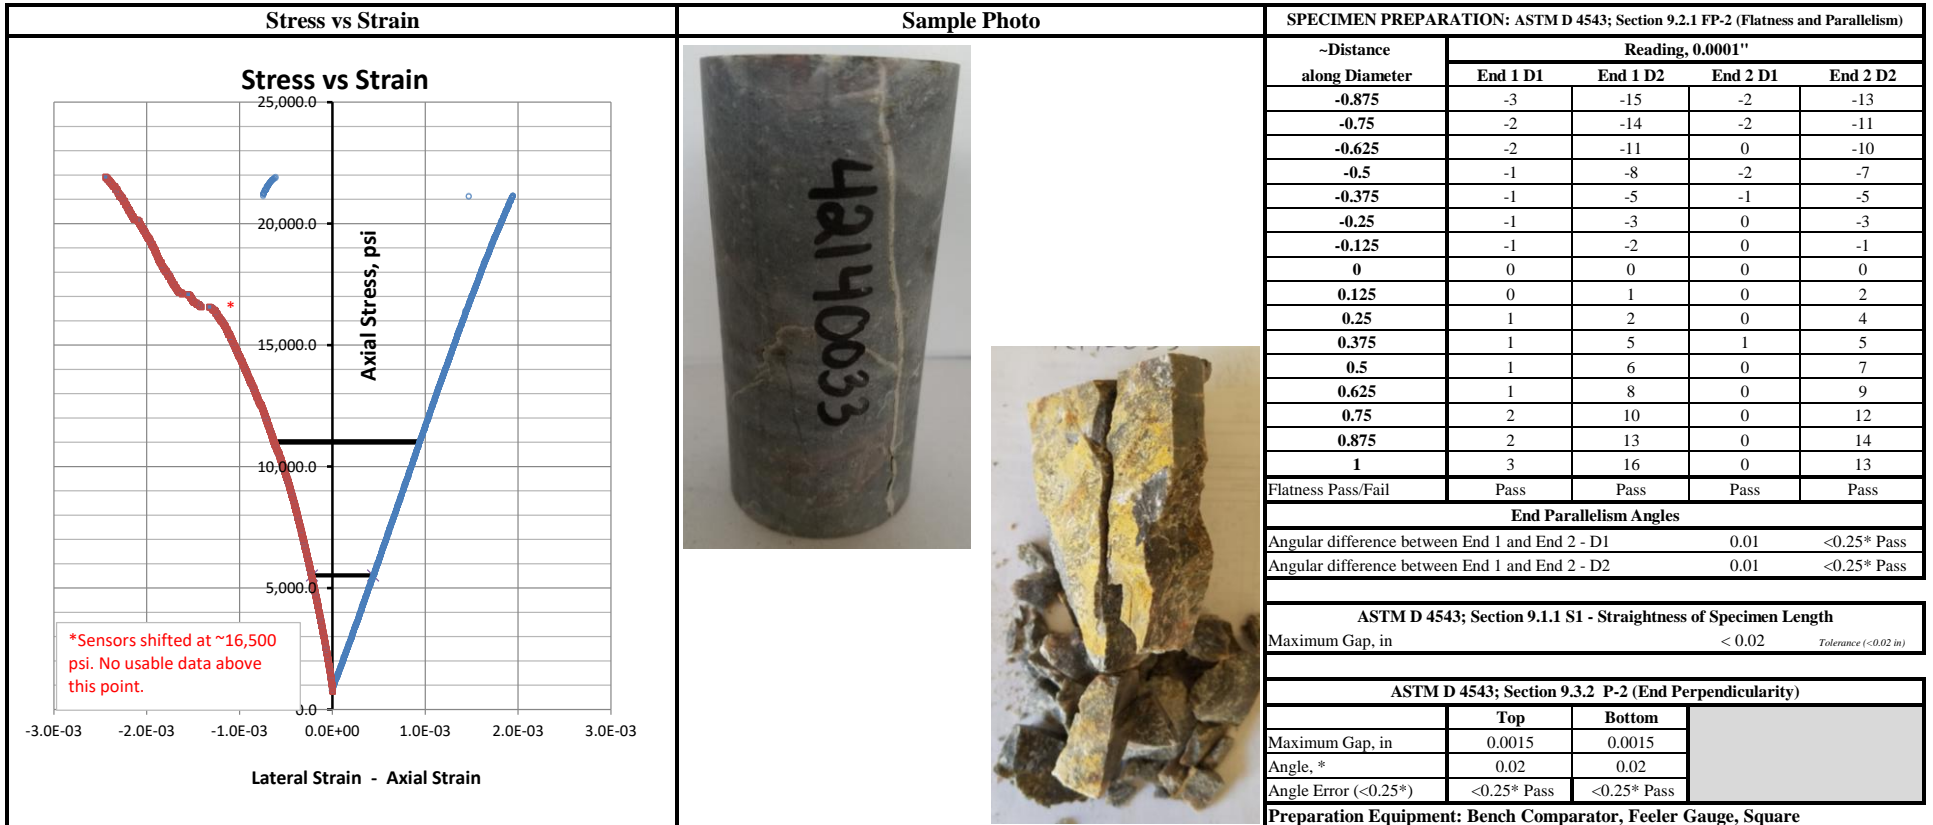
Elastic Moduli of Intact Rock Core Specimens in Uniaxial Compression
ASTM D7012-14e1 (D) / D4543-08e1

Description: Gray Quartzite
 As-Received Condition: Useable L/D > 2
 Sample Preparation: Diamond saw blade cut, surface ground flat

Test Parameters		
Test Temperature	Room	
Moisture Condition	As-Received	
Sample Weight, gms	489.73	
Sample Volume, cc	187	
Wet Density, pcf	163

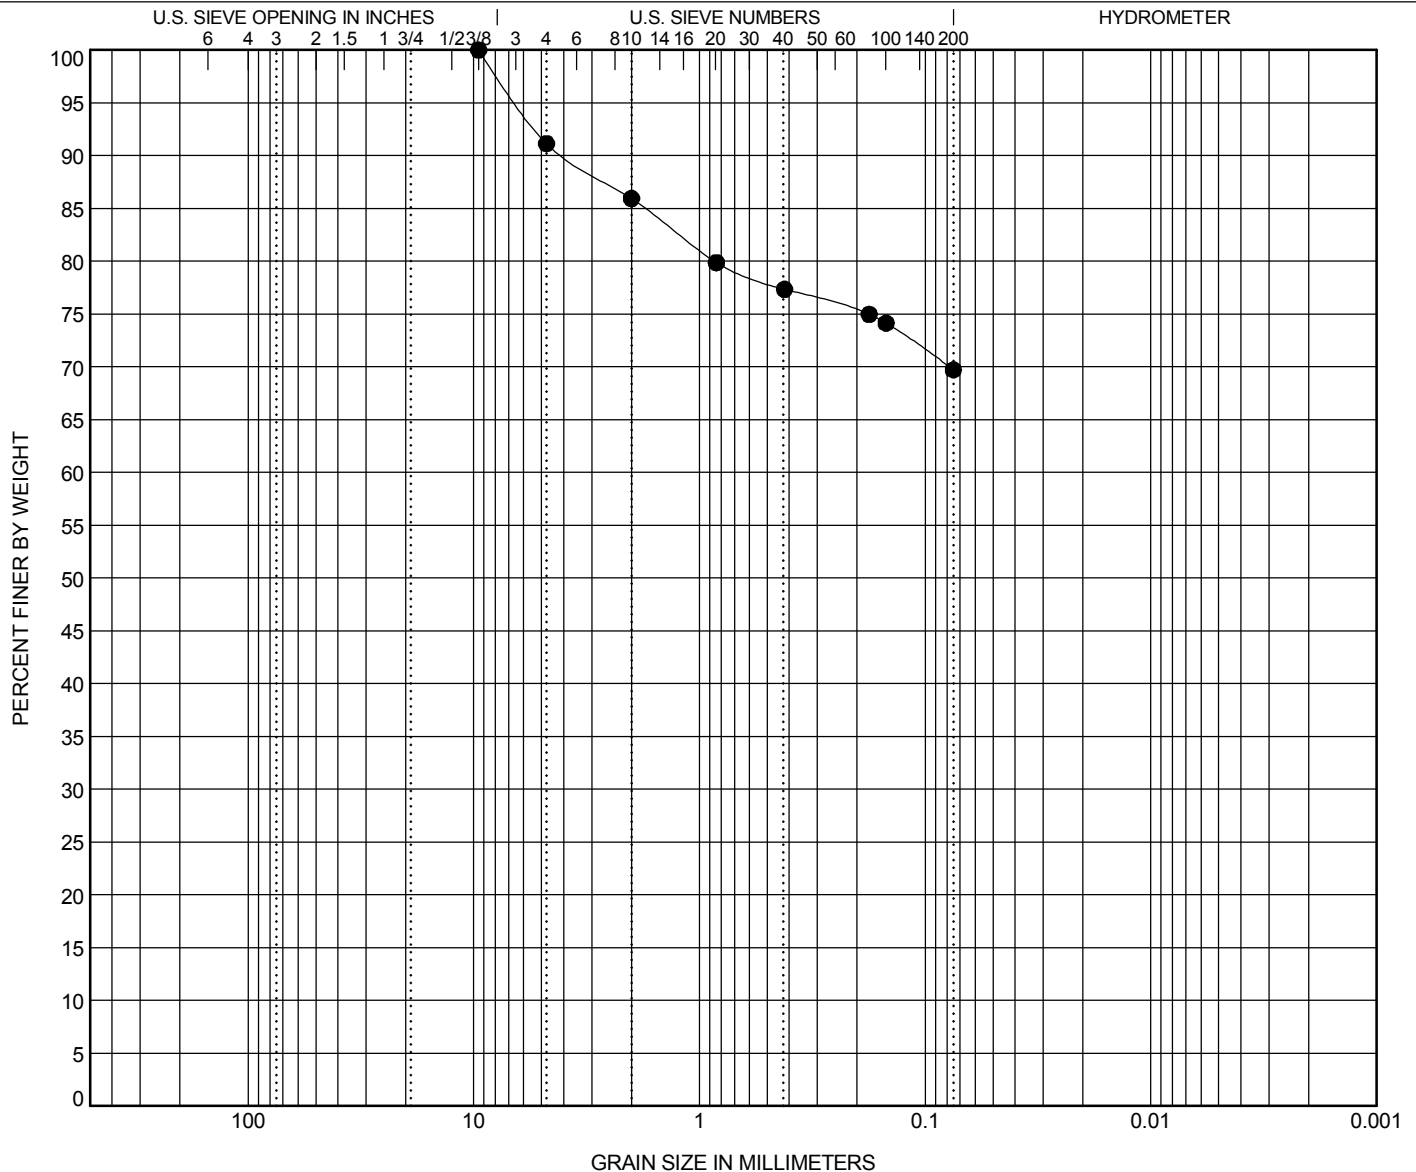
BOREHOLE	DEPTH	Classification					LL	PL	PI	Cc	Cu
● B-1102	2.0	Sandy Lean CLAY (CL/A-7-6(13))					45	26	19		
BOREHOLE	DEPTH	D100	D95	D50	D10	%Gravel	%Sand	%Silt		%Clay	
● B-1102	2.0	9.51	6.432			8.9	21.4	69.7

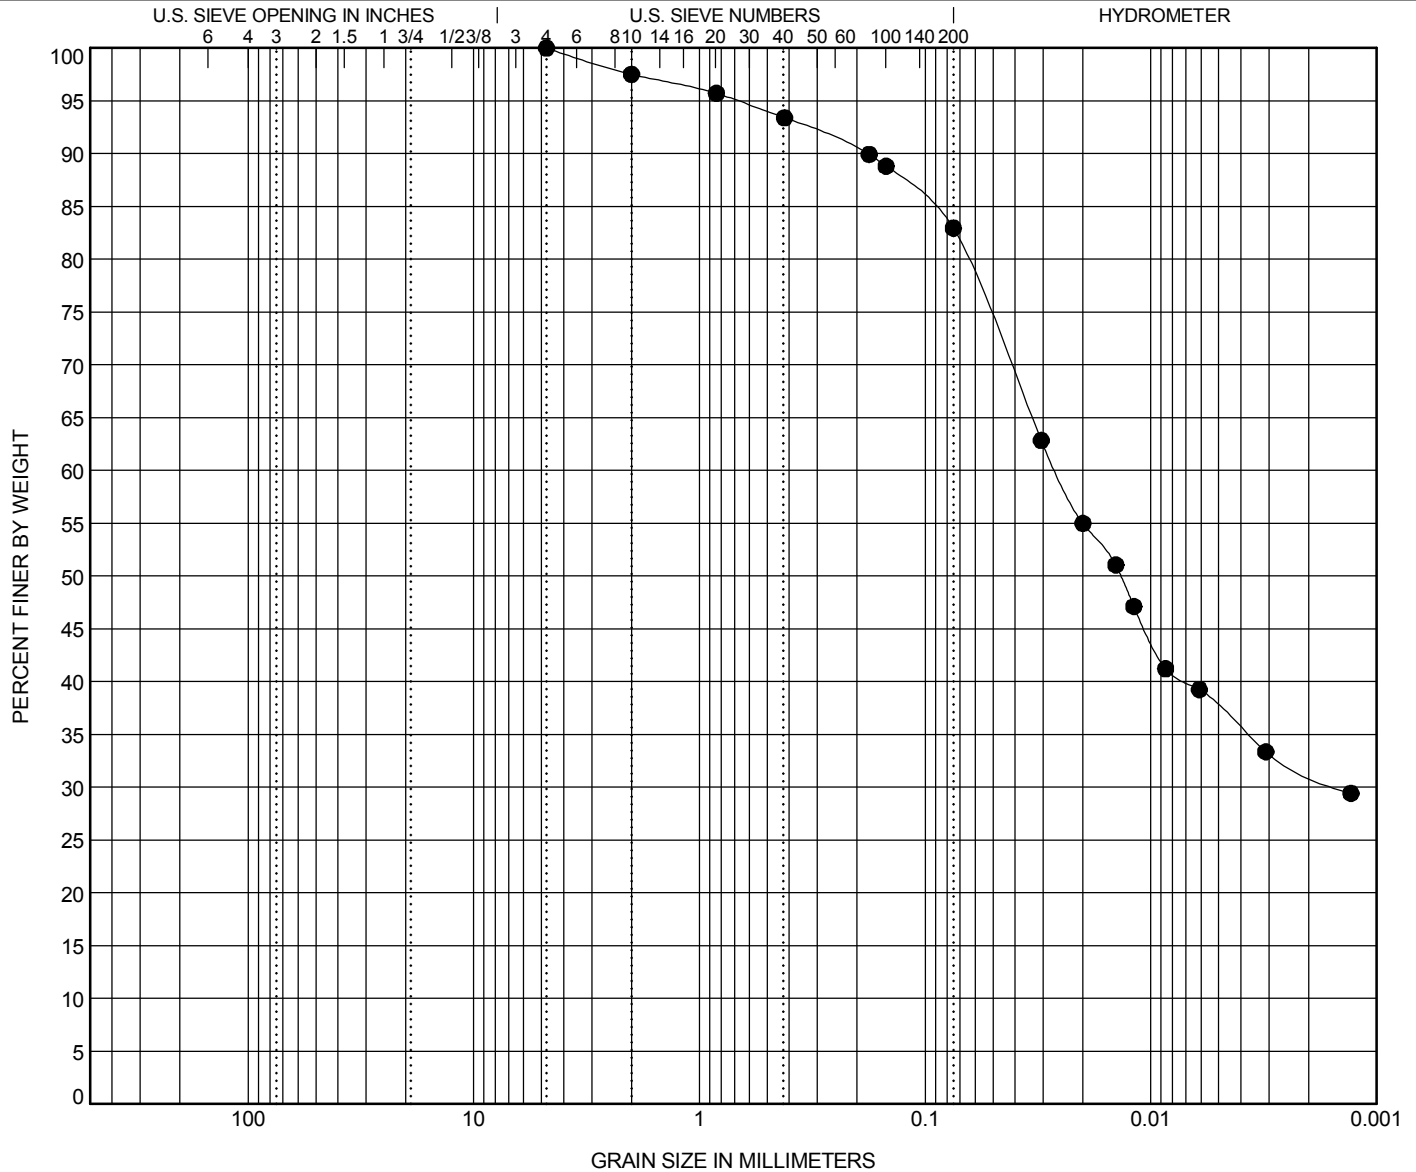
BOREHOLE	DEPTH	Classification					LL	PL	PI	Cc	Cu
● B-1102	6.0	Lean CLAY (CL/A-6(12)) with Sand					38	24	14		
BOREHOLE	DEPTH	D100	D95	D50	D10	%Gravel	%Sand	%Silt		%Clay	
● B-1102	6.0	4.76	0.679	0.014		0.0	17.0	45.4		37.5

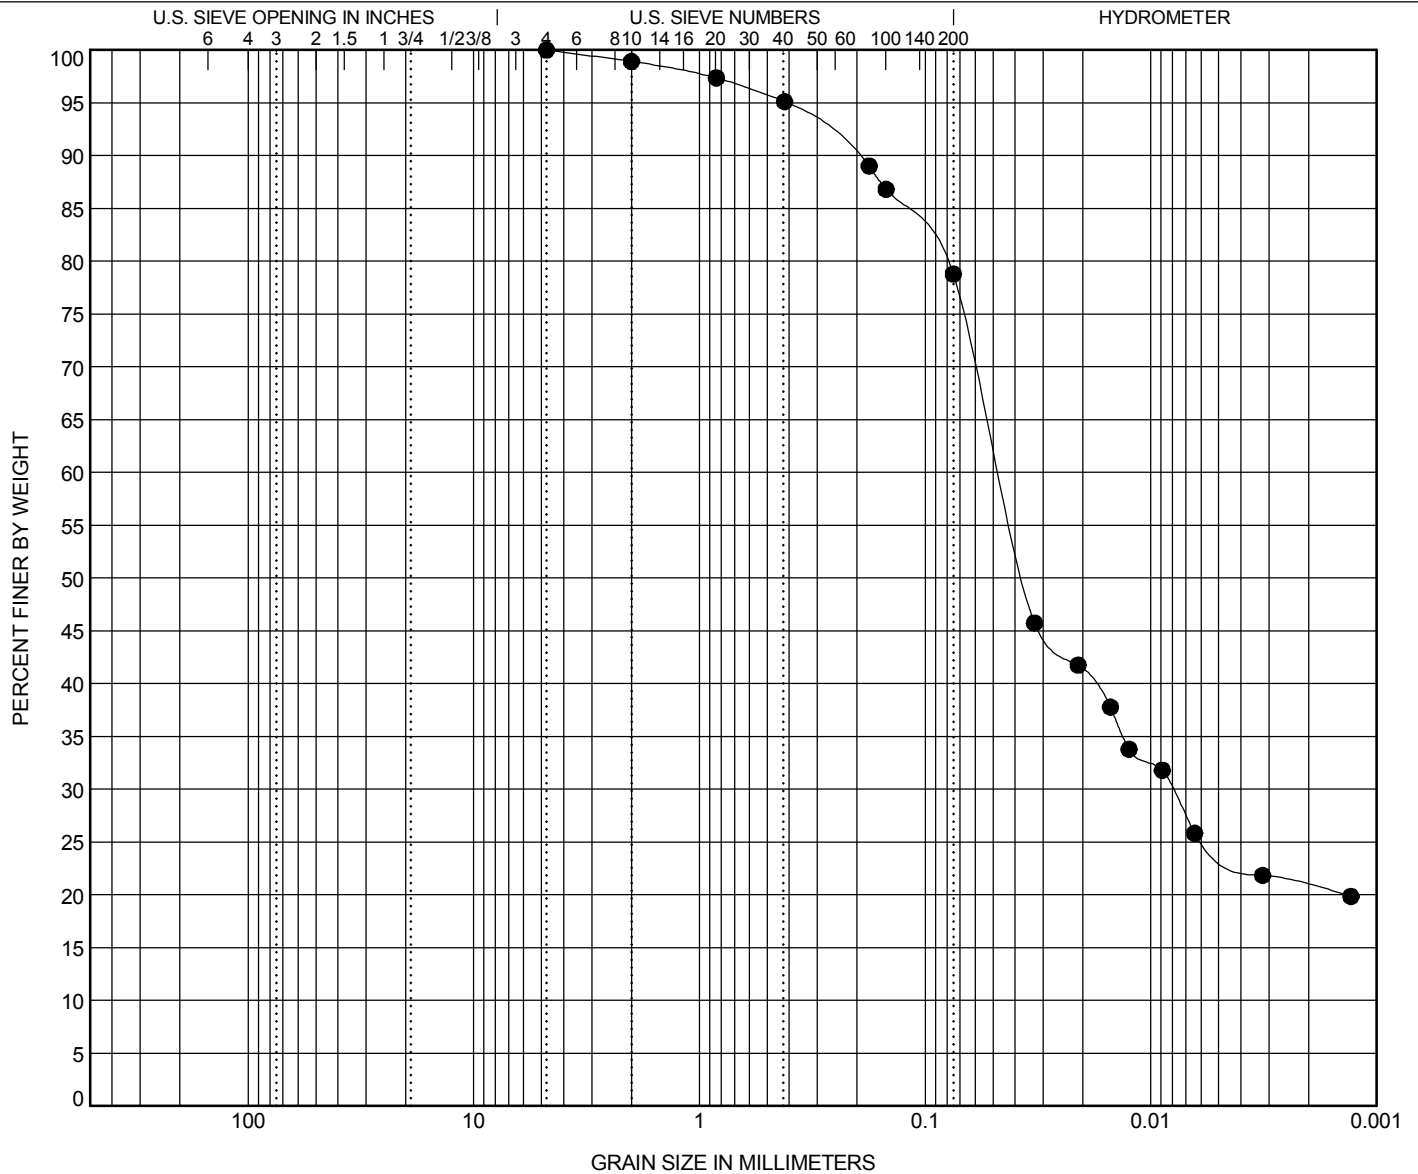
BOREHOLE	DEPTH	Classification					LL	PL	PI	Cc	Cu
● B-1102	8.0	SILT (ML) with Sand									
BOREHOLE	DEPTH	D100	D95	D50	D10	%Gravel	%Sand	%Silt	%Clay		
● B-1102	8.0	4.76	0.413	0.036		0.0	21.2	54.4	24.4
