(008) BRIDGE ID: 1420030101300
(420) ASSET NO: 1939
(419) RAMP NO:
(026) FUNCTIONAL CLASS: 04

(005) ROUTE: CLARENDON US 301
(006) CROSSING: BLACK RIVER (NO. 3)
(009) LOCATION: 8MI N OF MANNING
(016) LAT: 33 d 48 m 47.00 s (017) LON: 80 d 6 m 39.00 s

Bridge Element Group Textual Data

SPECIAL FLOOD INSPECTION COMPLETED ON 10-22-2015

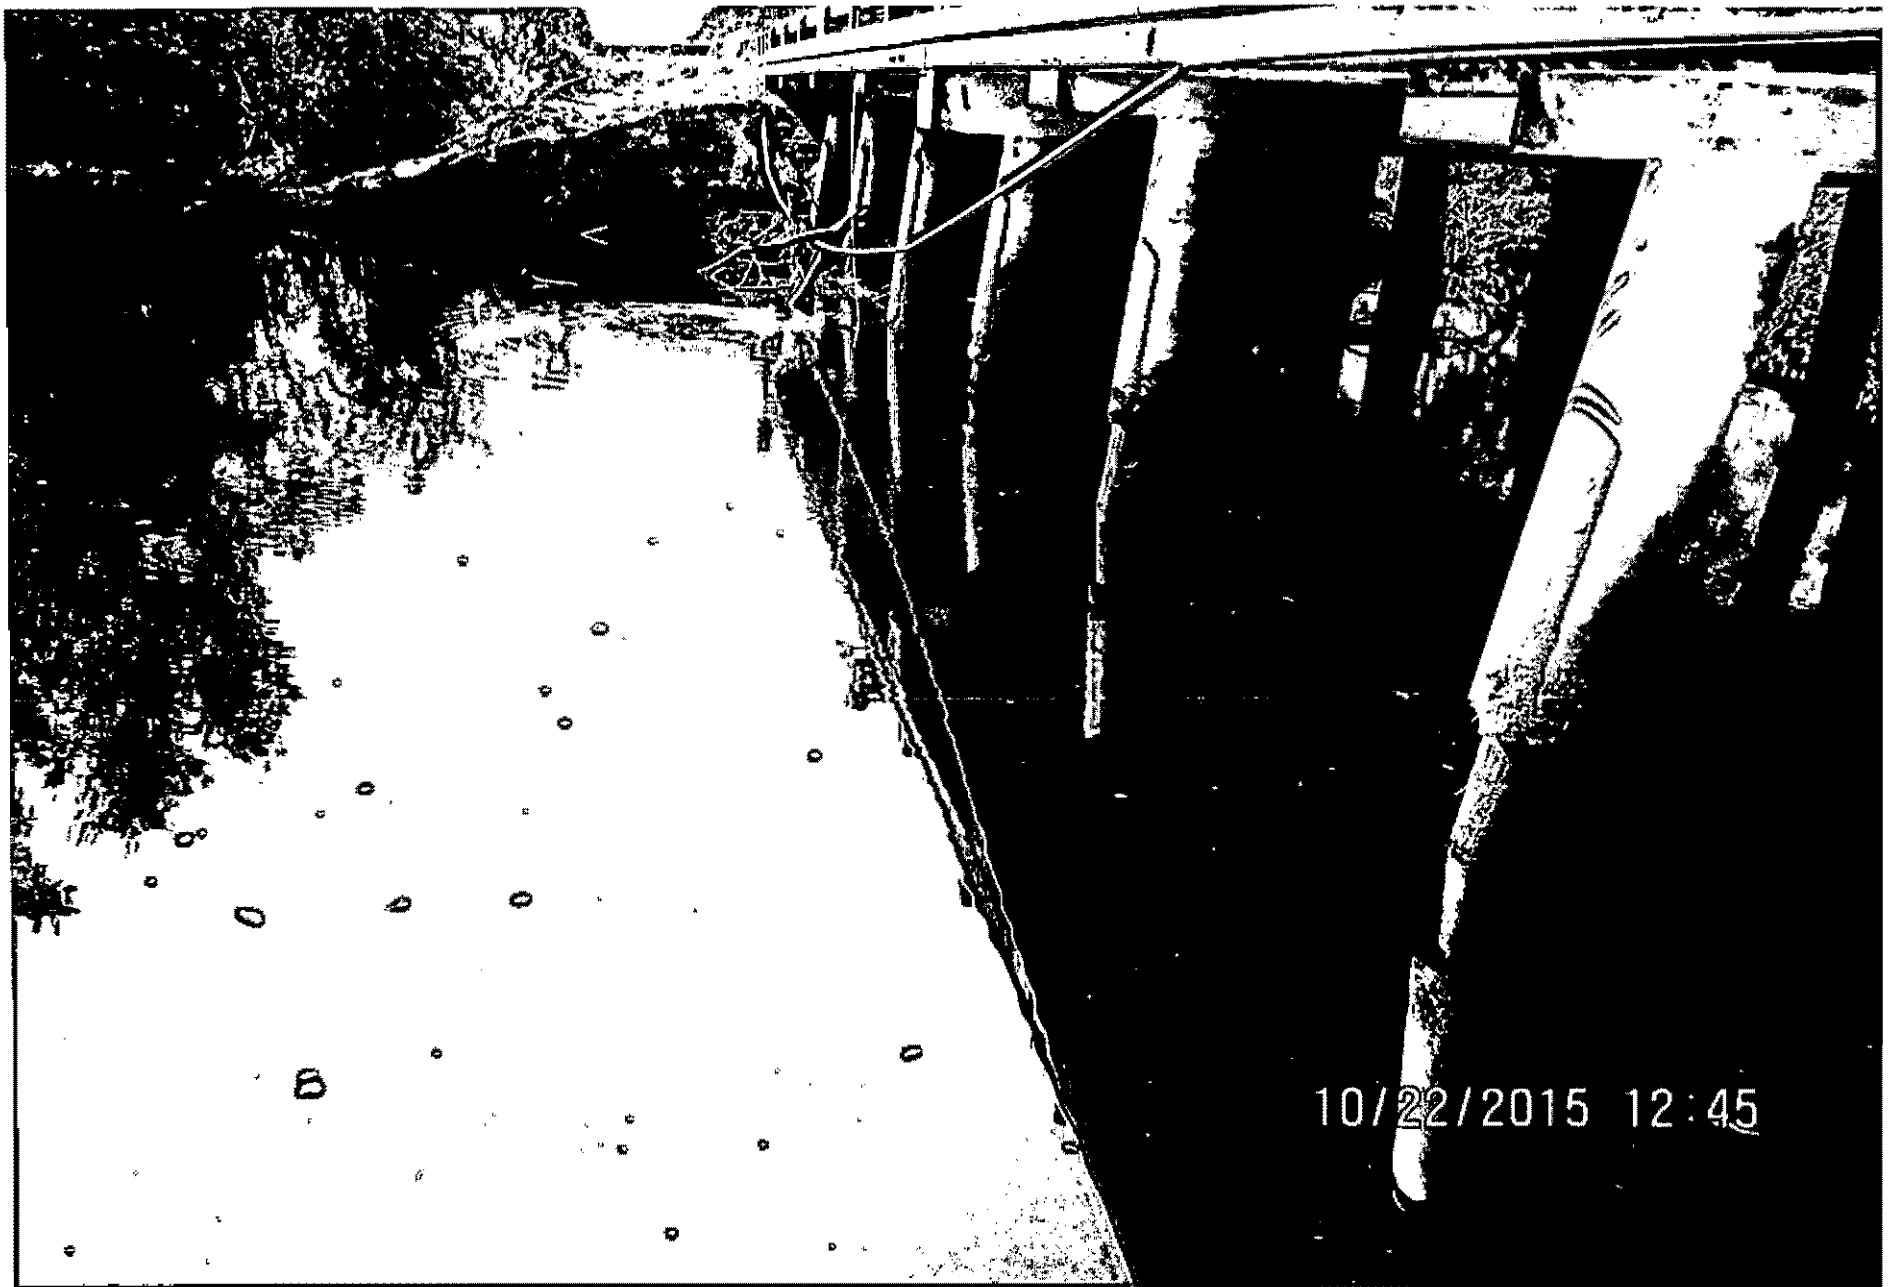
4-POOR: MAJOR TO SEVERE SCOUR AT PILES; LARGE AMOUNTS OF DEBRIS; SEE PROFILE SHEET FOR DETAILS;

14-2-00301-0-13-00 Scour of Streambed & Washing of Slope Protection under Beginning of Bridge
