S-46-1086 Bridge Replacement over Beaverdam Creek

Geotechnical Subsurface Data Report

August 18, 2023 | SCDOT Project ID: P041173

Terracon Project No.: 7323P100

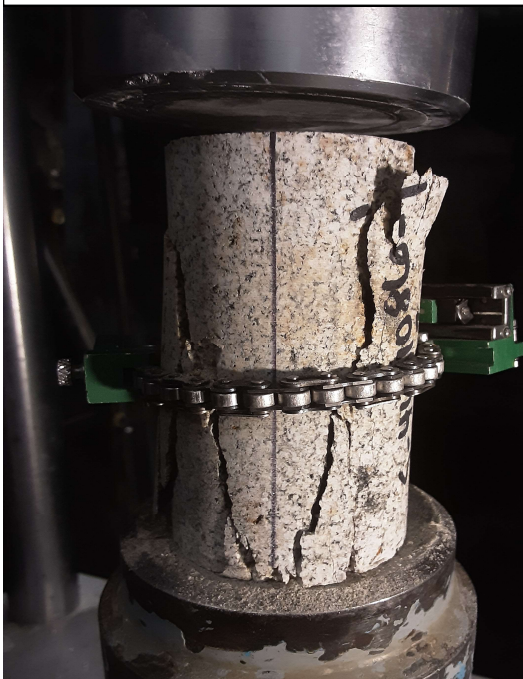
ASTM D7012 Stress/ Strain Curve

Failure Load (lbs):	19679
Failure Strain (%):	3.49
Unconfined Compressive Strength (psi):	6,378
Elastic Modulus, E, (ksi):	567
Poisson's Ratio, u:	0.611
Time of Failure (min):	03:00
Rate of Loading (psi/sec):	35.435
Moisture Content Post-break:	0.4%

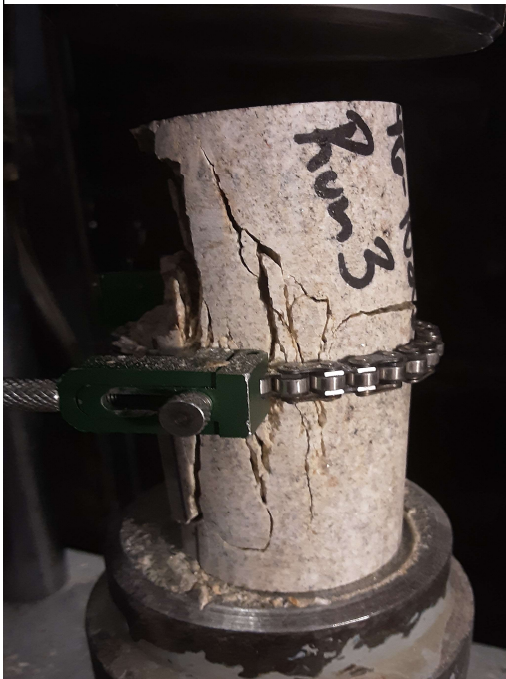
ASTM D7012 Stress/ Strain Curve

Failure Load (lbs):	32546
Failure Strain (%):	3.77
Unconfined Compressive Strength (psi):	10,538
Elastic Modulus, E, (ksi):	878
Poisson's Ratio, u:	0.408
Time of Failure (min):	03:43
Rate of Loading (psi/sec):	47.172
Moisture Content Post-break:	0.1%

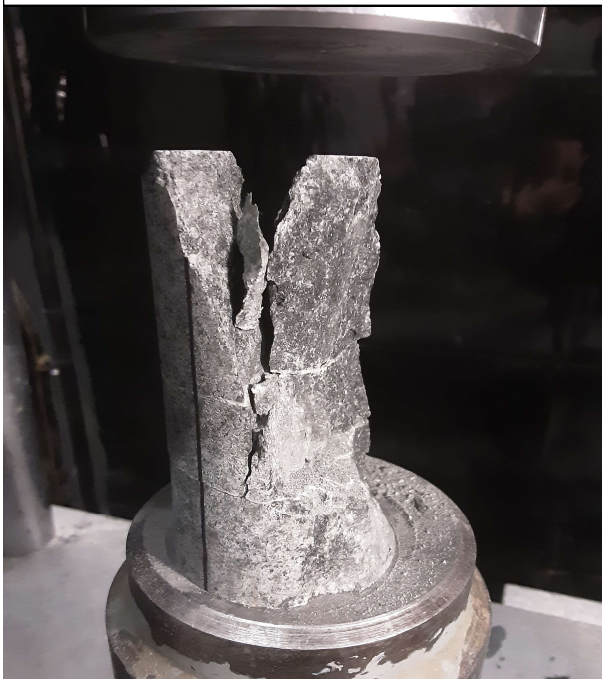
ASTM D7012 Stress/ Strain Curve

Failure Load (lbs):	34251
Failure Strain (%):	4.54
Unconfined Compressive Strength (psi):	11,146
Elastic Modulus, E, (ksi):	699
Poisson's Ratio, u:	0.002
Time of Failure (min):	03:30
Rate of Loading (psi/sec):	52.976
Moisture Content Post-break:	0.5%

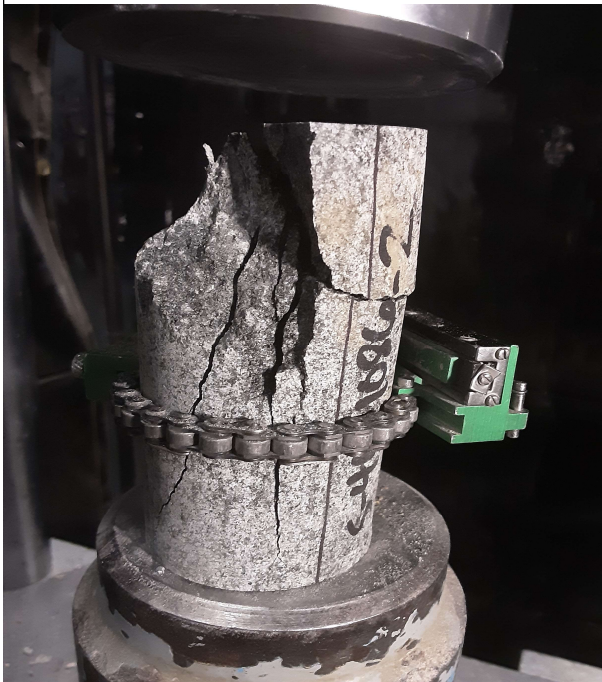
ASTM D7012 Stress/ Strain Curve

Failure Load (lbs):	18380
Failure Strain (%):	3.17
Unconfined Compressive Strength (psi):	5,988
Elastic Modulus, E, (ksi):	691
Poisson's Ratio, u:	0.020
Time of Failure (min):	03:05
Rate of Loading (psi/sec):	32.365
Moisture Content Post-break:	0.4%
