EC-2601

I-20/26/126 Corridor Improvement Project

6' x 6' RCB

Client: SCDOT

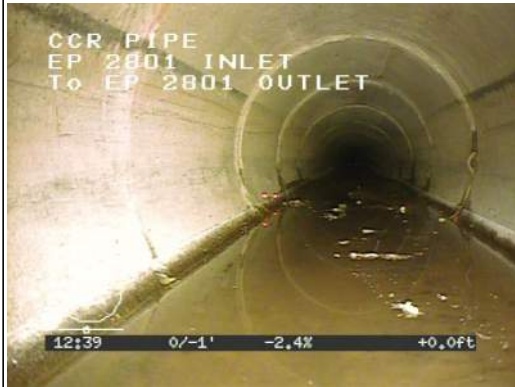
Distance	Fault Observation	Time	Picture
0.0	Discharge Point Severity: None	29	
0.0	Water Level Severity: None Percent: 10	40

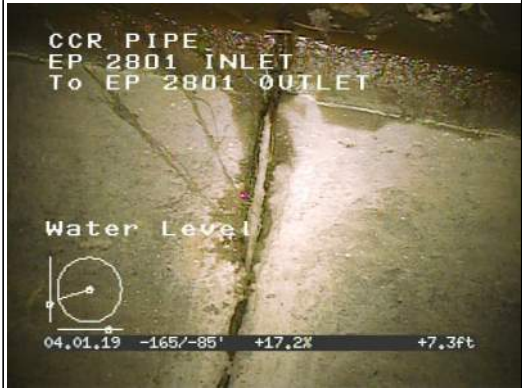
7.3	Roots Fine Joint Position: 8 Severity: None Joint Maint Weight: 1	05:42

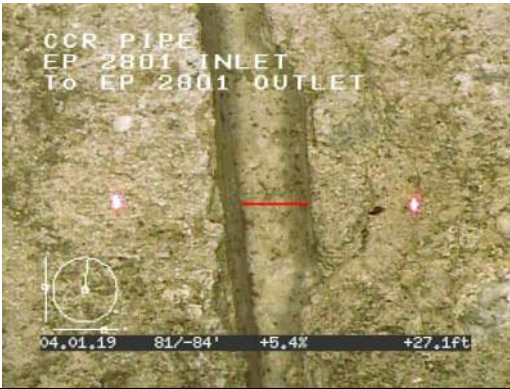
Distance	Fault Observation	Time	Picture
27.1	General Observation Severity: None Remarks: 0.546	15:17

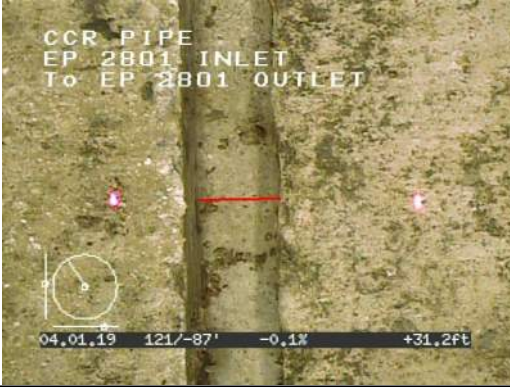
31.3	General Observation Severity: None Remarks: 0.67	16:25

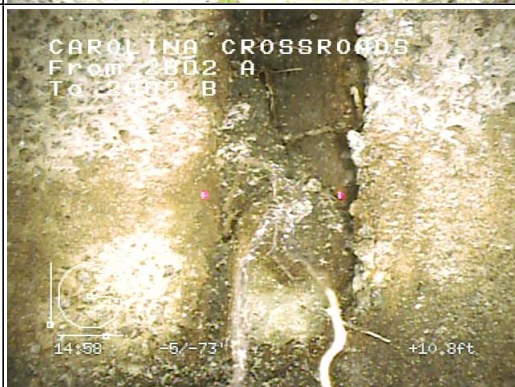
10.9	Roots Fine Joint Position: 3 Severity: None Joint Maint Weight: 1	02:09

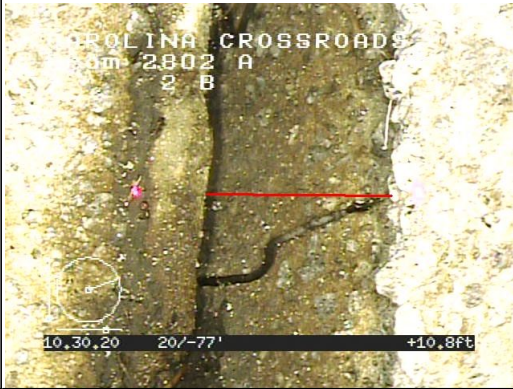
Distance	Fault Observation	Time	Picture
10.9	Miscellaneous General Observation Severity: None Remarks: GAP OBSERVATION 1.62	03:07

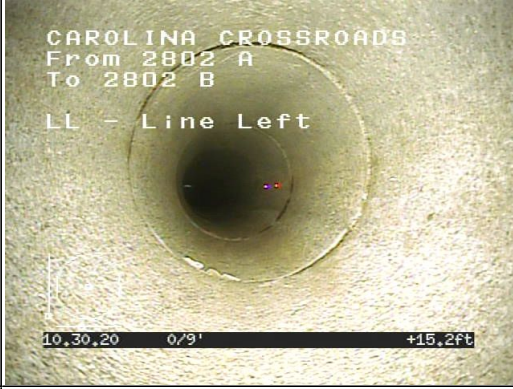
15.3	Line Left Severity: None Percent: 20 Remarks: LINE TURNS LEFT 10 DEGREES Maint Weight: 2	04:22

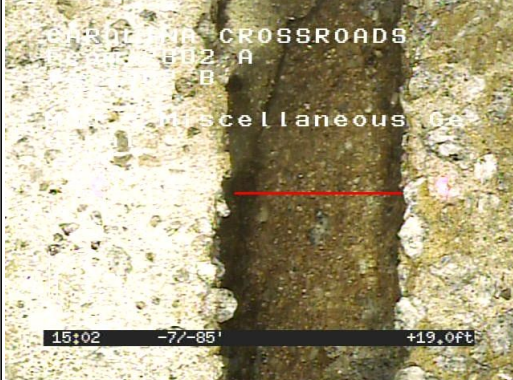
19.0	Miscellaneous General Observation Severity: None Remarks: GAP OBSERVATION 1.209	6:10

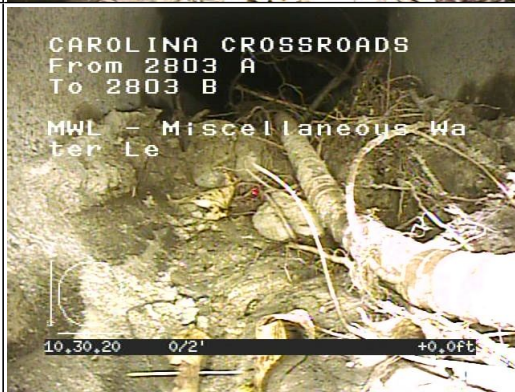
0.0	Miscellaneous Water Level Severity: None Percent: 0	31

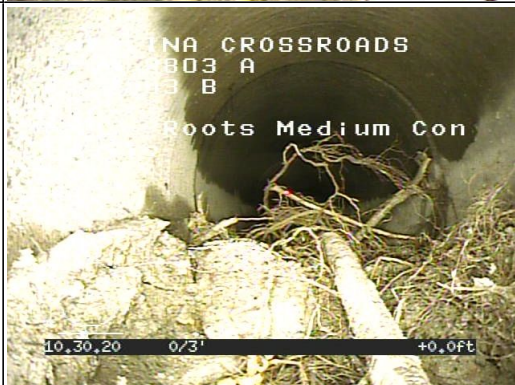
0.0	Roots Medium Connection Position: 3 To 7 Severity: None Percent: 20 Remarks: ROOT AT INLET Maint Weight: 3	01:25

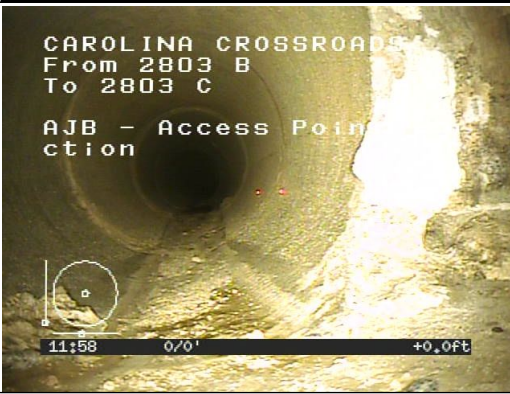
Distance	Fault Observation	Time	Picture
0.0	Access Point Junction Box Severity: None Remarks: HIDDEN JUNCTION 2803 B	17

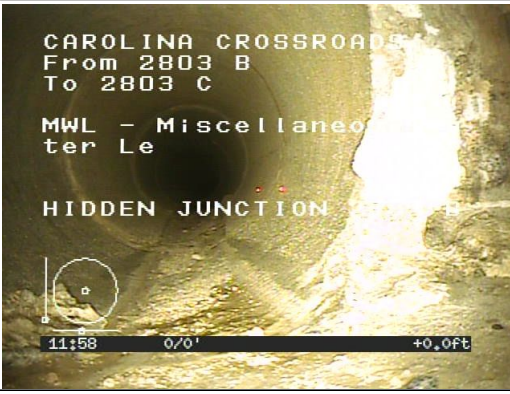
0.0	Miscellaneous Water Level Severity: None Percent: 0	32

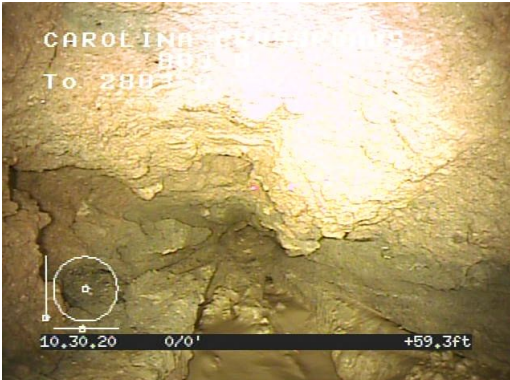
59.4	Access Point Discharge Point Severity: None Remarks: BURRIED END OF PIPE AT 2803 C	11:16

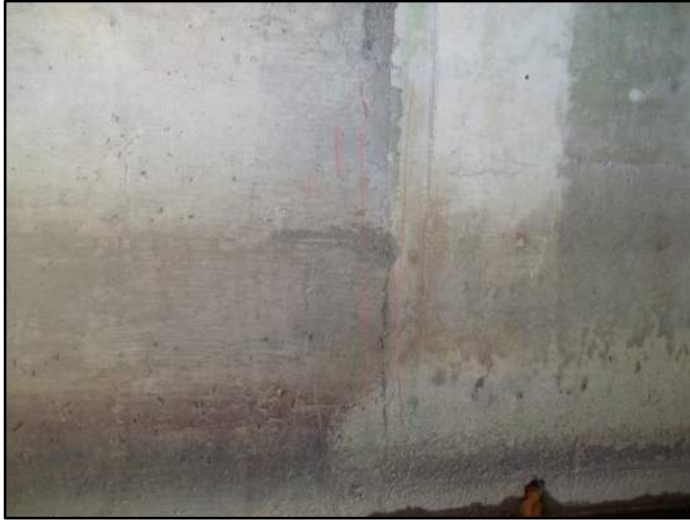
- 1) 15 feet – Transverse cracking on left and right sides.
 - 2) 30 feet – Transverse cracking on left and right sides.
 - 3) 40 feet – Transverse cracking on right side.

15' – Lt side
Transverse Cracking

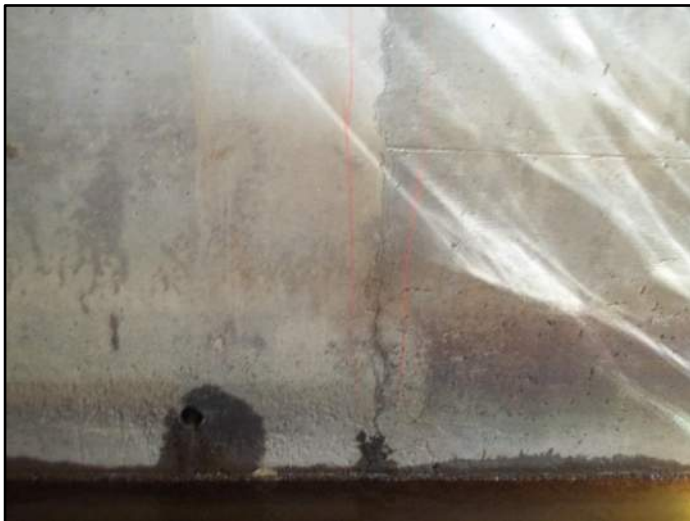
15' – Rt side
Transverse Cracking

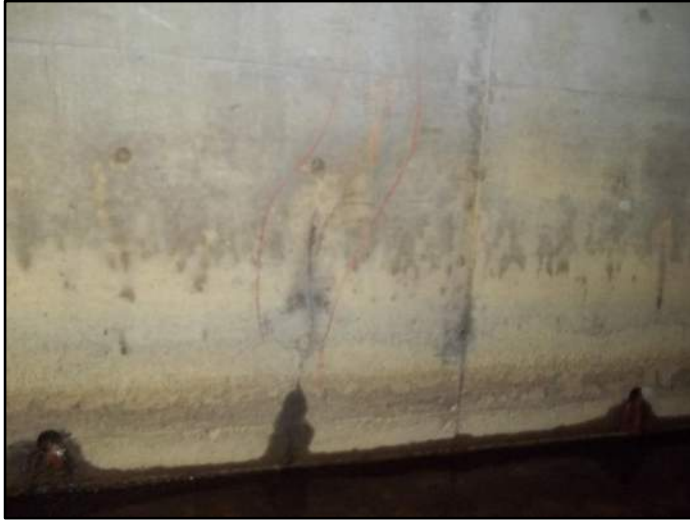
30' – Lt side
Transverse Cracking

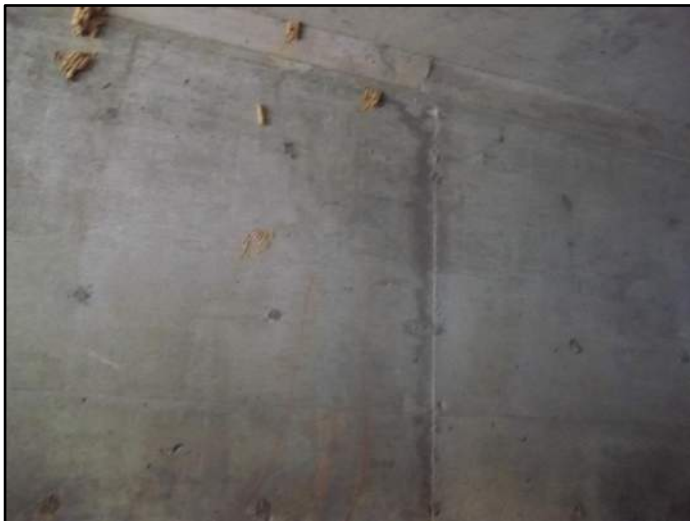
30' – Lt side
Transverse Cracking

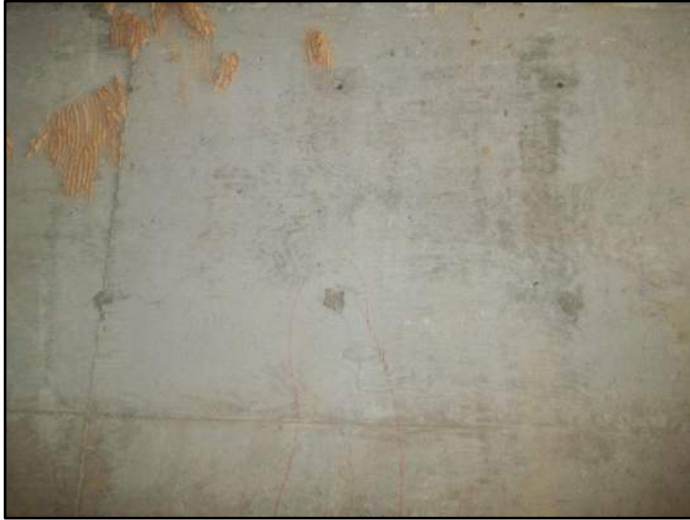
30' – Rt side
Transverse Cracking

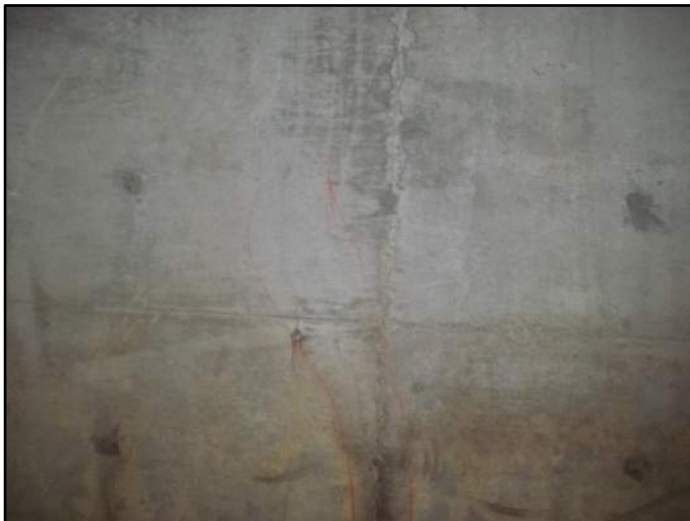
40' – Rt side
Transverse Cracking

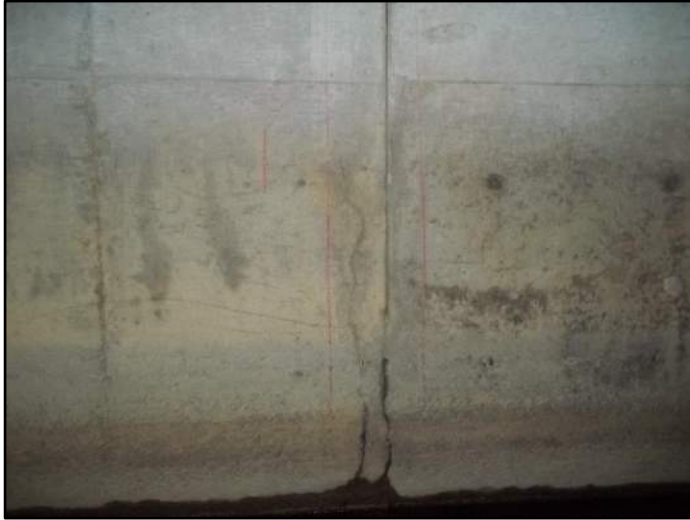
- 4) 43 feet – Transverse cracking on left side.
 - 5) 66 feet – 0.70" separation at joint.
 - 6) 91 feet – Transverse cracking with exposed rebar on right side.

66' – Lt side
Separation at joint

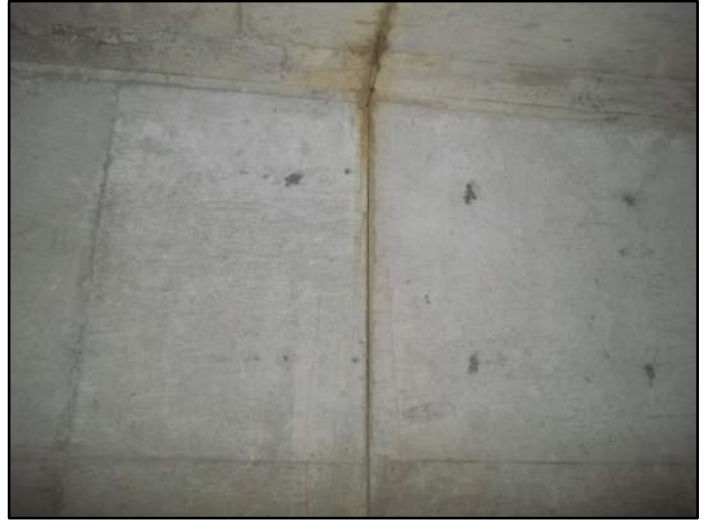
66' – Lt side
Separation at joint

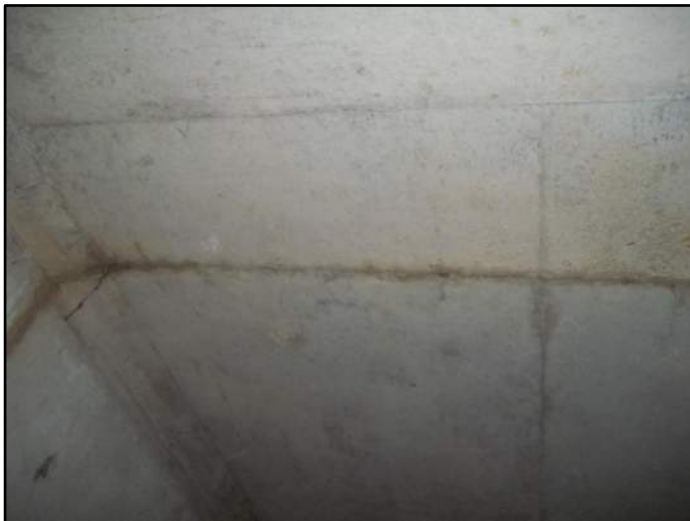
66' – Top
Separation at joint

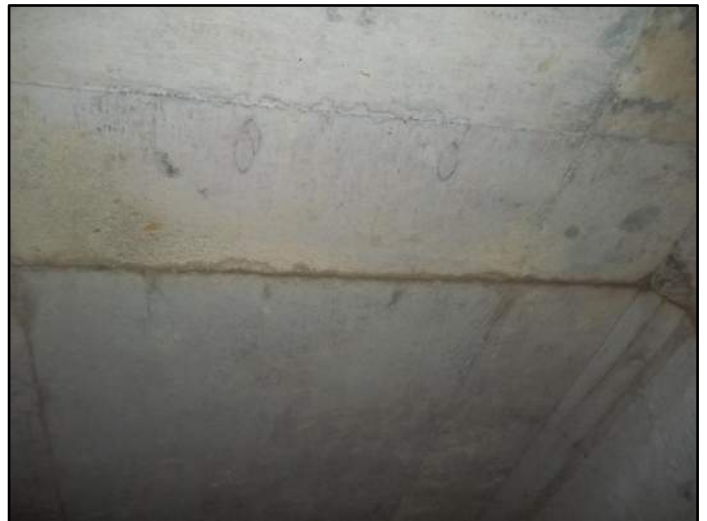
66' – Top
Separation at joint

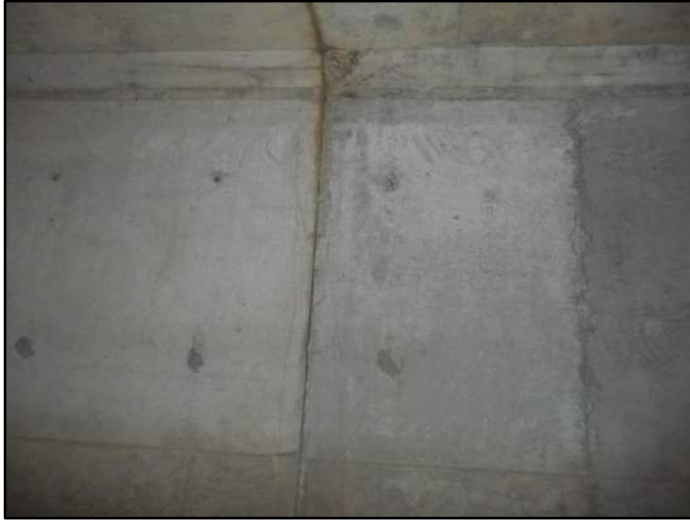
66' – Rt side
Separation at joint

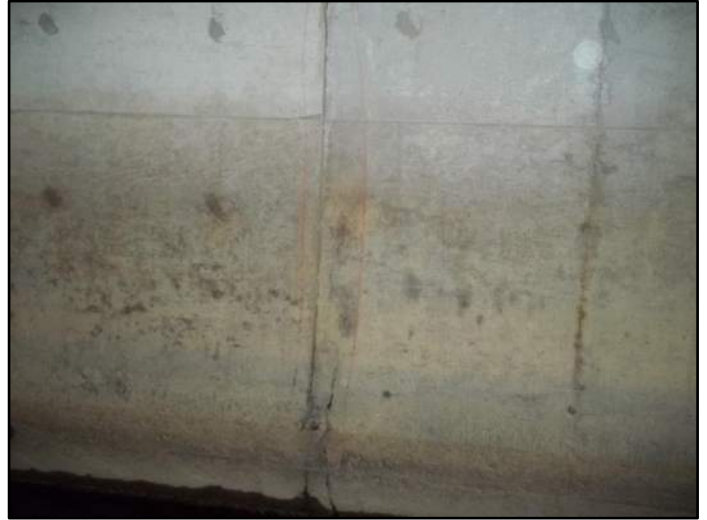
66' – Rt side
Separation at joint

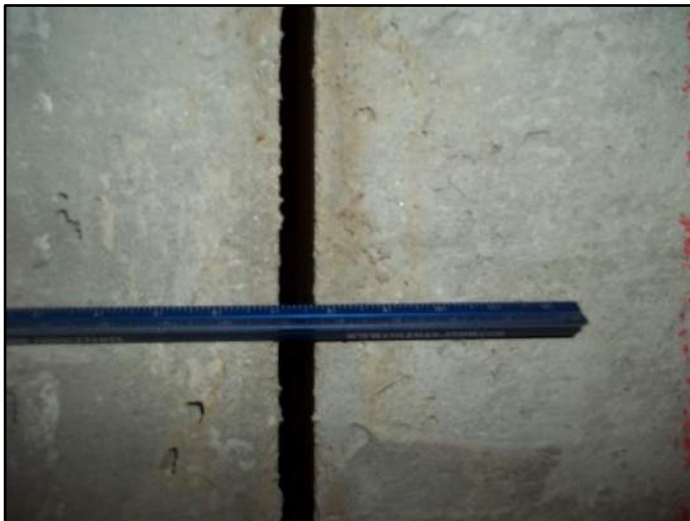
66' – Lt side
Separation at joint

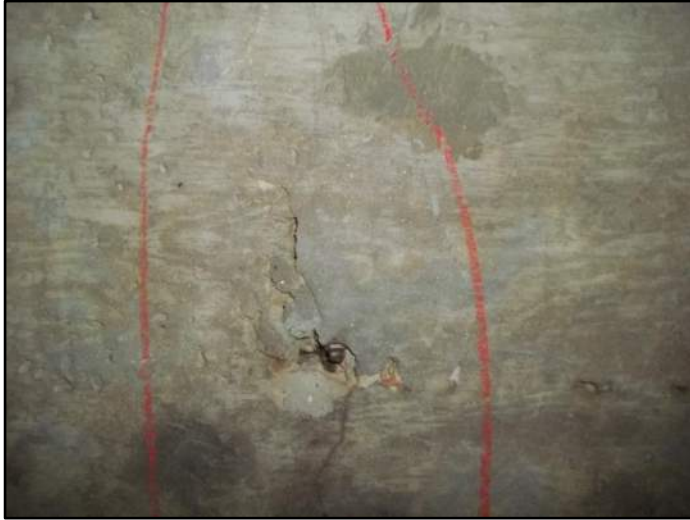
91' – Rt side
Transverse Cracking with exposed rebar

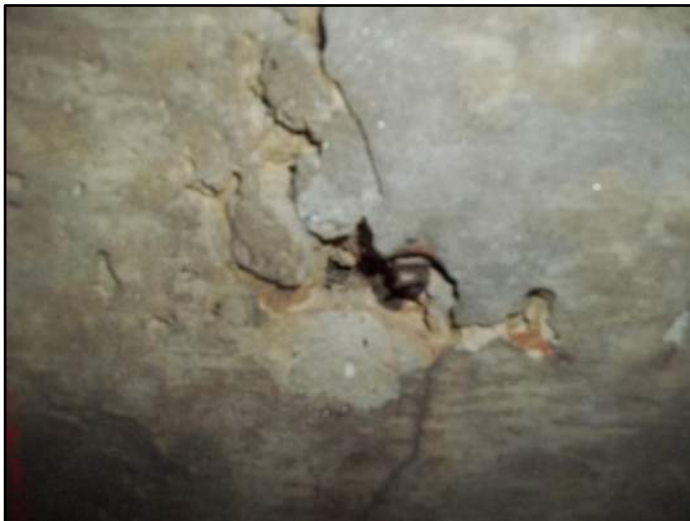
91' – Rt side
Transverse Cracking with exposed rebar

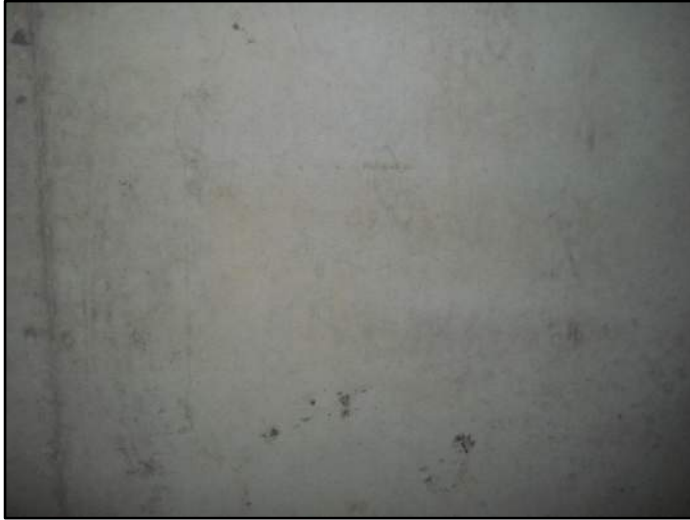
93' – Top
Horizontal crack

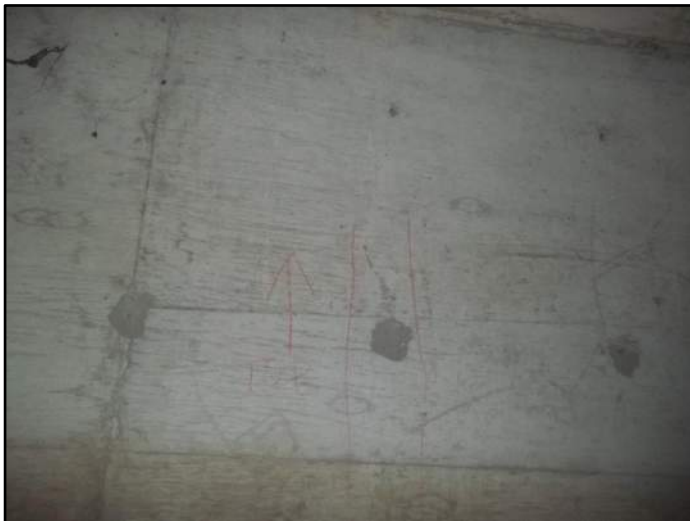
97' – Lt side
Transverse Cracking

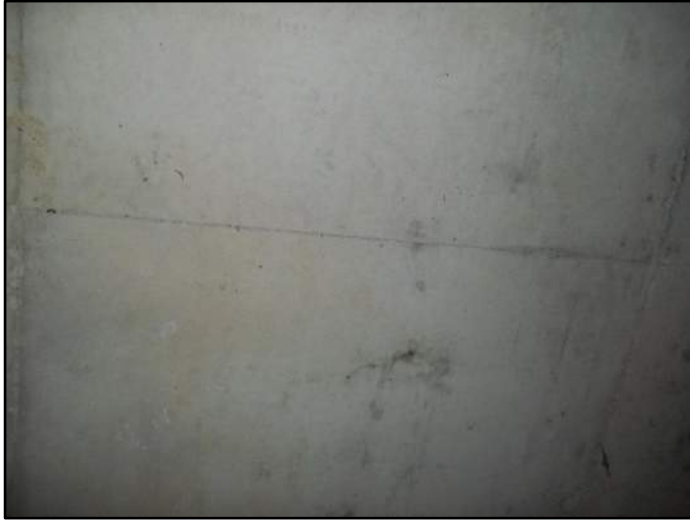
97' – Top
Transverse Cracking

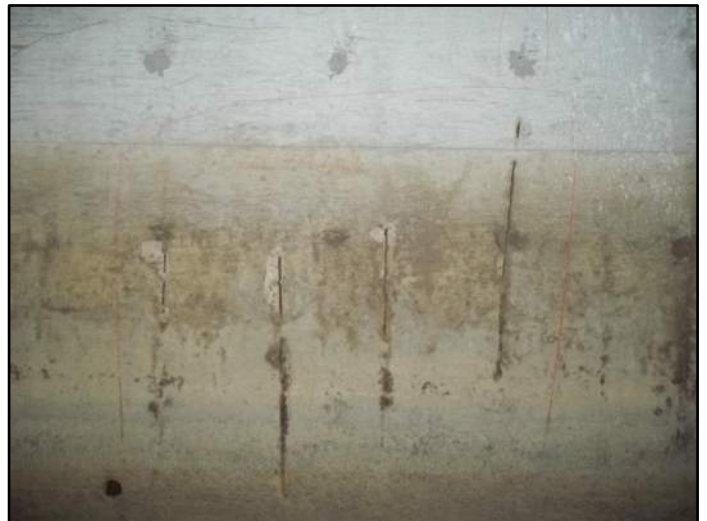
98 – 102' – Rt side
Exposed rebar

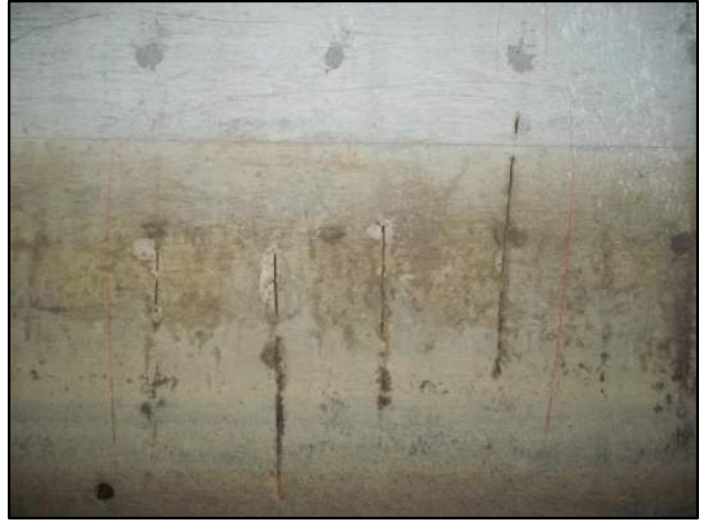
98 – 102' – Rt side
Exposed rebar

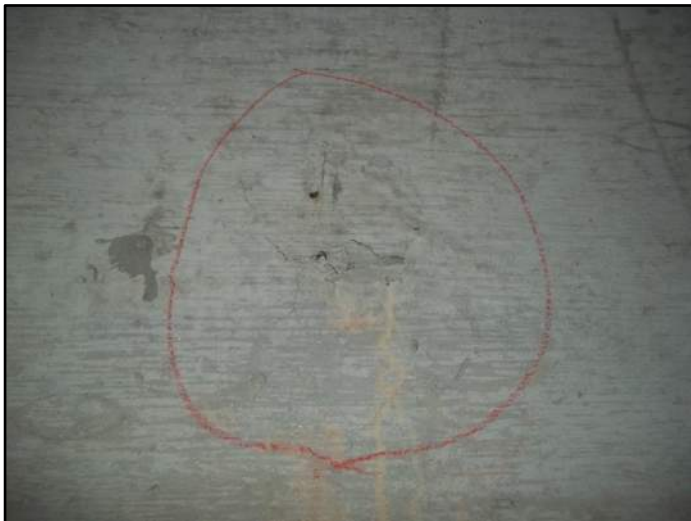
- 10) 115 feet – Spalled concrete with exposed rebar on right side.
 - 11) 125 feet – 0.60" separation at joint.
 - 12) 139 feet – Transverse crack on right side.

115' – Rt side
Exposed rebar

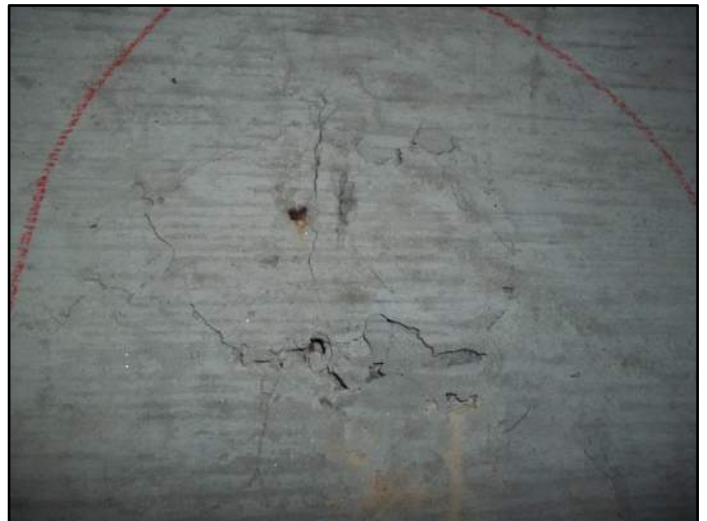
115' – Rt side
Exposed rebar

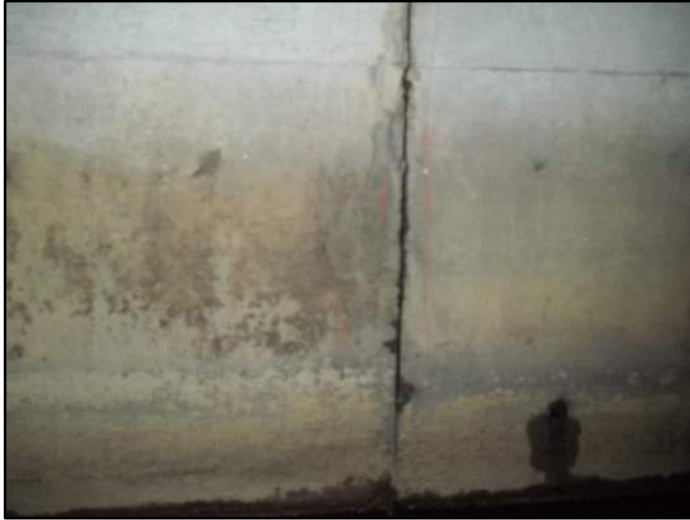
125' – Lt side
Separation at joint

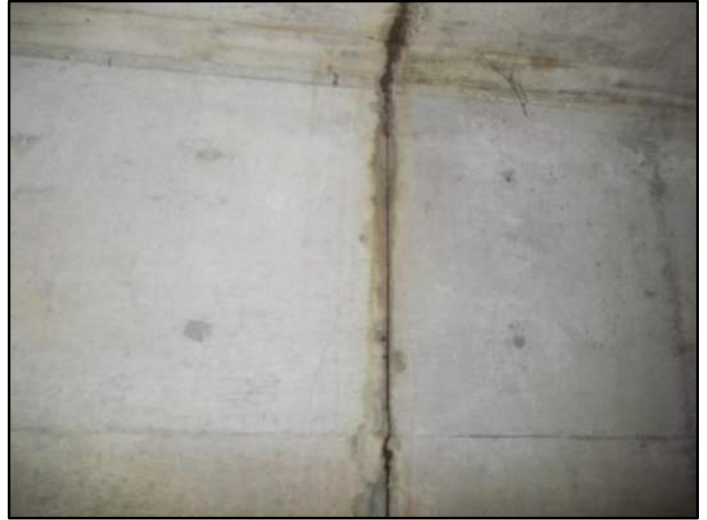
125' – Lt side
Separation at joint

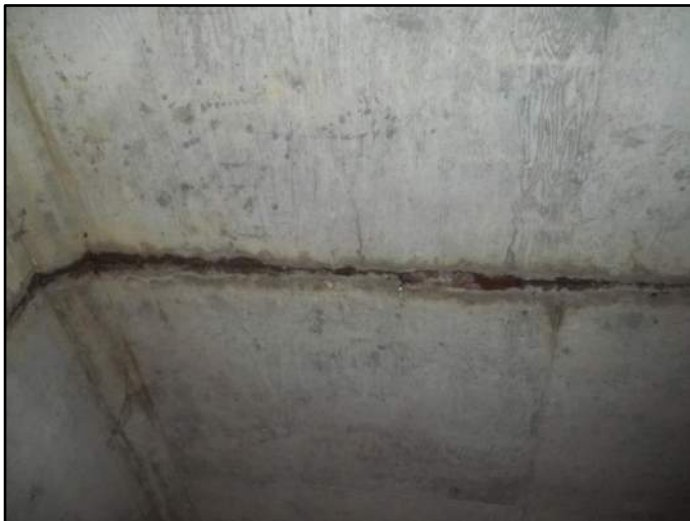
125' – Top
Separation at joint

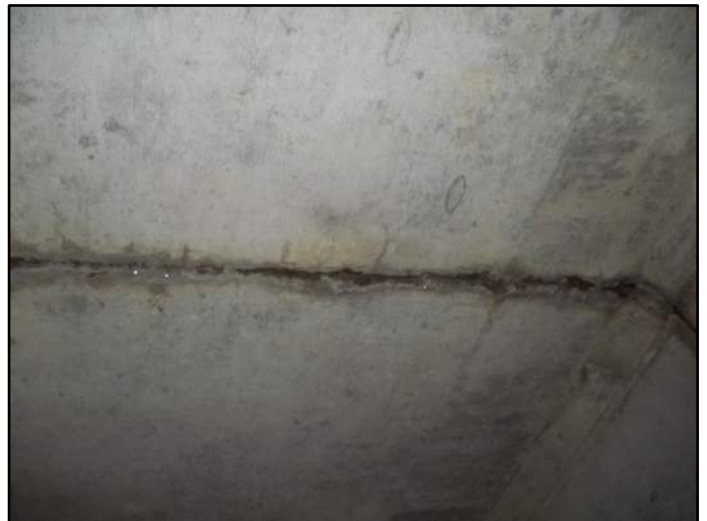
125' – Top
Separation at joint

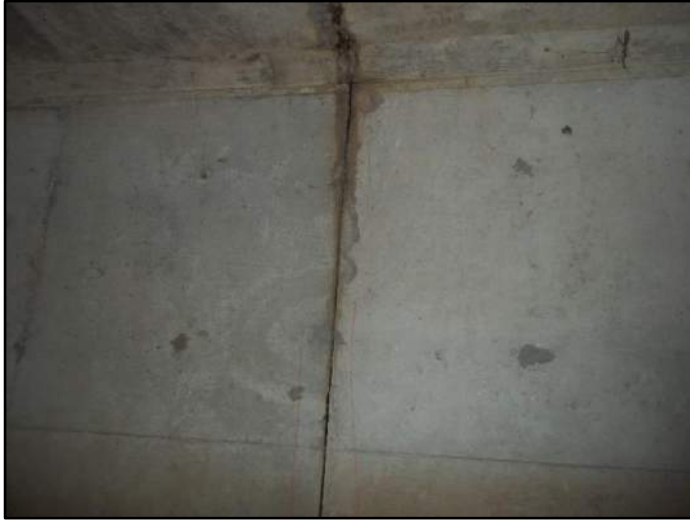
125' – Rt side
Separation at joint

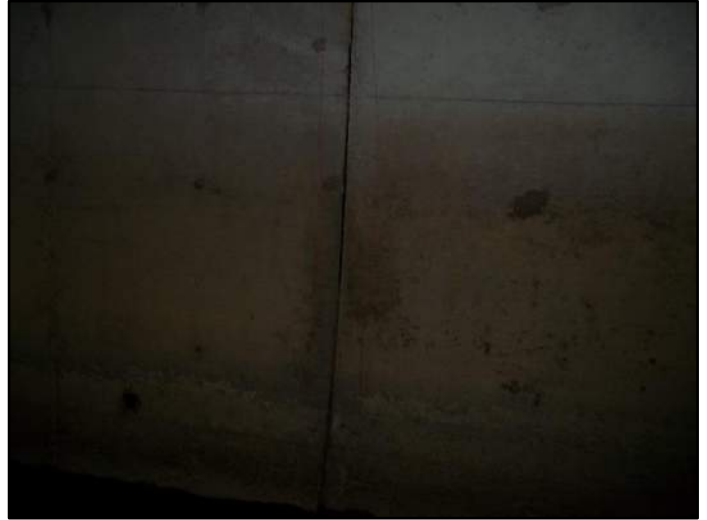
125' – Rt side
Separation at joint

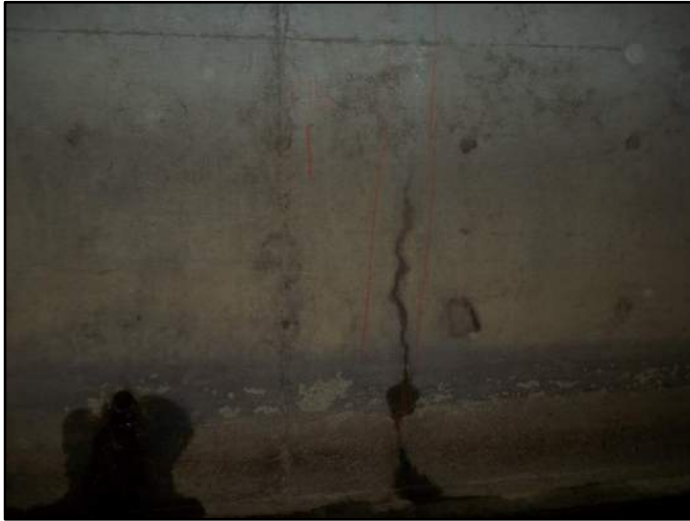
- 13) 146 feet – Transverse cracking on left and right sides.
 - 14) 151 feet – Concrete spalling on right side near top corner.

146' – Lt side
Transverse Cracking

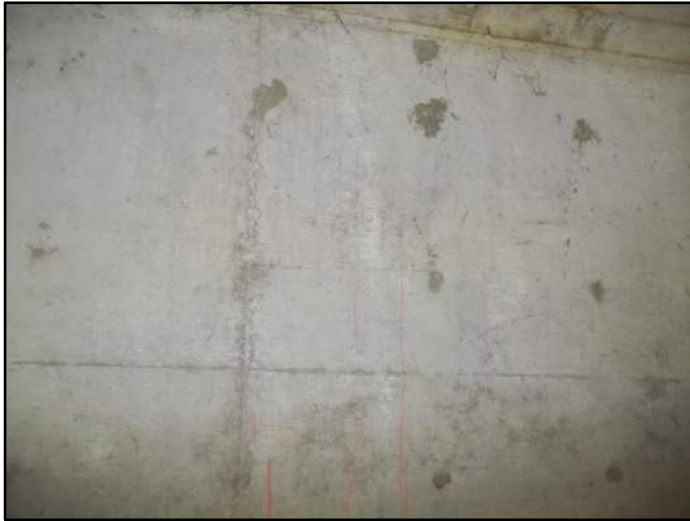
146' – Lt side
Transverse Cracking

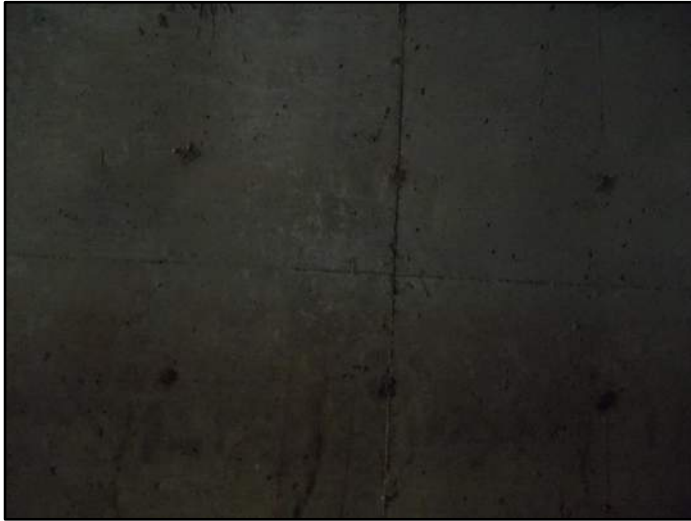
146' – Rt side
Transverse Cracking

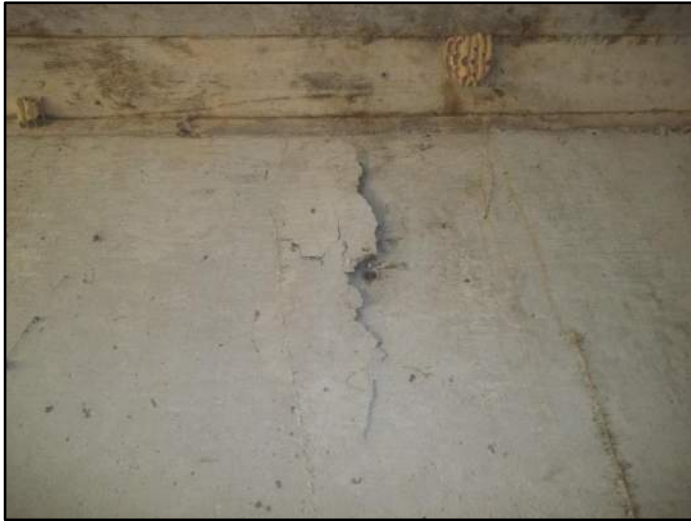
151' – Rt side
Spalling at top corner

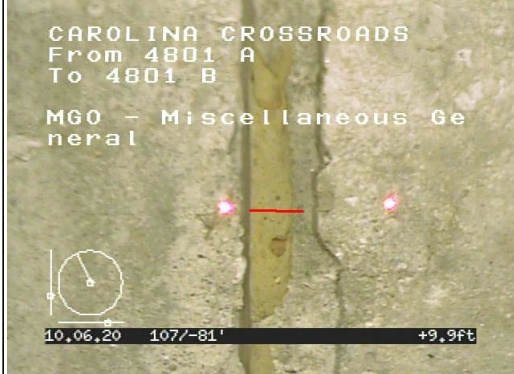
10.0	Miscellaneous General Observation Severity: None Remarks: GAP OBSERVATION 0.782	03:15

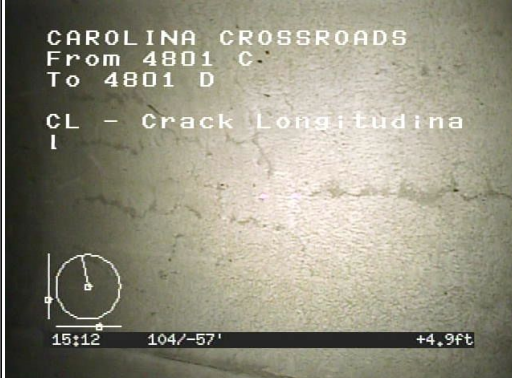
4.9	Crack Longitudinal Position: 12 Severity: None Joint Struct Weight: 2	01:06

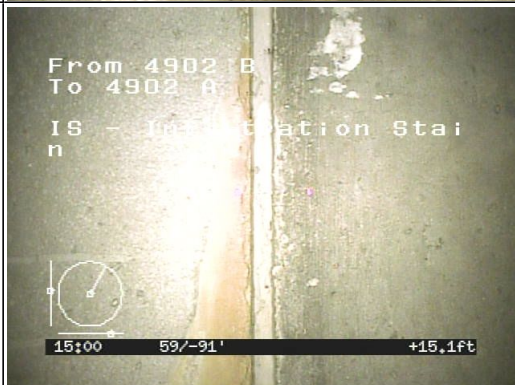
15.1	Infiltration Stain Position: 1 To 4 Severity: None Joint Maint Weight: 1	01:59

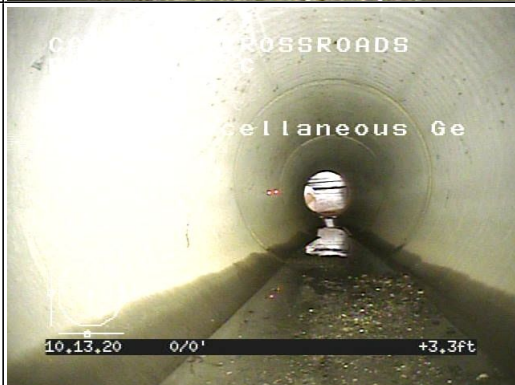
3.3	Miscellaneous General Observation Severity: None Remarks: MUD IN PIPE	01:00

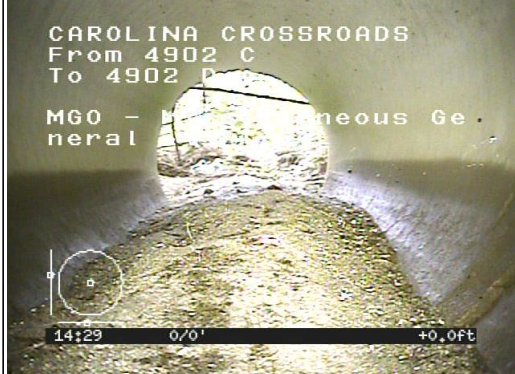
0.0	Miscellaneous General Observation Severity: None Remarks: DIRT AND DEBRIS IN PIPE	53

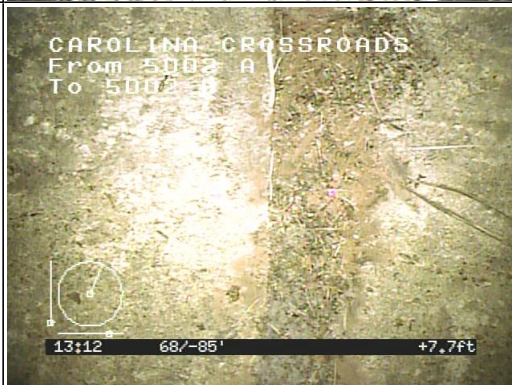
7.7	Roots Fine Joint Position: 9 To 4 Severity: None Joint Maint Weight: 1	01:15

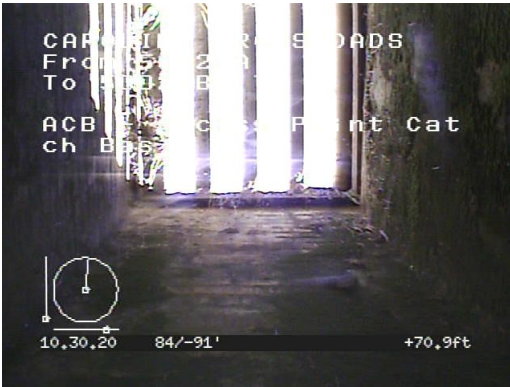
Distance	Fault Observation	Time	Picture
71.0	Access Point Catch Basin Severity: None Remarks: 5002 B	10:33

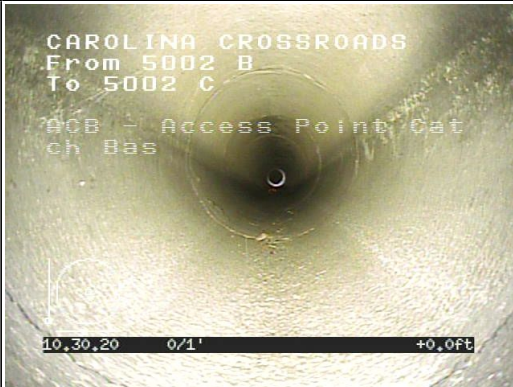
Distance	Fault Observation	Time	Picture
0.0	Access Point Catch Basin Severity: None Remarks: 5002 B	16

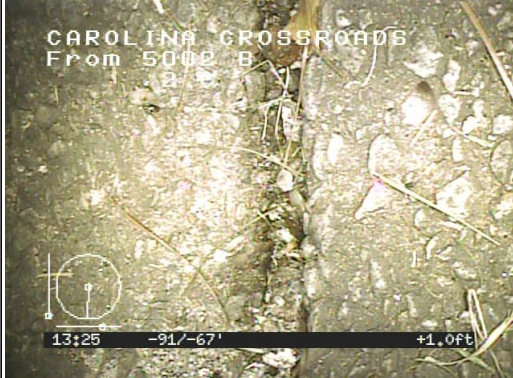
1.0	Roots Fine Joint Position: 5 To 7 Severity: None Joint Maint Weight: 1	01:33

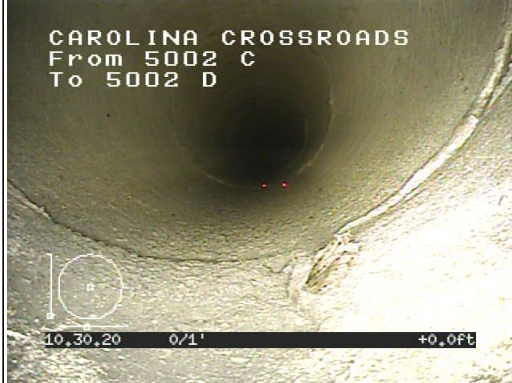
0.0	Miscellaneous Water Level Severity: None Percent: 0	29

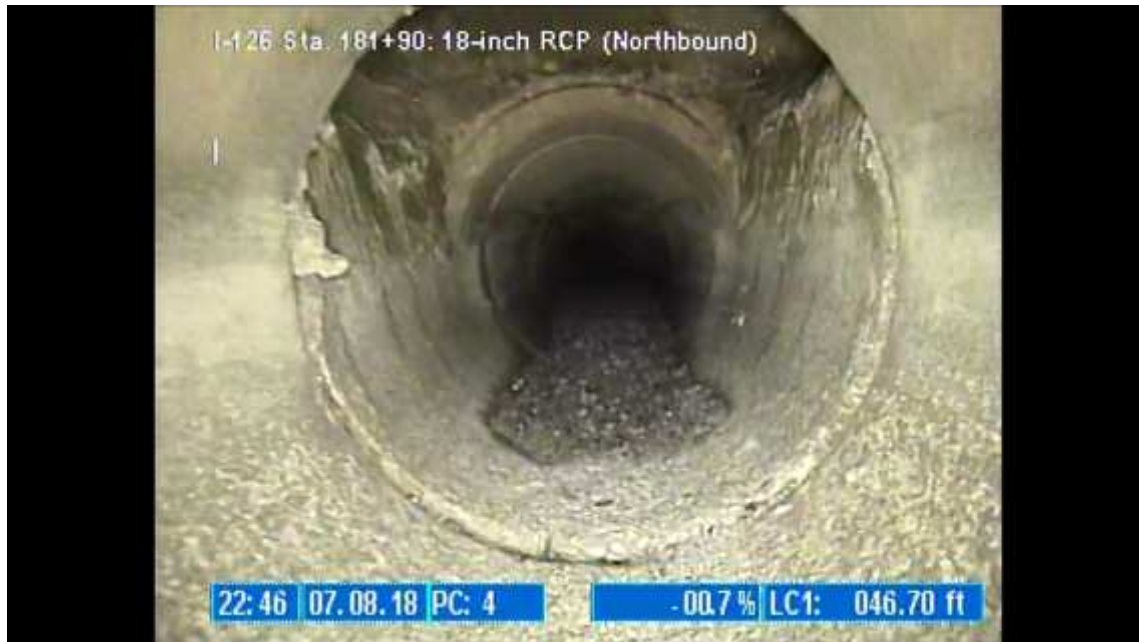
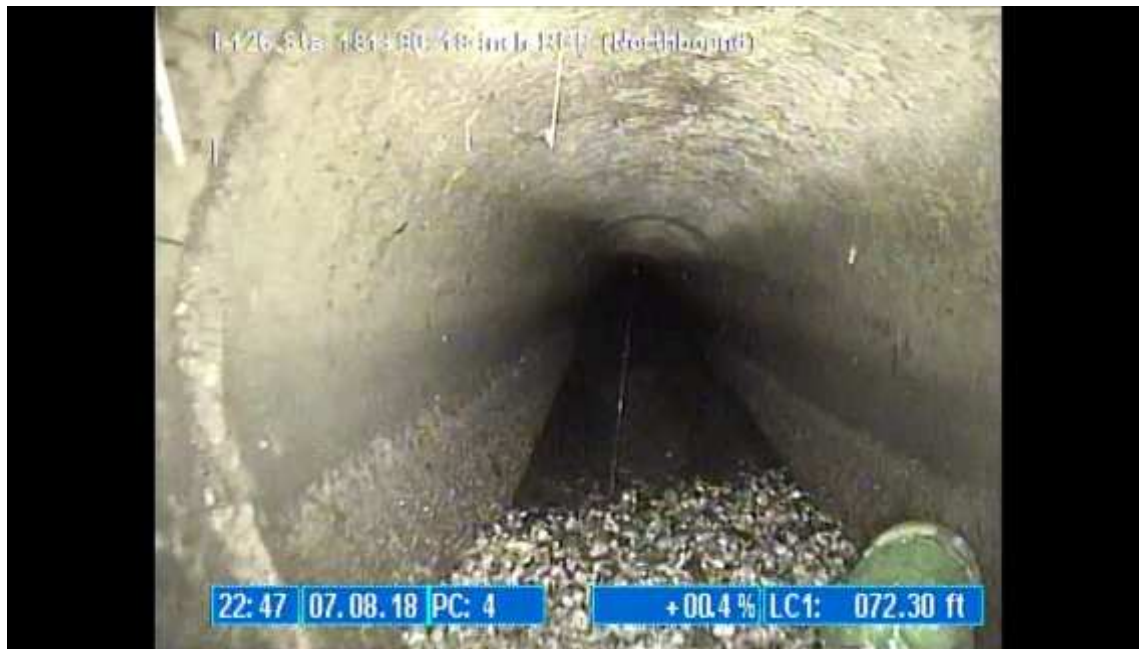
EP-5002

- Dimensions: Verified 18-inch RCP, Approximately 200 LF
- Observations
 1. North end of pipe appears to be blocked at entrance prohibiting water flow. Clean pipe in order to fix this issue.
- Recommendations
 1. Clean pipe.

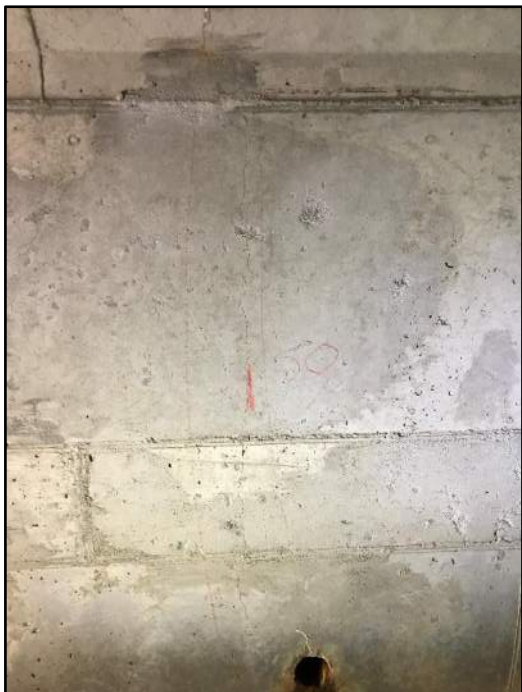
44' – Rt side
Transverse cracking

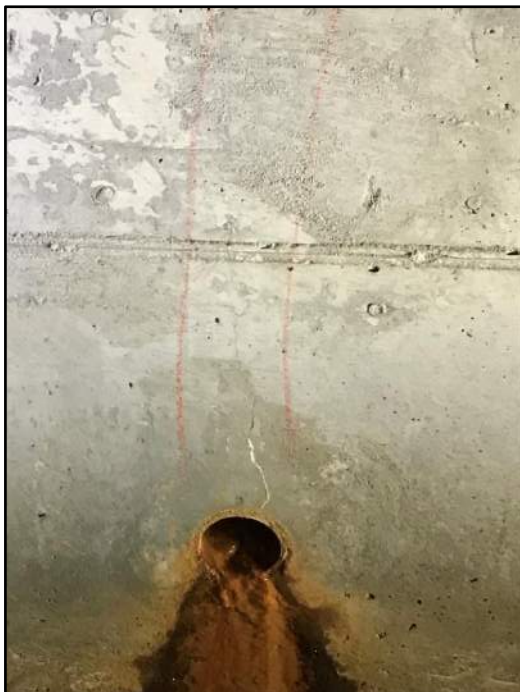
50' – Lt side
Transverse cracking

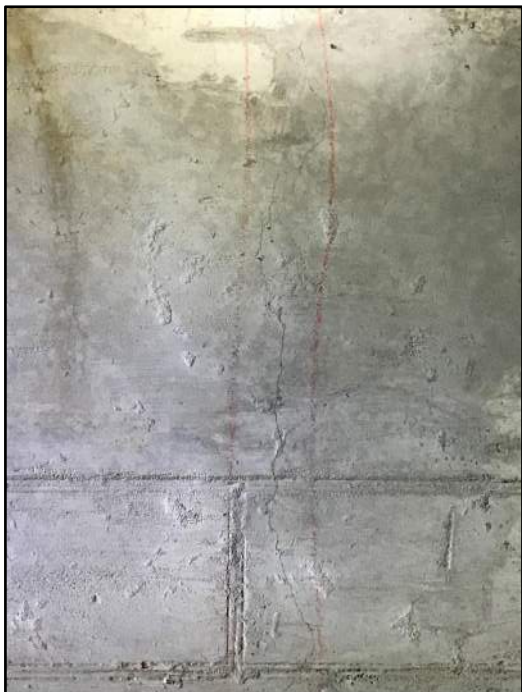
50' – Rt side
Transverse cracking

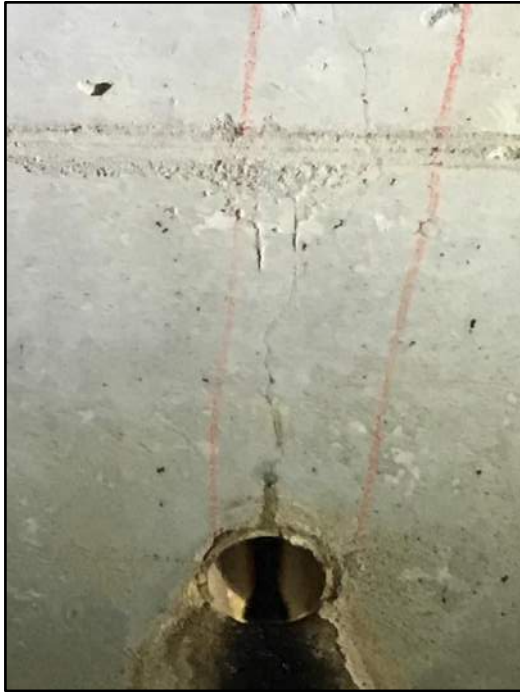
50' – Rt side
Transverse cracking

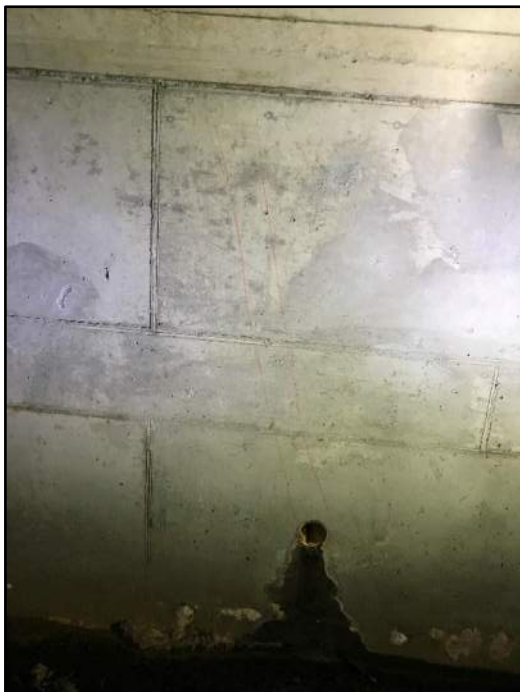
55' – Rt side
Transverse cracking

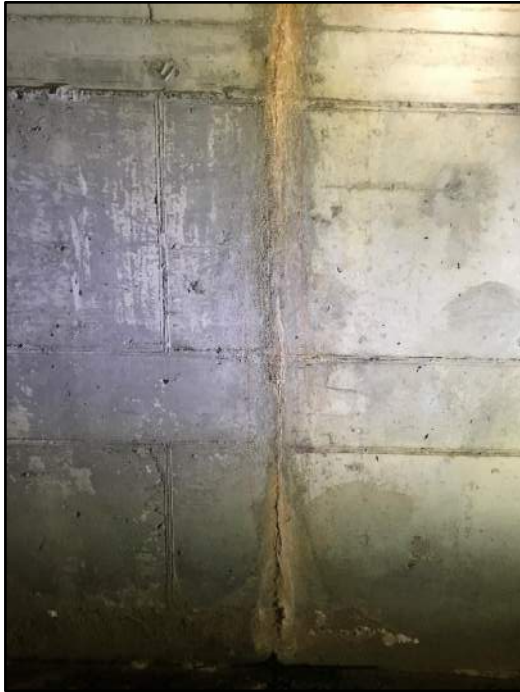
63' – Rt side
Transverse cracking

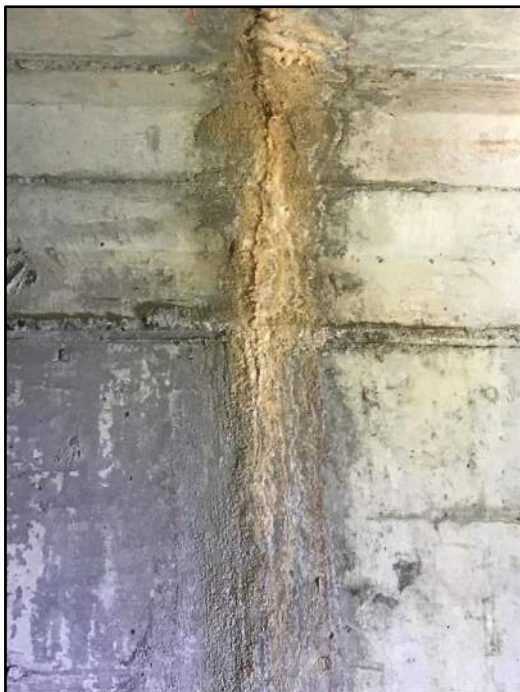
69' – Rt side
Transverse cracking

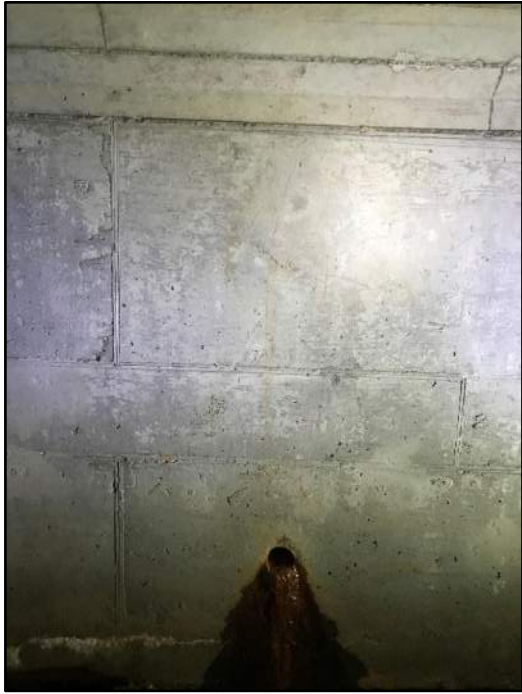
73' – Rt side
Transverse cracking

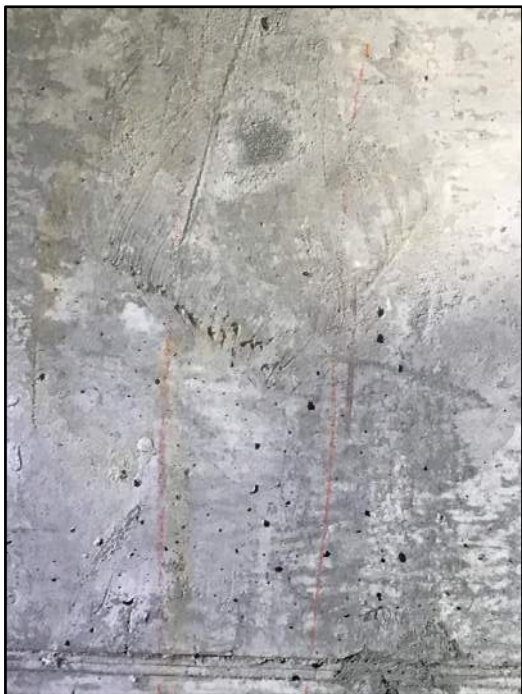
78' – Rt side
Transverse cracking

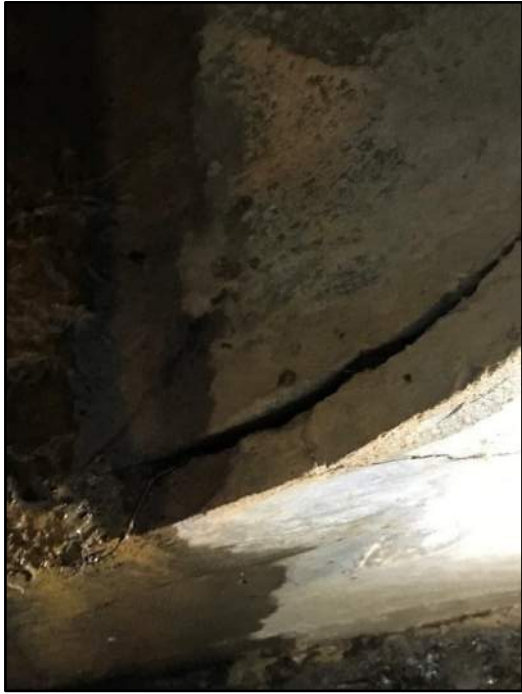
85' – Rt side
18" RCP cracking at tie interface

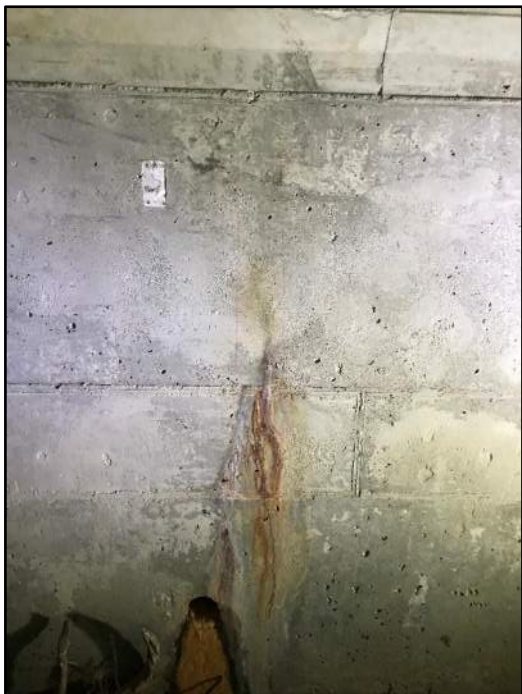
85' – Rt side
18" RCP cracking at tie interface

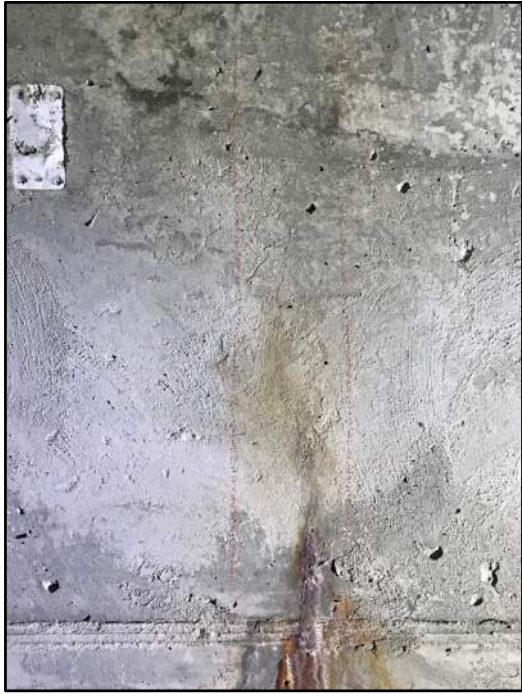
95' – Rt side
Transverse cracking
