EC-2601

I-20/26/126 Corridor Improvement Project

6' x 6' RCB

Client: SCDOT

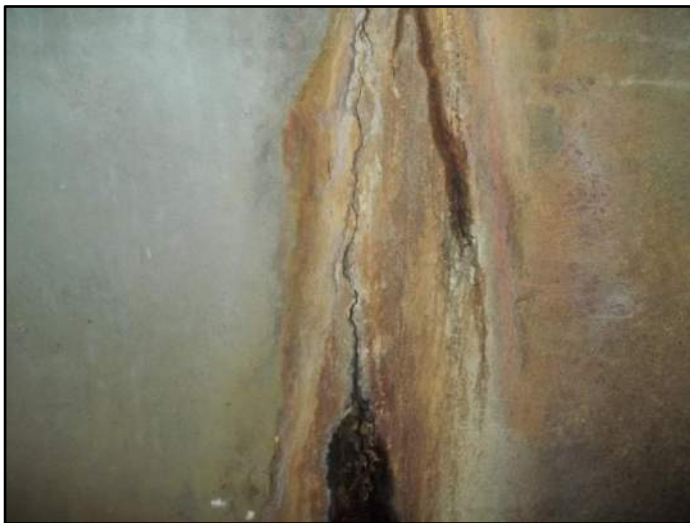
113' – Lt side
Transverse cracking

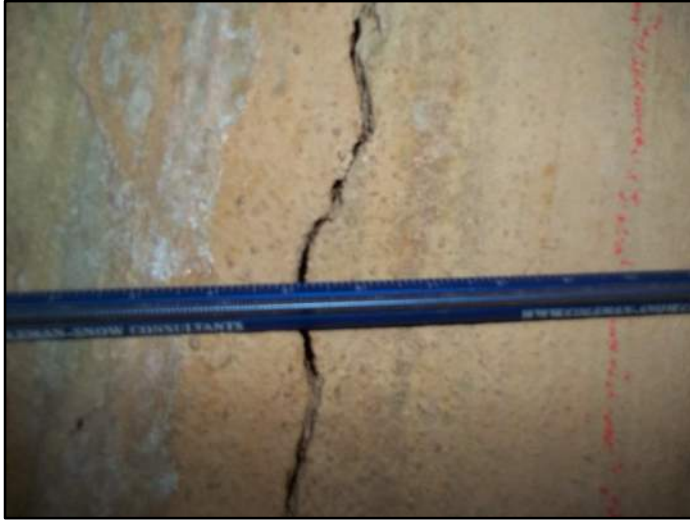
136' – Lt side
Transverse cracking

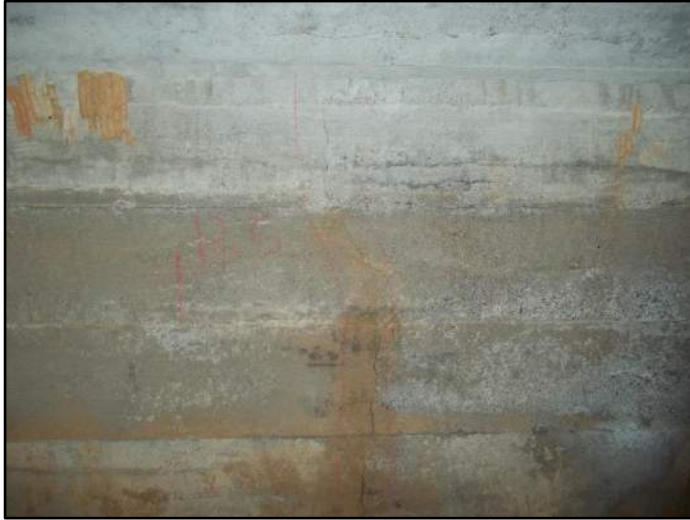
140' – Rt side
Transverse cracking

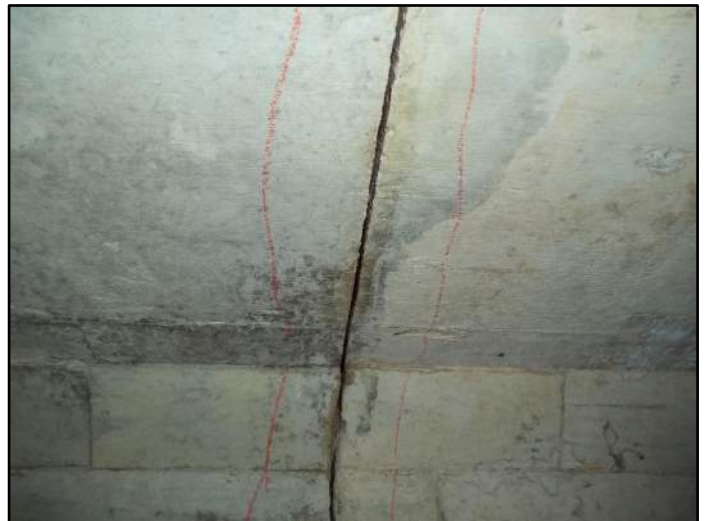
79.5' – Lt side
Separation at joint

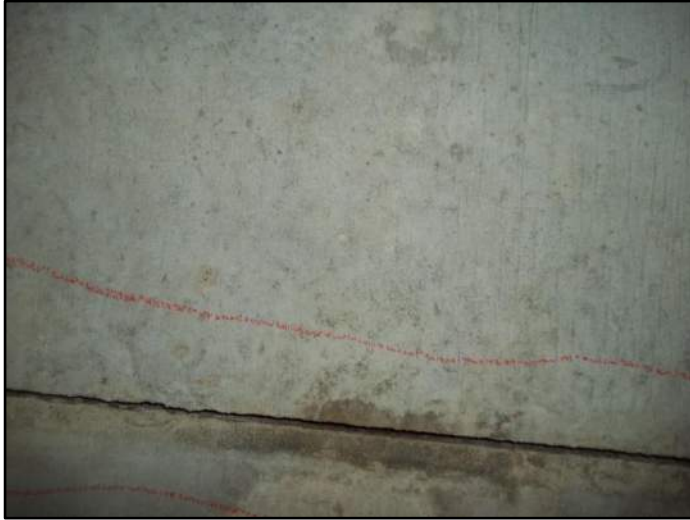
79.5' – Lt side
Separation at joint

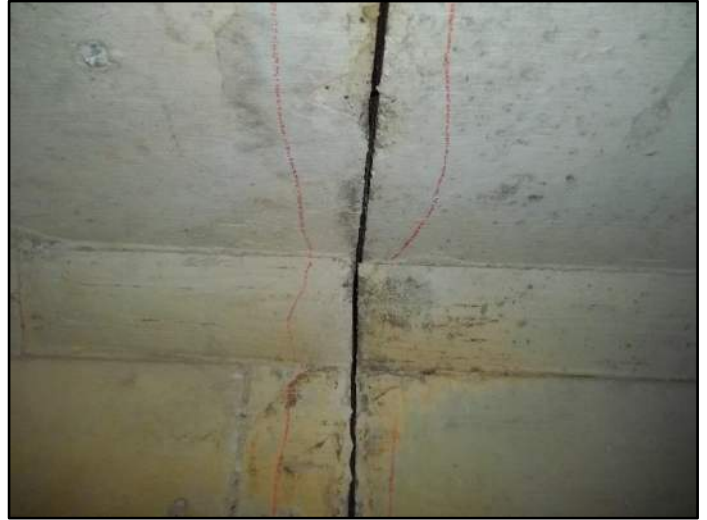
79.5' – Top
Separation at joint

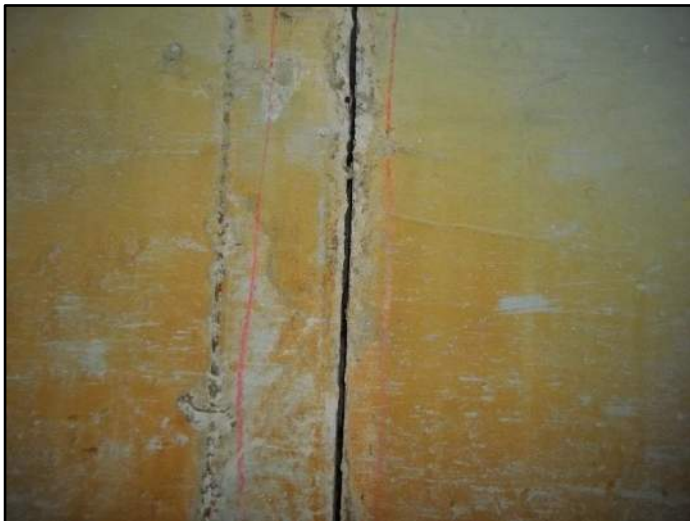
79.5' – Top
Separation at joint

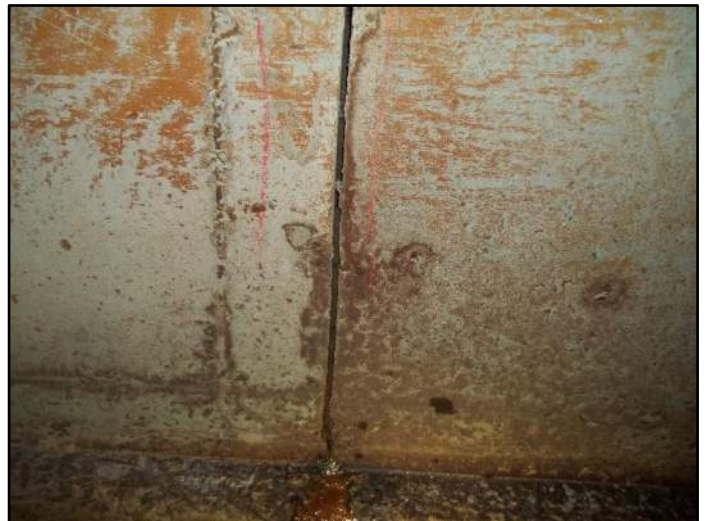
79.5' – Rt side
Separation at joint

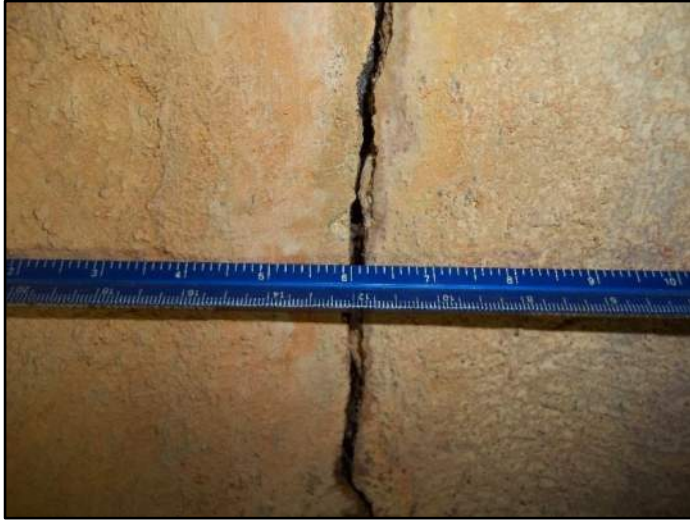
79.5' – Rt side
Separation at joint

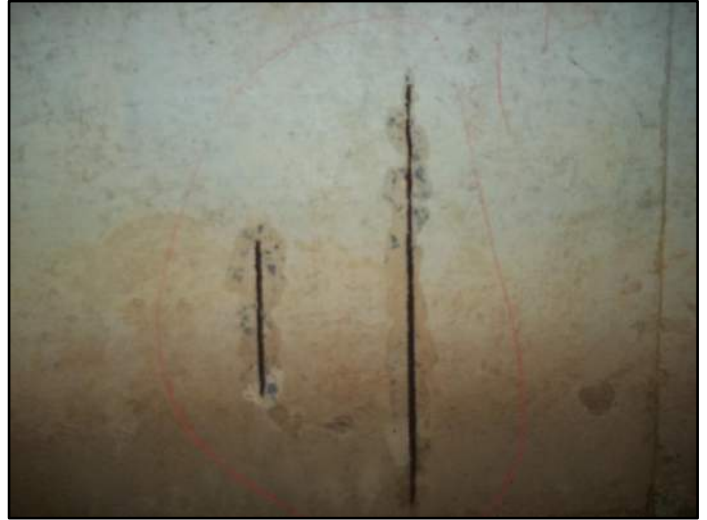
79.5' – Lt side
Separation at joint

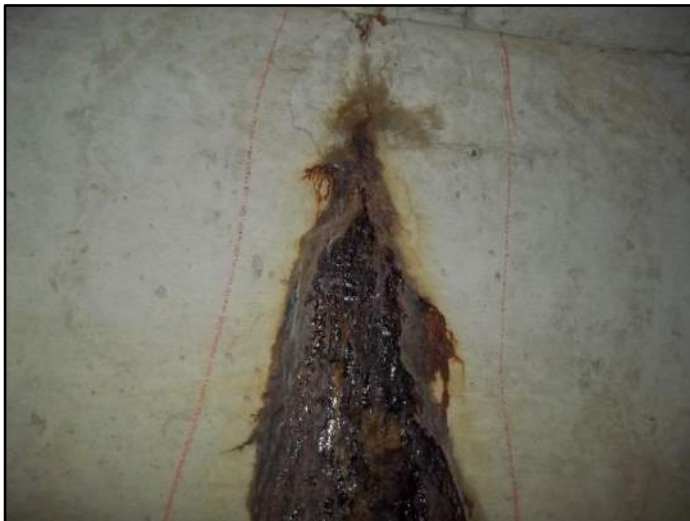
94' – Lt side
Exposed Rebar

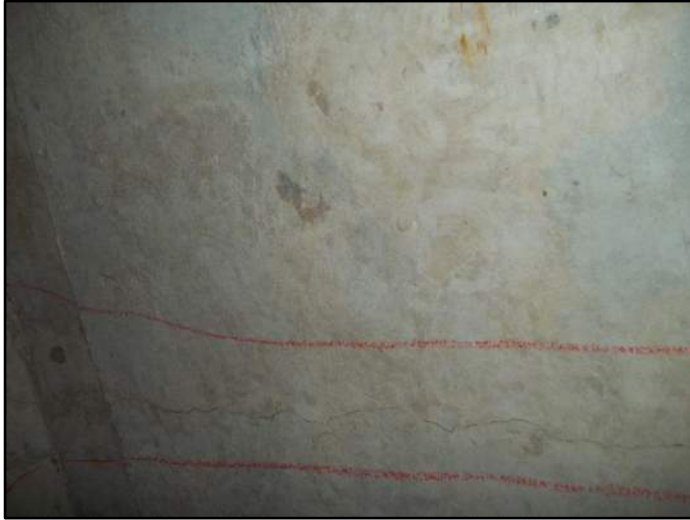
98' – Lt side and top
Transverse cracking

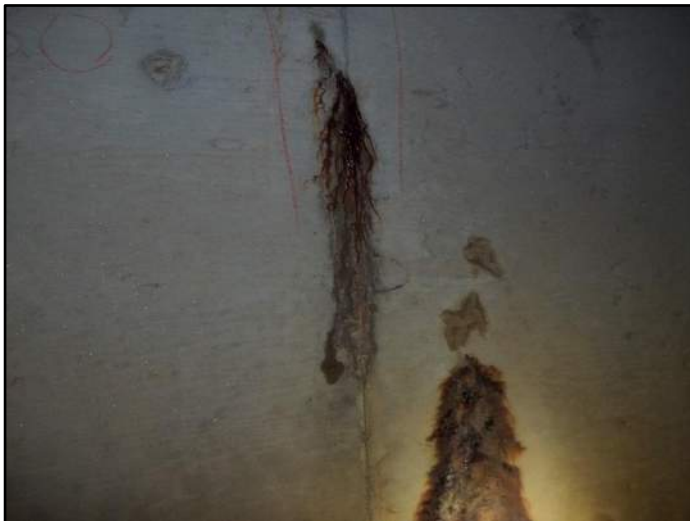
98' – Lt side and top
Transverse cracking

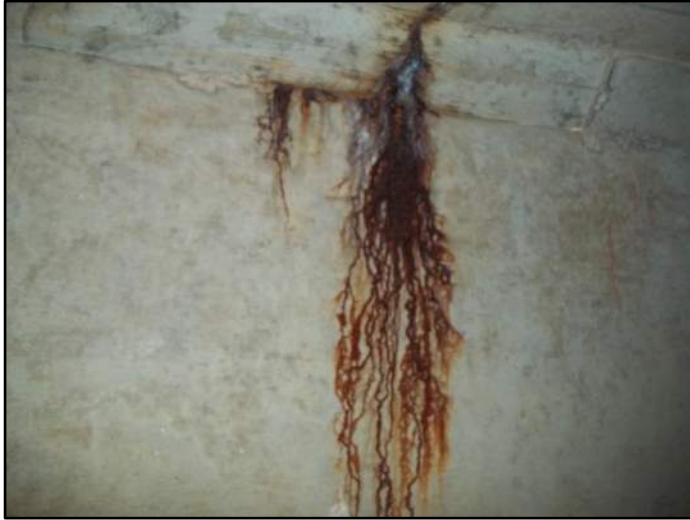
114' – Lt side
Transverse cracking

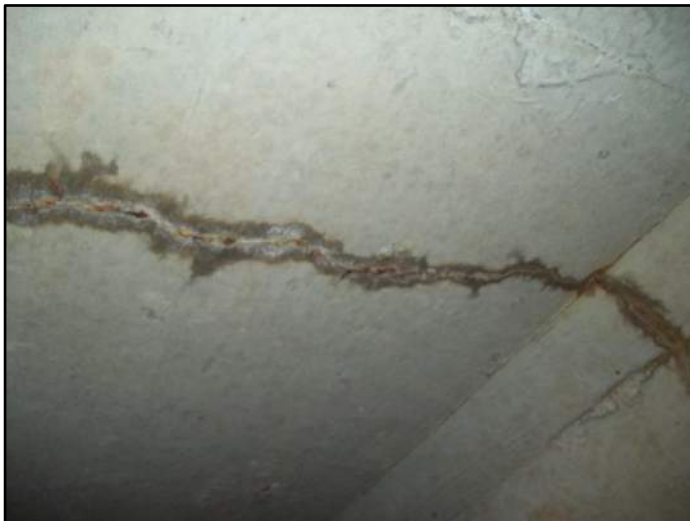
114' – Top side
Transverse cracking

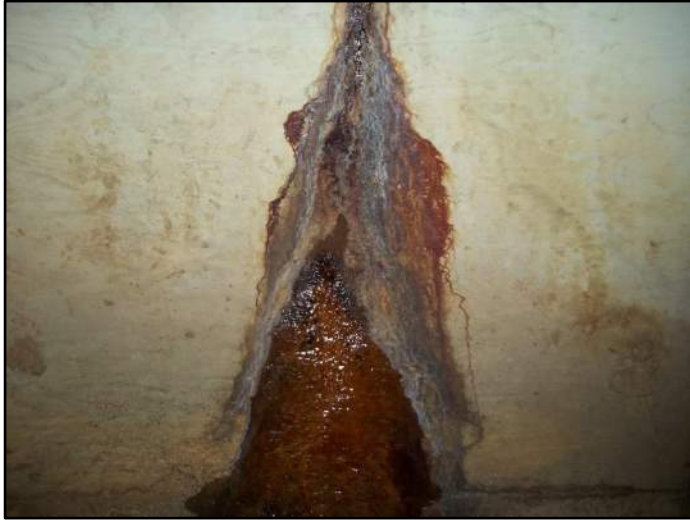
114' – Rt side
Transverse cracking

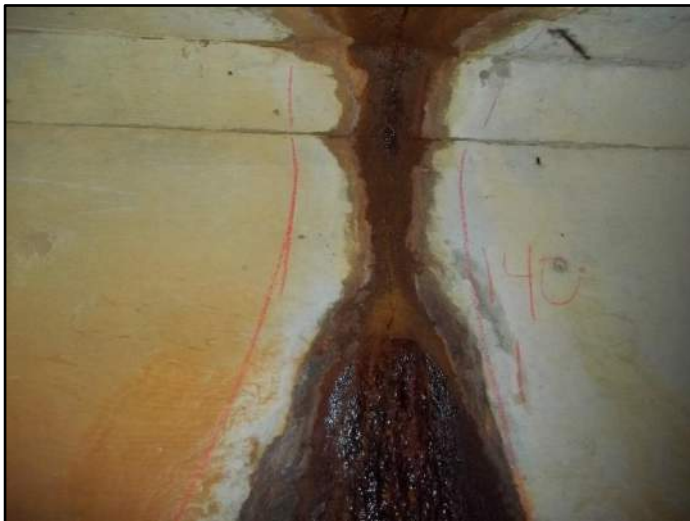
139.5' – Lt side
Separation at joint

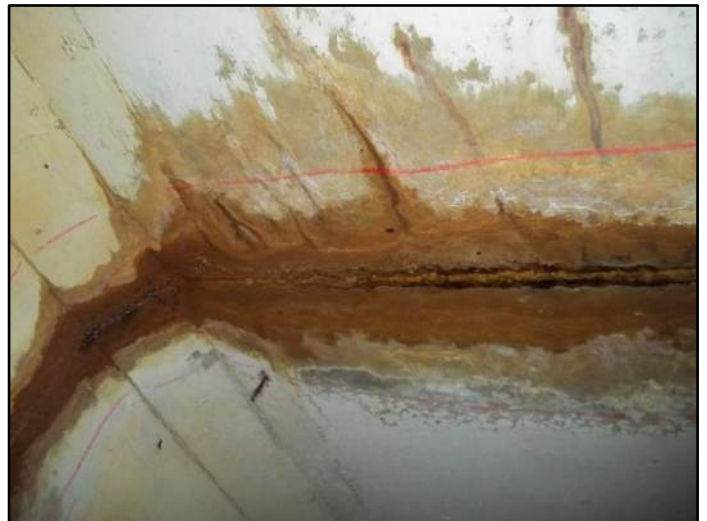
139.5' – Lt side
Separation at joint

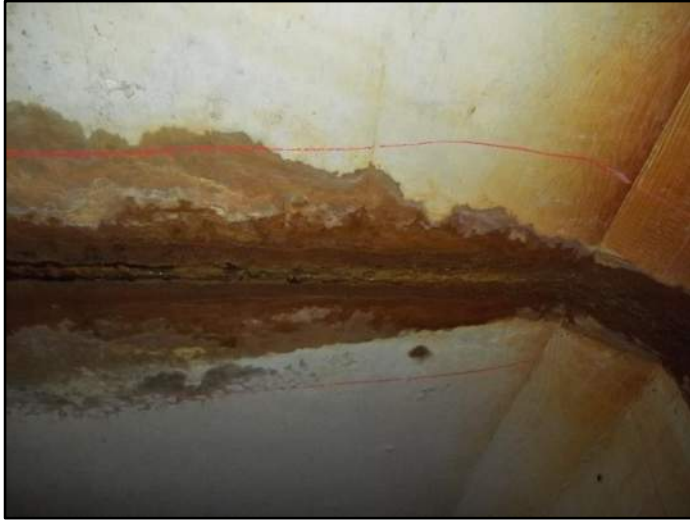
139.5' – Top side
Separation at joint

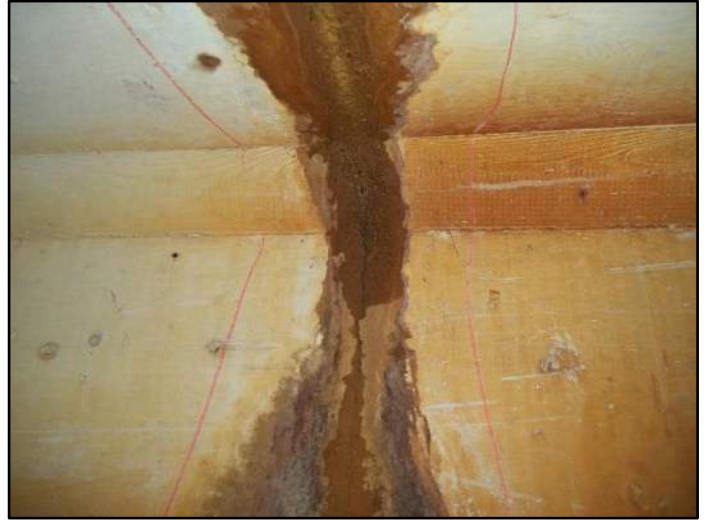
139.5' – Top side
Separation at joint

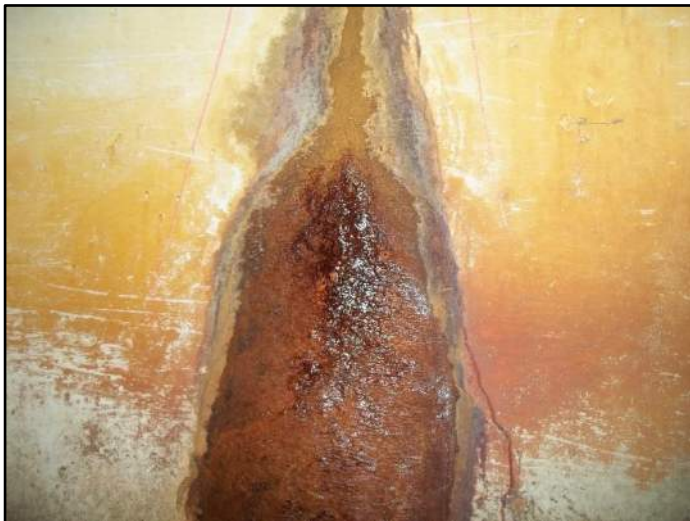
139.5' – Rt side
Separation at joint

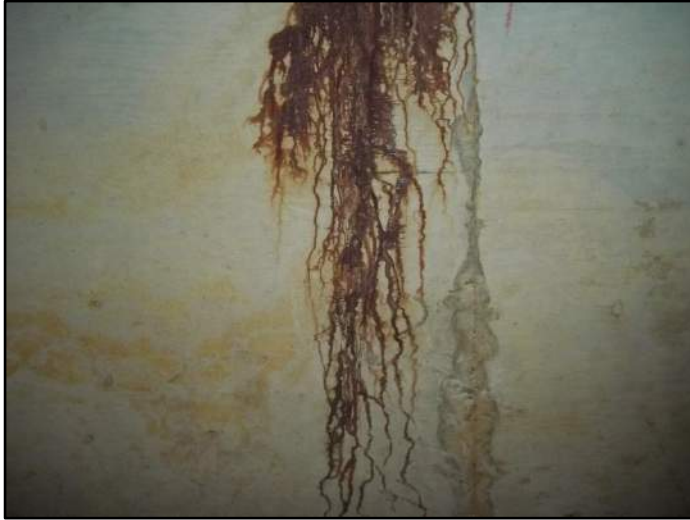
143' – Rt side
weeping crack

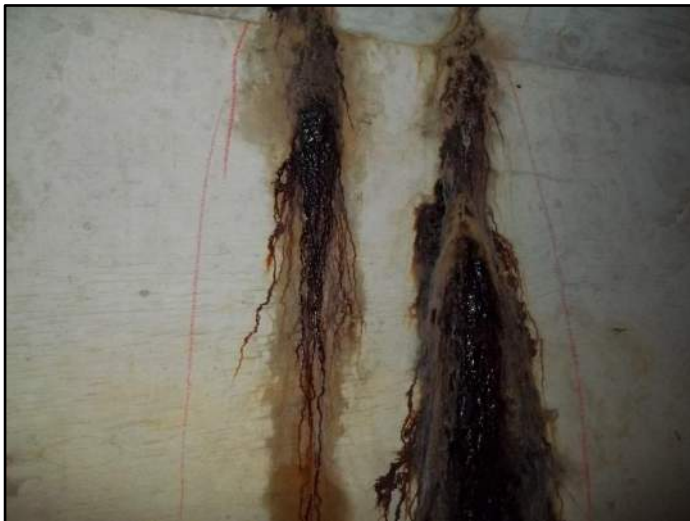
163' – Lt side
Transverse cracking

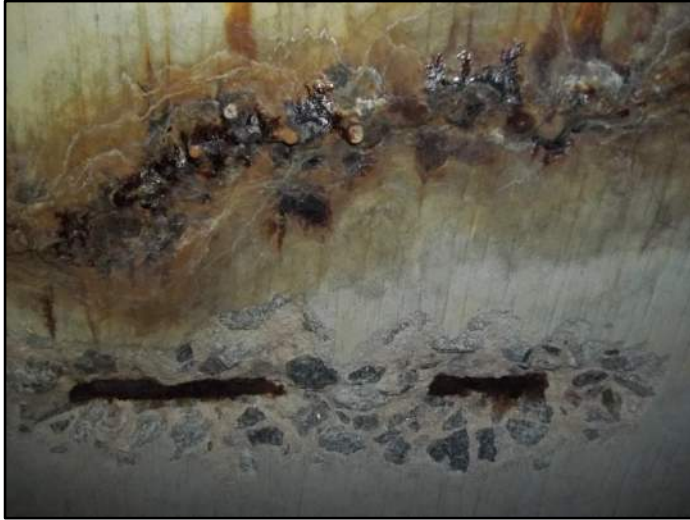
163' – Top
Transverse cracking with exposed rebar

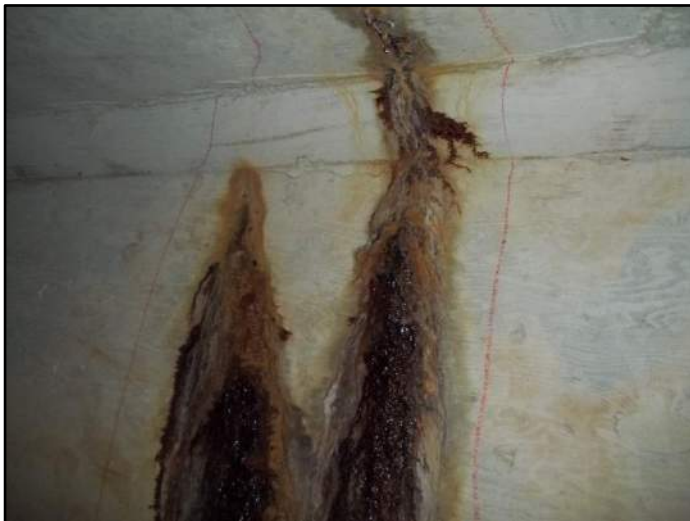
163' – Top side
Transverse cracking

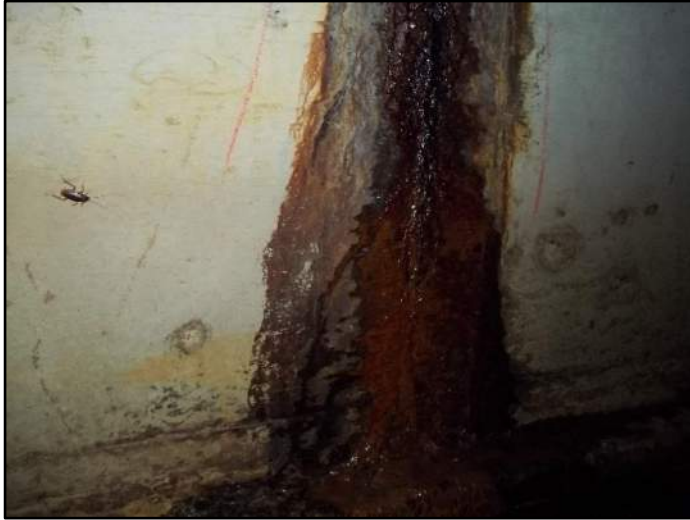
163' – Rt side
Transverse cracking

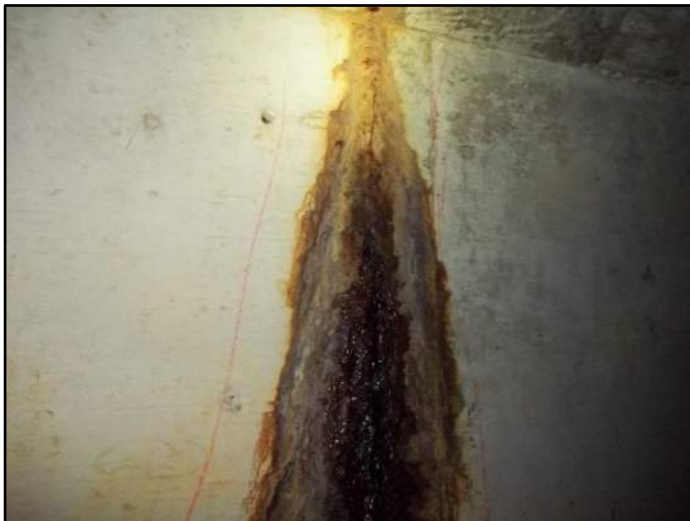
200' – Lt side
Transverse cracking

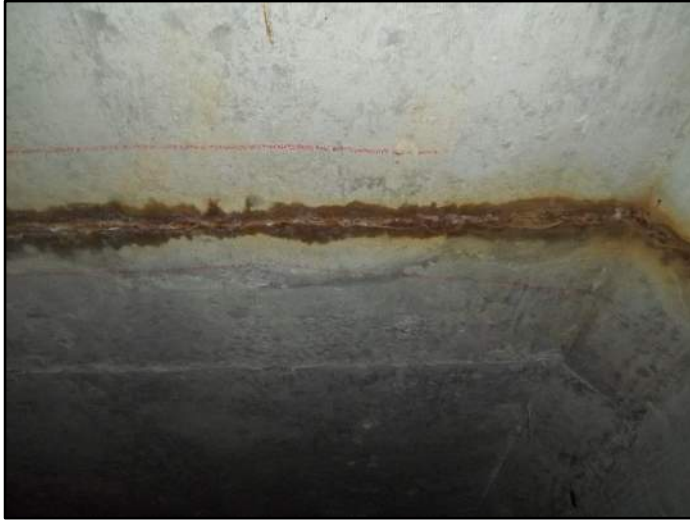
200' – Top side
Transverse cracking

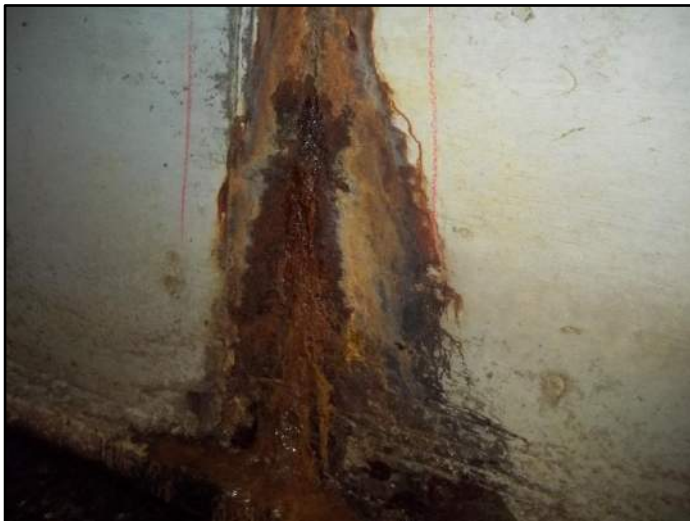
200' – Rt side
Transverse cracking

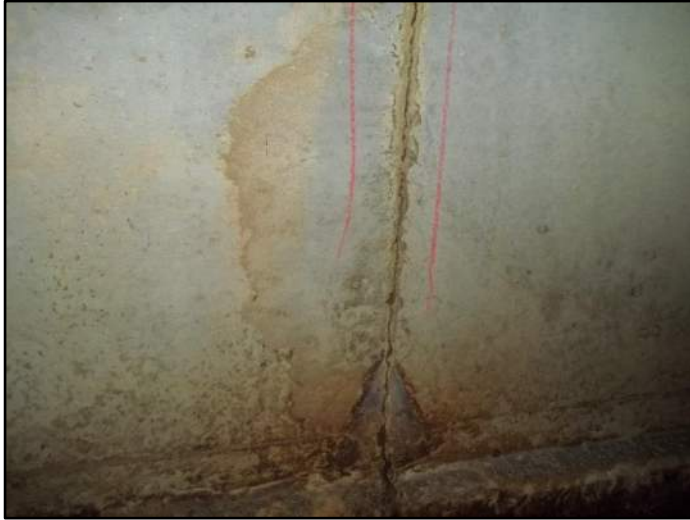
228' – Lt side
Weeping crack

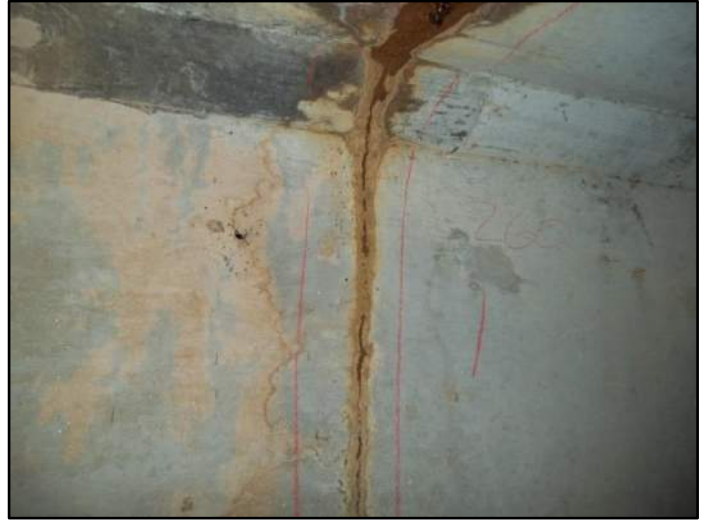
259' – Lt side
Separation at joint

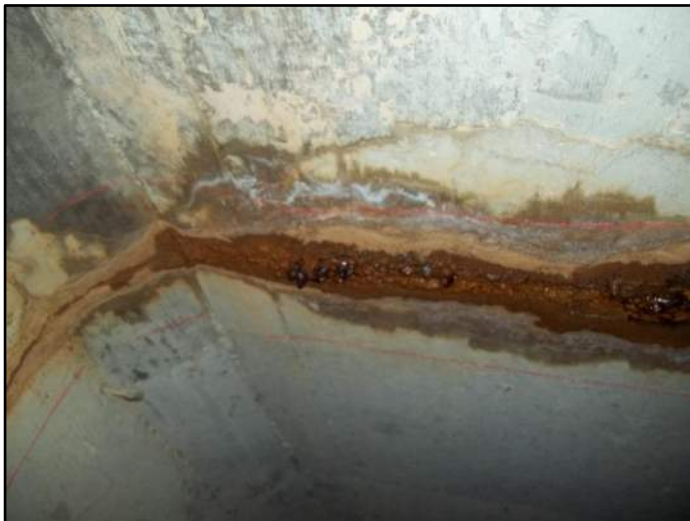
259' – Lt side
Separation at joint

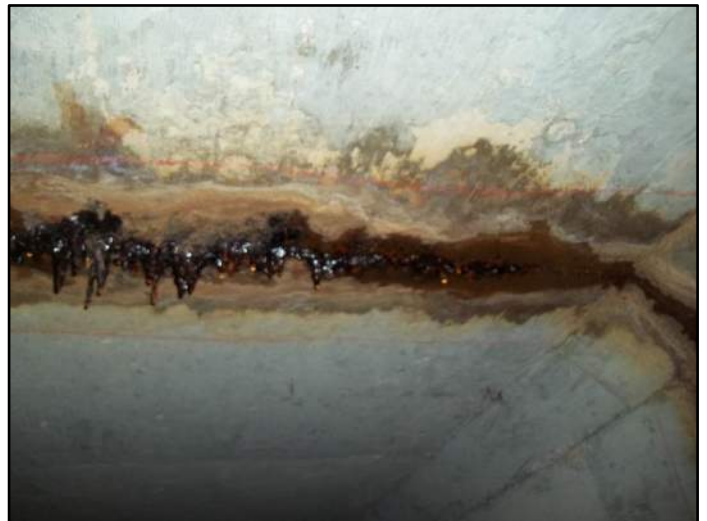
259' – Top
Separation at joint

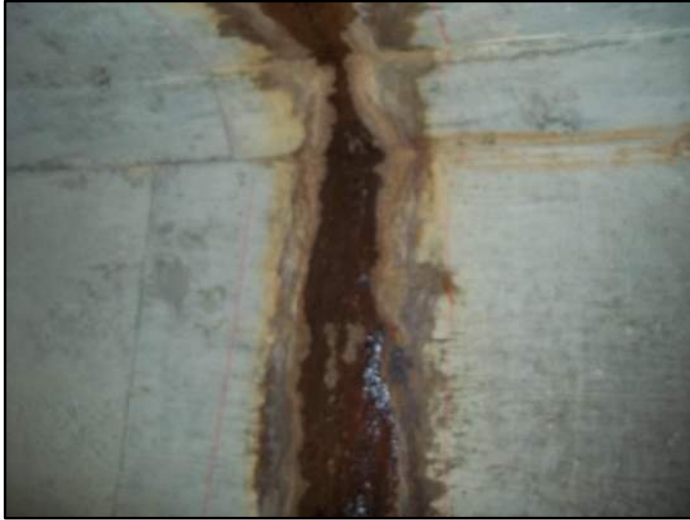
259' – Top
Separation at joint

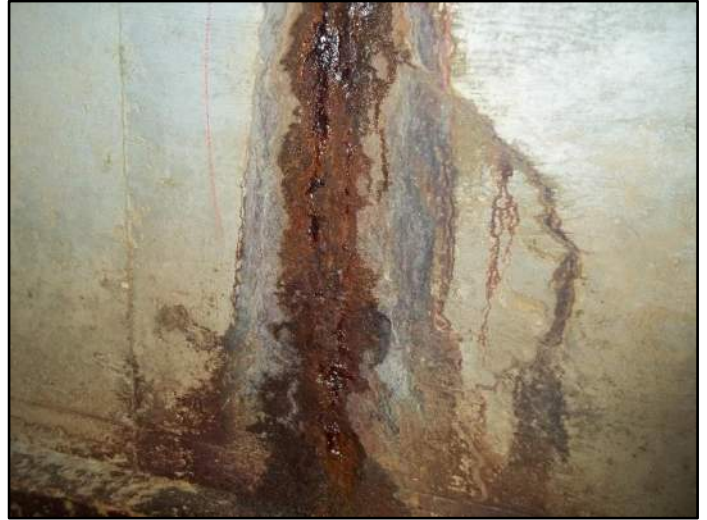
259' – Rt side
Separation at joint

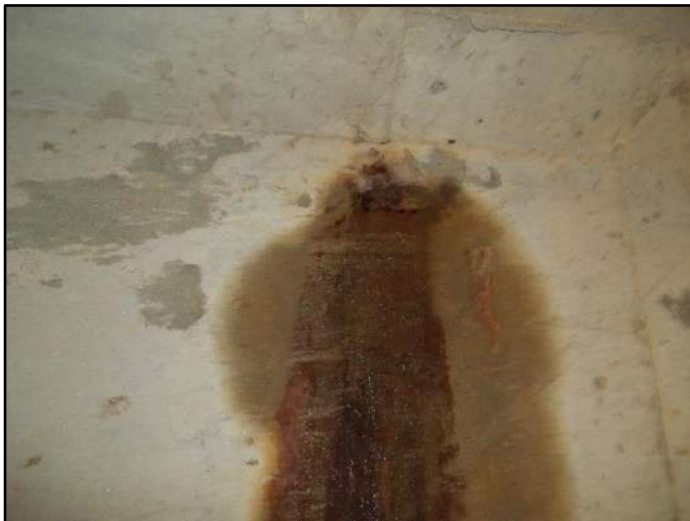
259' – Rt side
Separation at joint

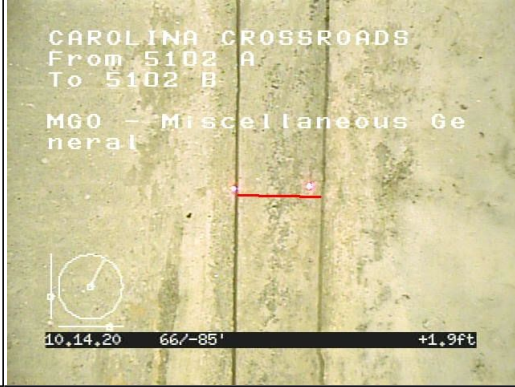
<p>CAROLINA CROSSROADS From 5102 A To 5102 B MGO - Miscellaneous General Observation 10.14.20 66/-85' +1.9ft</p>

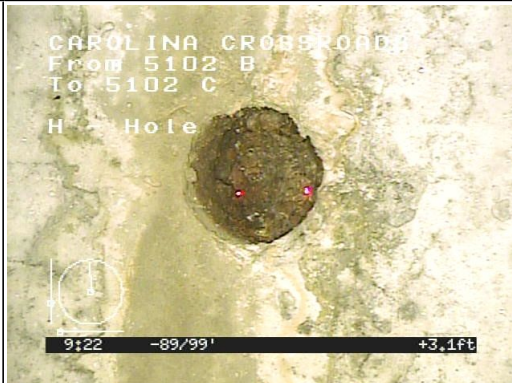
3.1	Hole Position: 12 Severity: None Cont Defect: S01 Remarks: LIFTING HOLE MAY NOT BE SEALED Struct Weight: 4	02:04

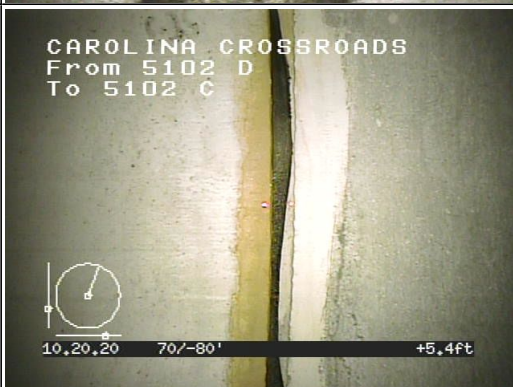
5.4	Intruding Sealing Material Sealing Ring Position: 12 To 1 Severity: None Percent: 5 Maint Weight: 2	01:43

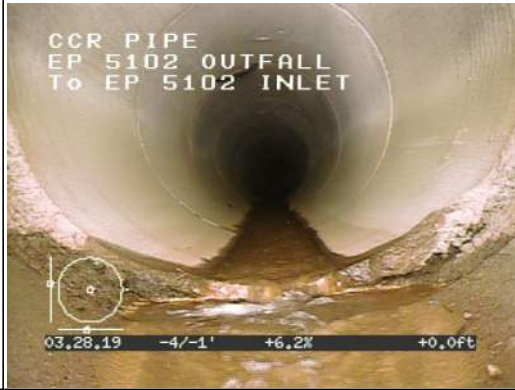
Distance	Fault Observation	Time	Picture
0.0	Discharge Point Severity: None Remarks: EP 5102 OUTFALL	23	
0.0	Water Level Severity: None Percent: 5	39

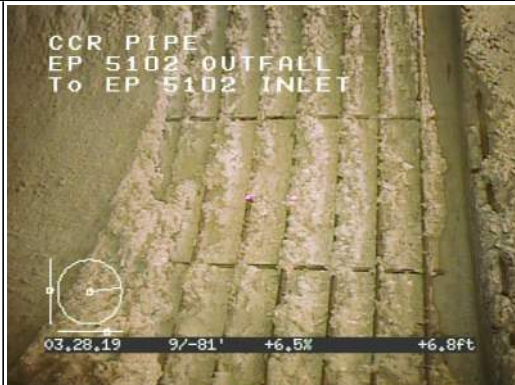
- Observations:
 - 1) 6.9 feet – Missing surface concrete; visible rebar.
 - 2) 13.8 feet – 0.81" gap in joint.
 - 3) 21.6 feet – Intruding sealing ring.
 - 4) 29.5 feet – 1.07" gap in joint; missing surface concrete; visible rebar.

6.9	Joint Separated Large Severity: None Remarks: PIPE SEPARATED PATCH JOB Struct Weight: 2	03:13

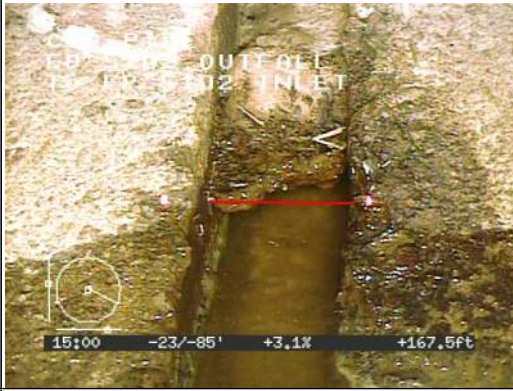
Distance	Fault Observation	Time	Picture
167.6	General Observation Severity: None Remarks: 1.742	57:54

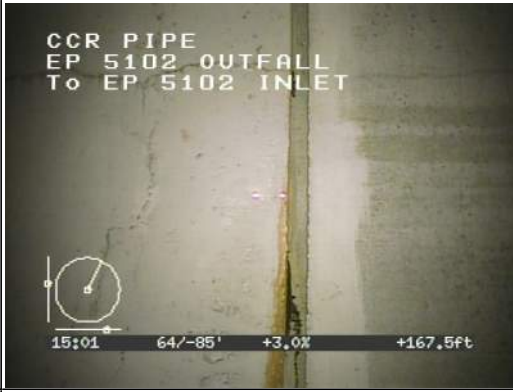
- 18) 139.5 feet – Junction box.
 - 19) 155.4 feet – Intruding sealing ring.
 - 20) 159.3 feet – 1.86" gap in joint; intruding sealing ring.
 - 21) 167.6 feet – 1.74" gap in joint; infiltration staining.

167.6	Infil Stain Position: 1 To 5 Severity: None Joint	58:30

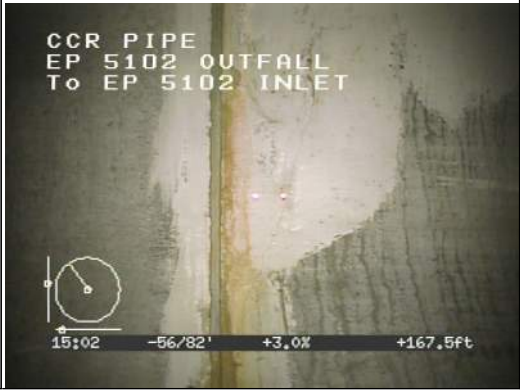
167.6	Infil Stain Position: 7 To 11 Severity: None Joint	57:06
