# I-95 BRIDGE REPLACEMENT OVER LAKE MARION

## PIPE INSPECTION REPORT

This report contains the results of the video pipe inspection and assessment of the existing storm water drainage pipes within the project area in Orangeburg and Clarendon Counties.

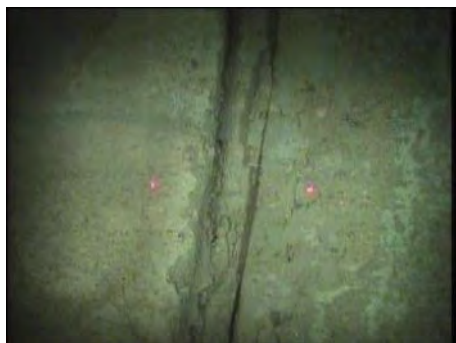
| 5.2 ft. | D | / | Joint Offset |

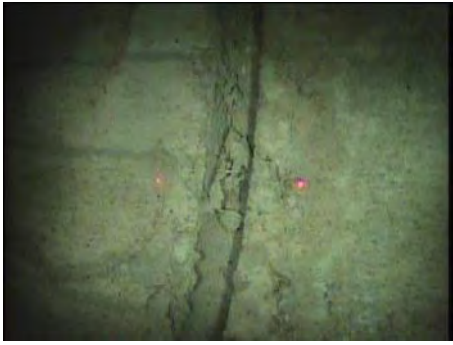
9.1 ft. D / Joint Offset

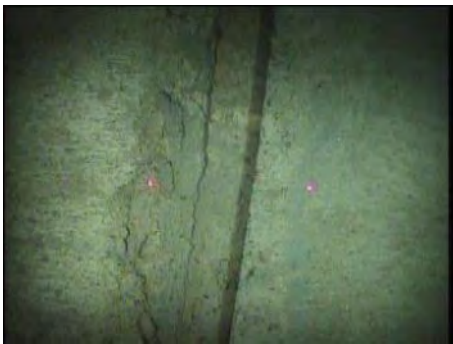
13.4 ft. D / Joint Offset

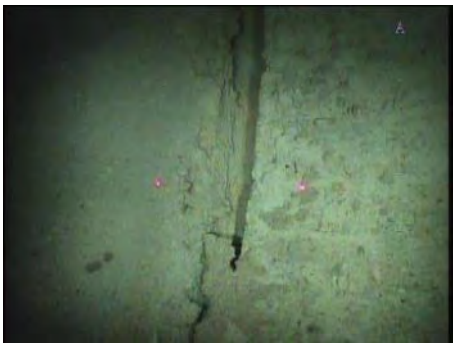
17.3 ft. D / Joint Offset

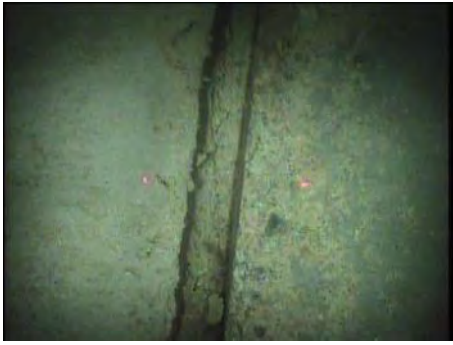
21.7 ft. D / Joint Offset

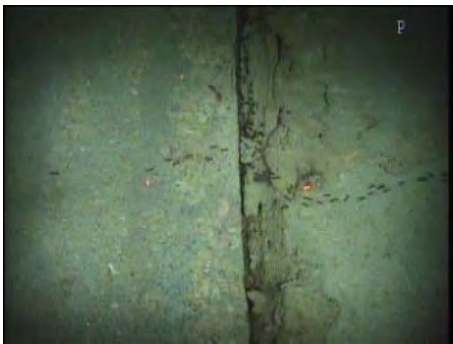
25.6 ft. D / Joint Offset

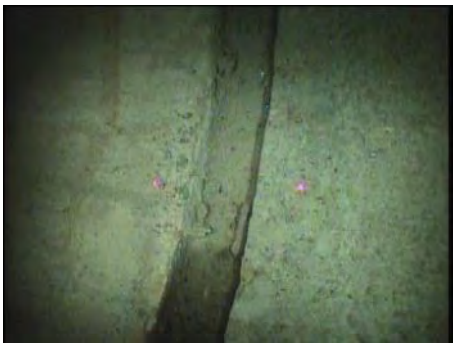
33.6 ft. D / Joint Offset

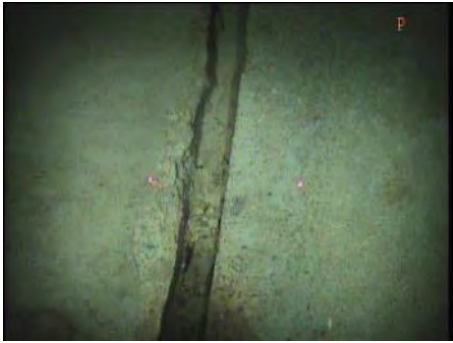
37.9 ft. D / Joint Offset

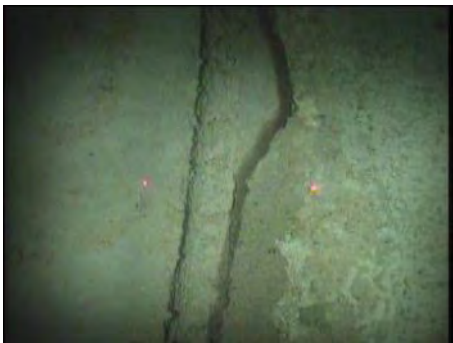
50.2 ft. D / Joint Offset

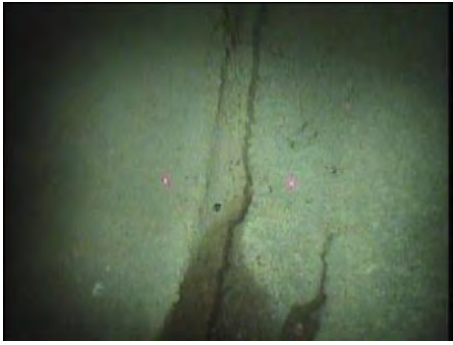
53.9 ft. D / Joint Offset

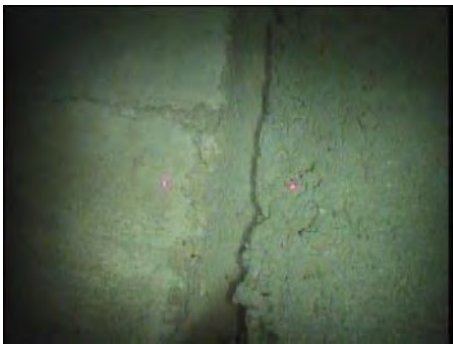
58.0 ft. D / Joint Offset

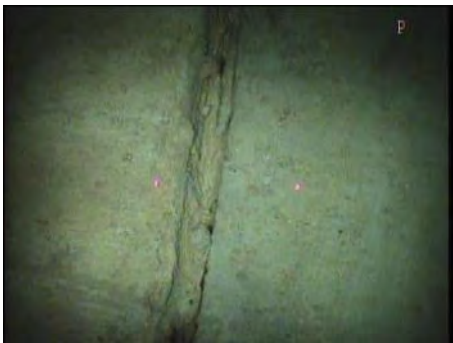
78.8 ft. D / Joint Offset

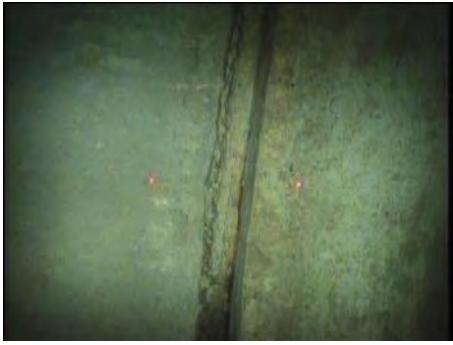
83.2 ft. D / Joint Offset

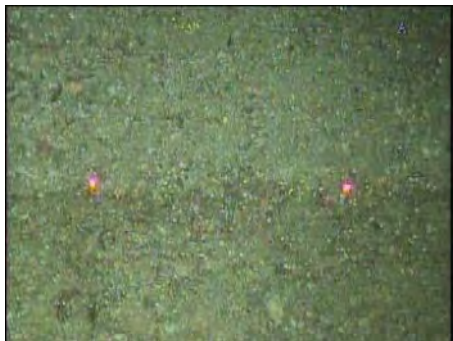
| 51.3 ft. | D | | 9 / | Crack | | | |

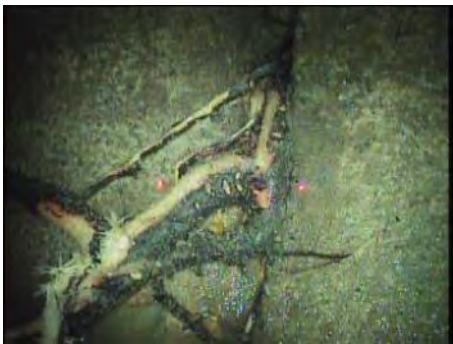
63.1 ft. D / Root-in-Joint

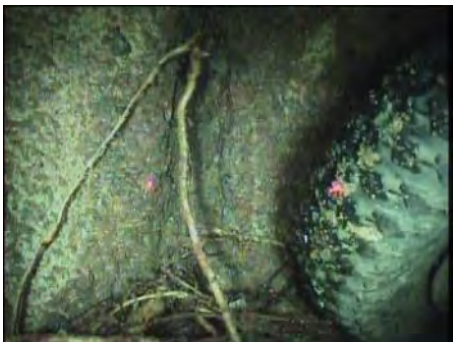
84.1 ft.    D                    /    Root-in-Joint

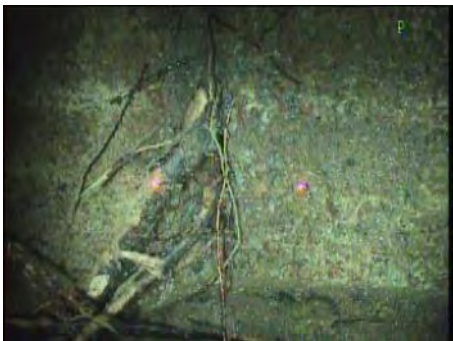
87.5 ft.    D                    /    Root-in-Joint

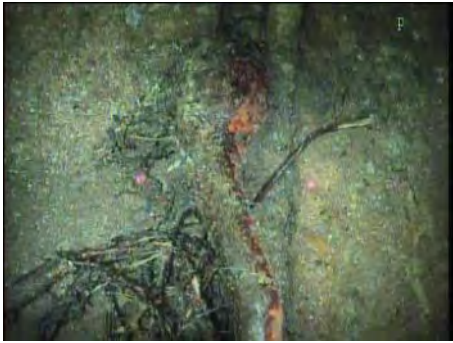
91.9 ft. D / Root-in-Joint

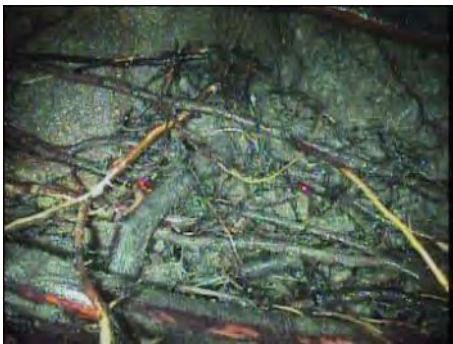
96.1 ft. D / Root-in-Joint

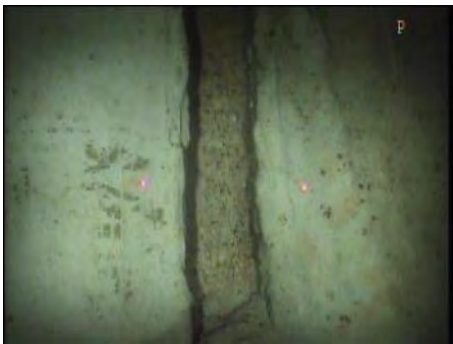
72.5 ft. D / Joint Offset

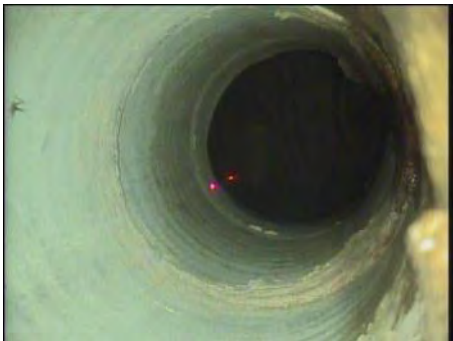
80.9 ft. D / Abandoned Survey

Pipe turns 90 degrees down

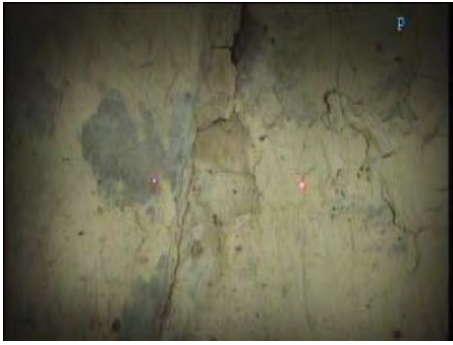
59.5 ft. U / Joint Offset

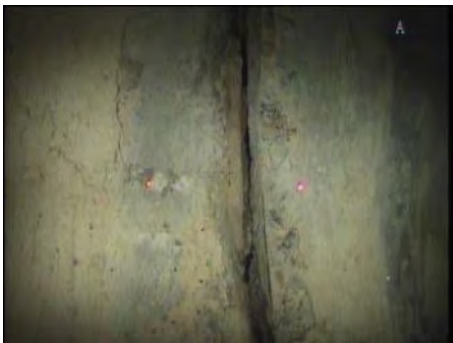
71.7 ft. U / Joint Offset

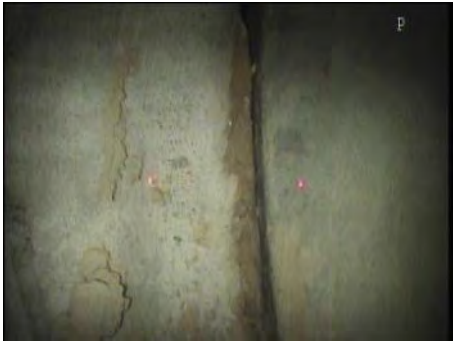
77.9 ft. U / Joint Offset

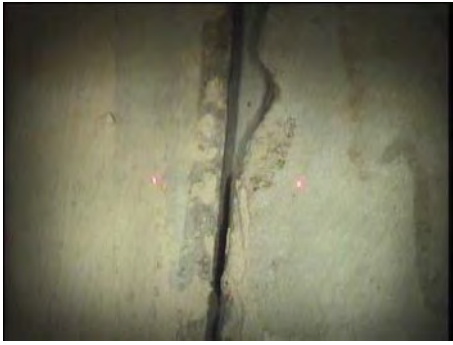
133.0 ft. U / Joint Offset

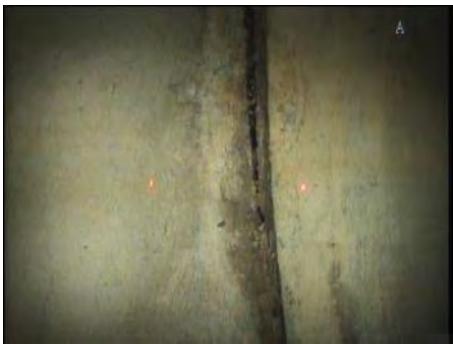
139.0 ft. U / Joint Offset

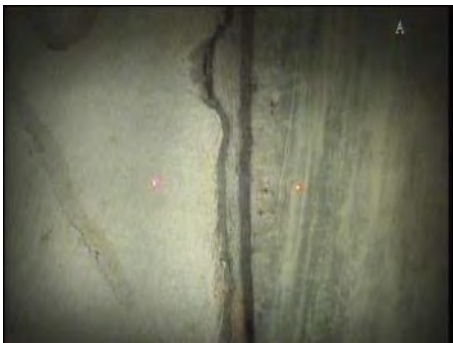
151.3 ft. U / Joint Offset

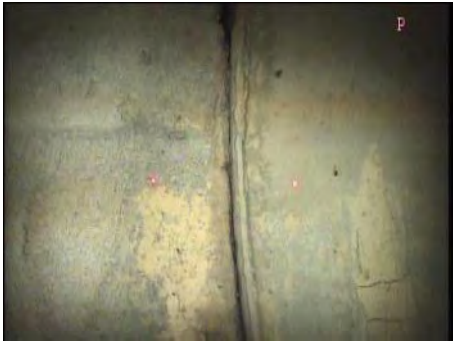
194.1 ft. U / Joint Offset

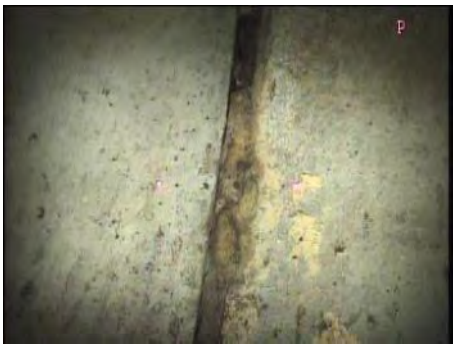
231.0 ft. U / Joint Offset

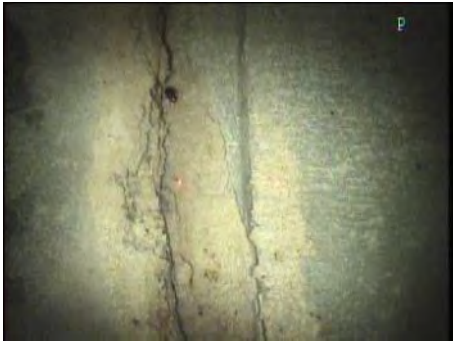
27.1 ft. D / Joint- Wide

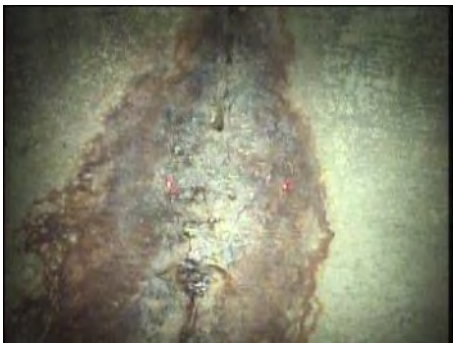
47.6 ft. D / Joint - Infiltration

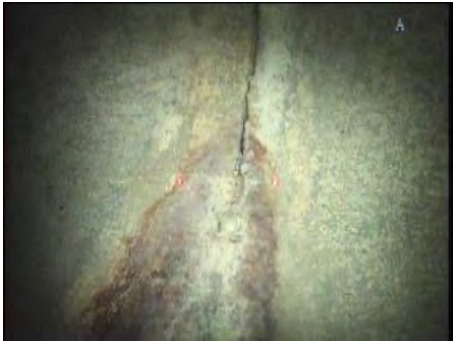
51.5 ft. D / Joint - Infiltration

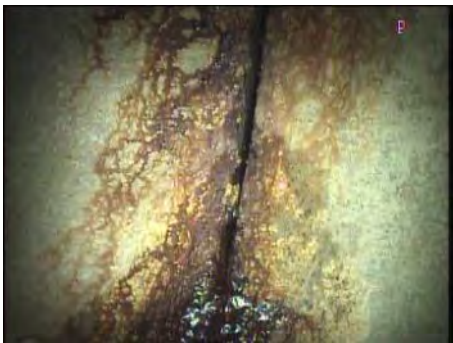
76.3 ft. D / Joint - Infiltration

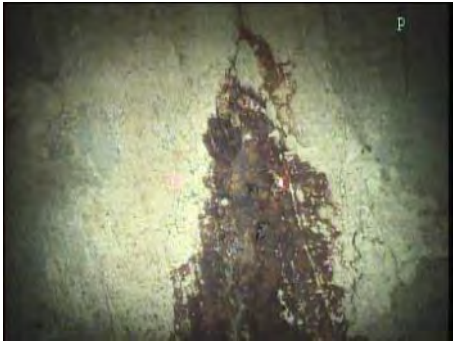
92.9 ft. D / Joint - Infiltration

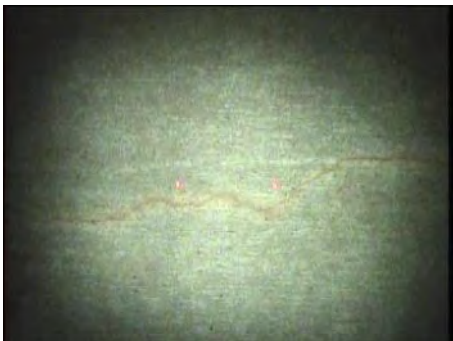
102.1 ft. D 35.8 ft. 12 / Crack

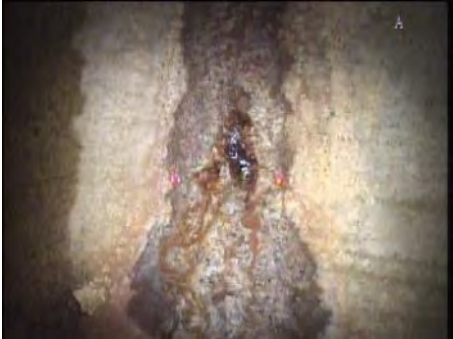
| Distance | Dir. | Length | From/To | Code | Modifier/Severity | Rating | Comments |
|---|---|---|---|---|---|---|---|
| 109.0 ft. | D | | / | Joint - Infiltration | | | |

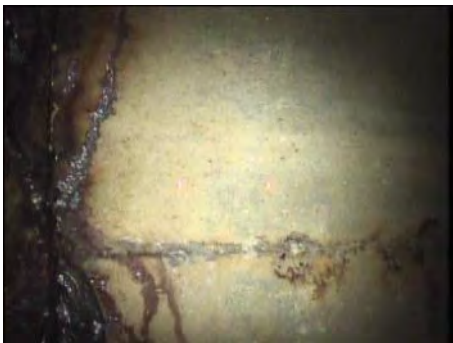
207.6 ft. D 78.9 ft. 12 / Crack

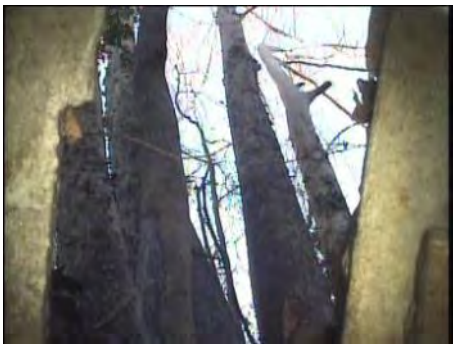
286.2 ft. D / Joint - Separated

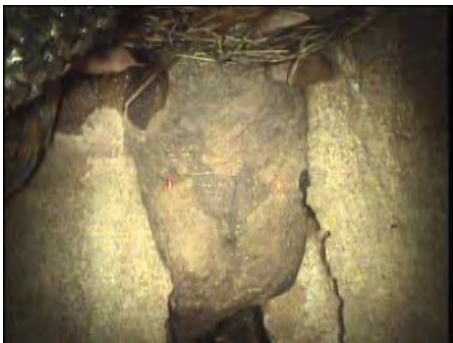
286.2 ft. D / Root-in-Joint

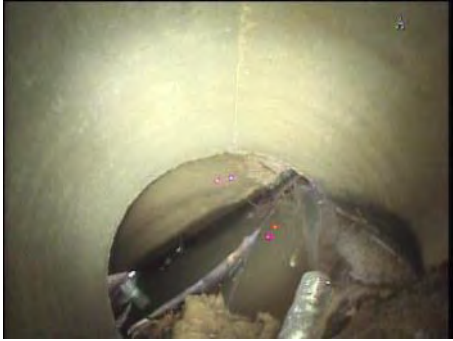
| Distance | Dir. | Length | From/To | Code | Modifier/Severity | Rating | Comments |
|---|---|---|---|---|---|---|---|
| 286.4 ft. | D | | / | Abandoned Survey | | | Abandoned due to Joint Seperation and Last Joint Broken Off |

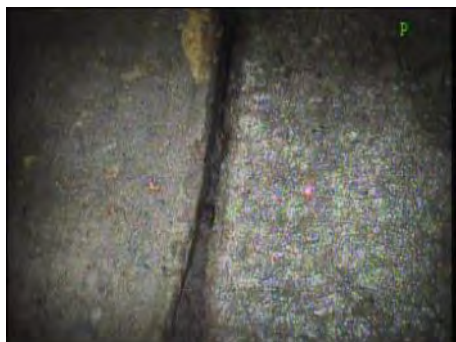
| Distance | Dir. | Length | From/To | Code | Modifier/Severity | Rating | Comments |
|---|---|---|---|---|---|---|---|
| 5.1 ft. | U | | / | Joint Offset | | | Misaligned |

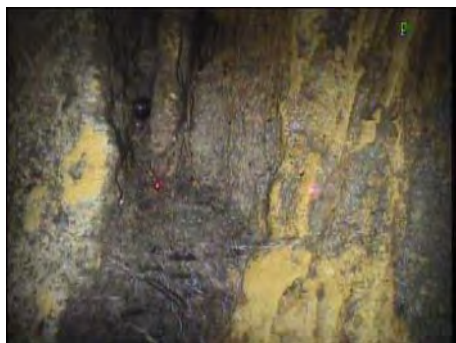
| 9.2 ft. | U | | / | Joint Offset | | | Misaligned |

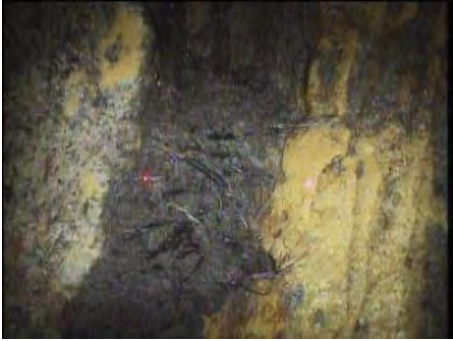
| Distance | Dir. | Length | From/To | Code | Modifier/Severity | Rating | Comments |
|---|---|---|---|---|---|---|---|
| 9.5 ft. | U | | / | Root-in-Joint | | | |

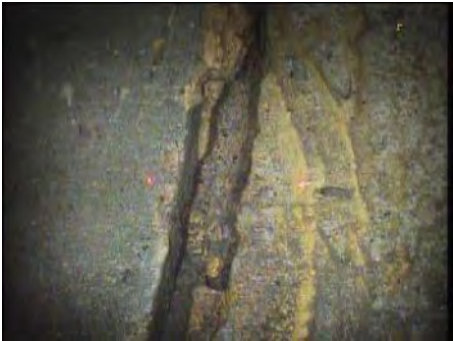
| Distance | Dir. | Length | From/To | Code | Modifier/Severity | Rating | Comments |
|---|---|---|---|---|---|---|---|
| 13.2 ft. | U | | / | Joint Offset | | | Misaligned |

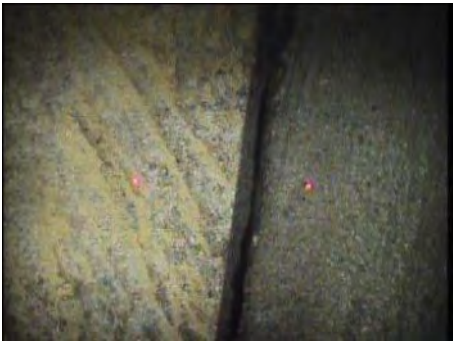
| Distance | Dir. | Length | From/To | Code | Modifier/Severity | Rating | Comments |
|---|---|---|---|---|---|---|---|
| 16.9 ft. | U | | / | Joint Offset | | | |

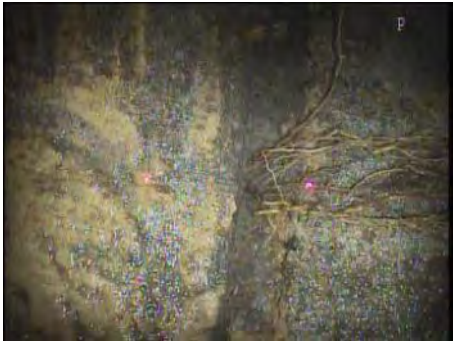
95.4 ft. U / Root-in-Joint

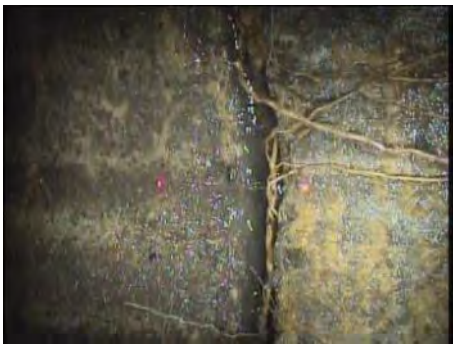
103.5 ft. U / Root-in-Joint

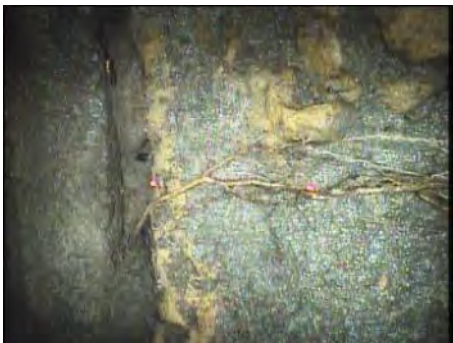
107.6 ft. U / Root-in-Joint

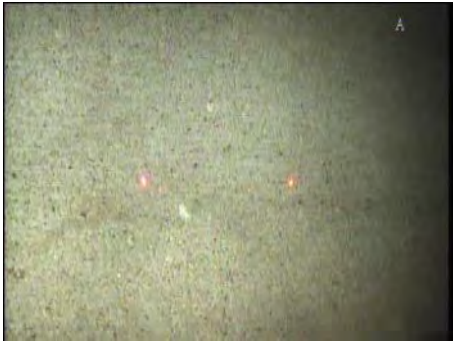
80.0 ft. U 9 / Crack

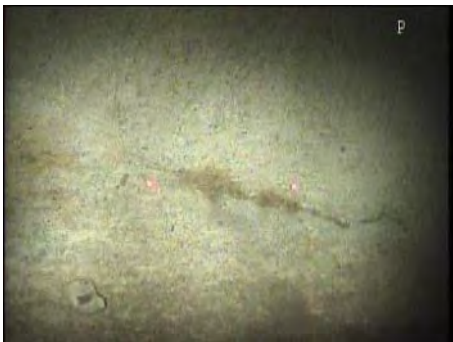
120.9 ft. U 8 / Crack

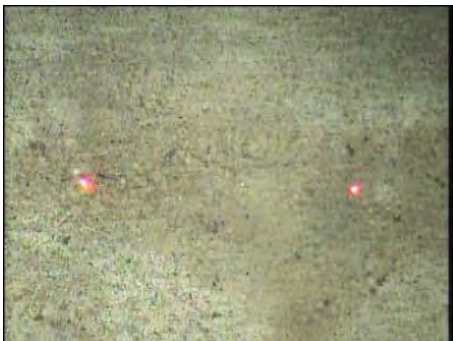
125.5 ft. U 9 / Crack

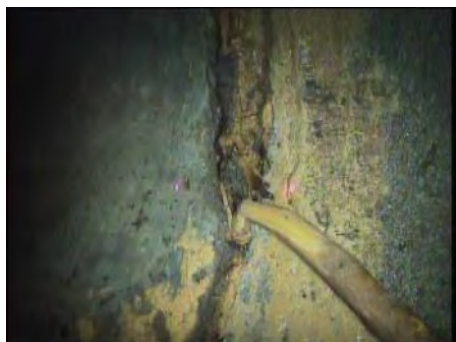
| Distance | Dir. | Length | From/To | Code | Modifier/Severity | Rating | Comments |
|---|---|---|---|---|---|---|---|
| 4.9 ft. | U | | / | Root-in-Joint | | | |

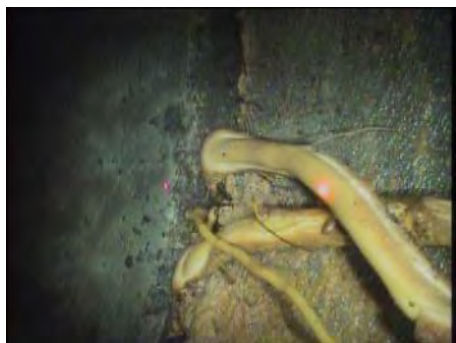
| 11.0 ft. | U | | / | Root-in-Joint | | | |

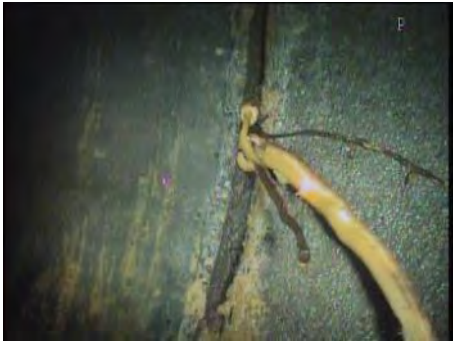
17.1 ft. U / Root-in-Joint

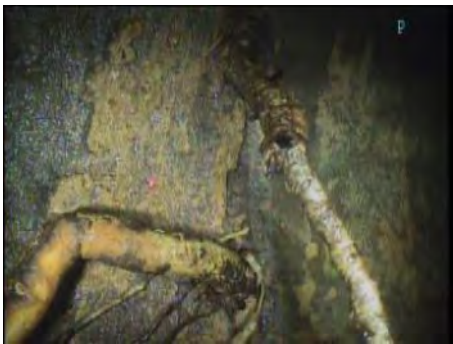
23.3 ft. U / Root-in-Joint

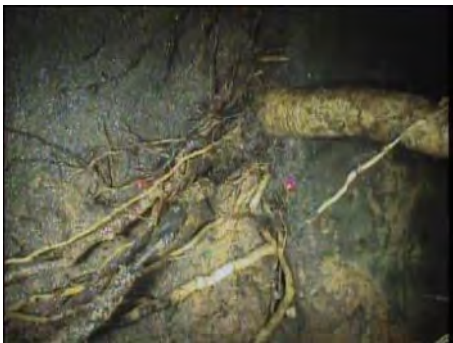
35.3 ft. U / Root-in-Joint

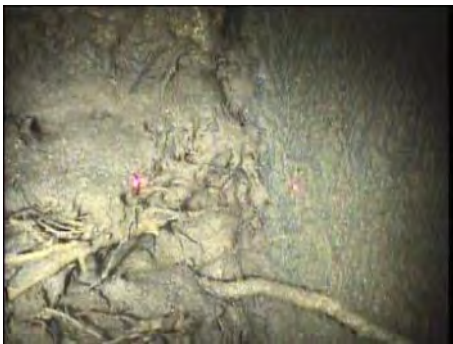
47.9 ft. U / Root-in-Joint

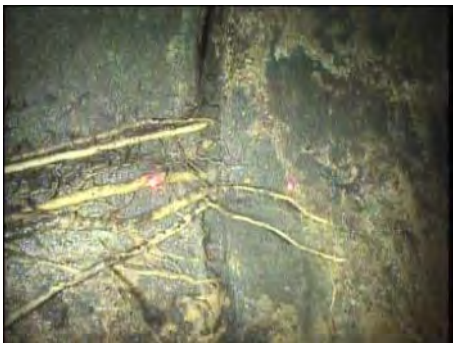
72.3 ft. U / Root-in-Joint

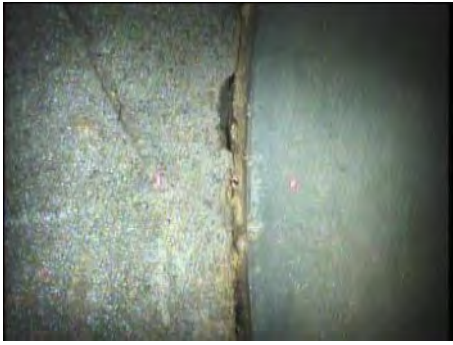
84.5 ft. U / Joint Offset

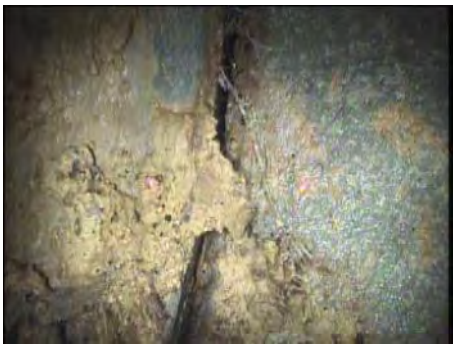
90.7 ft. U / Joint Offset

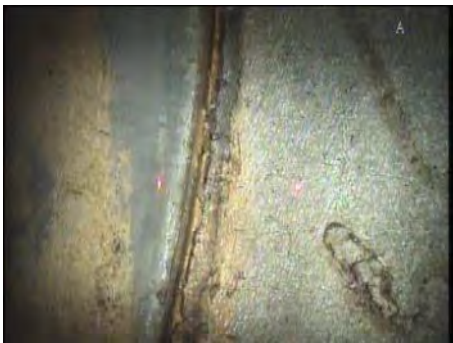
108.9 ft. U / Joint Offset

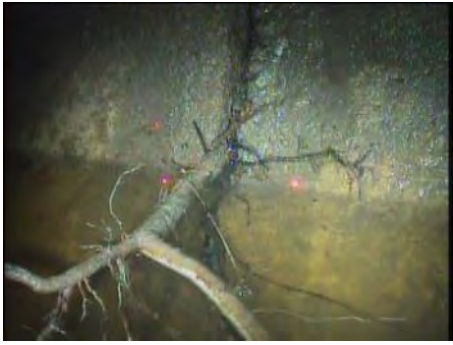
111.0 ft. D / Root-in-Joint

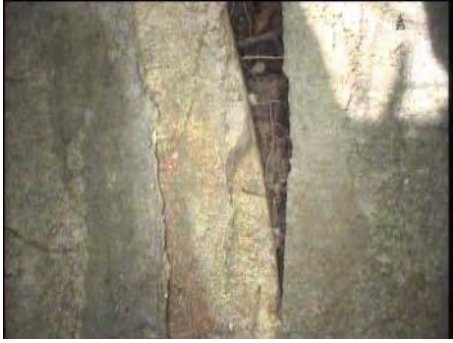
265.2 ft. D / Joint - Separated

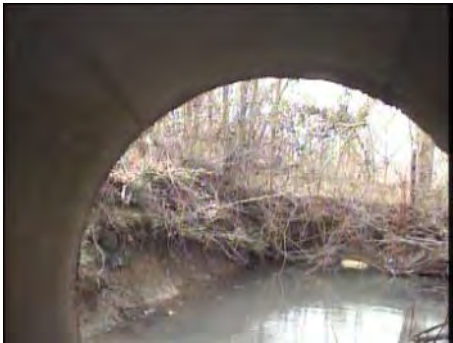
265.8 ft. D / Abandoned Survey

Abandon due to last  
pipe broken seperated

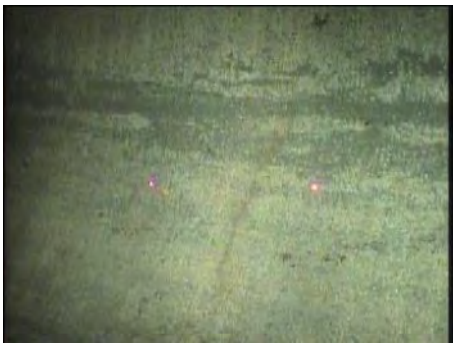
50.1 ft. D 3 / Crack

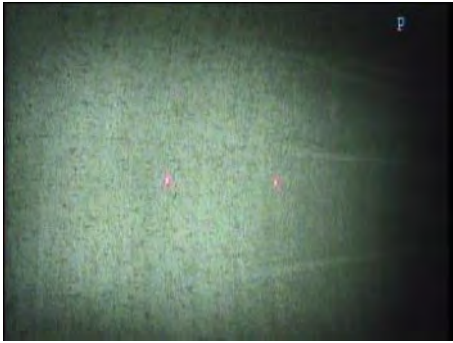
55.4 ft. D 55.9 ft. 12 / Crack

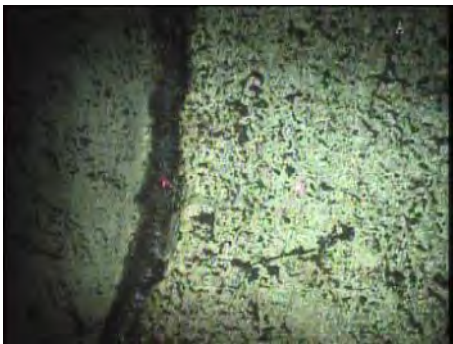
104.3 ft. D / Joint - Gasket

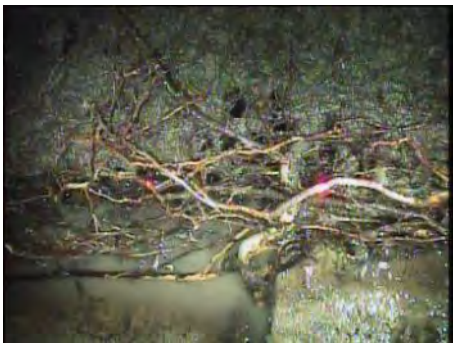
104.6 ft. D / Root-in-Joint

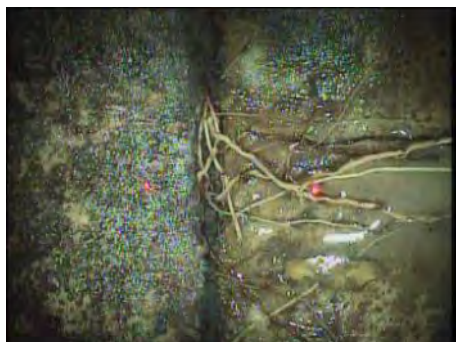
| Distance | Dir. | Length | From/To | Code | Modifier/Severity | Rating | Comments |
|---|---|---|---|---|---|---|---|
| 7.2 ft. | D | | / | Root-in-Joint | | | |

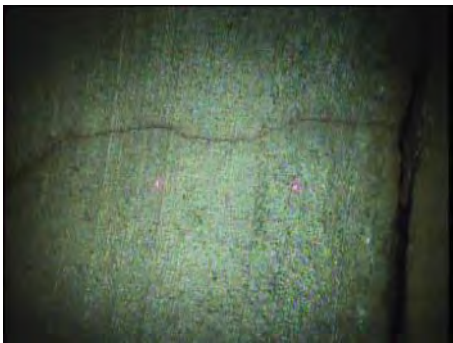
23.4 ft. D 7.9 ft. 2 / Crack

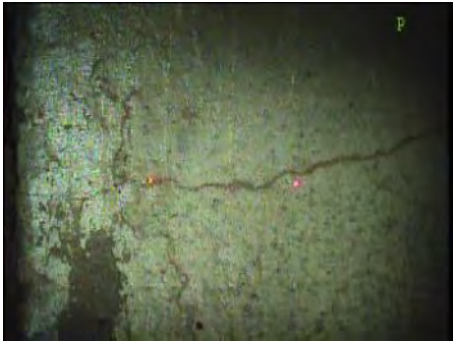
31.3 ft. D 9 / Crack

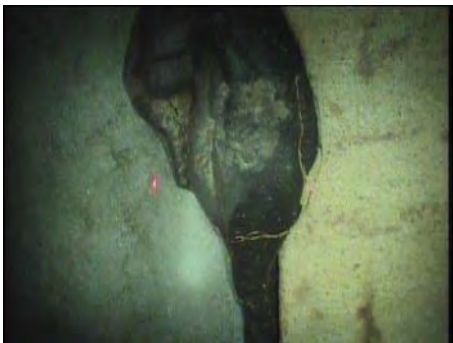
96.3 ft. D / Joint - Gasket

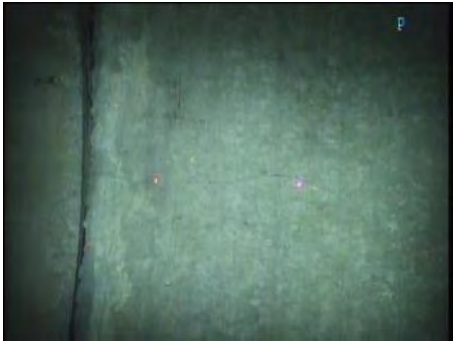
67.1 ft. D 39.4 ft. 12 / Crack

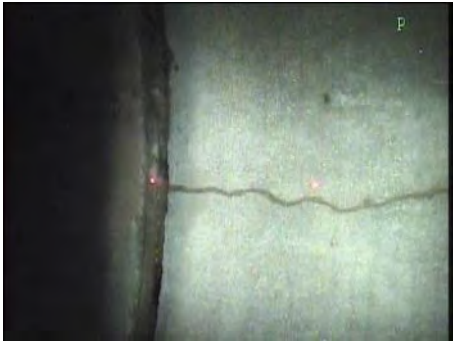
19.3 ft. D 12 / Crack

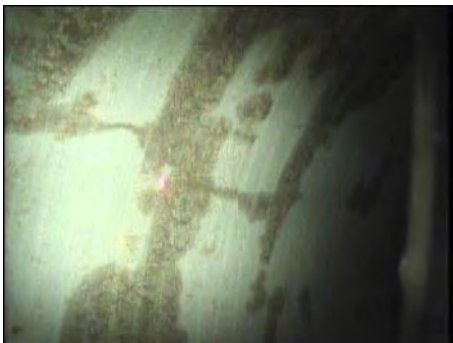
72.7 ft. D 3 / Crack

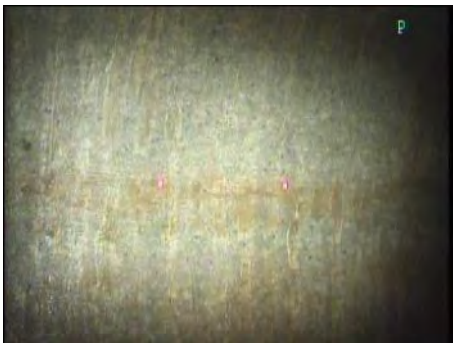
89.8 ft. D 7 / Crack

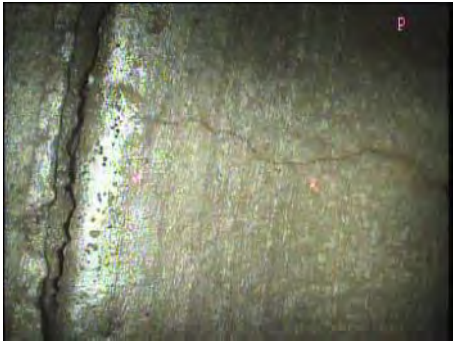
108.5 ft. D 32.0 ft. 12 / Crack

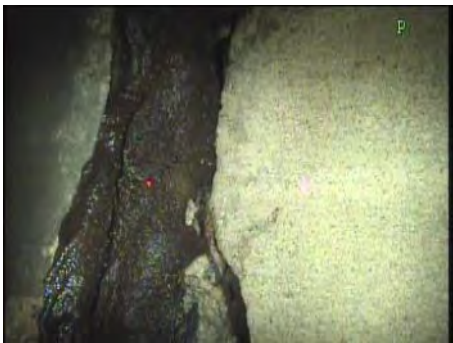
140.5 ft. D 11 / 3 Broken

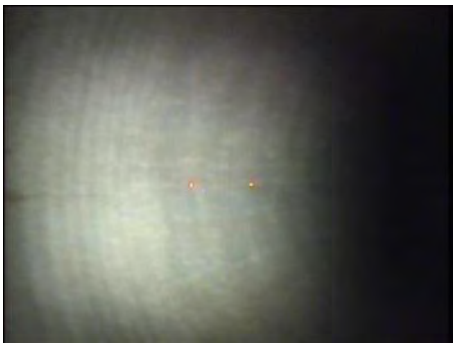
68.4 ft. U 42.7 ft. 12 / Crack

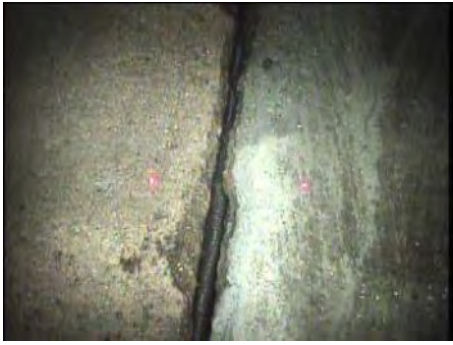
125.8 ft. U / Joint Offset

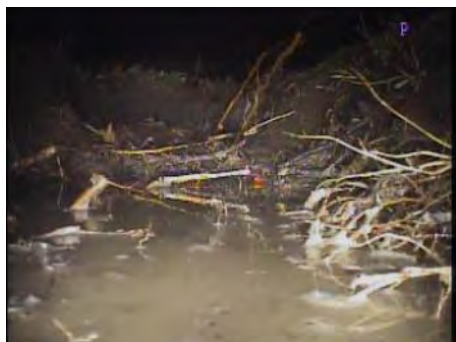
| Distance | Dir. | Length | From/To | Code | Modifier/Severity | Rating | Comments |
|---|---|---|---|---|---|---|---|
| 115.1 ft. | D | | / | End of Pipe | | | End of Pipe was unable to be cleaned due to ground elevation higher than pipe invert |

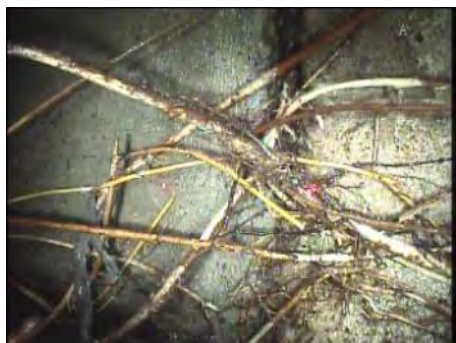
| 110.6 ft. | D | | / | Root-in-Joint | | | |

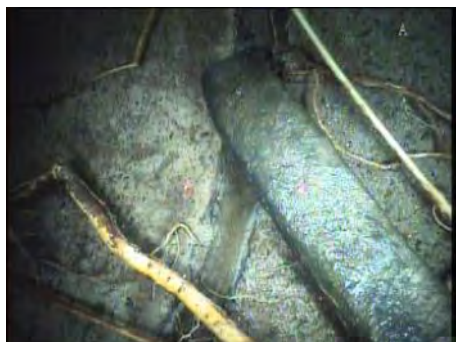
| Distance | Dir. | Length | From/To | Code | Modifier/Severity | Rating | Comments |
|---|---|---|---|---|---|---|---|
| 4.6 ft. | U | | / | Root-in-Joint | | | |

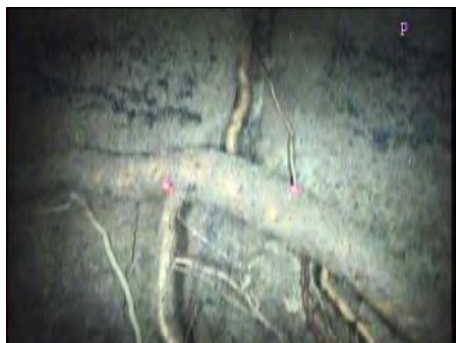
| 12.0 ft. | U | | / | Root-in-Joint | | | |

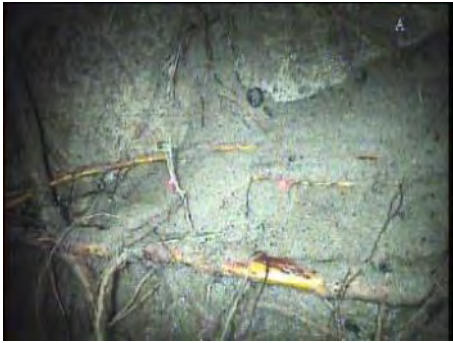
20.0 ft. U / Root-in-Joint

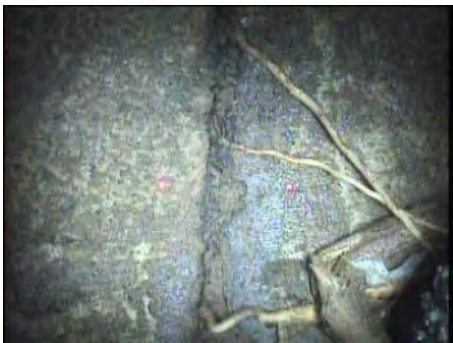
36.8 ft. U / Root-in-Joint
